PCC PAVEMENT JOINT RESTORATION
AND REHABILITATION
(Federal Highway Administration NEEP Project 27)
Final Report

J. E. Simonsen
A. W. Price

Research Laboratory Section
Materials and Technology Division
Research Project 79 F-159
Research Report No. R-1298

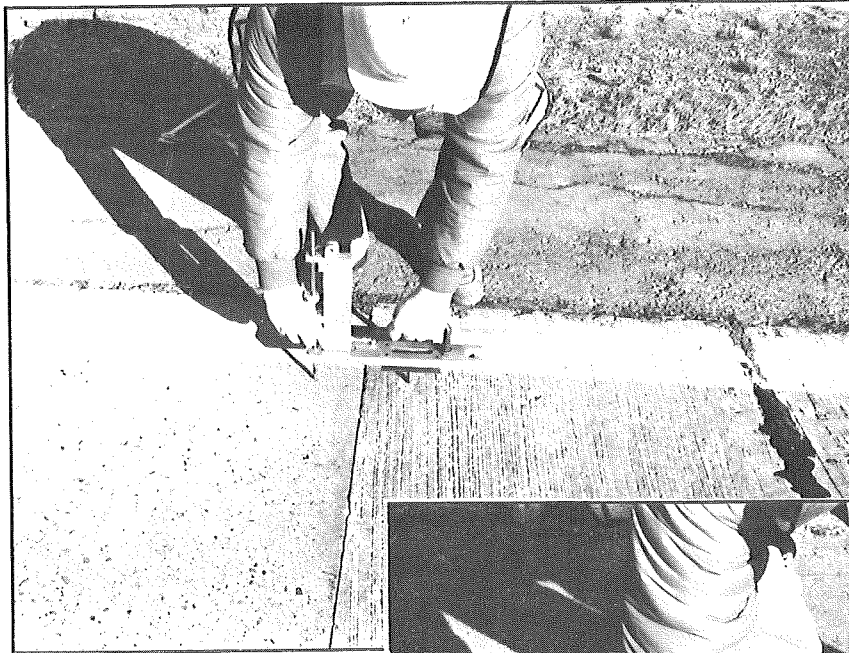
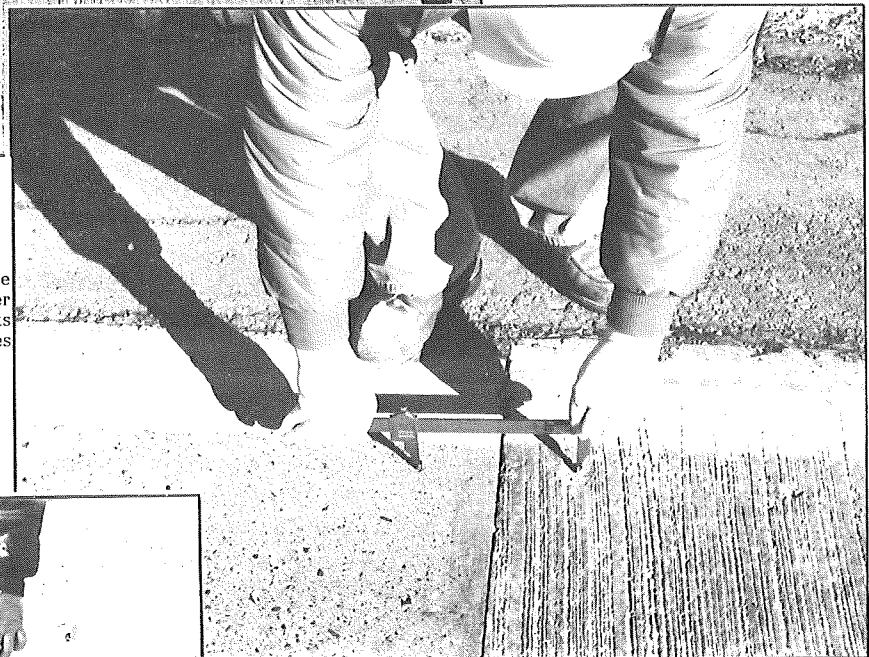
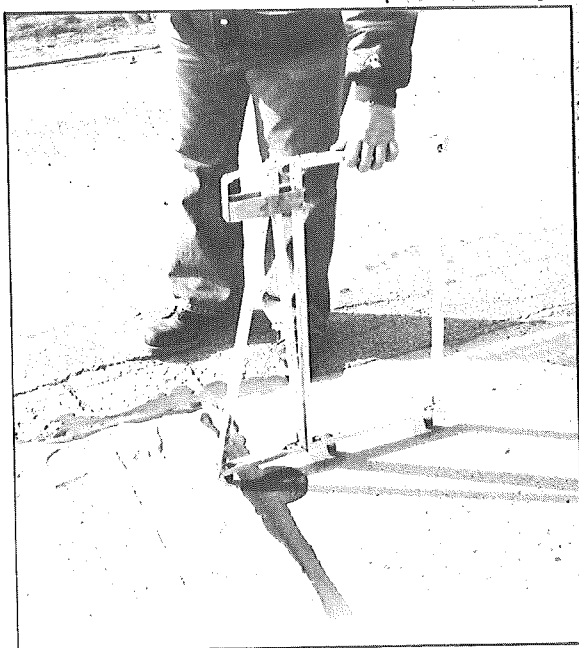
Figure 1. Measurement of vertical and horizontal movements at repair joints.

(a) Measurement of vertical change to the nearest 1/32 in. The two legs of the instrument fit into counter drilled holes in the reference pins. The instrument is held level and vertical difference between the length of the movable and the fixed leg is read on a linear scale.

(b) Measurement of horizontal change to the nearest 0.001 in. The vernier caliper is equipped with tapered points which fit into the counter drilled holes in the reference plugs.

(c) Measurement of vertical change to the nearest 1/16 in. The instrument rests on three feet and is hinged between the second and third feet. The upward or downward rotation is measured as the vertical displacement on a linear scale mounted to the handle.

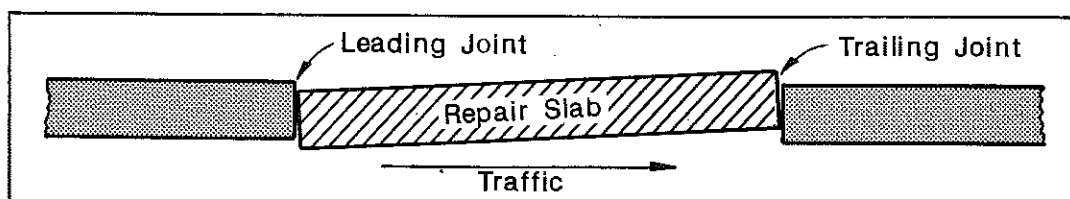
Figure 2. Sketch showing most common mode of faulting.

In nearly all cases the vertical measurements indicated that the repair slabs will settle at the leading joint and rise at the trailing joint. Figure 2 illustrates the common mode of faulting at repair slabs.

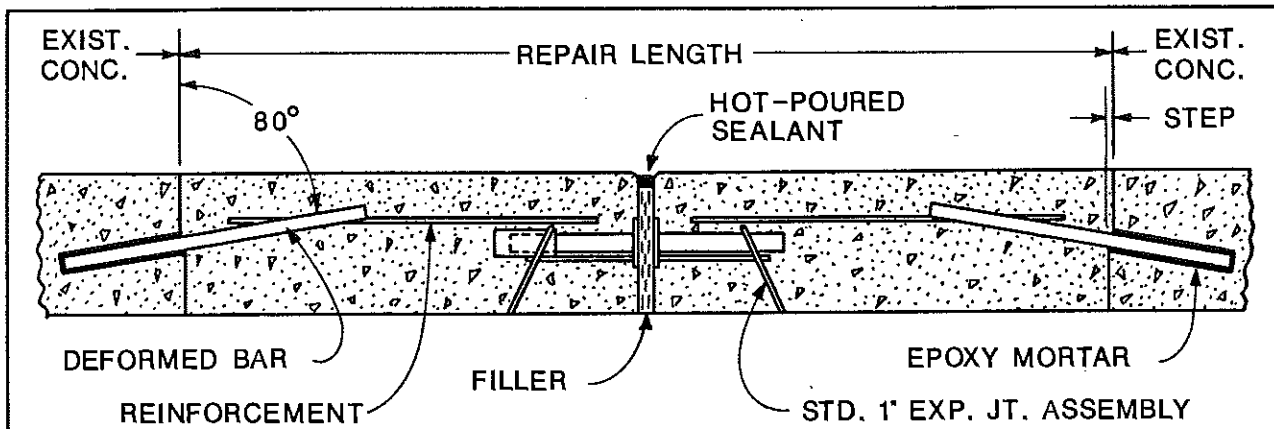
Step-cut tied end joints (expansion joint in center)

Two of the repairs utilizing step-cut tied joints have failed, one in 1983 and one in 1984. The failures occurred as a result of slippage of the tie bars grouted into the existing concrete. Joint openings as large as 0.5 in. were measured at the time the failures were noted. The remaining joints of the third repair have functioned properly with the horizontal movements not exceeding 0.04 in. (Fig. 8). The graph in Figure 8 showing the vertical movement includes the measurements at the failed tied joints; however, as shown the maximum average offset measured was just slightly over 1/16 in.

The end joints had a 1/4-in. wide sawed step at mid-depth (constructed by mounting two 18-in. blades next to a single 26-in. diameter blade). Seven No. 6 deformed bars, 20 in. long were set in epoxy mortar in 1-3/8-in. diameter holes, drilled 8 in. deep into the end face at mid-depth of the slab. The bar spacing was: 12-18-18-24-24-18-18-12 in. (the first and last bar were 12 in. from the lane edge). A conventional 1-in. expansion joint was installed in the repair's center to accommodate slab length changes.

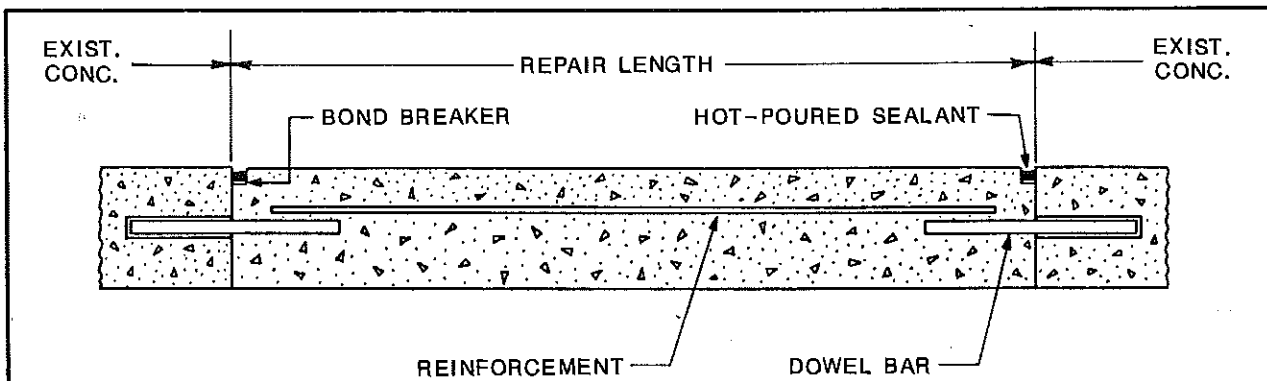
Dowelled contraction joints

The dowelled contraction joints (Fig. 10) and the dowelled expansion joints (Fig. 11) have moved in a quite similar manner. Both showed a 1/16-in. vertical offset at the first winter measurement and since then have varied from 1/32 to slightly over 3/32 in.

A contraction joint was constructed at each end joint by placing nine 1-5/16-in. diameter steel dowels, 15 in. long in 1-3/8-in. diameter holes drilled 7-1/2 in. deep into the end face at mid-depth of the slab. The spacing from edge to edge of the lane was: 12-18-12-12-18-18-12-12-18-12 in.
