TRANSVERSE JOINT PROBLEMS

**Report No. 327
Research Laboratory Division
Office of Testing and Research
Research Project 39 F-7(14)**

**Michigan State Highway Department
John C. Mackie, Commissioner
Lansing, April 1960**

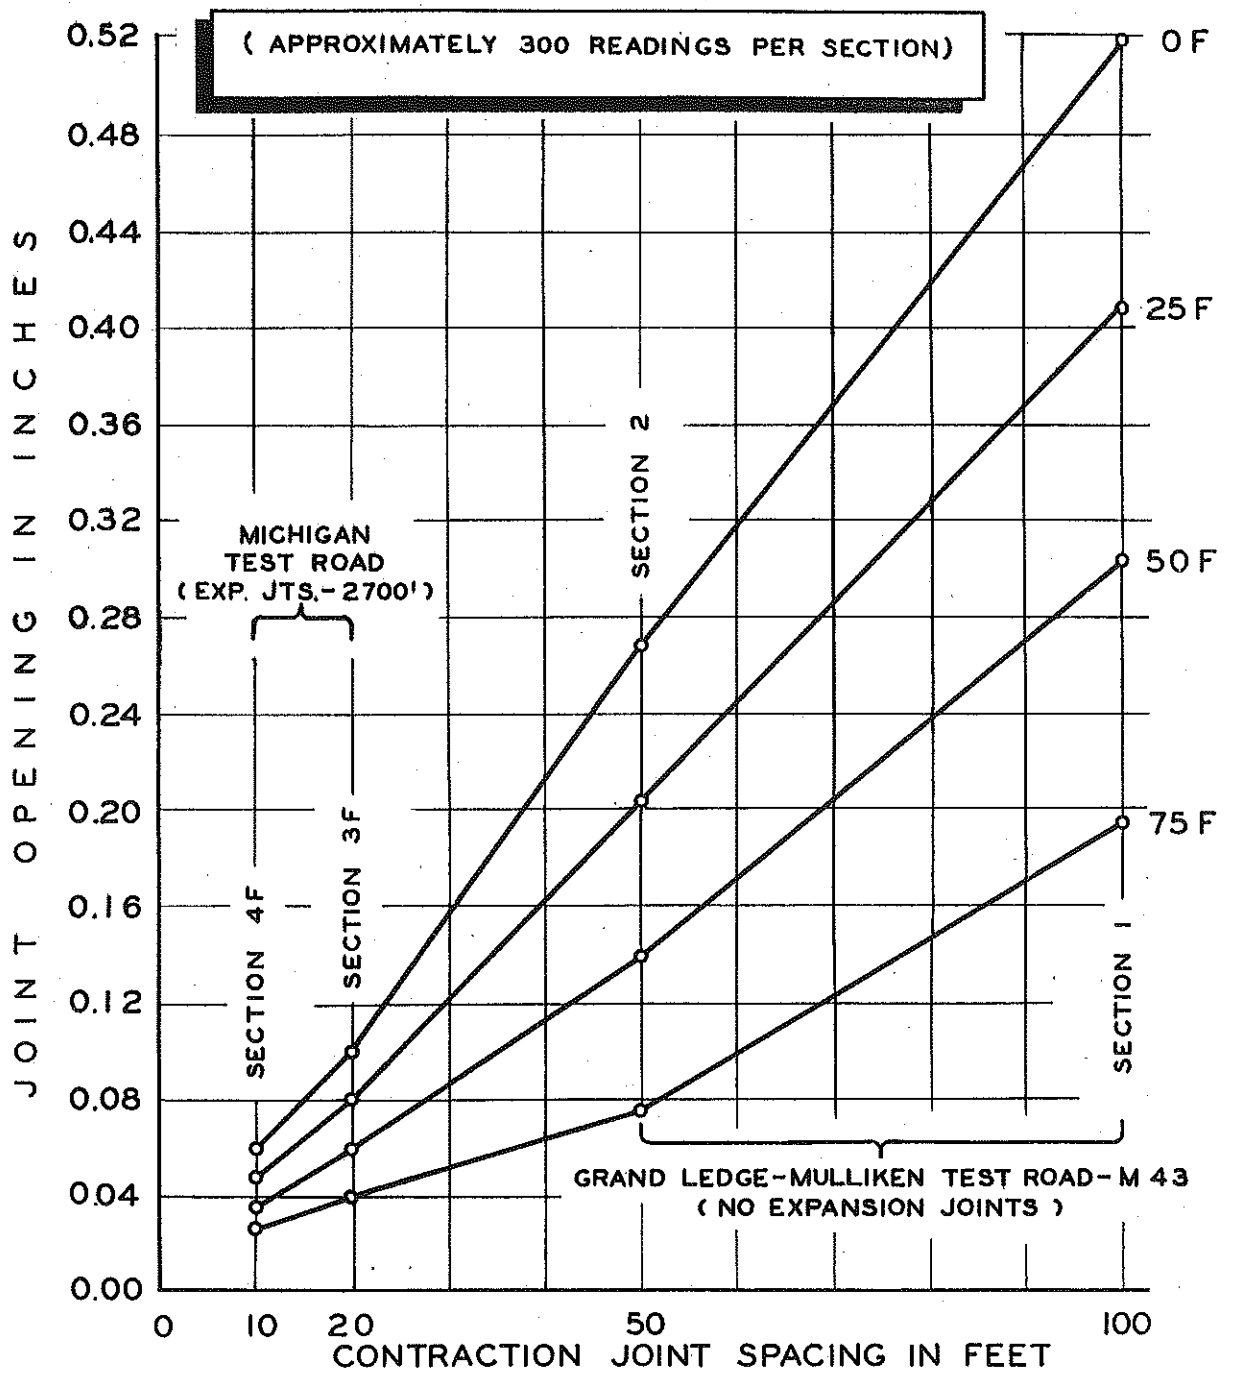
Figure 18. Effect of Slab Length on Contraction Joint Opening

The graph in Figure 18 shows the effect of slab length on contraction joint opening, based on Michigan data. This graph clearly shows that present contraction joints can be expected to open as much as 0.50 in. under extreme temperature conditions.

Measurements of joint width openings on several experimental pavements in Michigan indicate that under normal conditions, joint width movements of around 0.2 to 0.3 in. may be expected. Considering this fact in conjunction with the data above, it is indicated that the formed joint opening should be 3/4-in., instead of 1/2-in. as now constructed.
