PROTECTIVE COATINGS FOR HIGHWAY METALS

MICHIGAN DEPARTMENT OF STATE HIGHWAYS

**A. J. Permoda
A. R. Gabel**

**Research Laboratory Section
Testing and Research Division
Research Project 49 G-50(5)
Research Report No. R-916**

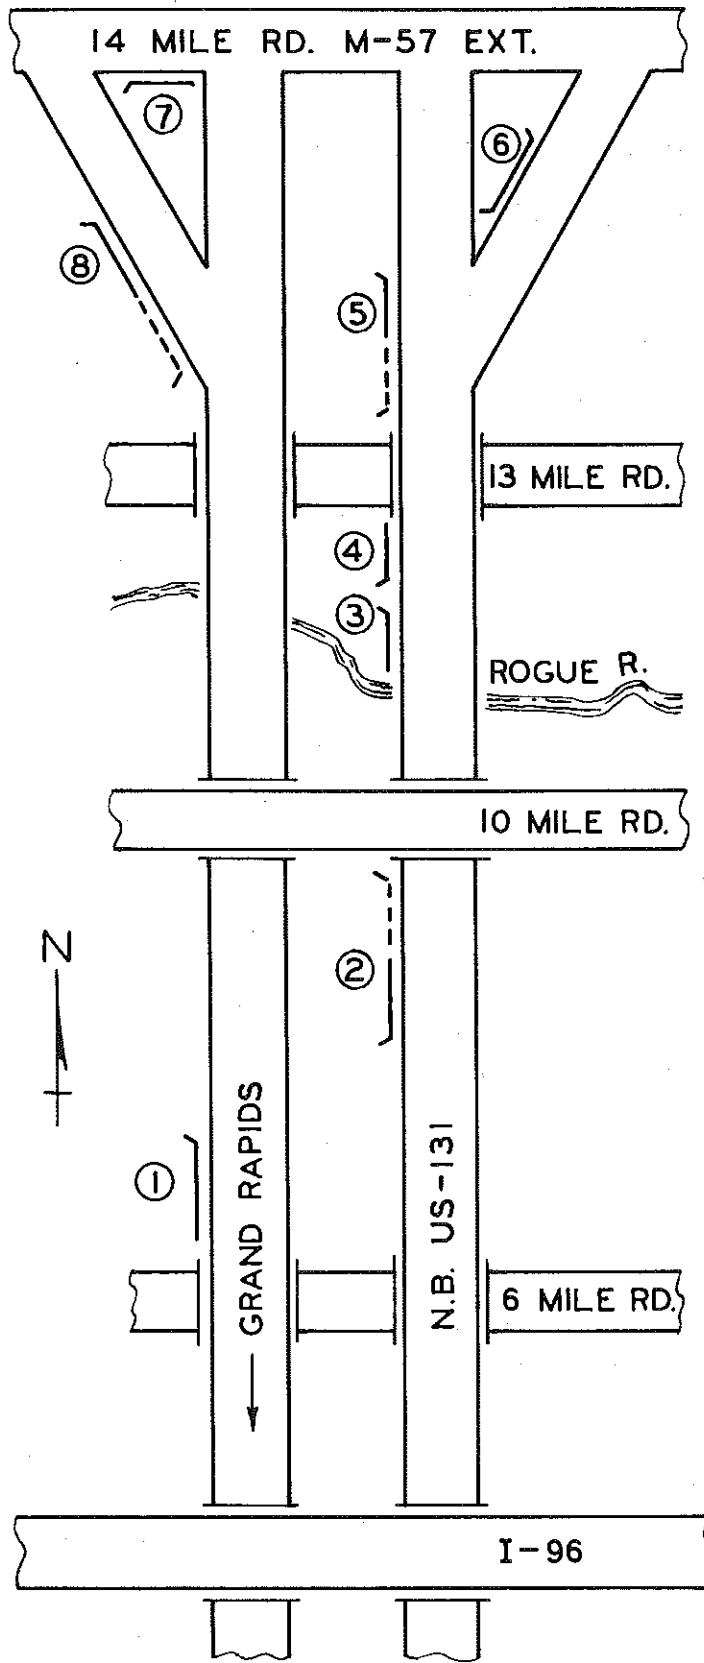
Figure 9. Location of test topcoated galvanized guardrail on US 131.

Area 1 galvanizing installed in fall '68 ; all others installed in summer through fall '69 . Area 1 showed no white rusting over winter exposure, unopened to traffic. Galvanizing is a mixture of pregalvanizing and hot dipped.

Coatings were applied on October 22, 1969 at about 45 F; a light wind was blowing.

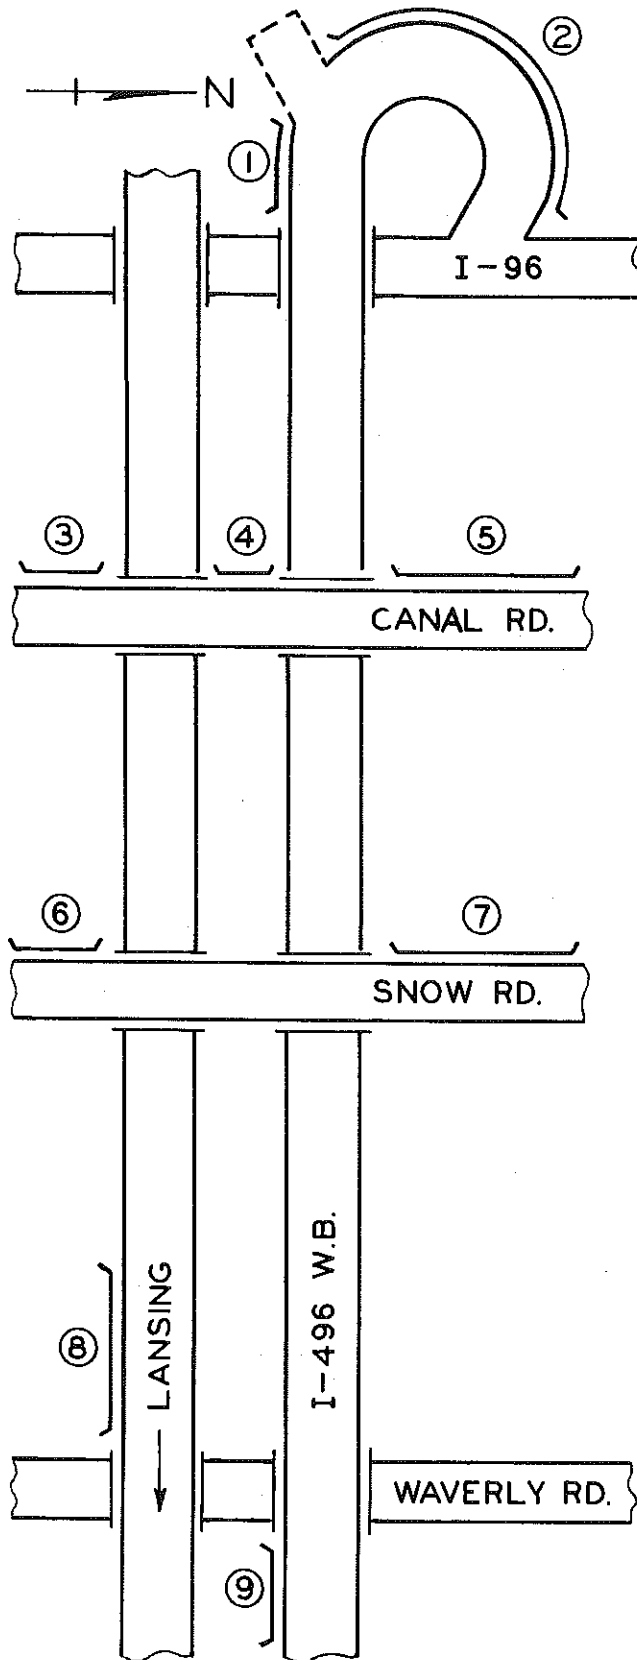
*Guardrail installed in fall '68 ; pregalvanized with long edges ungalvanized. No white rusting apparent during over-winter exposure, unopened to traffic. All others installed in November '69 , consisting of 'Syro' pregalvanized rails with long edges galvanized.

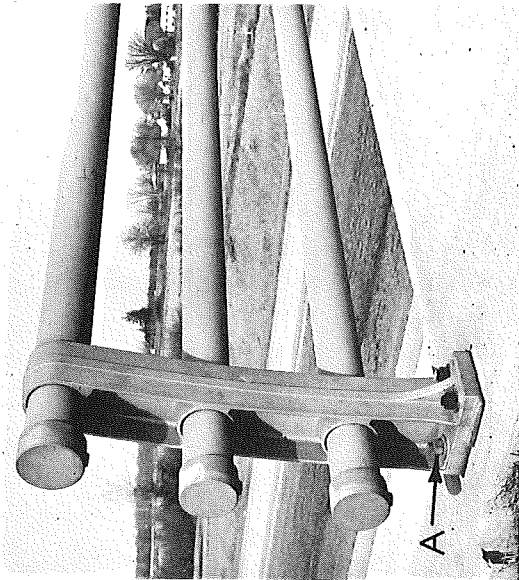
Figure 18. Three-tube all aluminum bridge railing on S01 of 23152 (1961) over I 96 in west Lansing. Aluminumized post bolts (A) are being evaluated on the structure.

3) All Aluminum - In about 1960, the Department began evaluating this type railing consisting of several longitudinal tubes, supported by cast-aluminum posts (Figs. 18 and 19). Comparatively, it was a lower cost railing which was specified on some new construction for about two years.

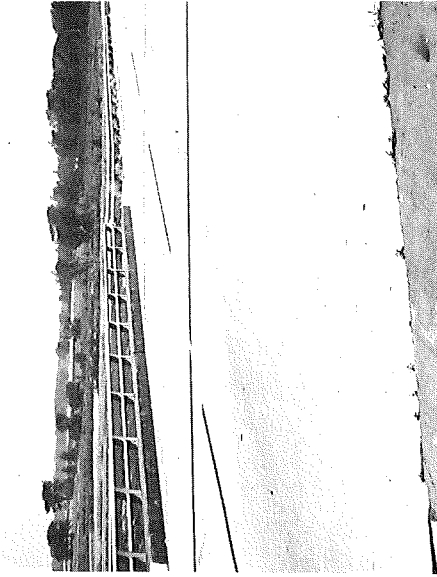
Figure 19. Two-tube all aluminum bridge railing on S07 of 23152 (1962) on I 96 over Canal Rd in southwest Lansing.

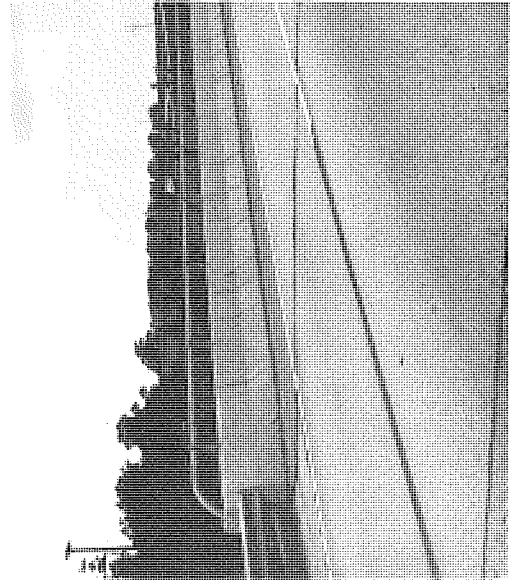
Figure 21. Concrete barrier railing on B02 of 23151 (1962) on I 96 over the Grand River in southwest Lansing. The railing replaced the original of another design in 1969.

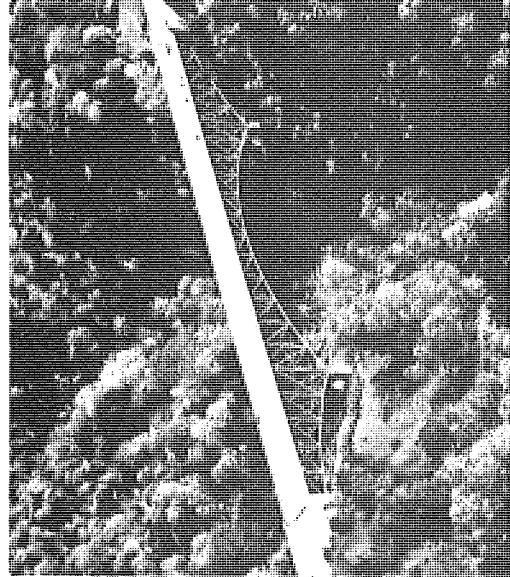
Figure 22. US 2 over the Cut River in the Upper Peninsula borders on Lake Michigan, lower right. B01 of 49023 (October 1965).

1) B01 of 49023 (1948) carrying US 2 over the Cut River was painted in 1962-64 by a succession of three contractors, with Neumann Co. finishing. The bridge is a somewhat unusual structure and a tourist attraction with the scenic park below overlooking Lake Michigan (Fig. 22). The two end-spans are subject to an abnormal amount of vandalism -- name inscribing and paint damage -- by young tourists. The bridge is 555 ft long, with the deck 147 ft above the river. The structural steel weighs 875 tons and includes many latticed box beams. The applicable specifications called for spot cleaning by mechanical tools, if needed, followed by sandblasting. The spots were then primed with No. 1 red lead, followed by No. 2 MP brown and No. 5B aluminum. All steel was then finish painted with No. 5B aluminum. Before repainting, the gutters and downspouts were removed and plugged since it was noticed that windblown drainage was accelerating the breakdown of the coatings on the significant height of steel below them.

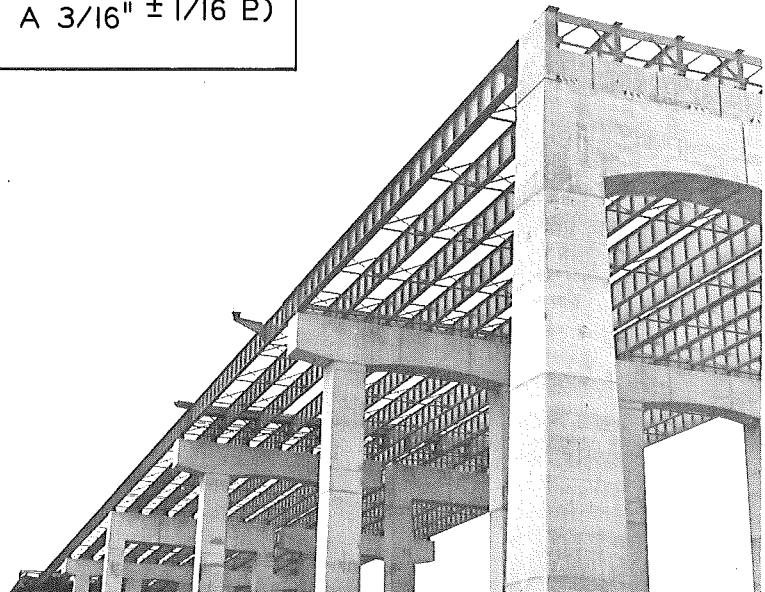
Figure 25. Setting shop primed beams on Rouge River bridge piers no. 40, 41, etc. just north of river piers no. 38 and 39. The biggest beams were 129-in. high. (B01 of 82194, November 1965.)

I 75 over Rouge River in Detroit, B01 of 82194 - This is an eight-lane, divided structure, 8,626 ft long. It has 106 spans, with beam depths varying from 3 to 11 ft. The structural steel weighs 20,000 tons. All steel was blastcleaned to a SSPC No. 6 (commercial) specification. The painting was divided into two contracts, with the first including application of the standard Department No. 1A(1) red-lead shop primer, field spot priming over the mars, and the No. 2A(2) brown first field coat (Fig. 25). The second contract covered application of the Department's No. 3A(1) gray intermediate and No. 5E blue-gray topcoat. It also included application of an additional "striped" coat on beam-ends under open expansion joints and outside faces of fascia beams using a 1:1 mixture of the two topcoats. The painting extended through October 1968, though the bridge was opened to traffic in December 1967.

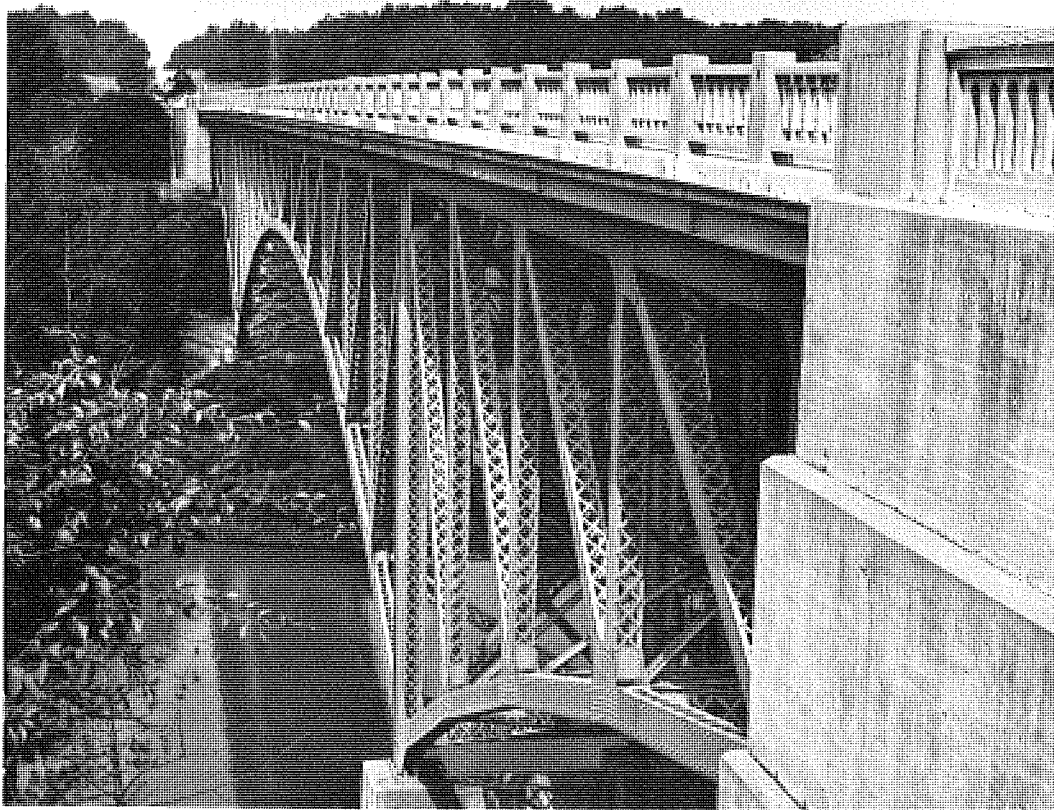
The Cooley bridge is a prototype of the Cut River Bridge (Fig. 27). Because of difficulties in estimating the amount of spot painting required on the latter, the Department required complete blastcleaning on the Cooley bridge. Airless spray painting was allowed. The cost of repainting the Cooley bridge came to about \$86 per ton of structural steel. Companion maintenance on the bridge included a bituminous overlay of the deck and plugging of mid-deck gutters. The latter was done to prevent localized aggressive corrosion as described on the Cut River bridge.

Figure 27. M 55 over the Pine River is a 3-span structure utilizing mostly latticed members that are difficult to paint. B03 of 51021 (Cooley Bridge) utilizes a design similar to that shown in Figure 22 (July 1972).

The governing specifications required complete removal of all rust and old paint by sandblasting to a SSPC No. 10 requirement followed by application of No. 2A brown (faster drying primer), No. 2 MP brown and No. 3A gray undercoats. The topcoat was No. 5B aluminum to yield a 5+ mil dry thickness for the coating system.

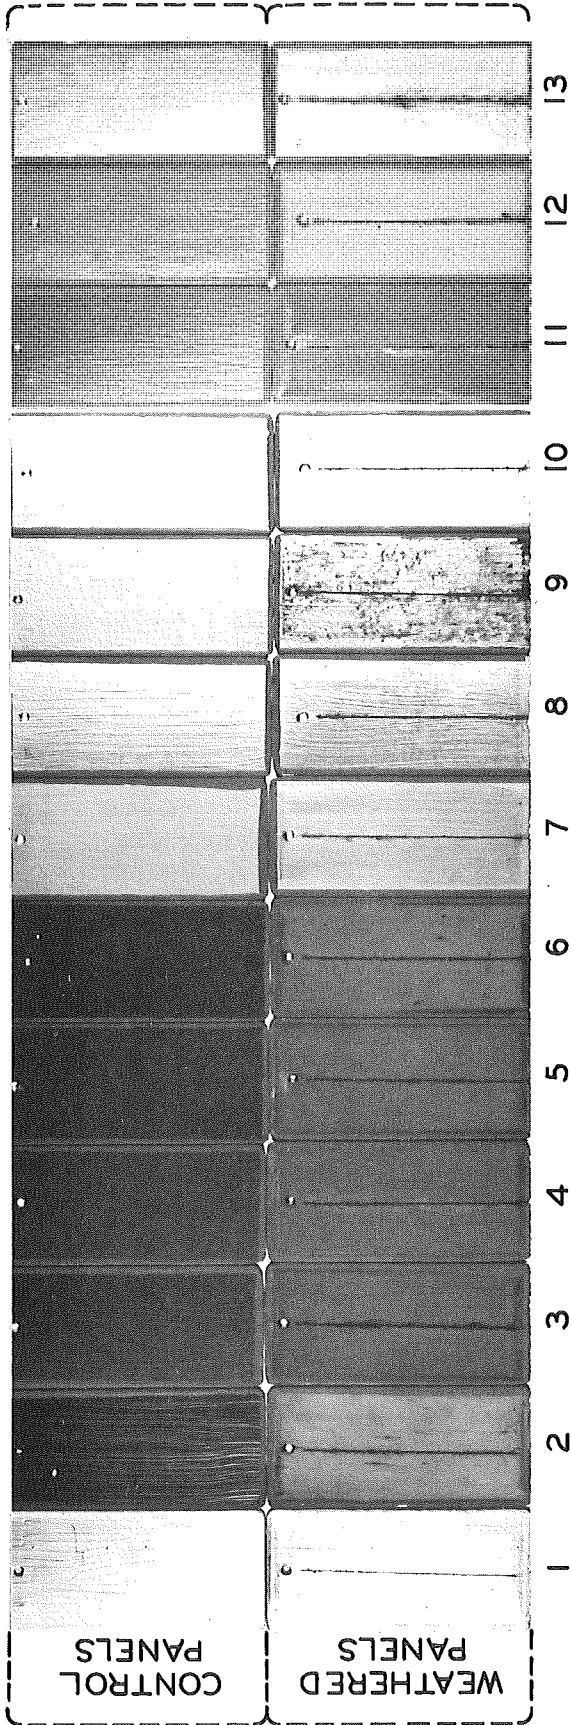
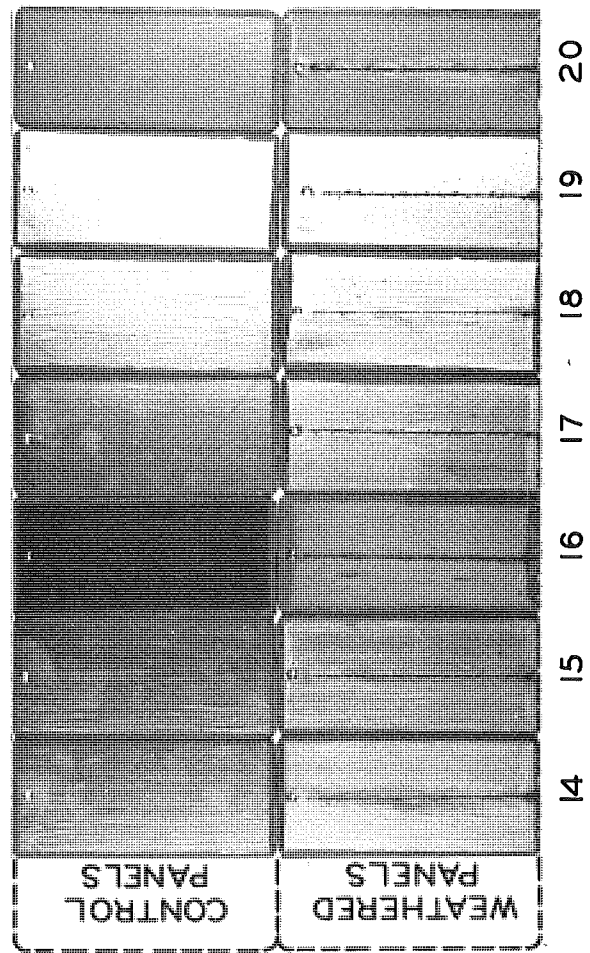
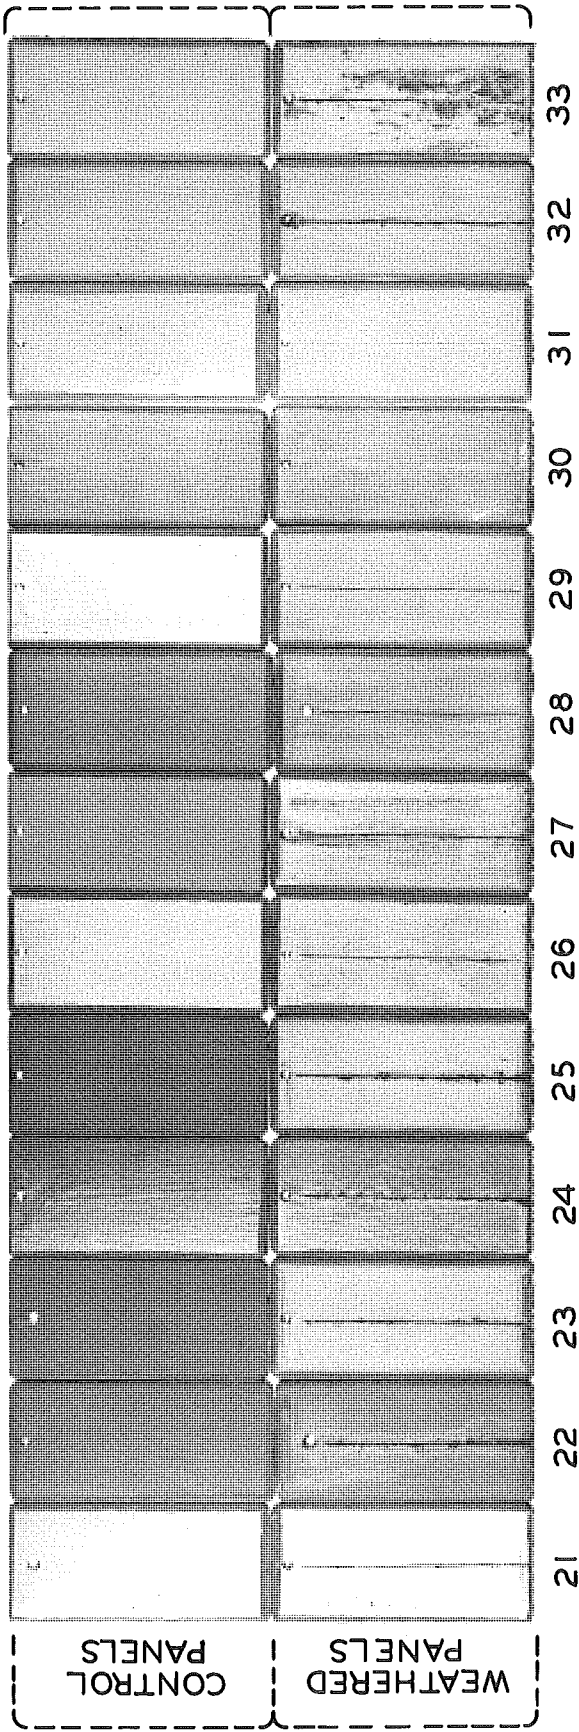
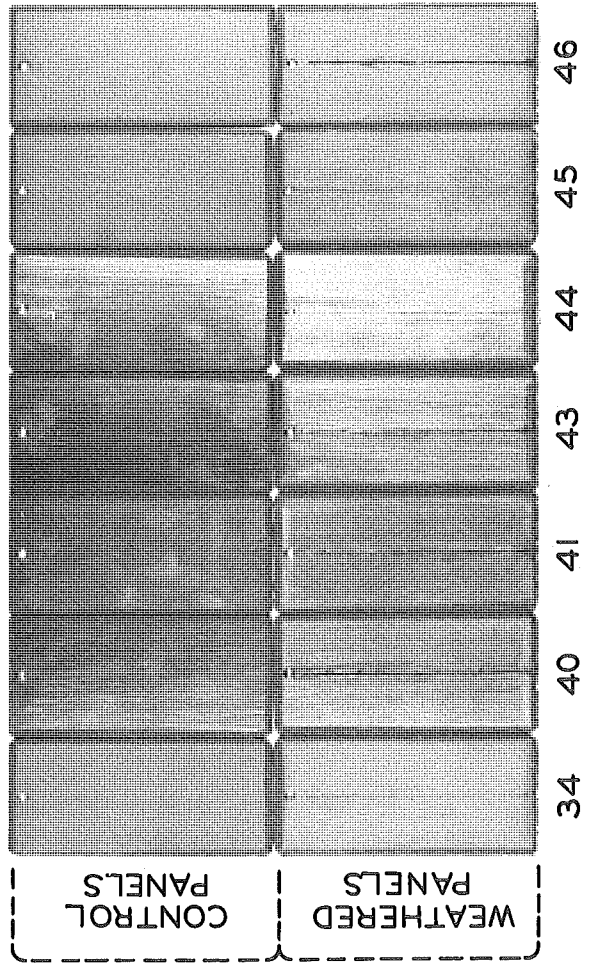
by 50 hours at 95F in a combination salt spray-humidity cabinet. The coated panels were exposed to seven such cycles for a total exposure of 1400 hours in the Weatherometer and 350 hours in the cabinet. At the conclusion of the laboratory testing, the exposed test panels were photographed with their respective control panels to show the amounts of degradation (Fig. 1) and were also rated visually.

Of the 46 test systems (listed in Table 1 and shown in Figure 1) 14 were classified as "very good" (defined as having received 24 or more points of a possible 30-point maximum performance rating) and carry the highest potential for possible Department use. They are listed in descending order of rating merit:

Figure 1. Test paint system panels with unexposed control above in each pair and weathered panel with vertical scratch below (identification and performance ratings in Table 1).

Figure 1 (Cont.). Test paint system panels with unexposed control above in each pair and weathered panel with vertical scratch below (identification and performance ratings in Table 1).

As in previous reports in this series, we recommend that evaluations be continued--via field tests on structural steel--on at least some of the best performing systems in these tests. The selection could by-pass systems already under field test, and could be made on either construction or maintenance-repainting projects.

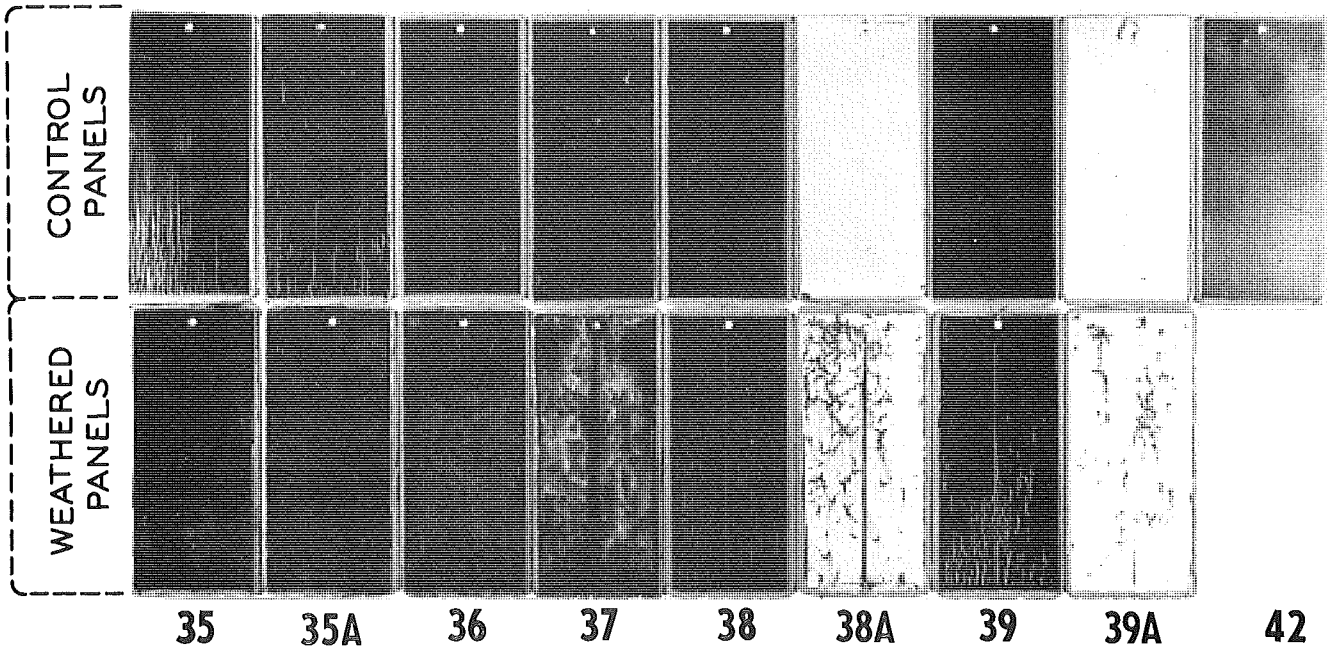
Figure 2. Test "grease type" coated panels with unexposed control, above, and laboratory weathered panel with vertical scratch, below (identification and performance ratings in Table 1).

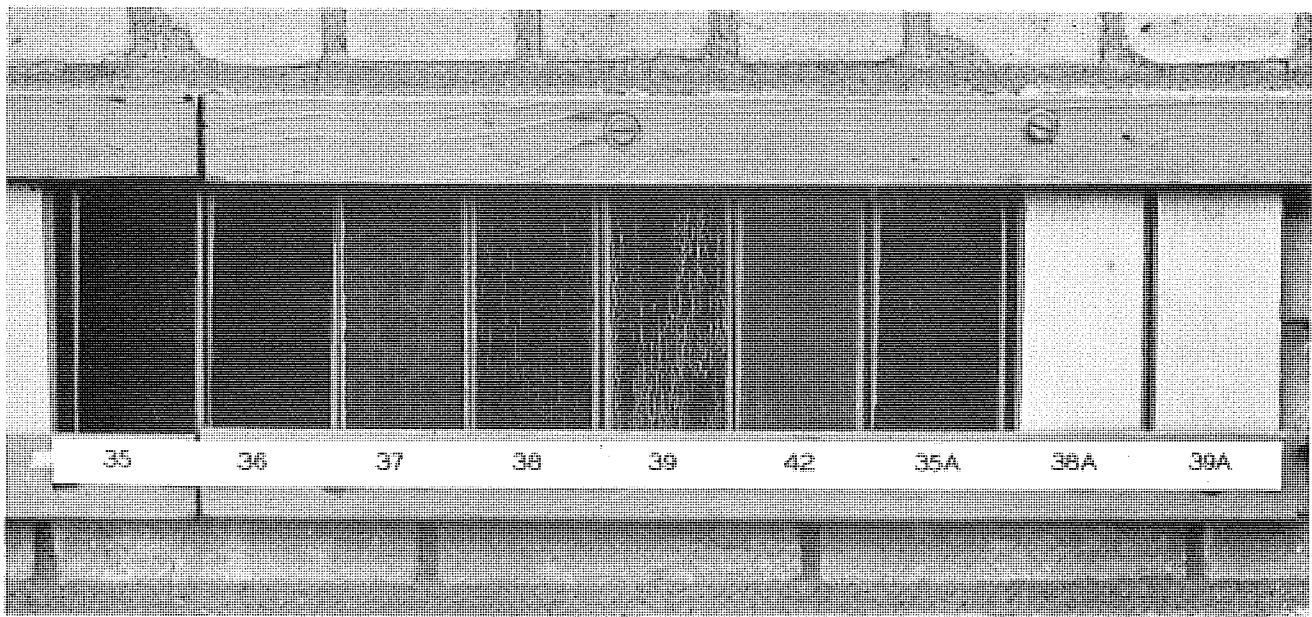
Figure 3. Appearance of test "grease type" coatings on roof exposure, as of February 12, 1969 (identification and performance comments in Table 2).
