***STUDY OF MICHIGAN'S
LINK PLATE AND
PIN ASSEMBLIES***

1. Report No. Research Report R-1358	2. Government Accession No.	3. Recipient's Catalog No.	
4. Title and Subtitle Study of Michigan's Link Plate and Pin Assemblies		5. Report Date April 1998

Study of Michigan's Link Plate and Pin Assemblies

**Testing and Research Section
Construction and Technology Division
Research Project 93 TI-1683
Research Report No. R-1358**

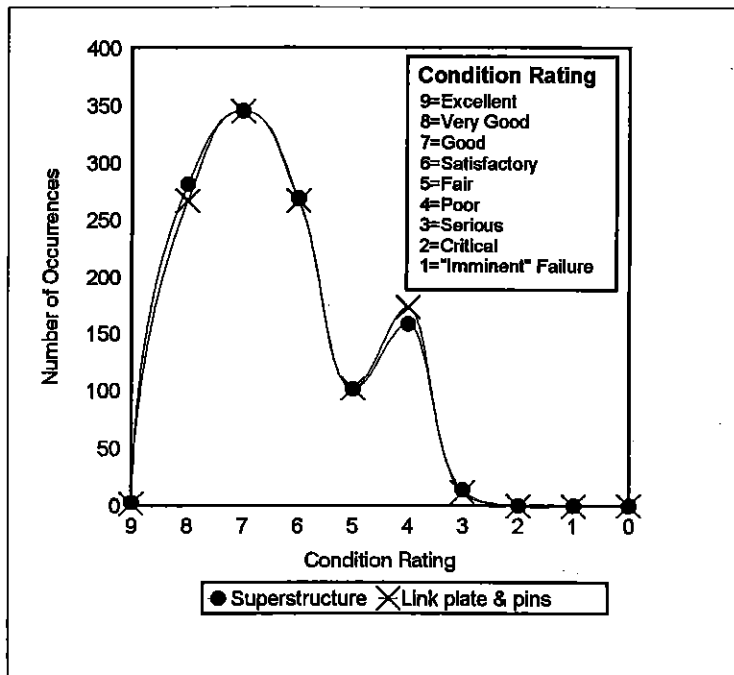
Michigan has approximately 1,100 bridges with pin and hanger details. Figure 1 shows a histogram of the condition rating of link plates and superstructures, along with the definition of each rating. There are 170 bridges, or 15 percent with link plate and pin assemblies rated in *poor* or *serious* condition, and 54 percent of these structures are rated in *good* condition or better. We can also see the condition of the link plates are almost always rated the same as the superstructure. Figure 2 shows the number of bridges with link plate and pin assemblies built in a given decade. Link plate and pin assemblies are replaced when a bridge is scheduled for work such as painting or deck joint replacements, or when a problem associated with the link plate and pin assembly is discovered. The decision to update the detail is usually made by a bridge scoping engineer or designer. By our estimates, approximately 20 to 30 percent of Michigan's structures with link plates have had the original link plate and pin assemblies replaced with new ones.

Figure 1 - Condition Rating of Michigan's Bridges with link plates.

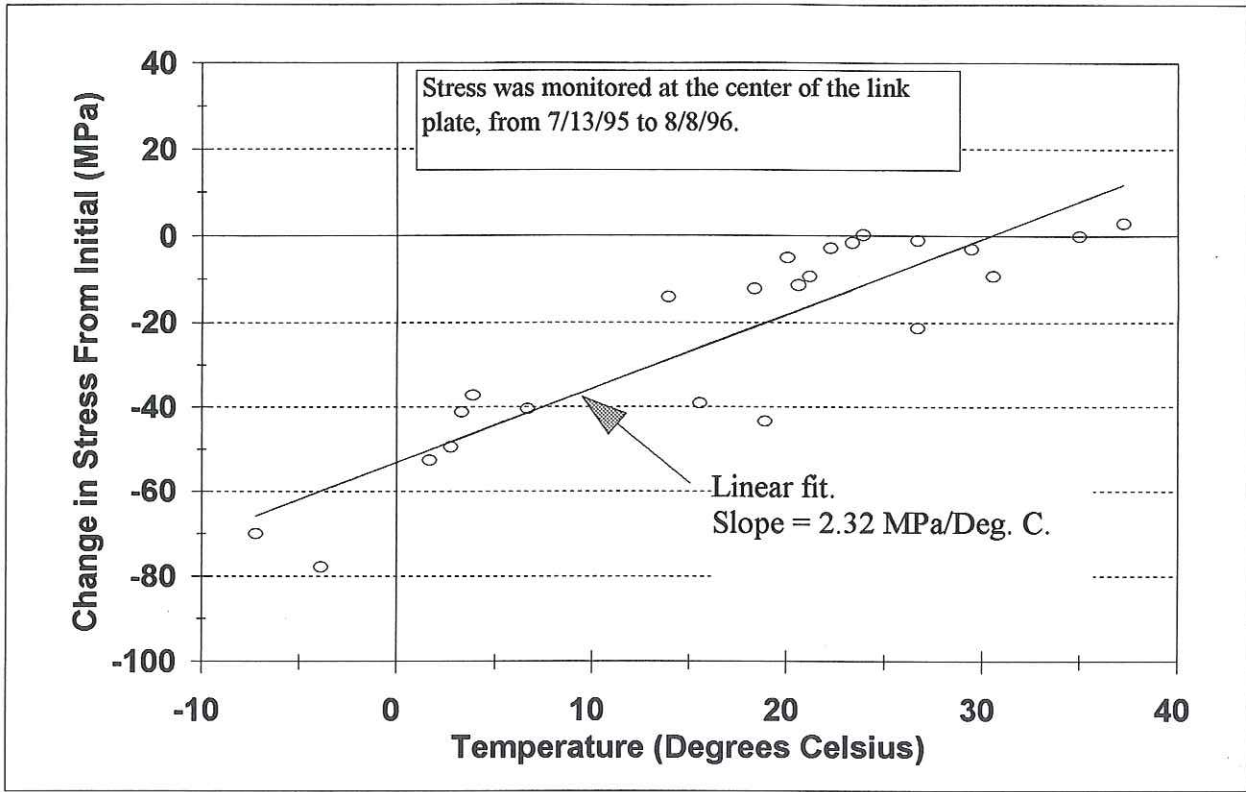
In an effort to measure the stress increase, we mounted vibrating wire strain gages on the link plates of the bridge carrying I-196 over the Grand River in Grand Rapids, Michigan (Structure Number B02 of 41027). In the link plate where the beam ends were in contact, strain was measured for one year to see if dead load stress varied with seasonal changes in temperature. We discovered the stress increase can be substantial. Figure 6 shows the results of the strain measurements referenced to temperature for a link plate where the beam ends were pushing against each other. From the strain data we estimate the stress in the link plate increased about 2.3 MPa per degree Celsius. For a 60° C temperature change the stress increased approximately 140 Mpa. We then mounted vibrating wire strain gages on a similar link plate where the beam ends were in contact. When the link plate was removed from the bridge we measured the change in the gages to find a difference of 230 MPa, which is a substantial amount of additional dead load stress in the link plate.

**Figure 6 - Stress change vs. Temperature.
 Beam A. Span 7. Structure B02 of 41027
 I-196 over the Grand River, Grand Rapids.**

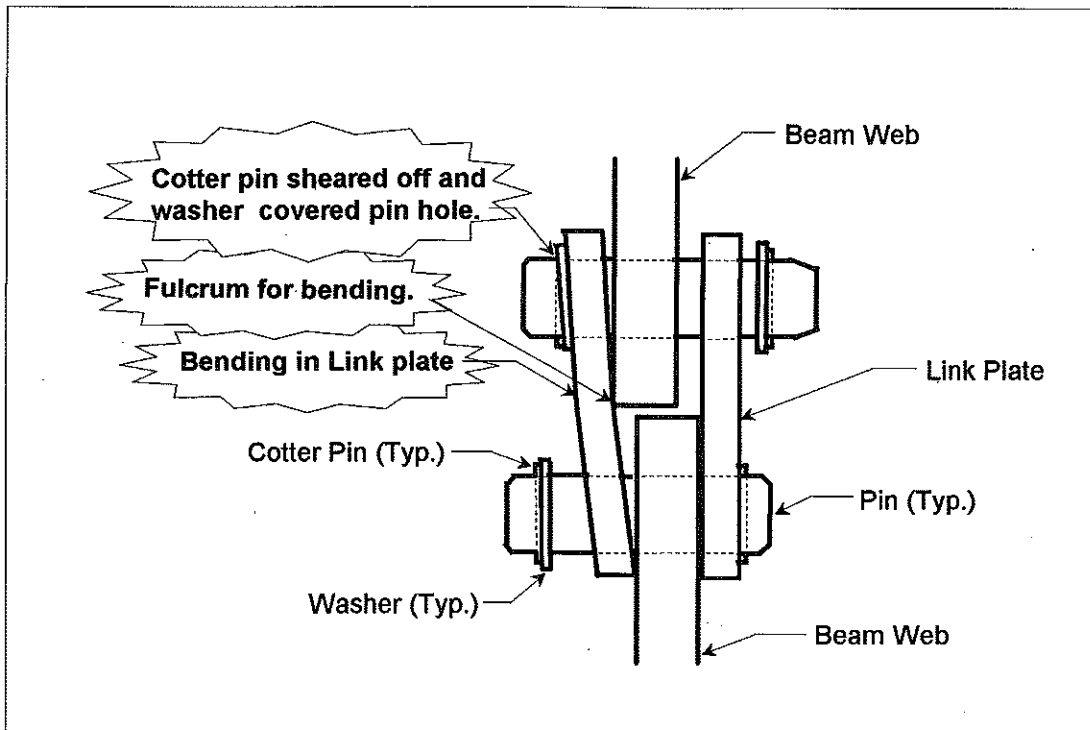
Figure 10 - Offset beam webs cause out-of-plane bending in the Link Plate.

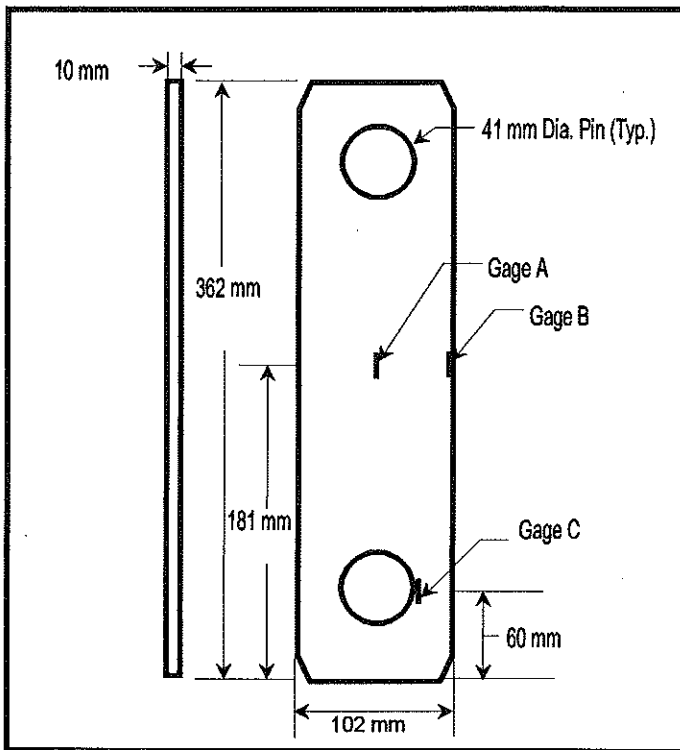
For the live load study we needed to understand the nature of the stress flow through the link plates. Strain gages were placed at the midsection and at the pin hole of a reduced size link plate as shown in Figure 12. Table 1 shows the results of a tension test. Notice the difference between the values of the gage placed at the pin hole and the gages at the mid section decrease as greater load is applied

Figure 12 - Reduced Size Link Plate for Lab Test to Determine Stress Concentration at Pin Hole.

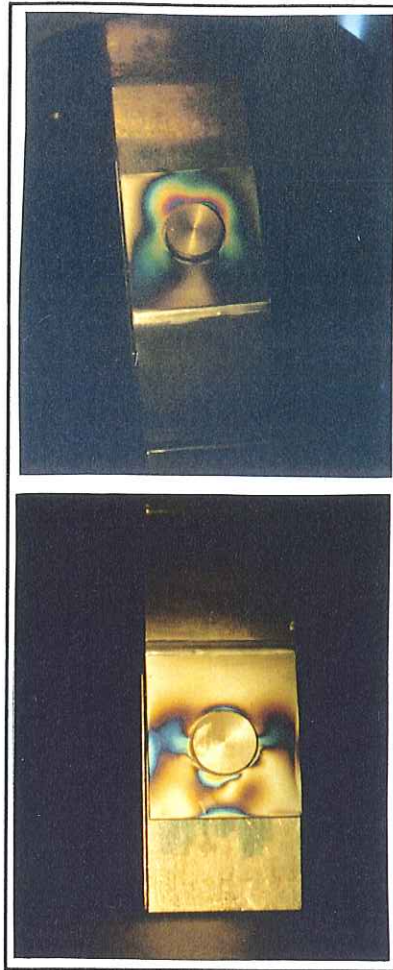
to the link plate. The changing values likely indicate the change in stress flow as the bearing area of the link plate on the pin increases as load is applied; i.e., - as more load is applied, the link plate deforms to match the shape of the pin along the bearing area. To provide a visual representation of the stress concentration, we applied a photoelastic coating to the link plate. In Figure 13 we see the stress concentration does not always appear ideally at the side of the pin hole even in a controlled lab test.

Figure 13.
Stress concentrations seen
with with Photolastic coating.

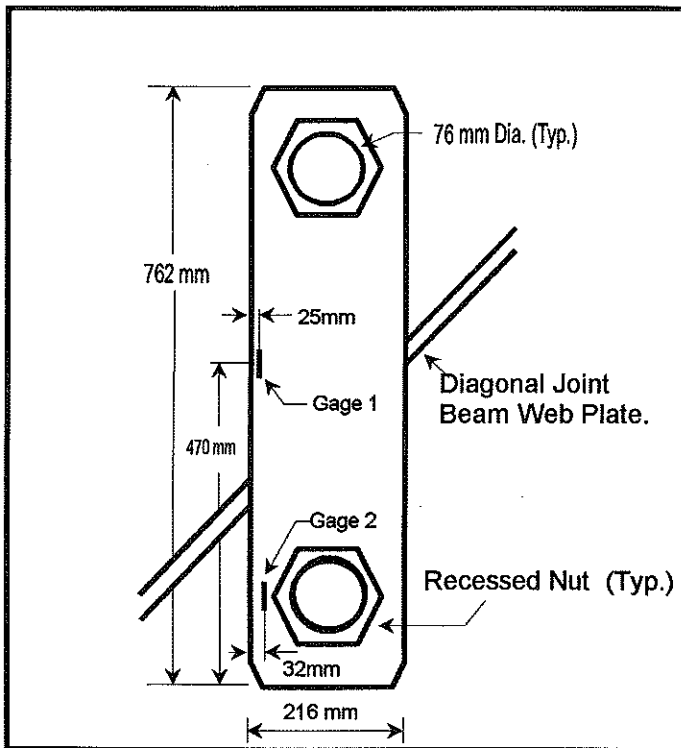
Two link plates were instrumented with strain gages. The gages were placed as shown in Figures 39 and 40 on beams 5 and 6 of span 8. Figure 39 shows the placement of Gages 1 and 2 on beam 6. Gage 1 was placed on the center section of the link plate near the edge, and Gage 2 was placed on the link plate's net section across the pin hole. On all of the link plates, heavy corrosion existed between the beam web and the link plate, so in an attempt to measure strong axis bending, we placed Gages 3, 4, and 5 on the link plate over the diagonal gap of the beam web as shown in Figure 40.

**Figure 39. I-75 over Toledo/Dix Avenue.
Beam 6, Span 8
Expansion End Link Plate with Strain Gages.**

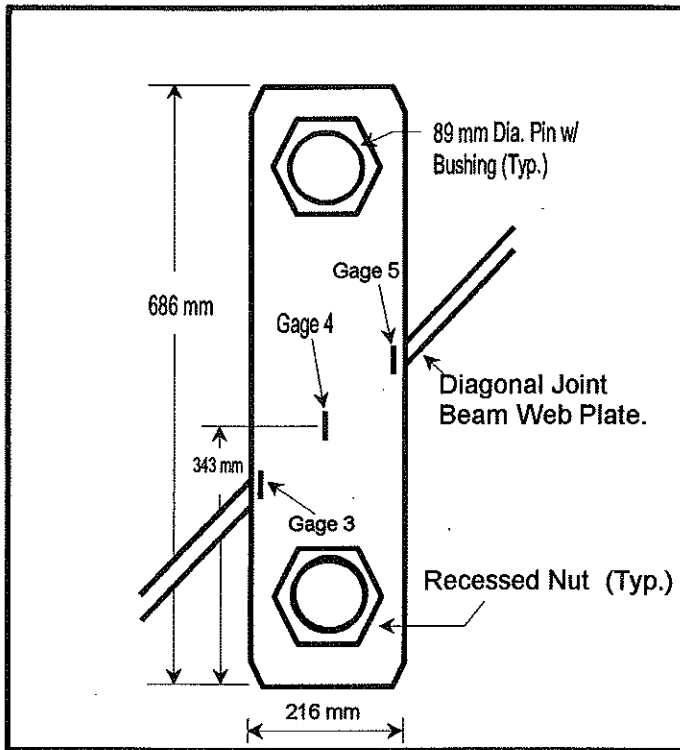
**Figure 40. I-75 over Toledo/Dix Avenue.
 Beam 5, Span 8
 Expansion End Link Plate with Strain Gages.**

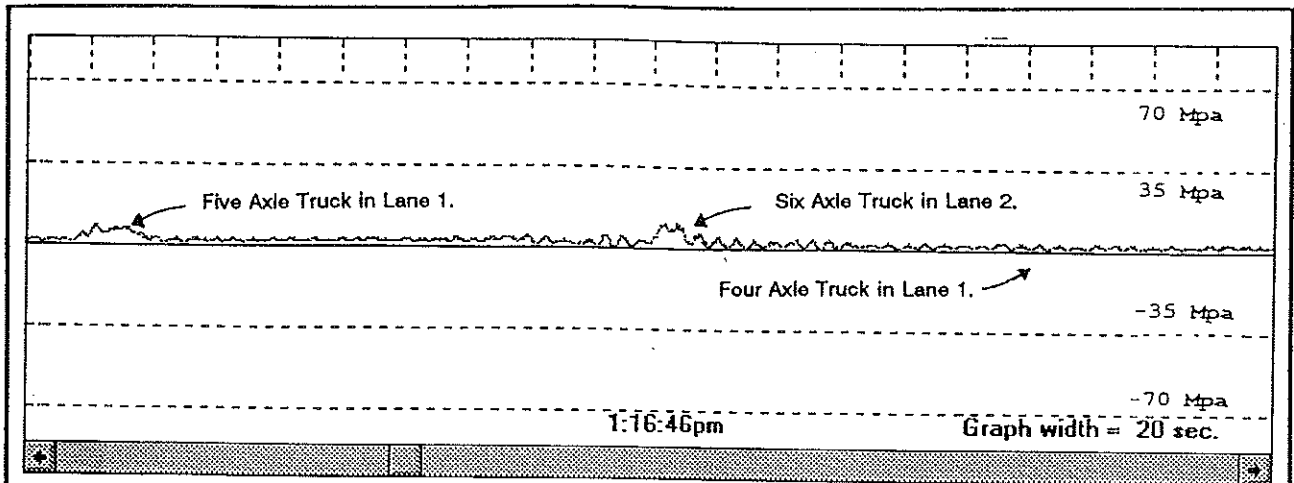
Gage #1

time plots for the three live load occurrences producing the highest stress in the link plates. Because of the corrosion buildup between the link plate and beam web, we found stress at the link plate's net section is greatly reduced. Gage 2 actually showed lower stress than Gage 1, and Gage 3 clearly showed the greatest strain response. We believe the primary stress being shown in Gage 3 is from out-of-plane bending. We could see the link plate move laterally as trucks crossed the bridge, and in-plane bending would show greater stress response in Gage 5. From Gage 3, we can see the strain pattern produced by the passage of each truck is a sinusoidal wave form with the frequency of each cycle being between 3 and 4 cycles per second. Ten to fifteen stress cycles per truck passage are produced. Figure 47 shows a histogram of the stress occurrences greater than 6.9 MPa for Gage 3. The maximum stress occurrence was 72.4 MPa. For the other Strain Gages (1, 2, 4, and 5) the cyclic stress is not as evident. This is likely because the out-of-plane bending shown in Gage 3 does not occur in the other locations. Since the stress flow in the link plate has changed considerably from what is typically expected; i.e., strain across the net section of the link plate is greatly reduced, we did not estimate the effective stress from the strain data.

Figure 43 - Stress vs. Time Plot.
 Structure Number S21 of 82191.
 I-75 over Toledo/Dix Avenue.
 Expansion End

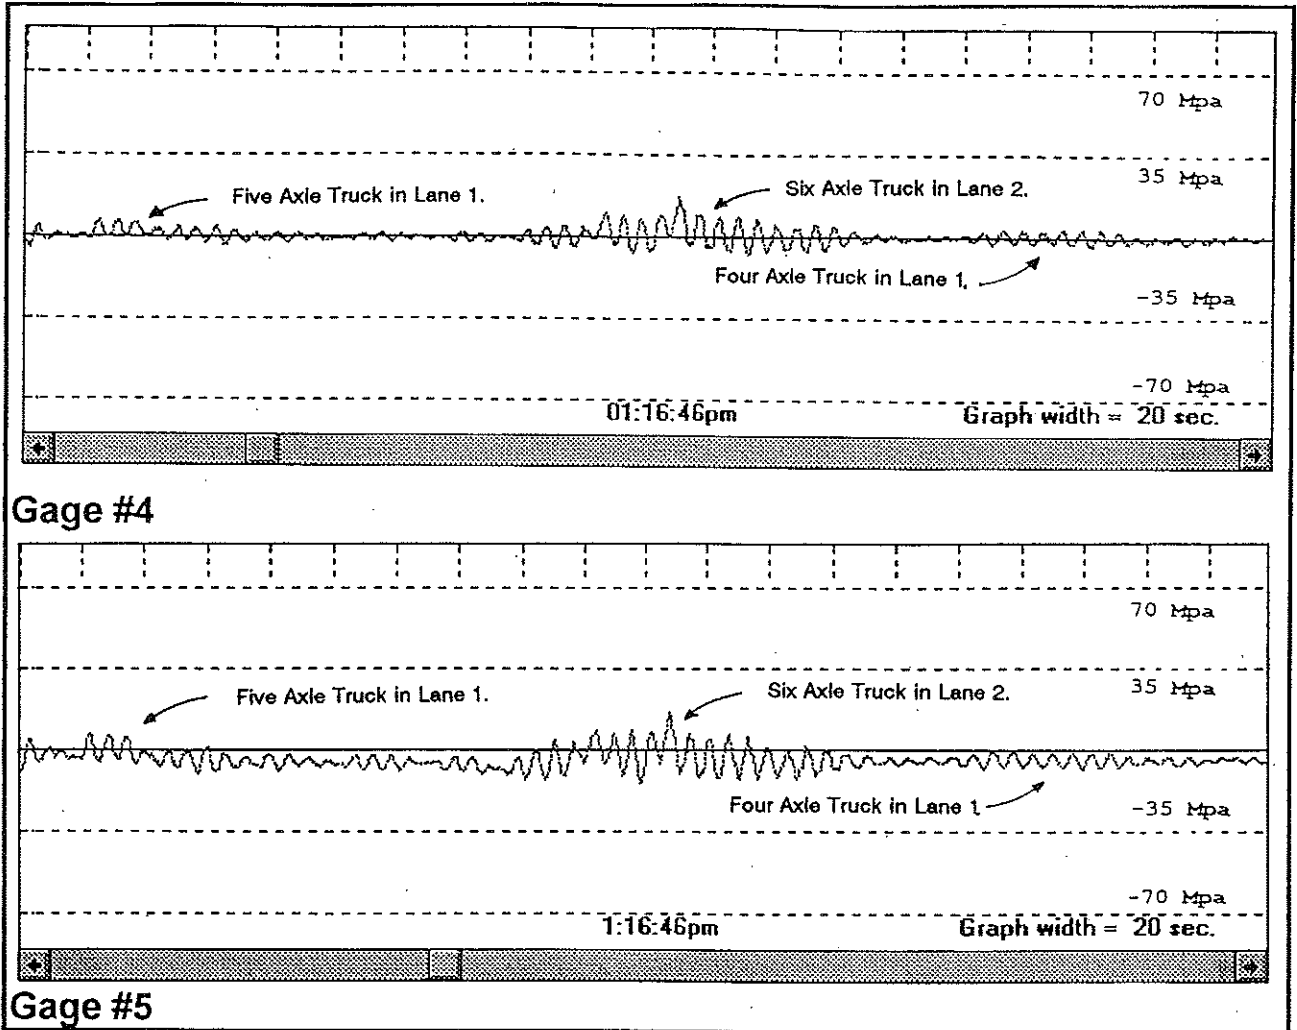
Figure 44 - Stress vs. Time Plot.
 Structure Number S21 of 82191.
 I-75 over Toledo/Dix Avenue.
 Expansion End

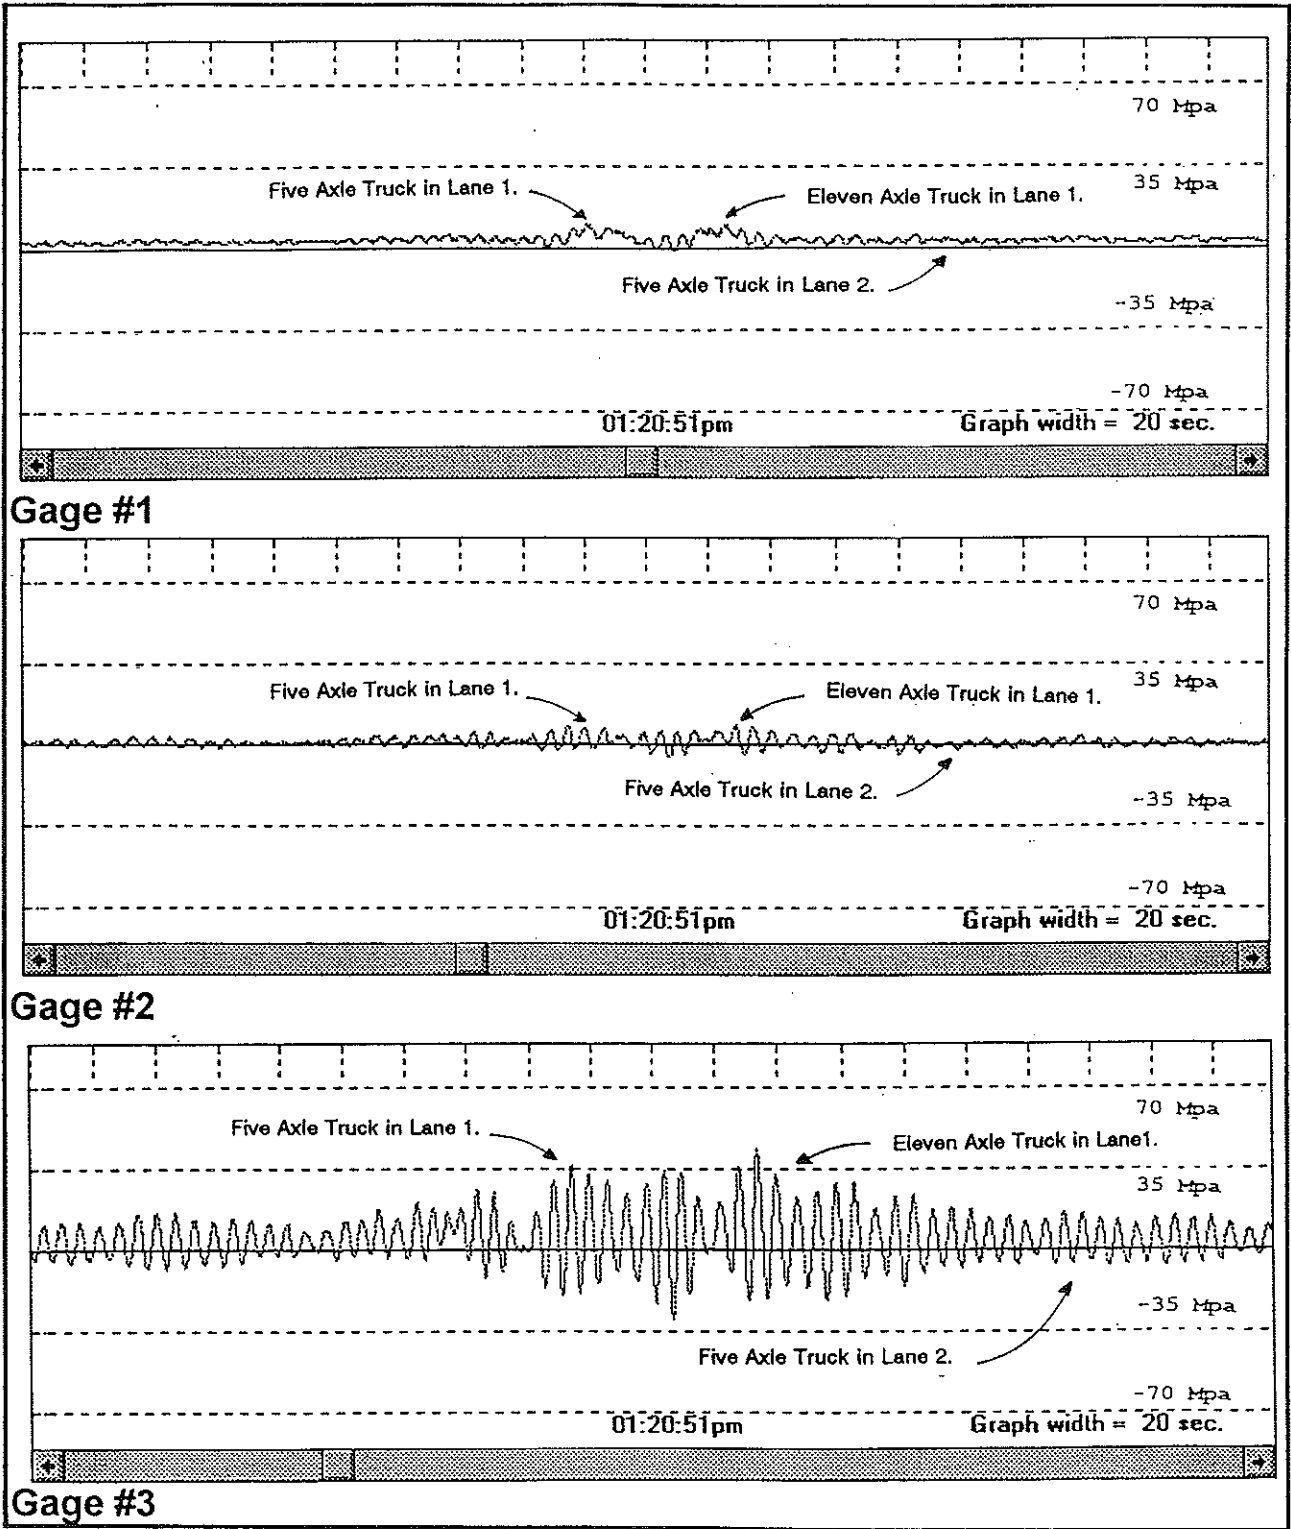
Figure 45 - Stress vs. Time Plot.
 Structure Number S21 of 82191.
 I-75 over Toledo/Dix Avenue.
 Expansion End

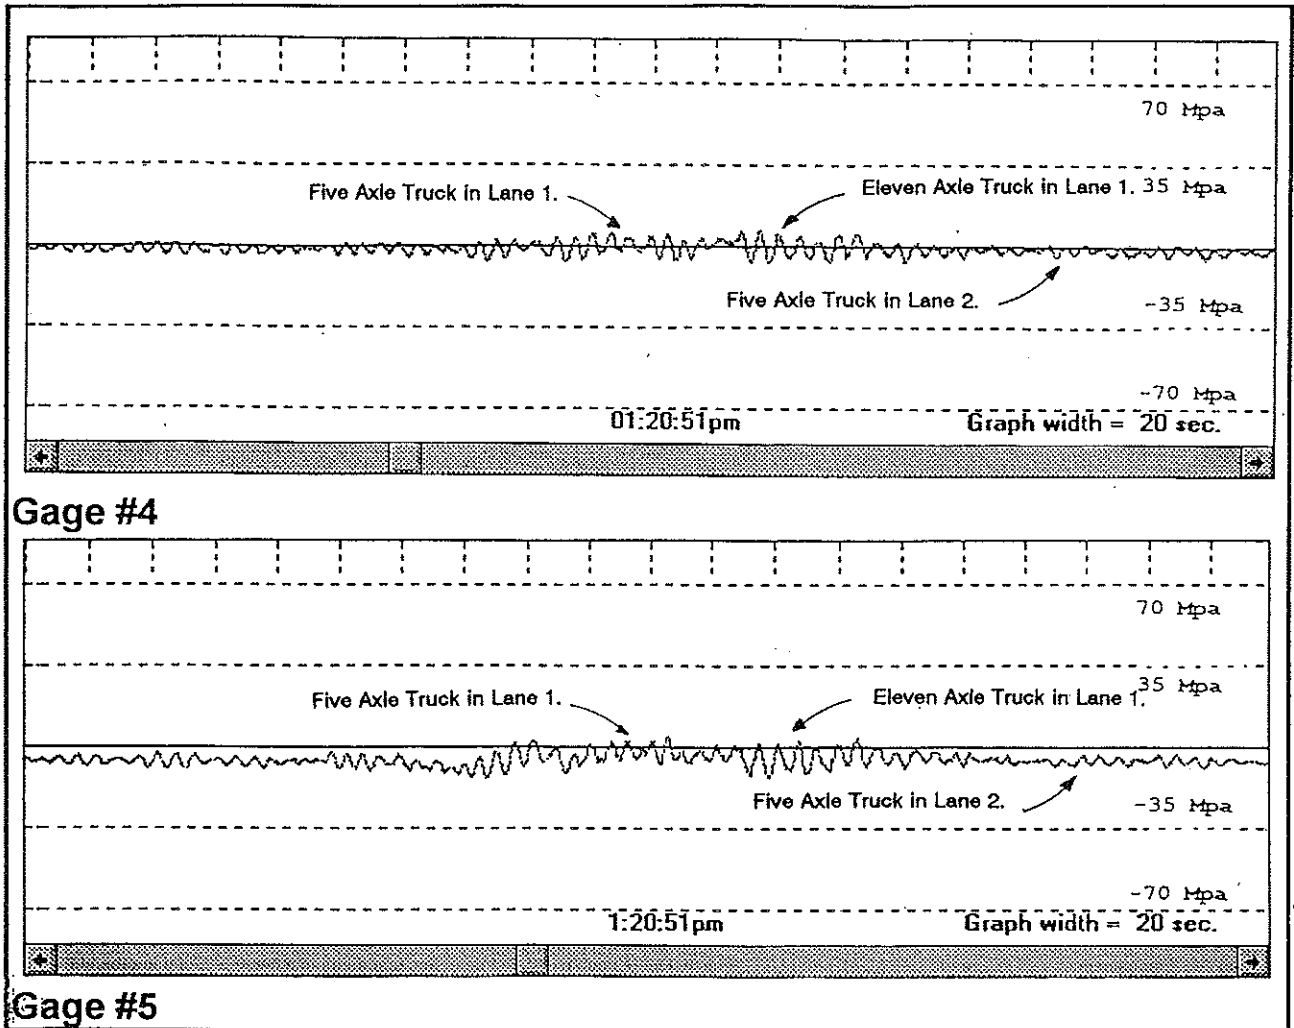
Figure 46 - Stress vs. Time Plot.
 Structure Number S21 of 82191.
 I-75 over Toledo/Dix Avenue.
 Expansion End

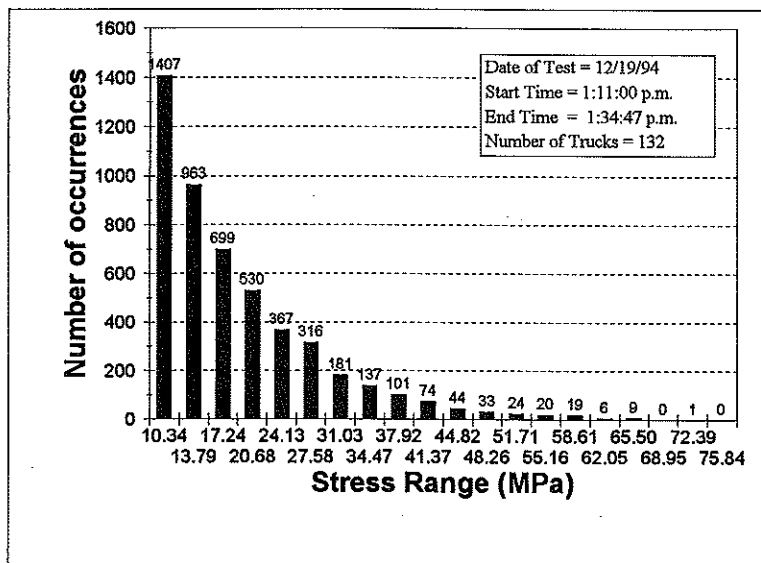
Figure 47 - Histogram.
 I-75 over Toledo/Dix Avenue.
 Gage 3.
