**PROOF LOAD TEST OF R01 OF 61131
M-37 OVER CSX RAILROAD, SOUTH OF BAILEY, MICHIGAN**

David A. Juntunen, P.E.
Michael C. Isola, P.E.

Research and Technology Section
Materials and Technology Division
Research Project 94 TI-1731
Research Report No. R-1336

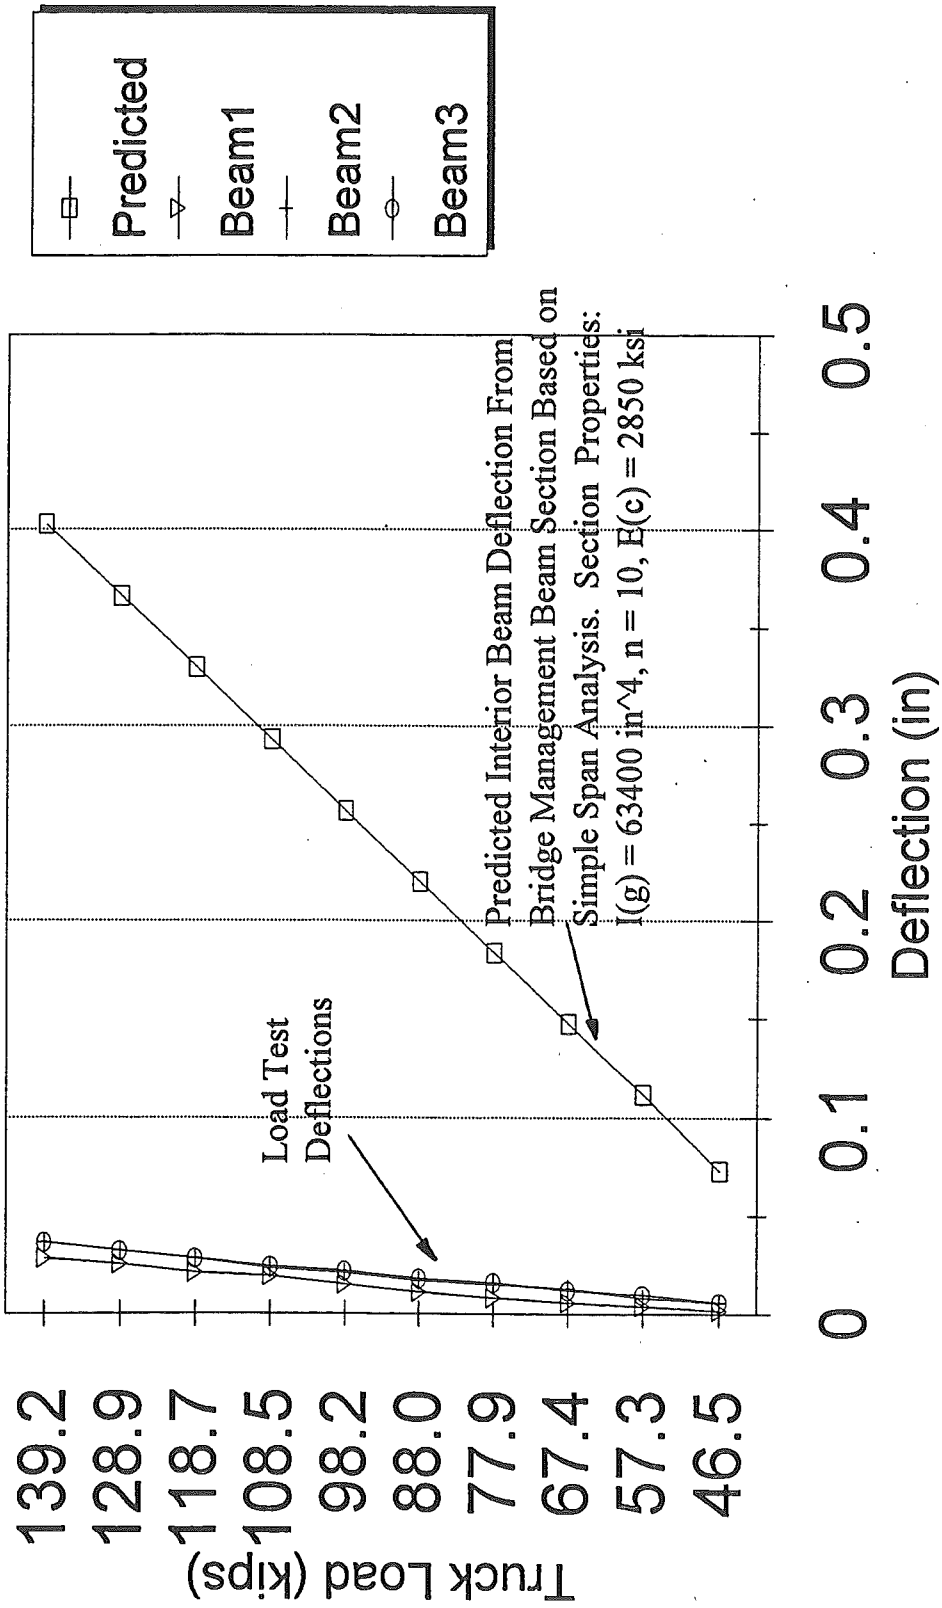
Figure 33

Bailey Bridge Load Test - Day 2
Load vs. Deflection - Position 1

After the contractor removed the load from the bridge and the bridge was allowed to settle for 15 minutes, we found beams 1 and 3 were still deflected 0.006 inches, a sign of permanent deformation or perhaps the need for more rebound time. During the pre-test inspection (see Table 1), we rated beam 1 as "serious condition" and beam 3 as "poor condition." Figure 34 shows the deflection of each instrumented beam for load cases 8, 9 and 10, and that the estimated maximum load distribution to a given beam is approximately 24 percent.

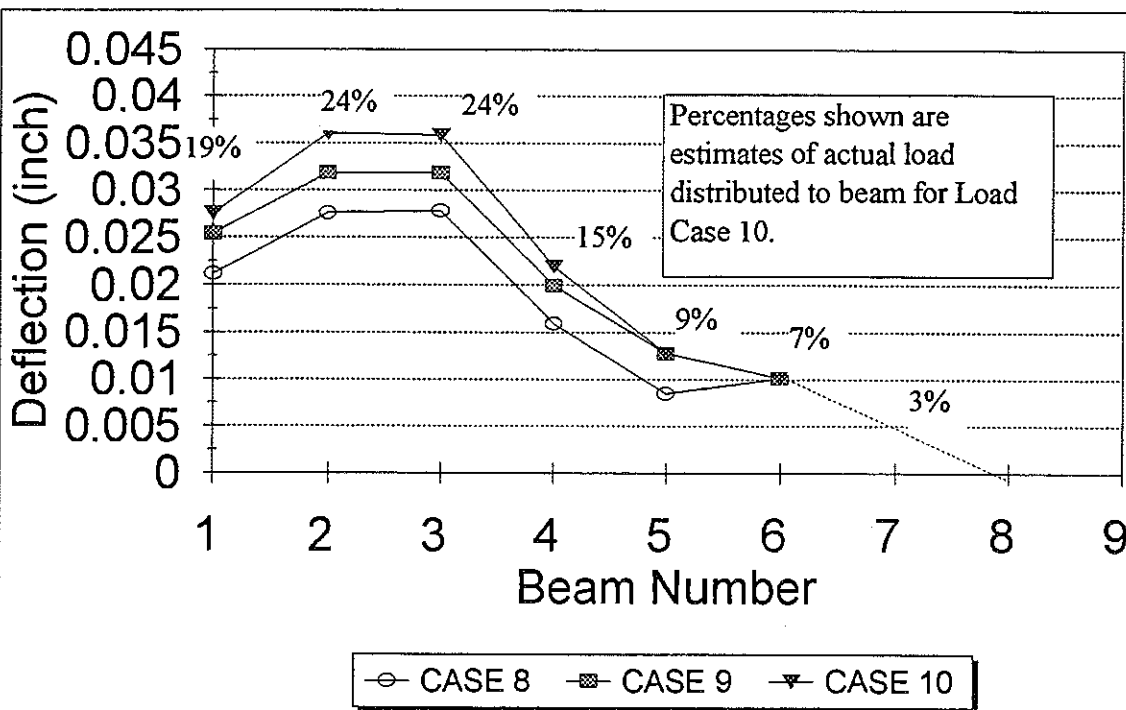
Figure 34 - Load Distribution
Day 2, Position 1

We rated both fascia beams (beams 1 and 9) as serious condition. Clearly, the south fascia beam (beam 9) is in the worst condition of the two fascia beams. Because the bottom row of reinforcement is fully exposed, it cannot be considered in the analysis of the beam because there is little bond of the bars to the concrete for development of strength. As a result, this leaves only one reinforcing bar in the second row of the section to provide resistance, which can cause a significant loss in load carrying capacity of the beam. In fact, this was verified during the load test. When reviewing the deflections (shown in Tables 12 and 13, and Figures 29 and 34), we found beam 9 has less relative stiffness than beam 1, a clear indication that the load carrying capacity of beam 9 has been reduced due to deterioration of the reinforcement. Therefore, the live load normally carried by this beam is being redistributed to the first interior beam (beam 8), which was rated in fair condition.

The test data indicate that both fascia beams may have exhibited permanent deformation during the load because the beam failed to return to its original position. This hypothesis is supported by the fact that the interior beams, rated in fair condition, returned to their initial position immediately. Due to the possible permanent deformation, beam 1, which was rated in serious condition, likely has also lost load carrying capacity, albeit not as much as beam 9.

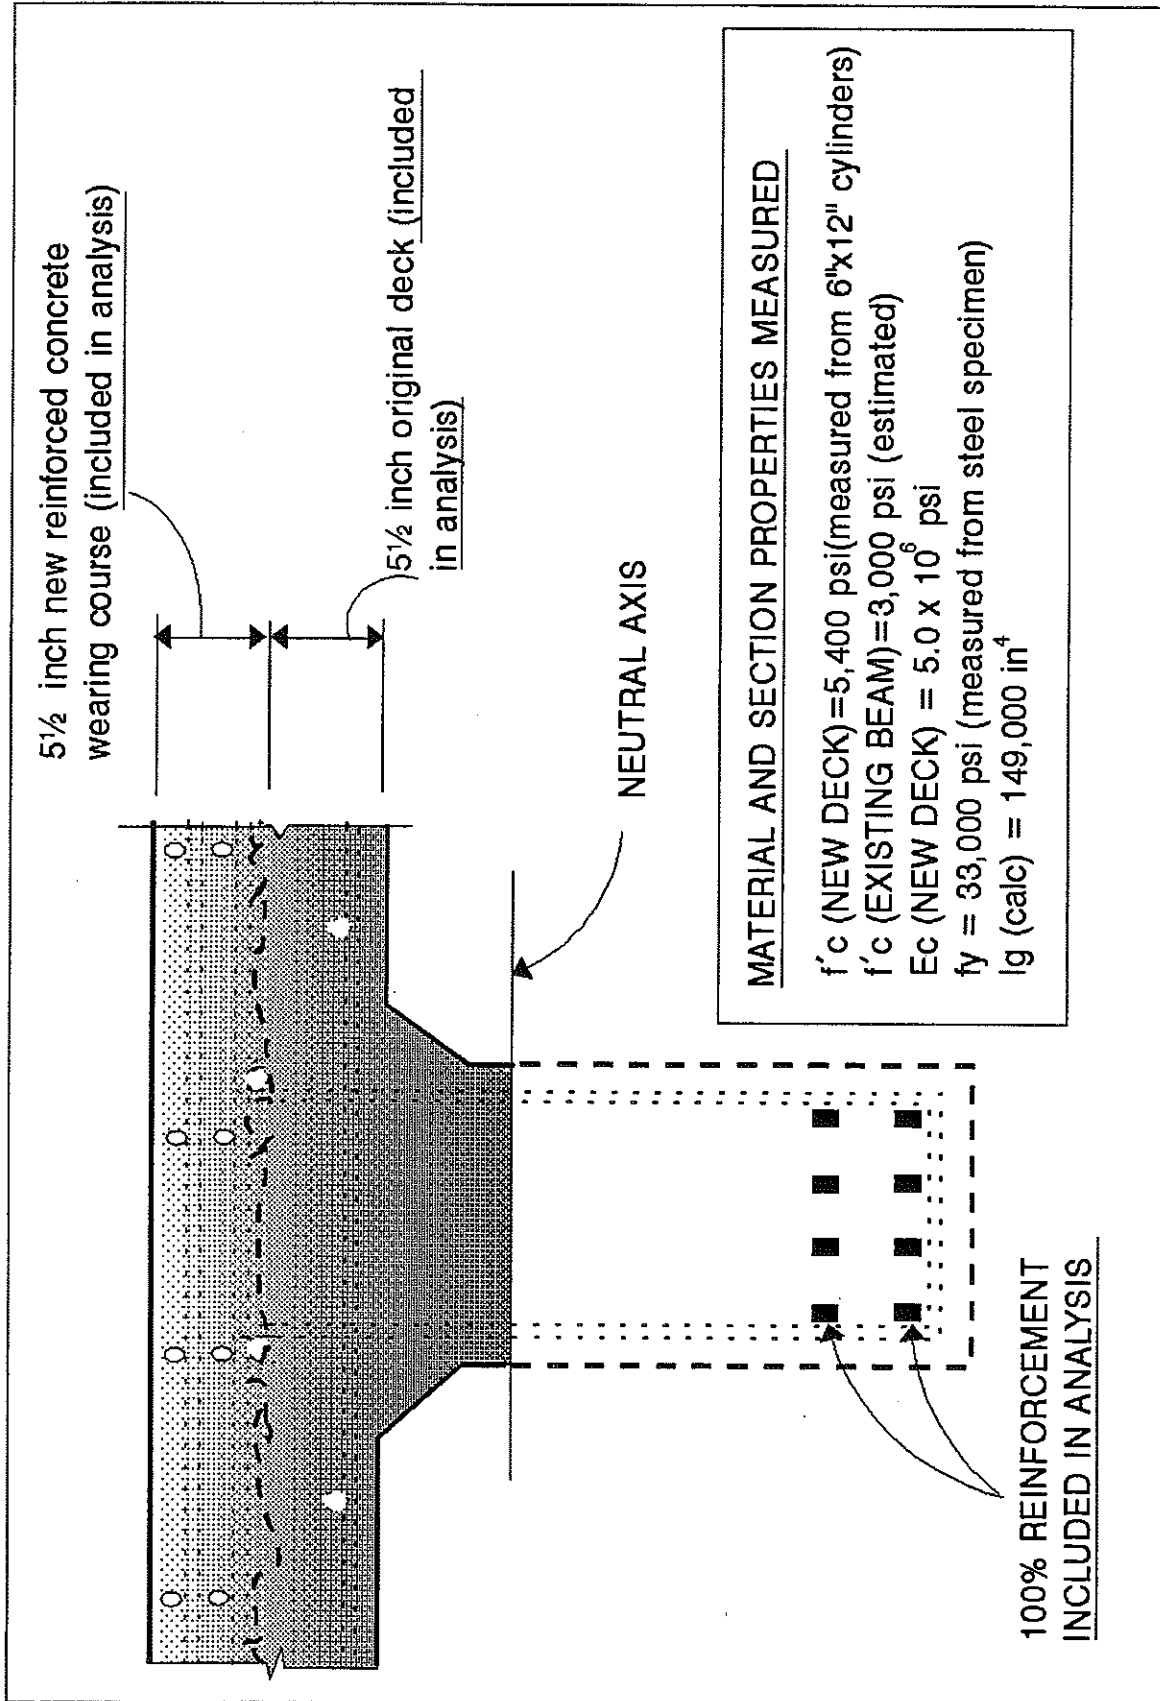
Figure 35 - POST TEST ESTIMATED SECTION FOR INTERIOR BEAMS

To explain why such small deflections resulted when compared to pre-test estimates, we used the information gathered during the detailed inspection and the load test to estimate a more accurate interior beam resisting section. For this estimate, we made the 5½ in. reinforced concrete wearing course composite with the existing deck and included 100 percent of the steel reinforcement in the beam. This resulted in a gross moment of inertia equal to 149,000 in.⁴ (see Figure 35). Given the maximum deflections for Day One and Day Two of the load test, we back-calculated the corresponding stiffness and moment of inertia using continuous spans rather than simple spans, and used the estimated distribution factors shown in Figures 29 and 34. The resulting moments of inertia are 135,000 in.⁴ and 150,000 in.⁴ for Day One and Day Two, respectively (see Table 14), which agree closely with the post-test estimated section.
