A TRAFFIC ACCIDENT ANALYSIS
AND TRAFFIC CONTROL DEVICES INVENTORY
IN THE CITY OF ST. JOSEPH

Report TSD-215-73

**TRAFFIC and
SAFETY
DIVISION**

**DEPARTMENT OF STATE HIGHWAYS
STATE OF MICHIGAN**

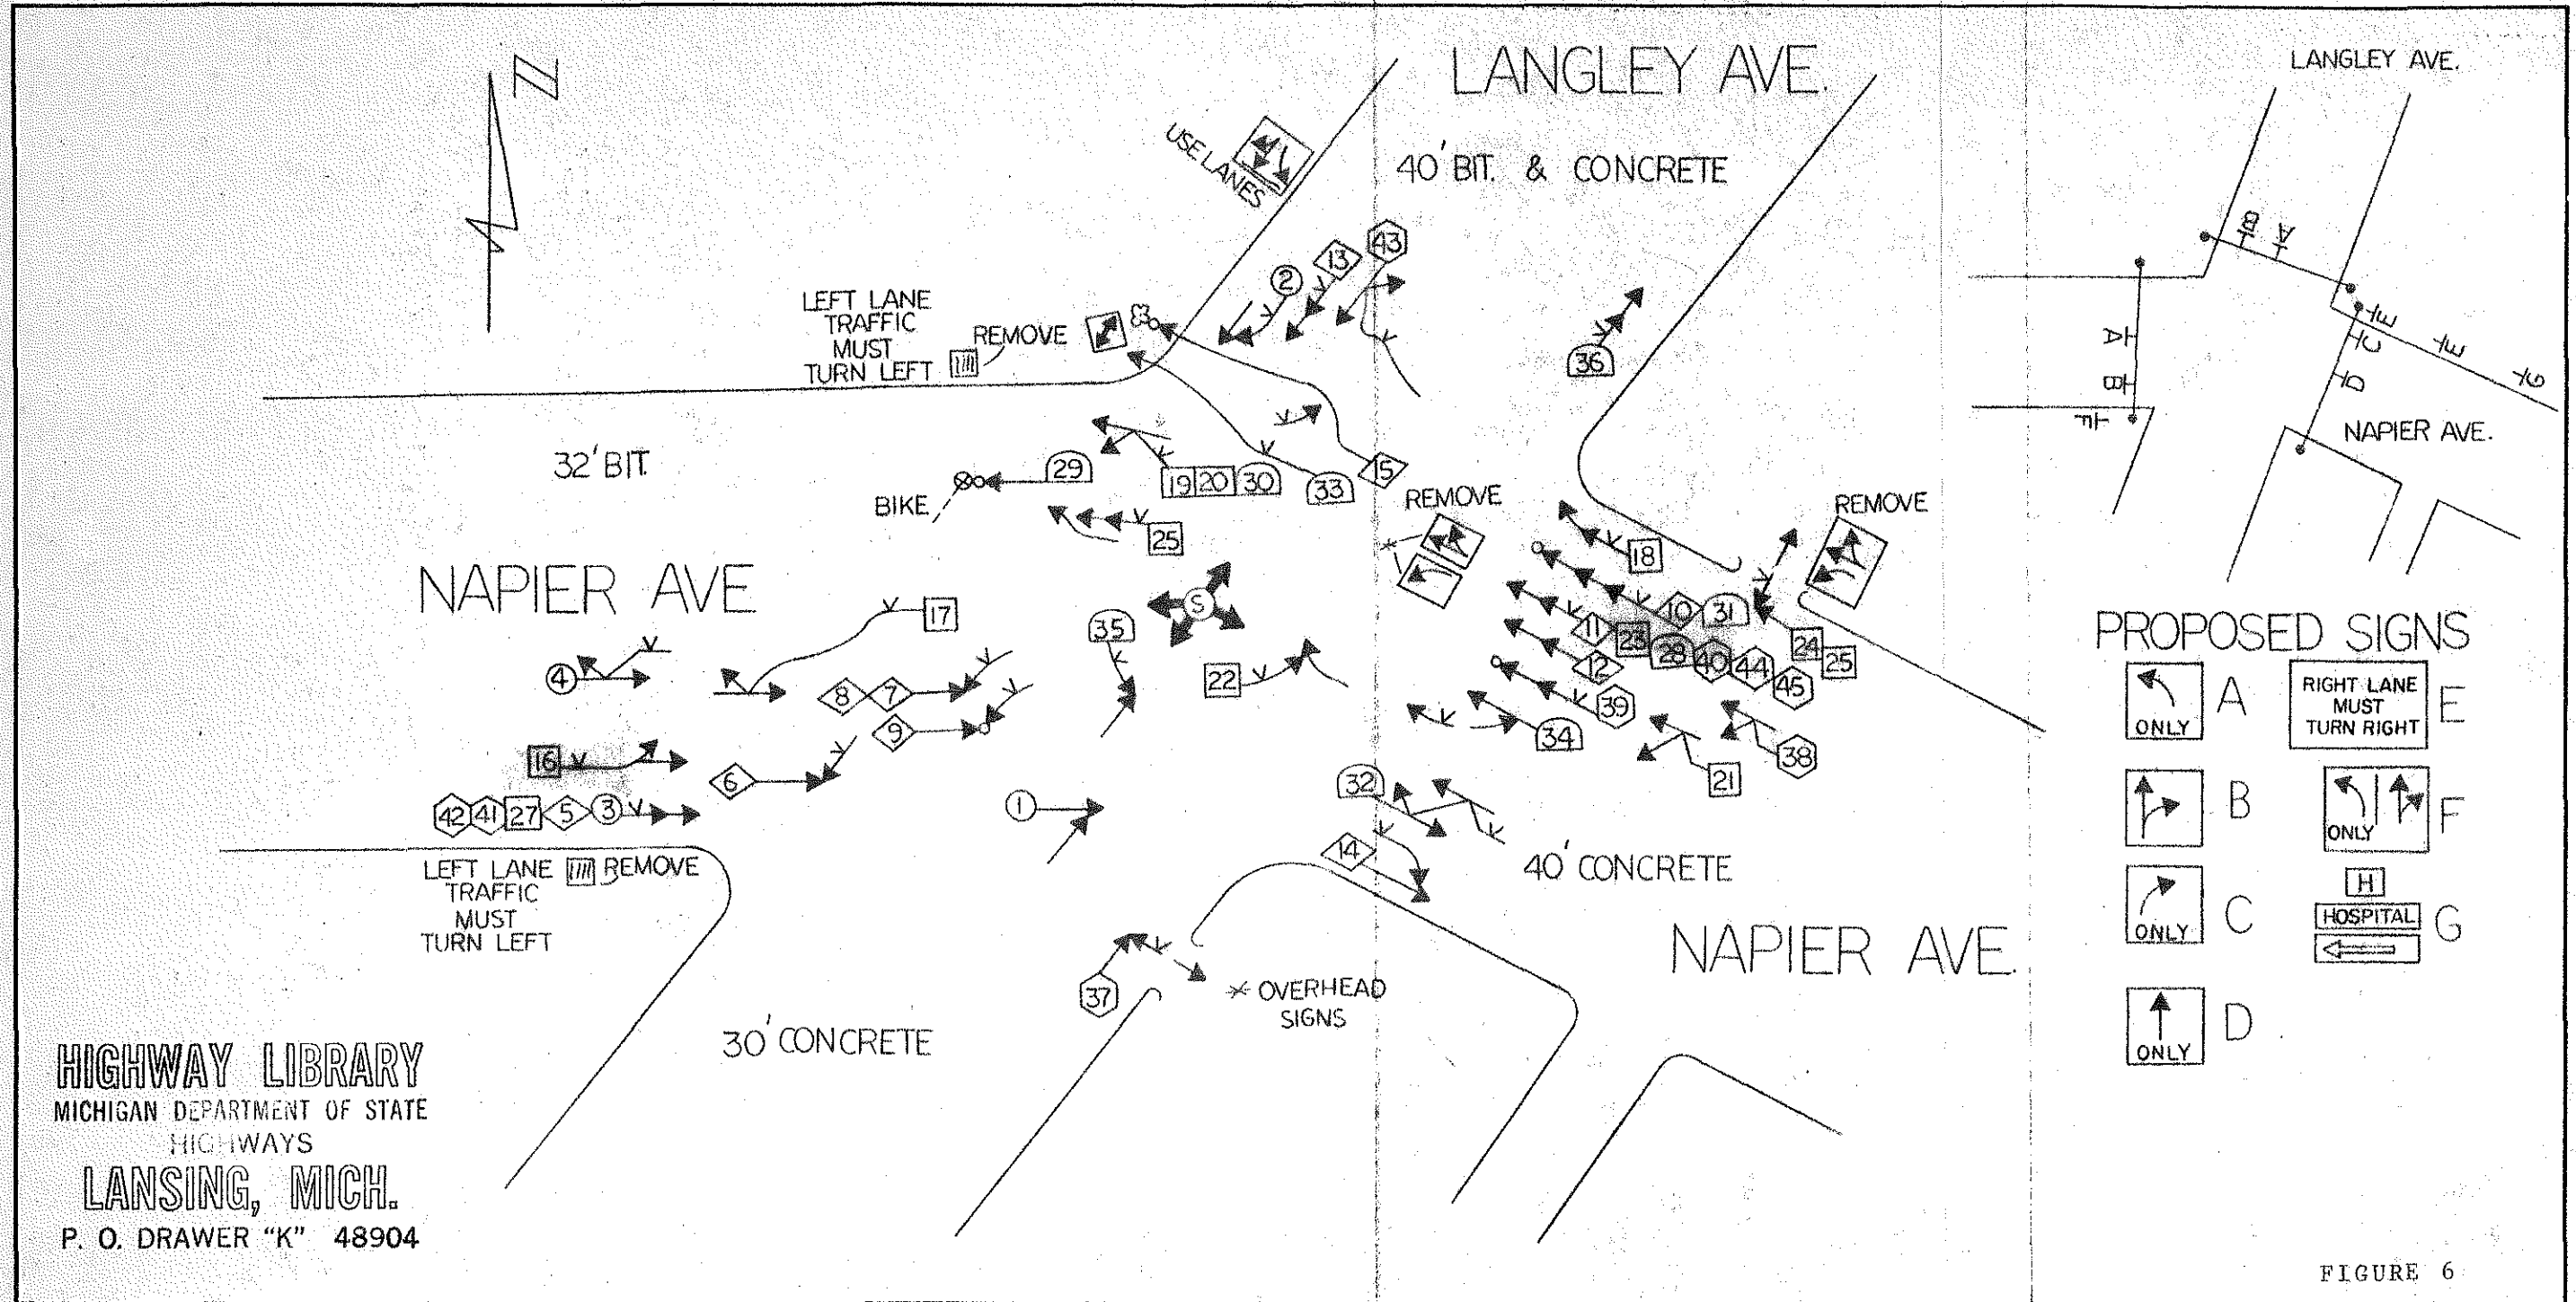
Napier and Langley Avenues form a four-legged intersection that is under signal control. The west leg of Napier Avenue has a 32 ft. wide bituminous cap that was placed on a concrete pavement. The bituminous surface has worn away in spots exposing the old pavement. The southeast leg of Napier Avenue has a three lane, 40 ft. wide concrete pavement. The horizontal alignment of Napier Avenue from east to west consists of a left hand curve. Langley Avenue northeast of the intersection has a three lane, 40 ft. wide pavement that is both concrete and bituminous. Langley Avenue southwest of the intersection has a two lane, 30 ft. wide concrete pavement. Parking at this intersection is allowed only on the west side of the southwest leg of Langley Avenue.

The west leg of Napier Avenue had only two sideswipe accidents during the study period. However, the proper lane assignments for eastbound traffic are not apparent. It is recommended that overhead Lane-Use Control signs, including a left turn only arrow (R3-5) over the center lane and a thru and right turn arrow (R3-6) over the curb lane be erected 75 ft in advance of the intersection. Additionally, the overhead signing should be supplemented by painted arrows and a 30 in. roadside sign (R3-8) to give advance warning of the lane assignments. Furthermore, a lane line should be applied to divide the two approach lanes for eastbound traffic.

Lastly, southwestbound Langley Avenue is offset to the west in relation to northeastbound Langley Avenue. Due to this alignment, it is recommended that a left turn only arrow (R3-5) be erected over the left turn lane and a thru and right turn arrow (R3-6) be erected over the curb lane. This overhead signing should be located 75 ft in advance of the intersection. These signs should eliminate confusion at this intersection by giving all motorists an unobstructed view of the required lane assignments.

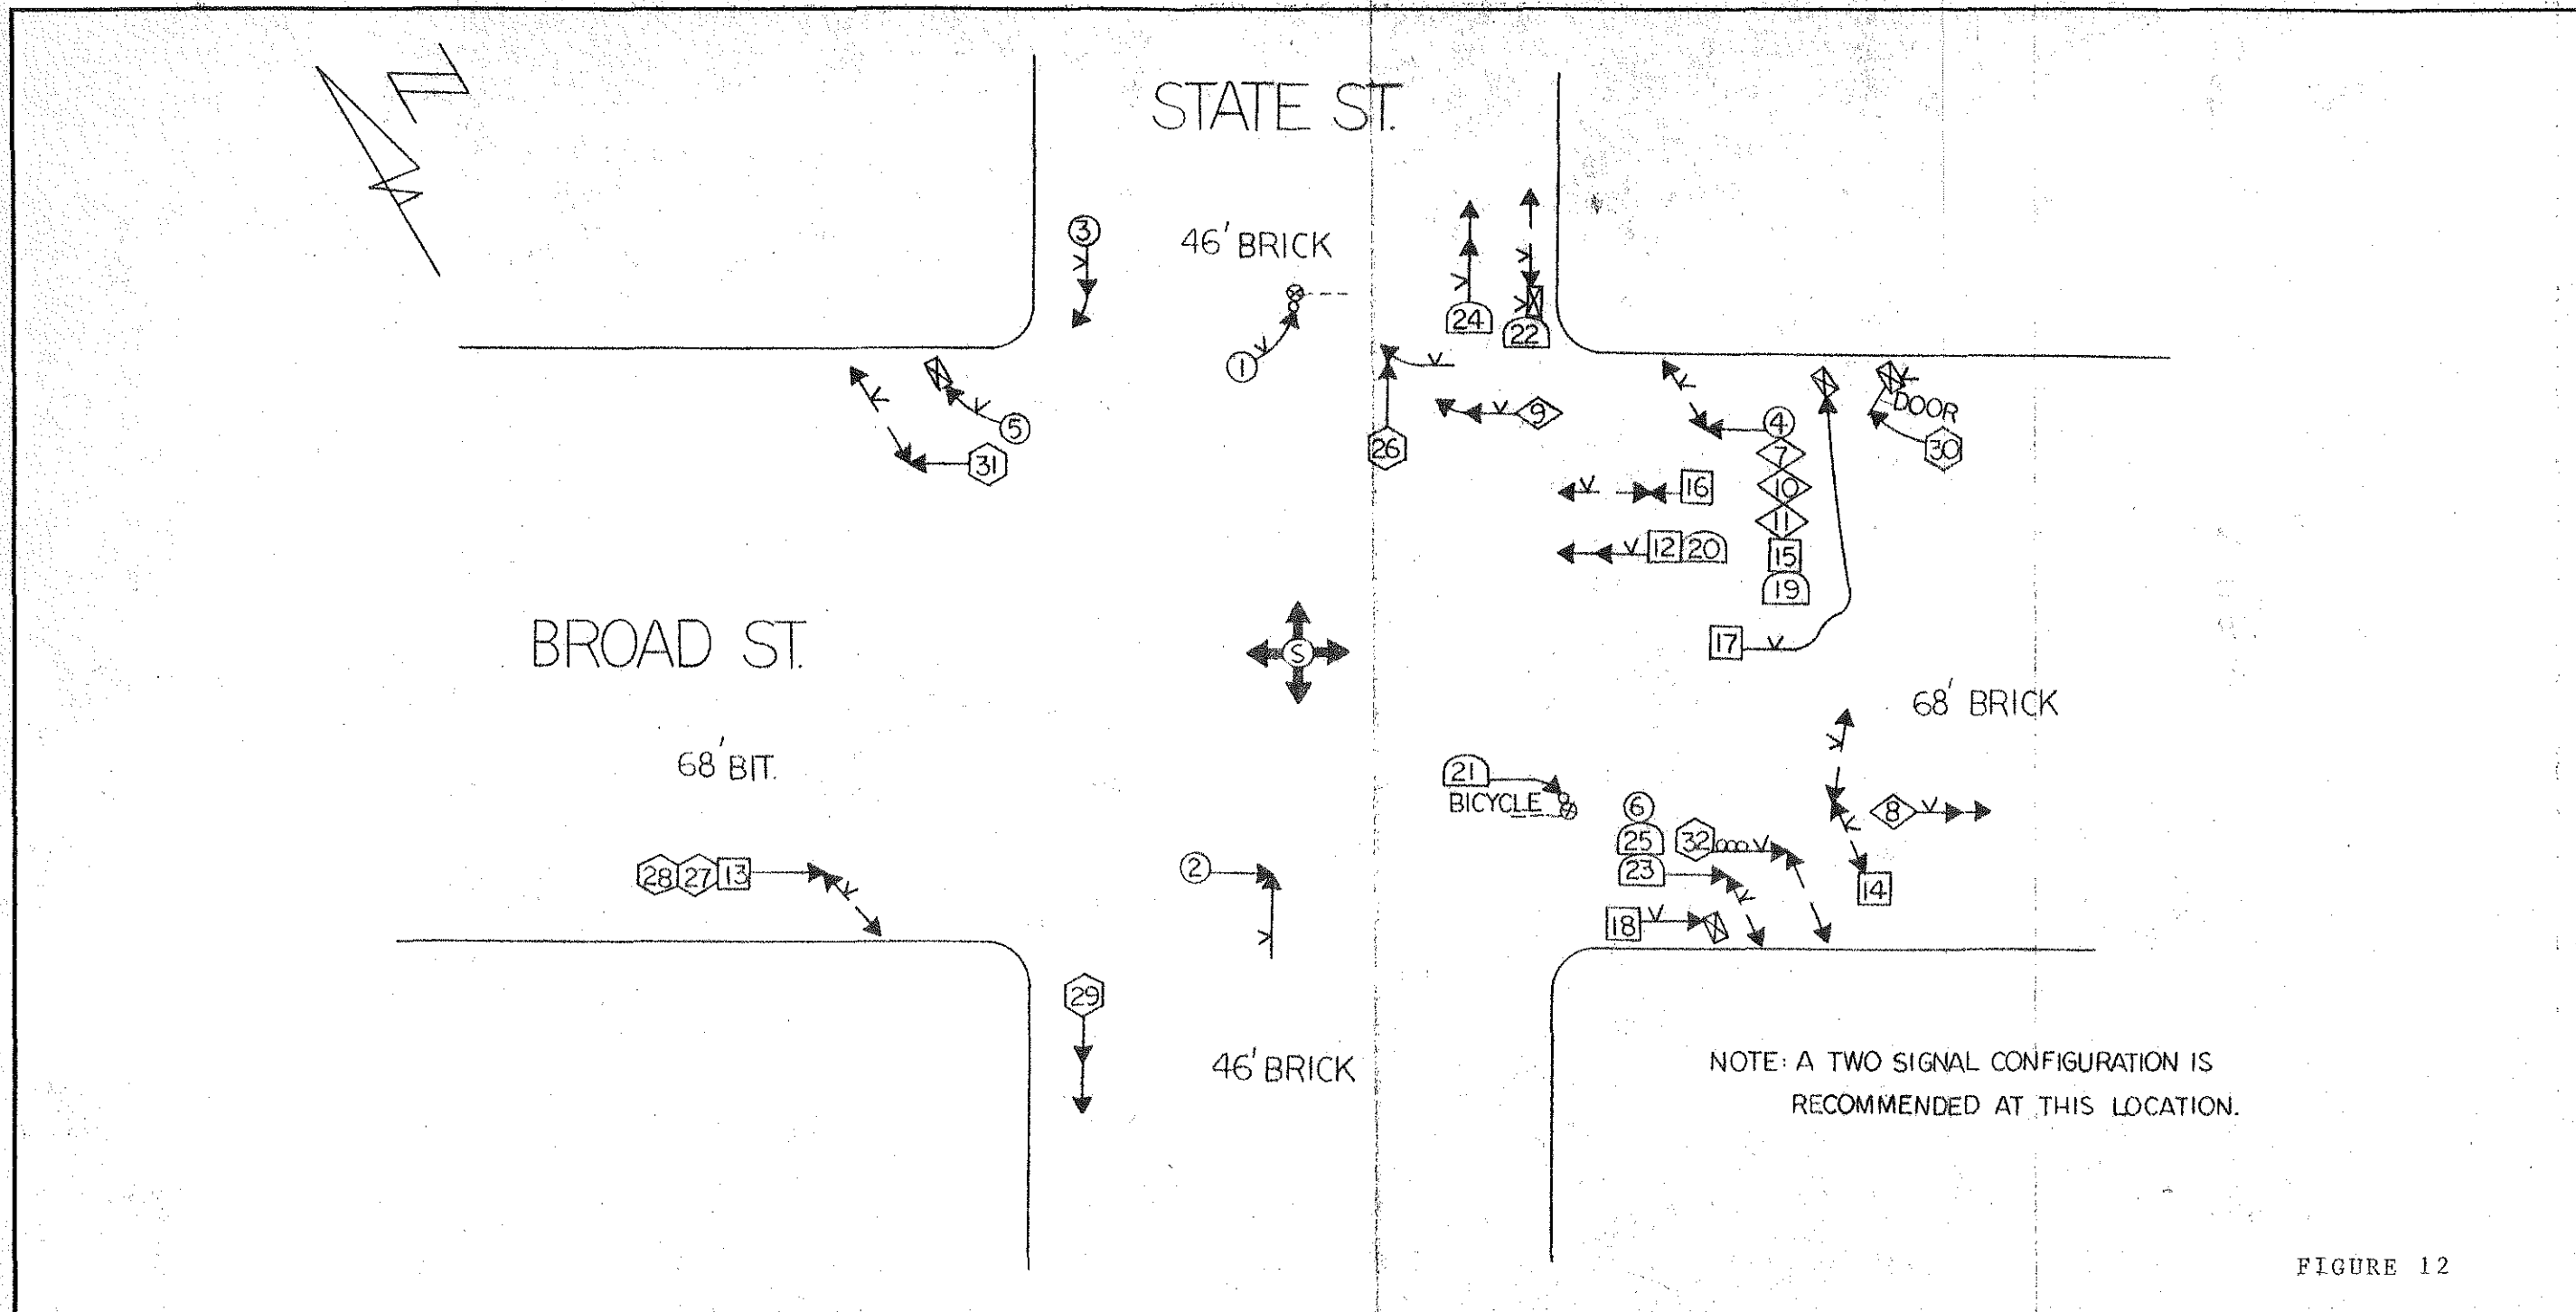
FIGURE 12

Another problem at this intersection involves the single signal head which provides only one visible signal face per approach. If this intersection remains signalized then a second signal head should be erected to provide two visible signal faces per approach.

Lastly, 31 percent of the accidents occurred on wet pavement. Furthermore, three of the four legs of this intersection have brick surfaces which produce a low coefficient of friction as they age. Therefore, it is recommended that skidometer tests be conducted.

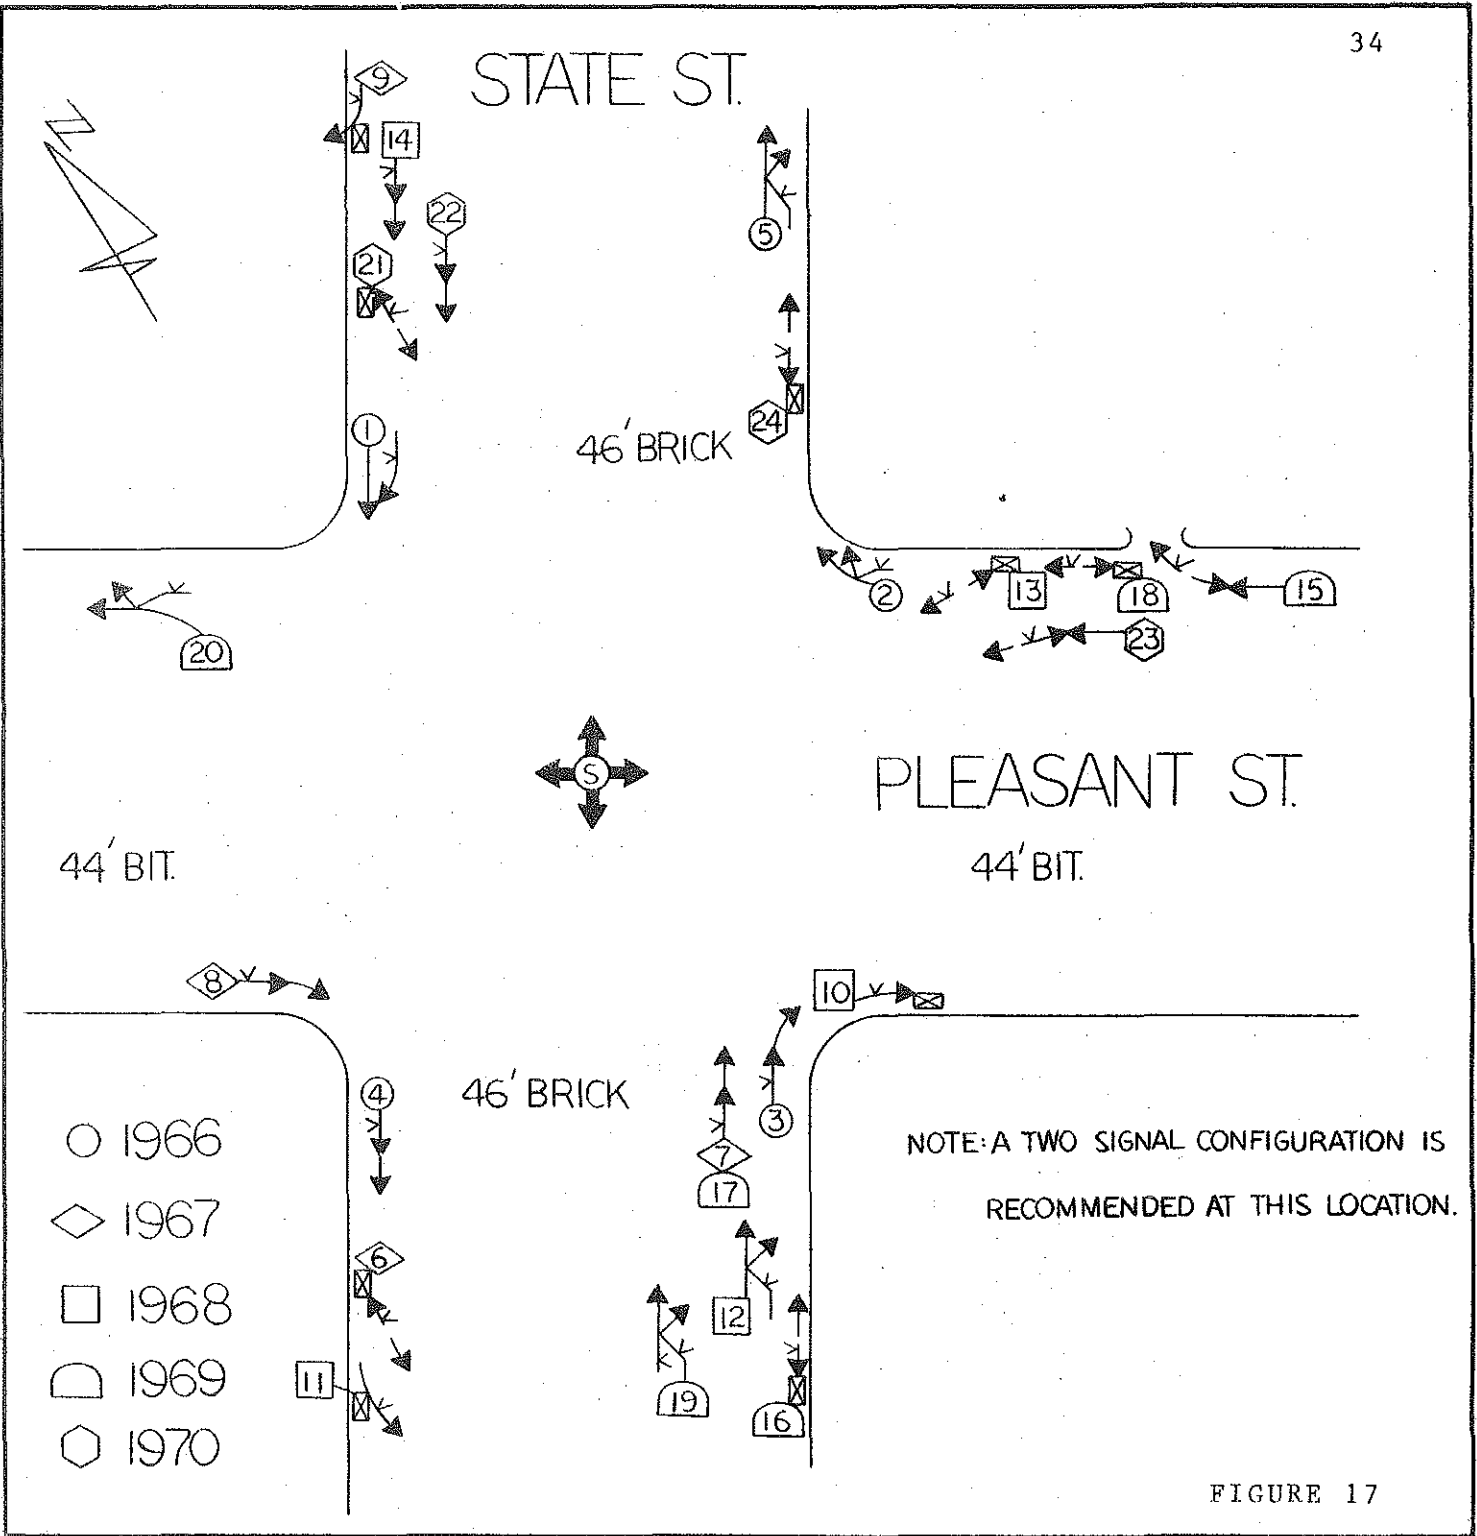
FIGURE 17

There were five sideswipe accidents during the study period, four of which were caused by a vehicle leaving a parking place. Neither State Street nor Pleasant Street have center line markings. Thus, it is recommended that center lines be applied to both streets. Center line markings will help reduce the conflict between vehicles entering or exiting a parking place and moving traffic by giving moving traffic an indication of the available pavement width.

Lastly, this intersection has only one overhead vehicular signal face visible to traffic on each approach. If this intersection remains signalized then a second signal head should be erected to provide two visible signal faces per approach.

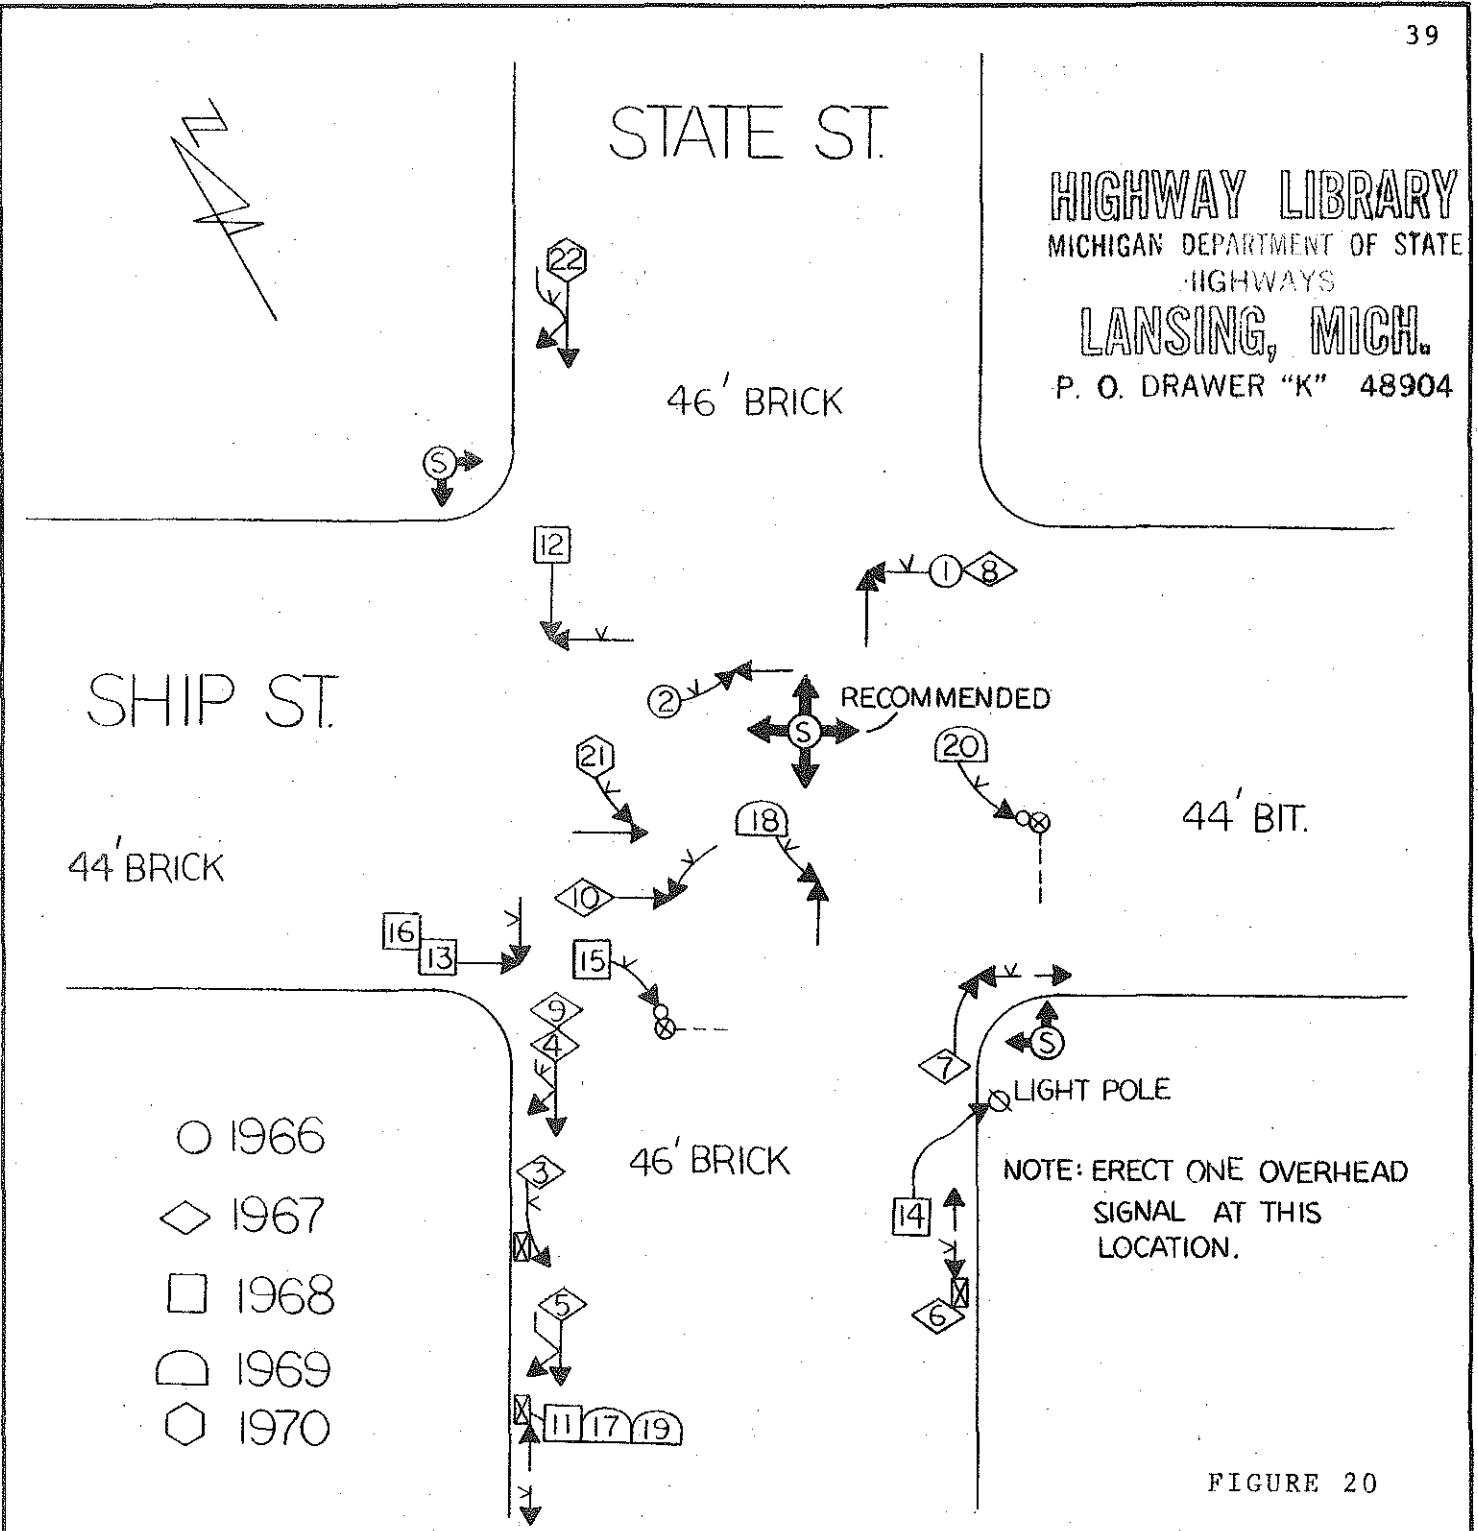
FIGURE 20

Furthermore, one of the signalized locations (State Street at Ship Street) had pedestal type signals only. The Michigan Vehicle Code (Revision of 1968) indicates under Law 257.612, Section 612, that "whenever traffic is controlled by traffic control signals, at least one signal shall be located over the traveled portion of the roadway so as to give drivers a clear indication of the right-of-way assignment from their normal positions approaching the intersection." Pedestal type signal heads can be used as a supplement to overhead signals but they cannot be used alone. It is recommended that this intersection and all future signalized intersections conform to the Michigan Vehicle Code in this regard.

A signalized intersection would be expected to cause a reduction in right-angle accidents and an increase in rear end accidents. However, at this signalized location during the five-year study period there were six right-angle accidents and no rear-end accidents. The fact that rear-end accidents did not occur over the past five years is very good. However, the fact that there were six right-angle accidents, with five of the operators involved reporting that they did not see the pedestal mounted traffic signals, indicates that a potential hazard does exist. According to the Michigan Vehicle Code (Revision of 1968, p. 103) at least one signal shall be located over the traveled portion of the roadway. Thus, it is recommended that this intersection conform to the law as set down in the Michigan Vehicle Code. In regard to the pedestal mounted traffic signals, it is felt that they do not have to be removed. Pedestal mounted traffic signals can be used as a supplement to overhead signals, but should not be used by themselves. Furthermore, it is recommended that this intersection eventually have two signal faces visible for each approach. If the pedestal signals are not removed one overhead signal will provide two visible signal faces per approach. If the pedestal signals are removed two overhead signals will have to be installed to provide two visible signal faces per approach. These recommendations will apply only if it is determined that this signal is warranted. If a signal is not warranted at this location, the pedestal mounted signals should be removed.

Also, it is recommended that State Street and the northwest leg of Ship Street be skid tested as part of the city-wide check of all brick surfaces. If these surfaces are found to have an unsatisfactory coefficient of friction, consideration should be given to resurfacing.

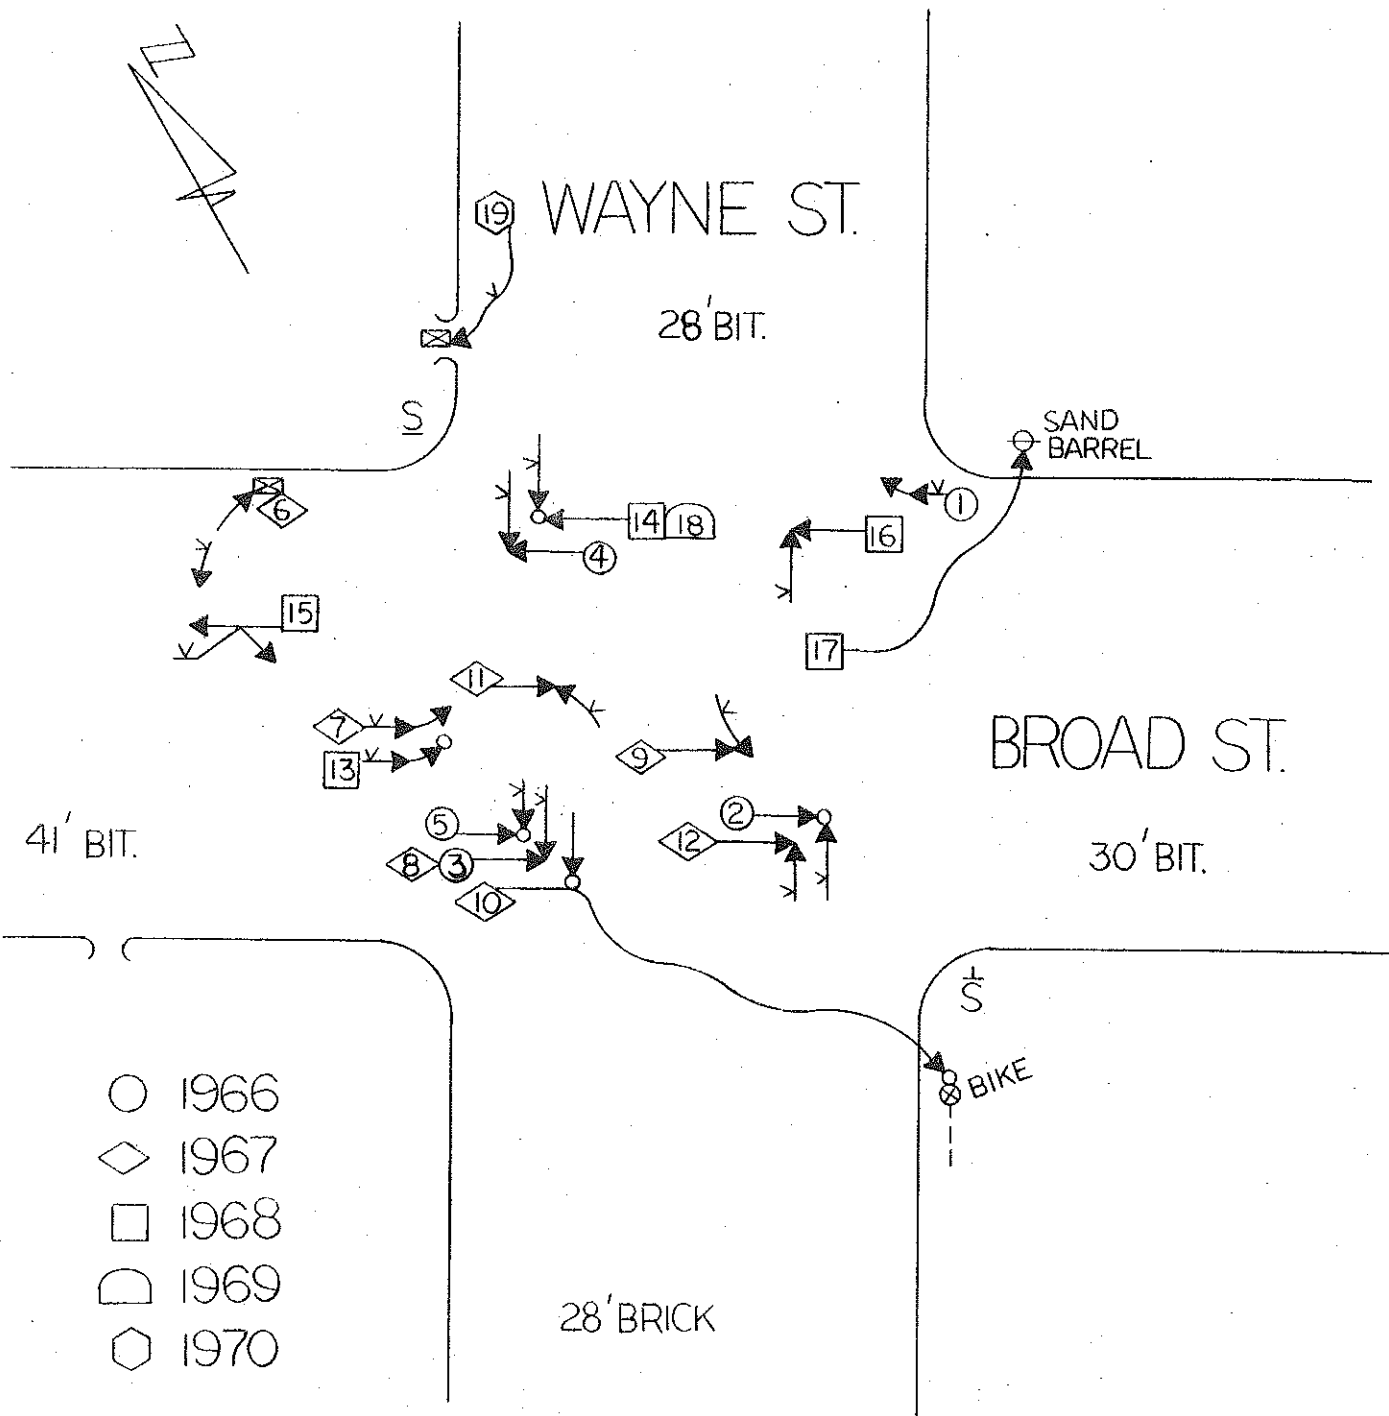
FIGURE 23

There were three operators who reportedly did not stop for the "Stop" signs on Wayne Street. The "Stop" sign for northbound Wayne Street is connected to an arm brace that protrudes from the bushes that are located above the retaining wall (See the middle picture on p. 45). Since this sign is obscured by the bushes, it is recommended that the bushes be maintained so that the "Stop" sign is completely visible to northeastbound Wayne Street traffic. There is also a tree located approximately 100 ft from the intersection that hangs over the roadway and also blocks an operator's view of the "Stop" sign. This tree should be trimmed and then maintained so that it doesn't hang over the roadway.

The "Stop" sign for southbound Wayne Street is located about 20 ft from the intersection. It is recommended that this sign be located at the point of obedience.

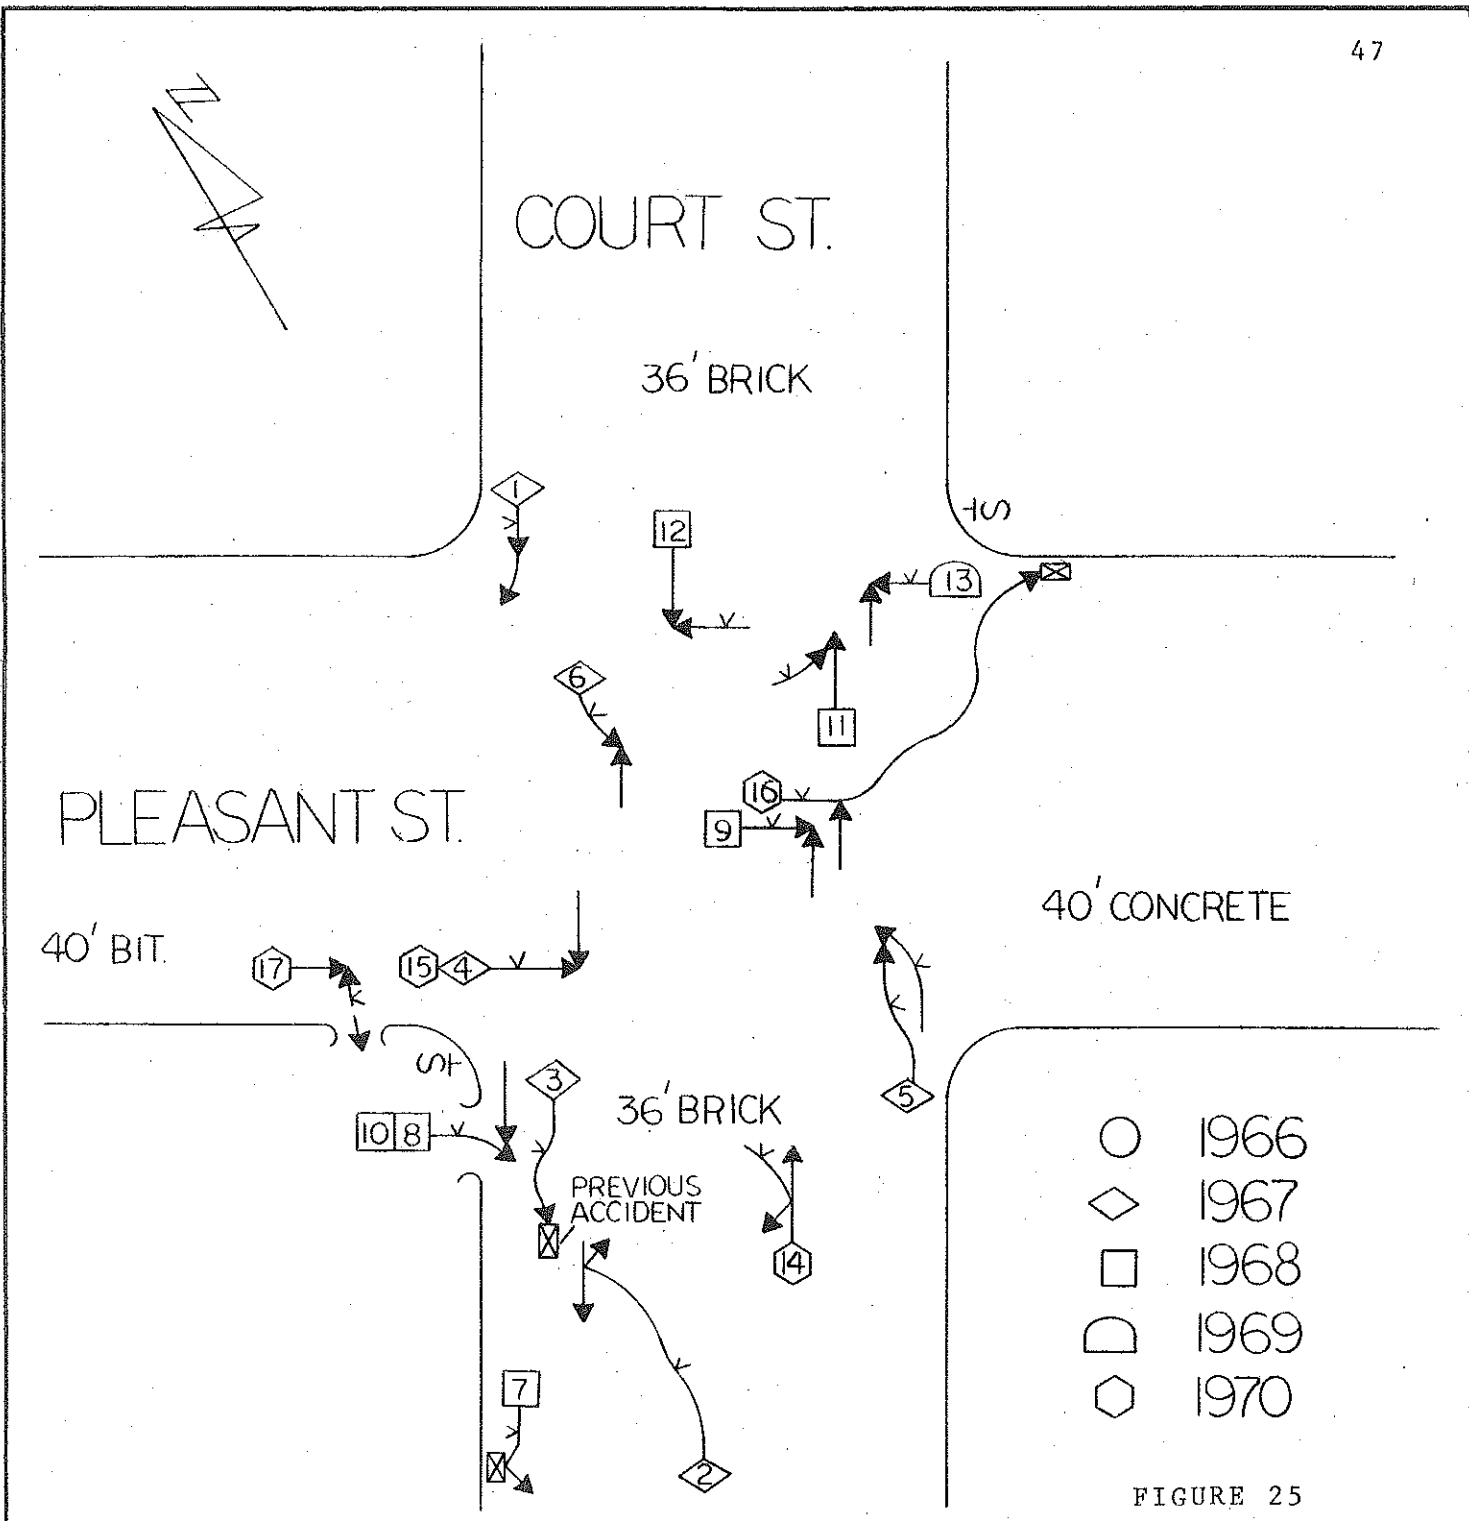
FIGURE 25

Fifty-three percent of the accidents at this intersection occurred on wet pavement while altogether almost 70 percent of the accidents occurred on either wet, snowy or icy pavement. All but one of the accidents that occurred during inclement weather happened on the brick surface. Thus, it is recommended that skidometer tests be conducted on Court Street.

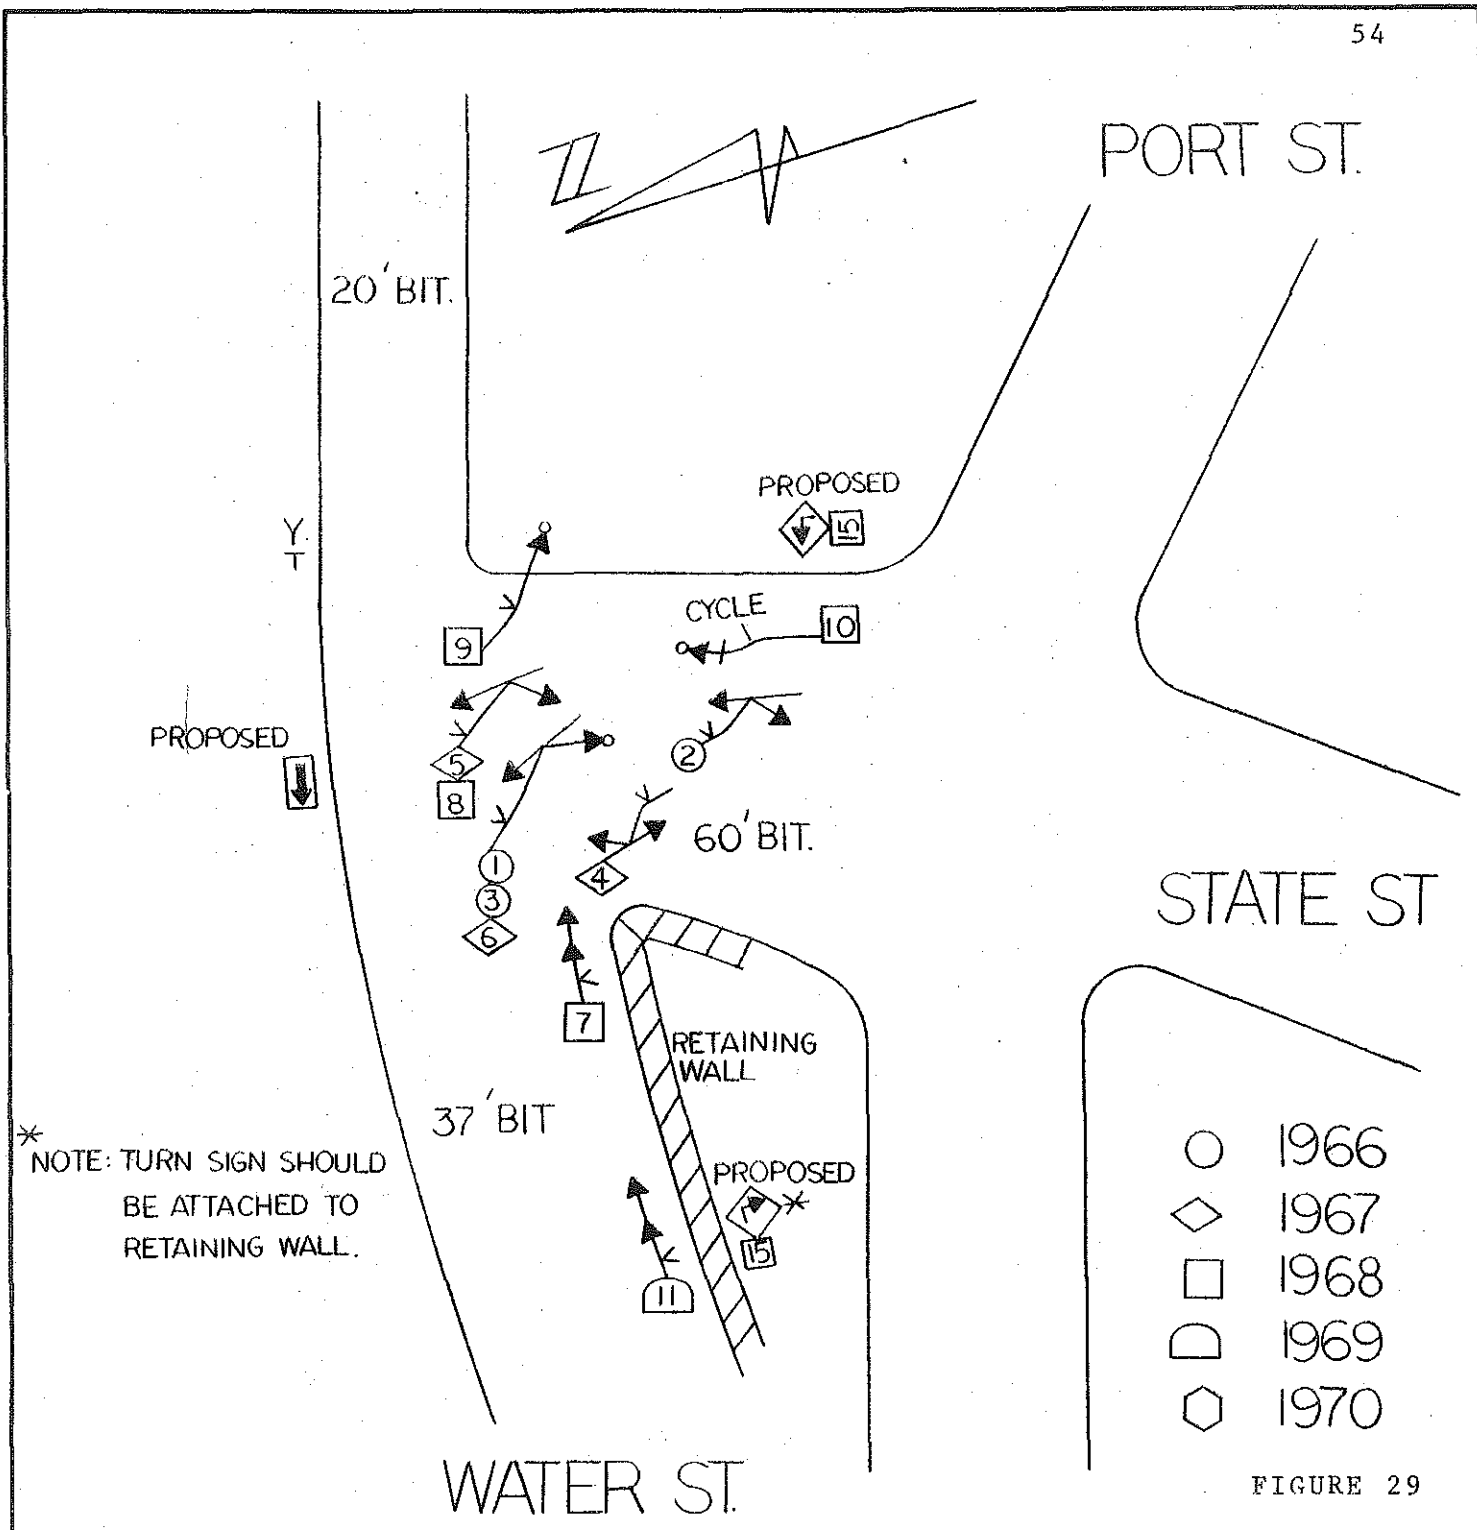
FIGURE 29

Due to these figures it is recommended that 15 mph Advisory Speed Panels accompany 30 in. Turn signs for both eastbound Water Street and northbound State Street traffic. It is also recommended that double yellow centerline markings be used in conjunction with this signing to help keep opposing traffic from crossing the centerline.

Lastly, it is recommended that a 48 in. Directional Target Arrow be placed at the end of State Street.

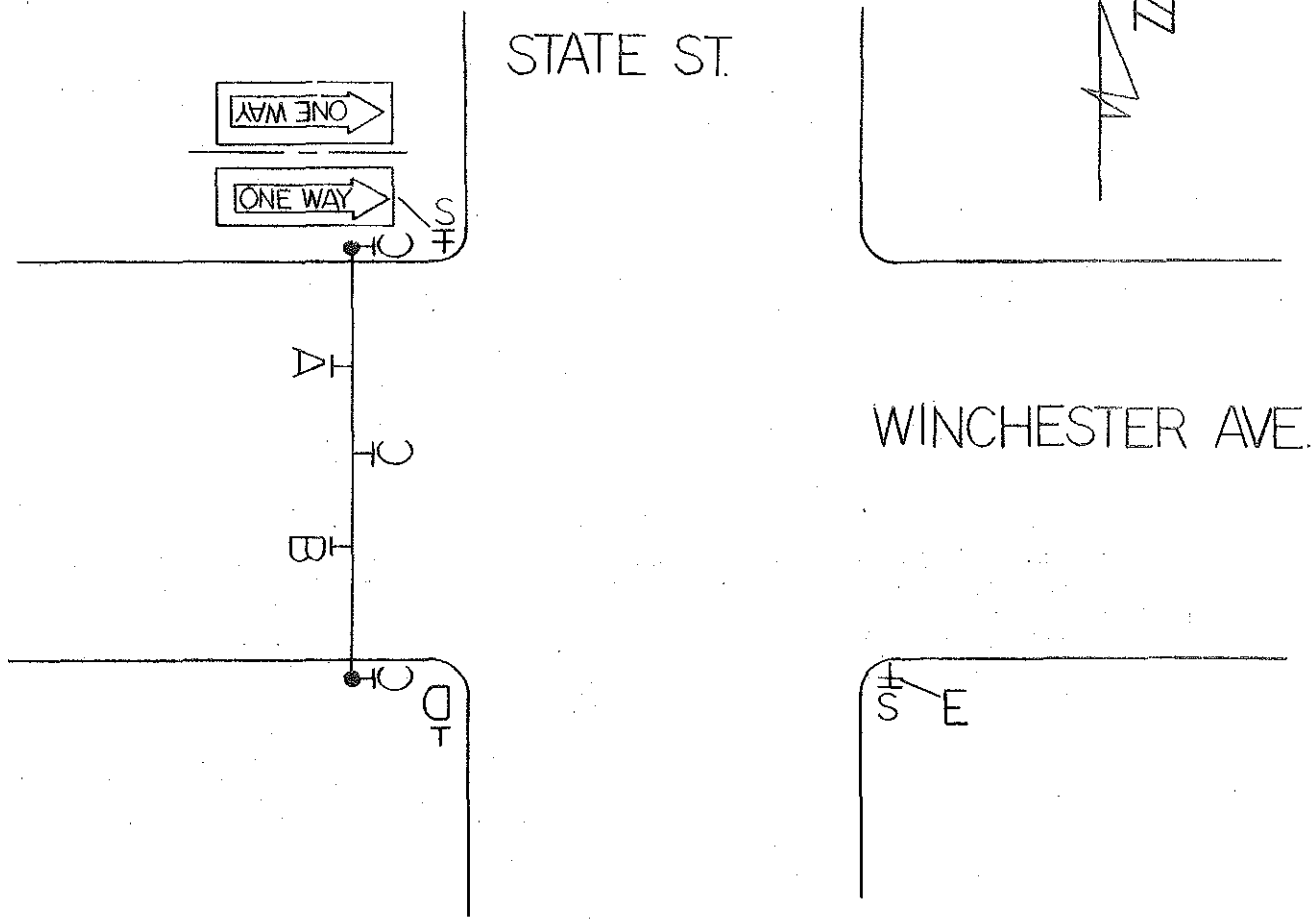
FIGURE 35

The remaining recommendations at this location involve signing changes and can be found under the Traffic Control Devices Inventory and on the proposed signing diagram (Figure 35).
