A TRAFFIC ACCIDENT ANALYSIS
AND TRAFFIC CONTROL DEVICES INVENTORY
IN THE CITY OF ST. JOSEPH

Report TSD-215-73

**TRAFFIC and
SAFETY
DIVISION**

**DEPARTMENT OF STATE HIGHWAYS
STATE OF MICHIGAN**

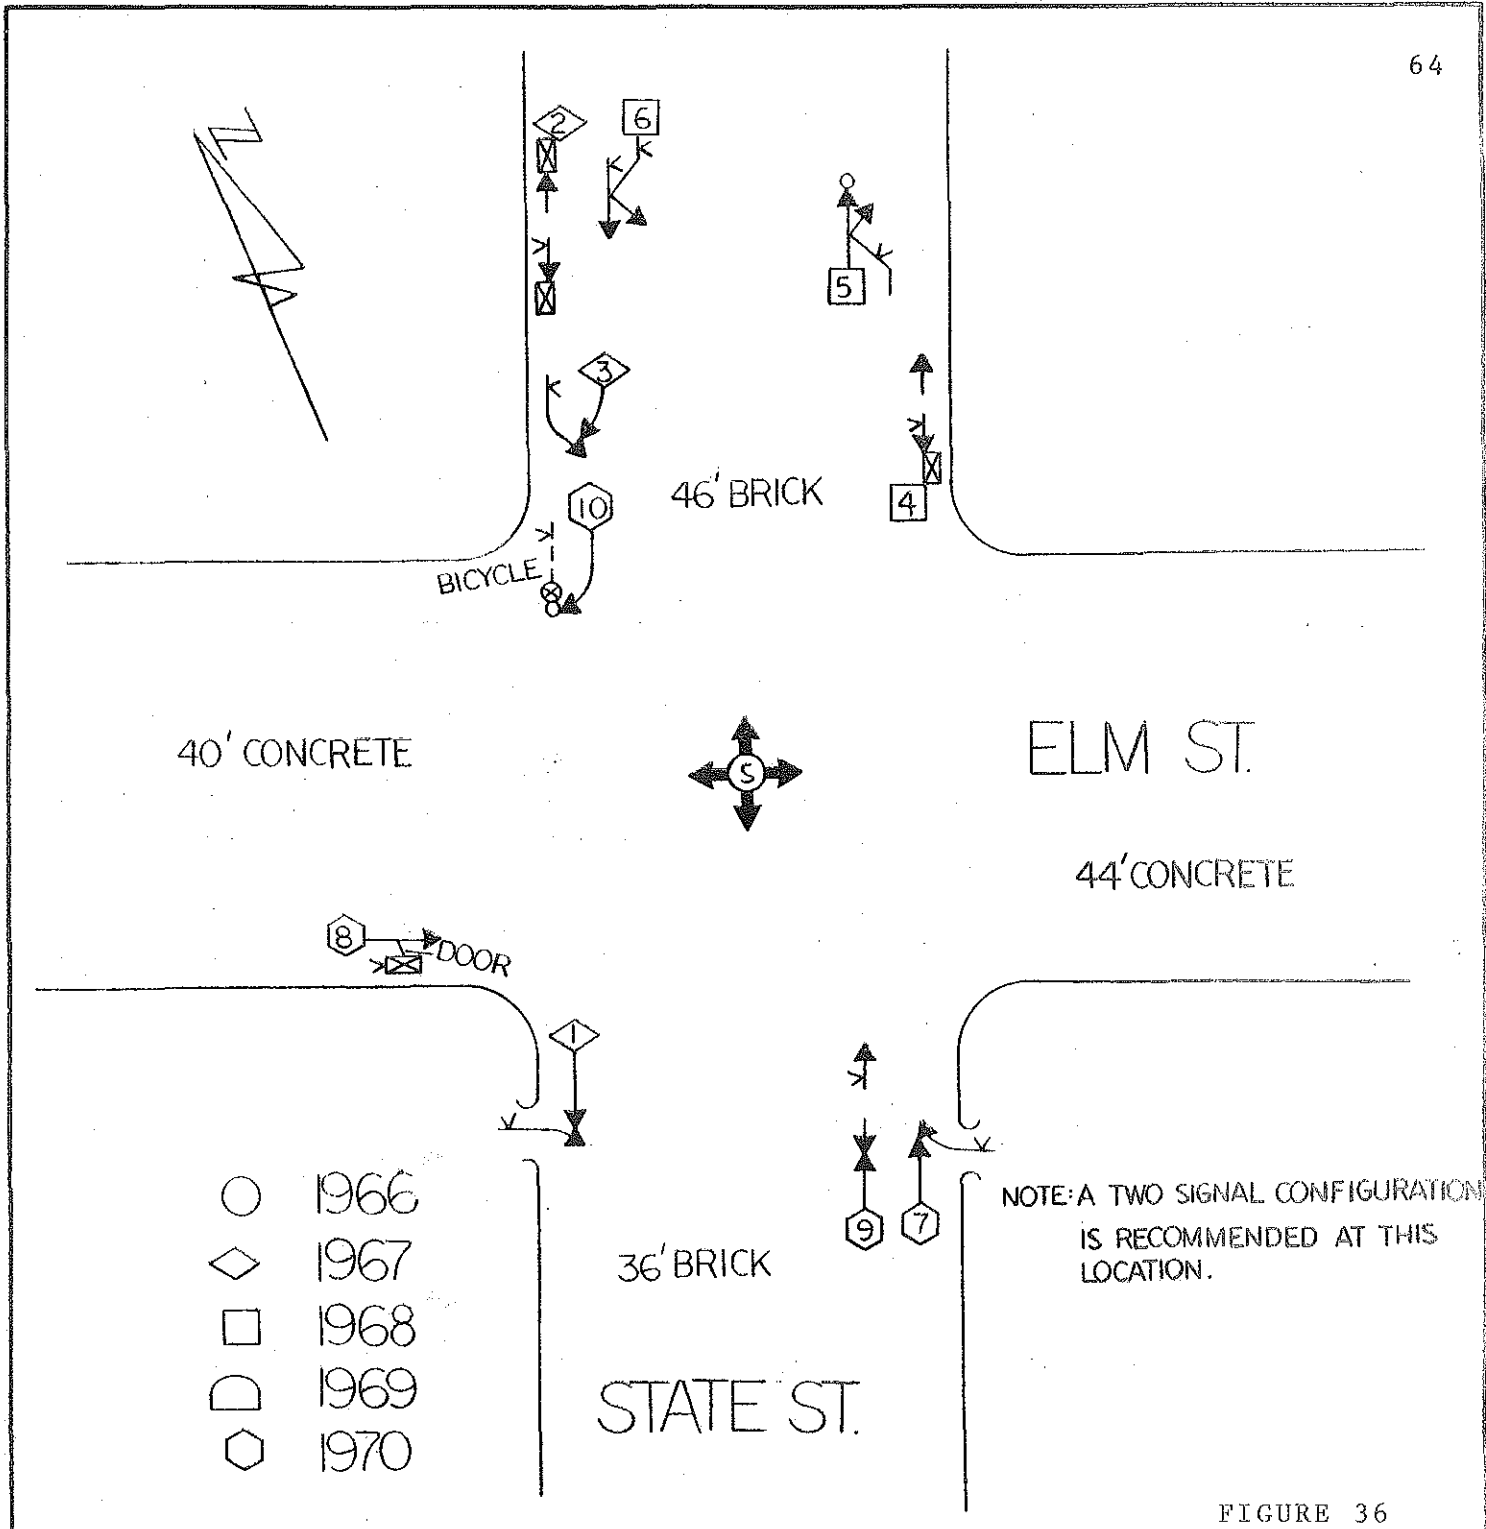
FIGURE 36

Seven of the ten accidents at this location occurred during adverse weather conditions. Furthermore, all but one of the accidents occurred on State Street which has a brick surface. Thus, it is recommended that State Street be skid tested as part of the city-wide check of all brick surfaces. If a slippery condition exists consideration should be given to resurfacing.

Lastly, this intersection has only one overhead vehicular signal face visible to traffic on each approach. If this intersection remains signalized then a second signal head should be erected to provide two visible signal faces per approach.

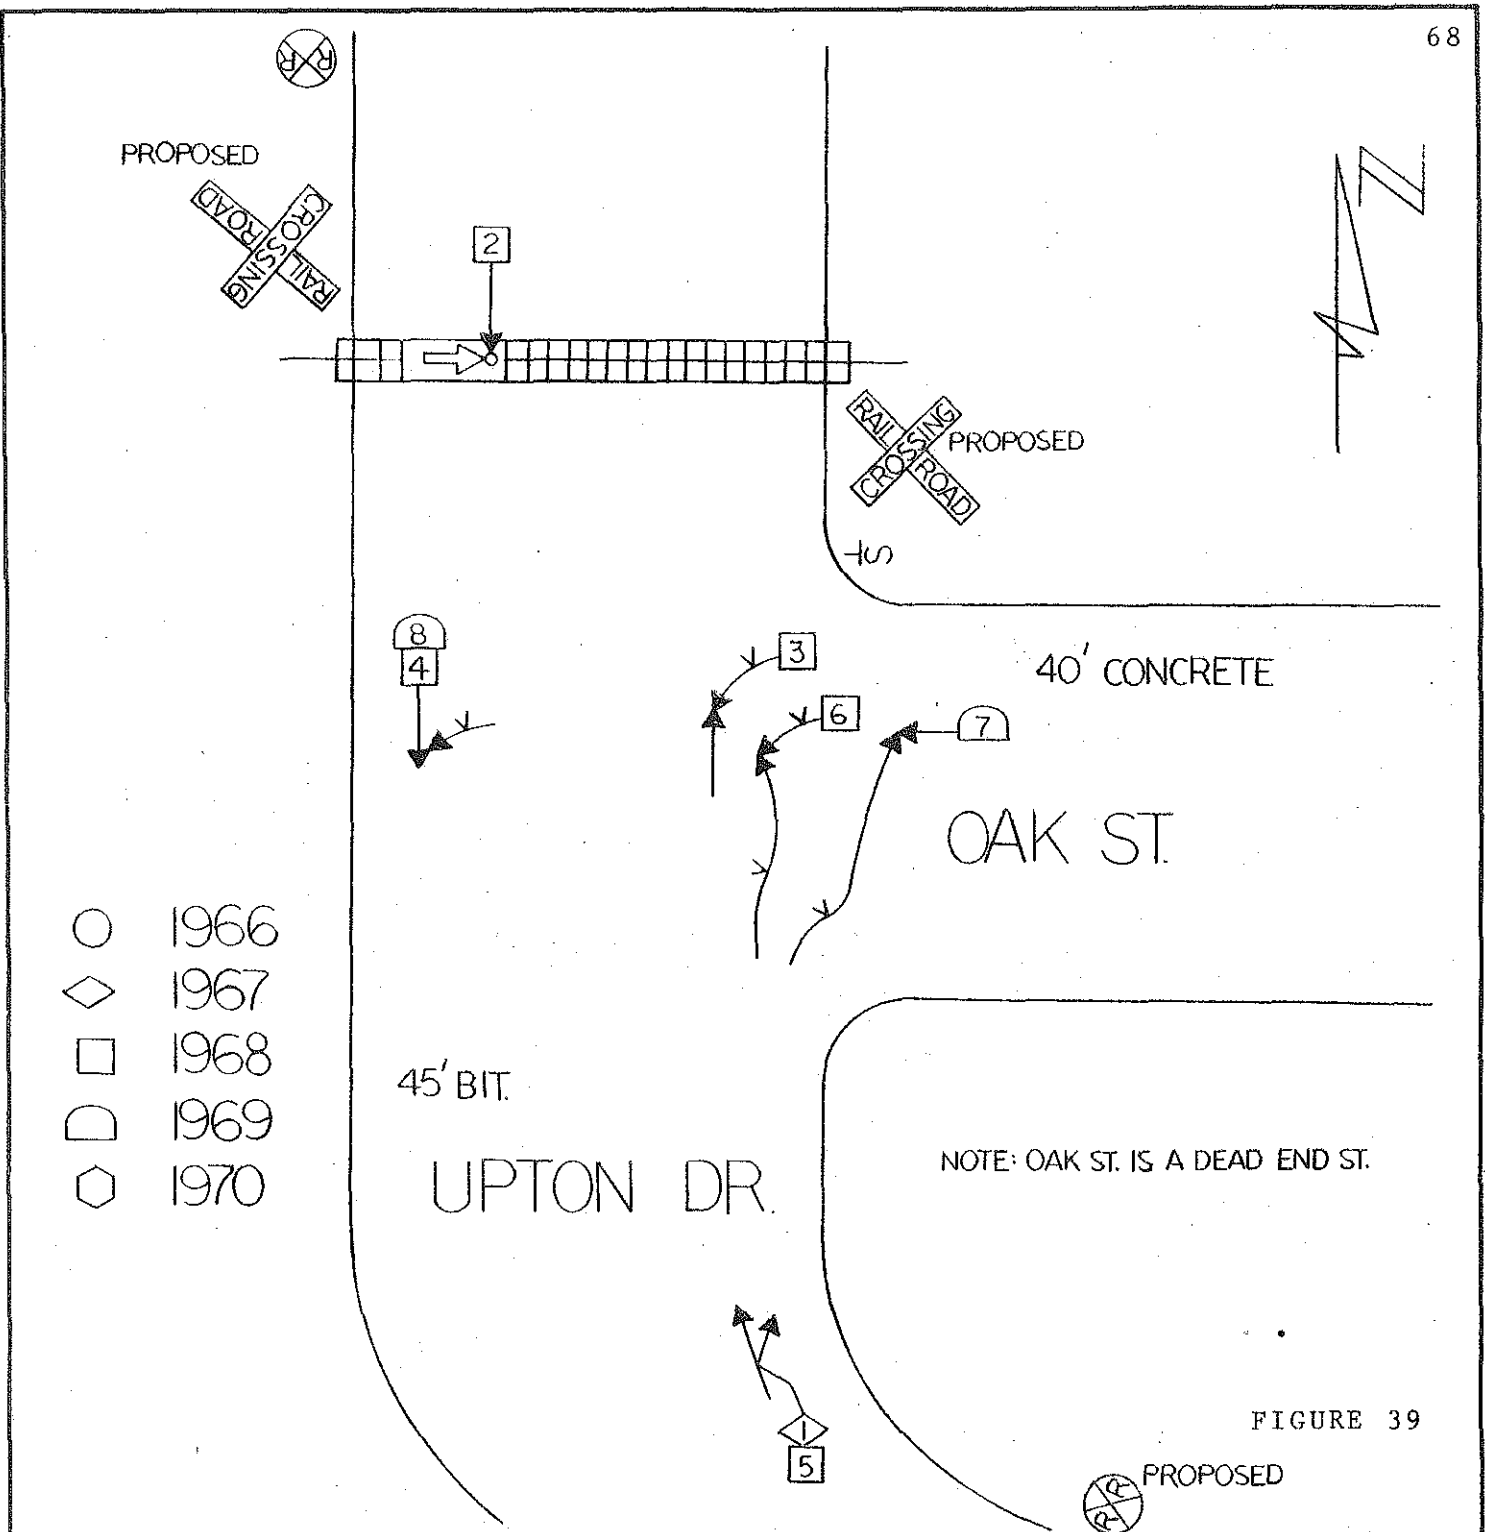
FIGURE 39

The railroad tracks that cross Upton Drive are not identified so that motorists can detect their presence. It is recommended that Railroad Crossing signs and Railroad Advance Warning signs be erected for both north and southbound Upton Drive.

Furthermore, the Manual suggests that all four lane undivided pavements have center line markings. Thus, it is recommended that a painted center line be applied to Upton Drive.
