INVESTIGATION OF SLIPPERY CONDITION
of
STONE SAND CONCRETE PAVEMENT
by
E. A. Finney

Highway Research Project 48 G-41

Research Laboratory
Testing and Research Division
Report 117
December 1, 1948

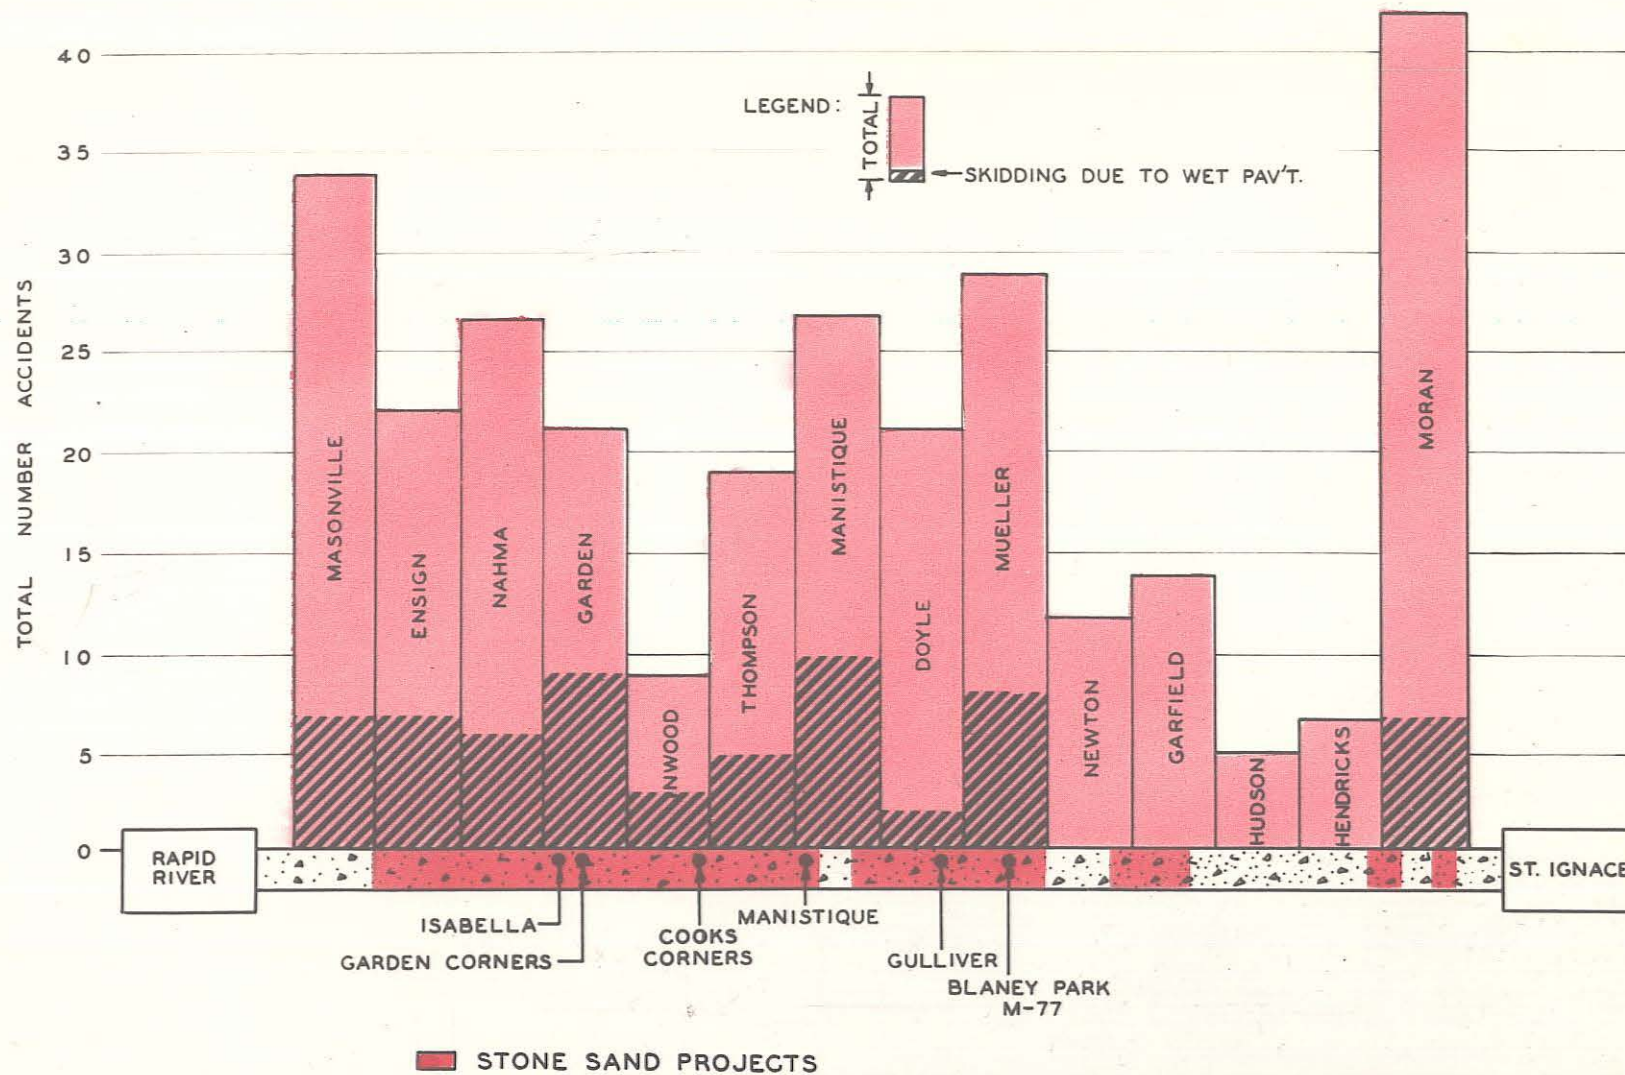
Figure 1

ACCIDENT RECORD *for* U.S. 2
 ST. IGNACE TO RAPID RIVER - 1946 TO SEPT. 1948

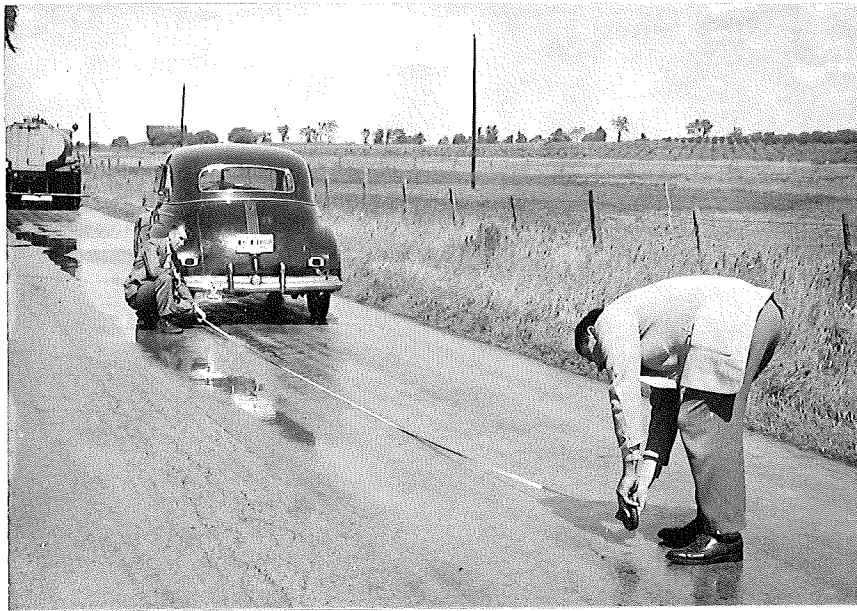
Figure 8. View showing water truck, skidding car and measurement of stopping distance.

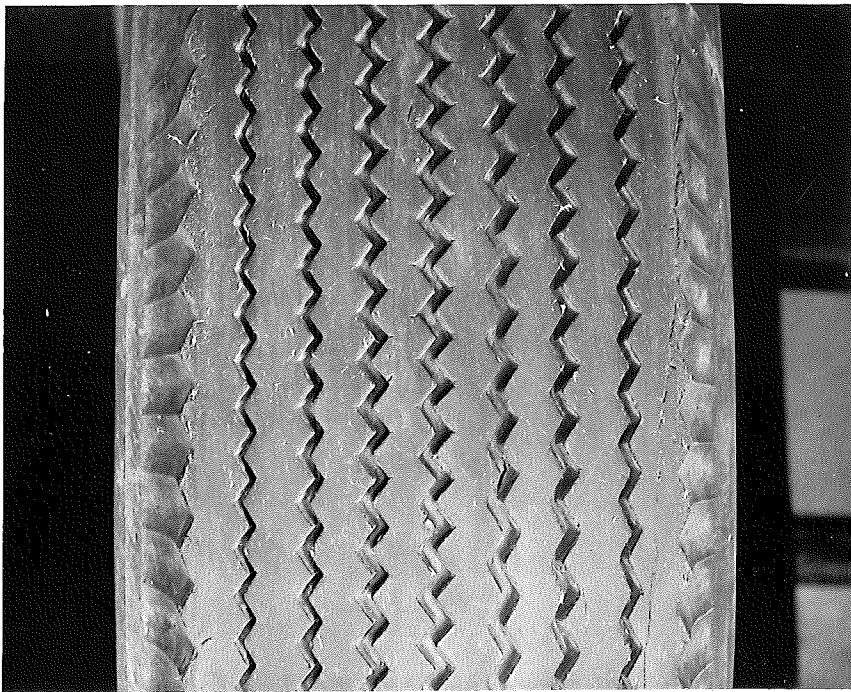
Figure 9. Typical tread pattern of all tires on test car.

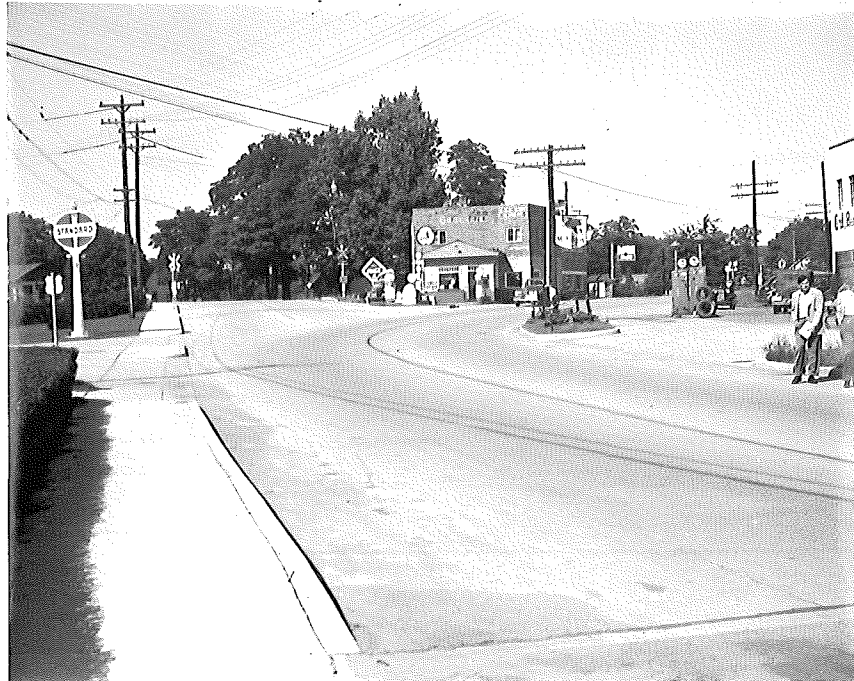
Test Area 22: This area is on a curve on US-31 in the City of Manistee at the intersection with M-110, Project 51-2, C 3-5. As may be seen in Figure 20, this area has several undesirable features which enhance the seriousness of the slippery pavement. They include the sharp curvature and down grade of US-31 at this point, the short sight distance due to adjacent buildings and converging traffic from M-110. The surface of the pavement was smooth and slippery as in the case of the other stone sand projects. See Figure 21. The average coefficient of friction was 0.24. According to local State Police there are many accidents on this spot.

Figure 20. General view at US-31 and M-110. City of Manistique. Project 51-2, C3-5, test area 22.

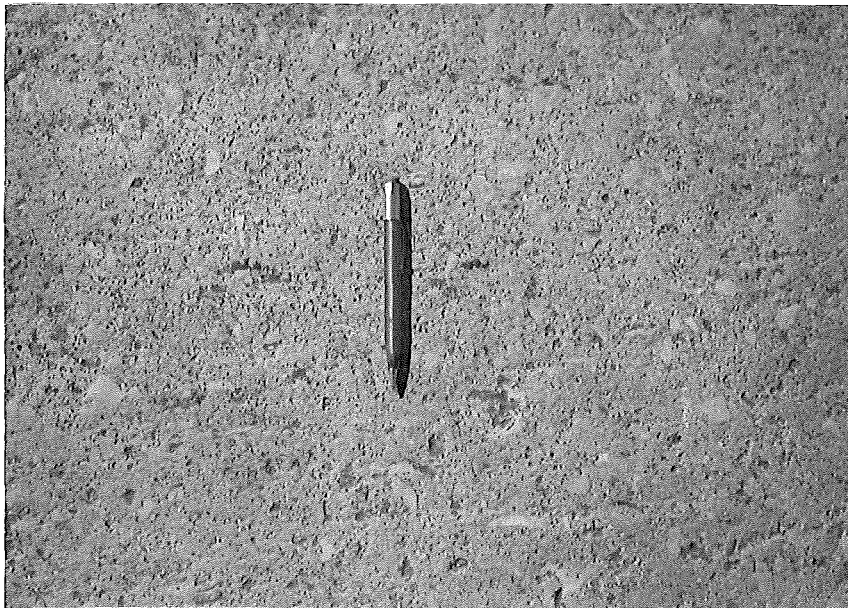
Figure 21. Stone sand concrete on US-31 at M-110, Manistee, Project 51-2, C3-5.

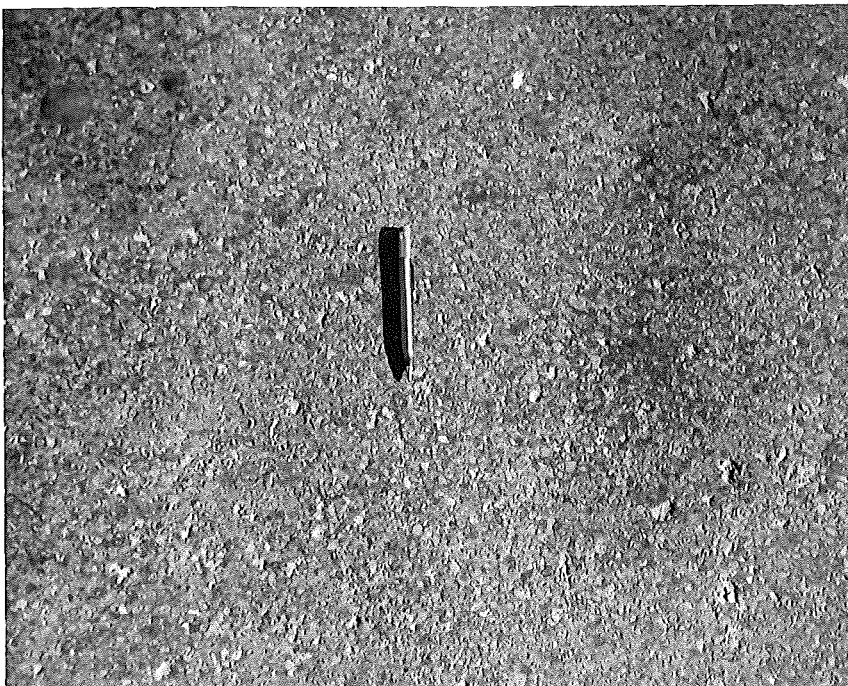
Figure 22. Bituminous concrete resurfacing on Front Street, Traverse City, between Oak and Maple Sts. Test area 26. Laid in 1945.

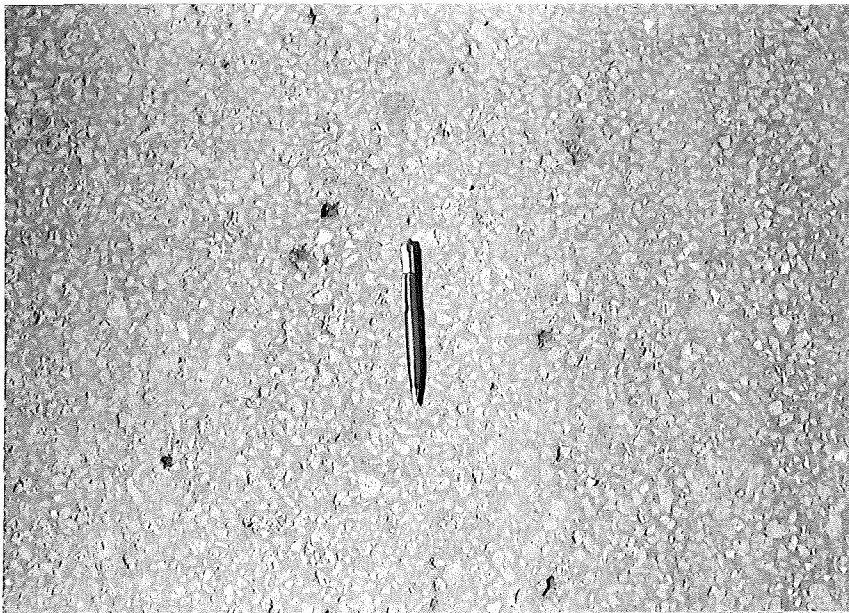
Figure 23. Bituminous concrete resurfacing on Front Street, Traverse City, 400 block. New pavement put down in 1945. Test area 28.

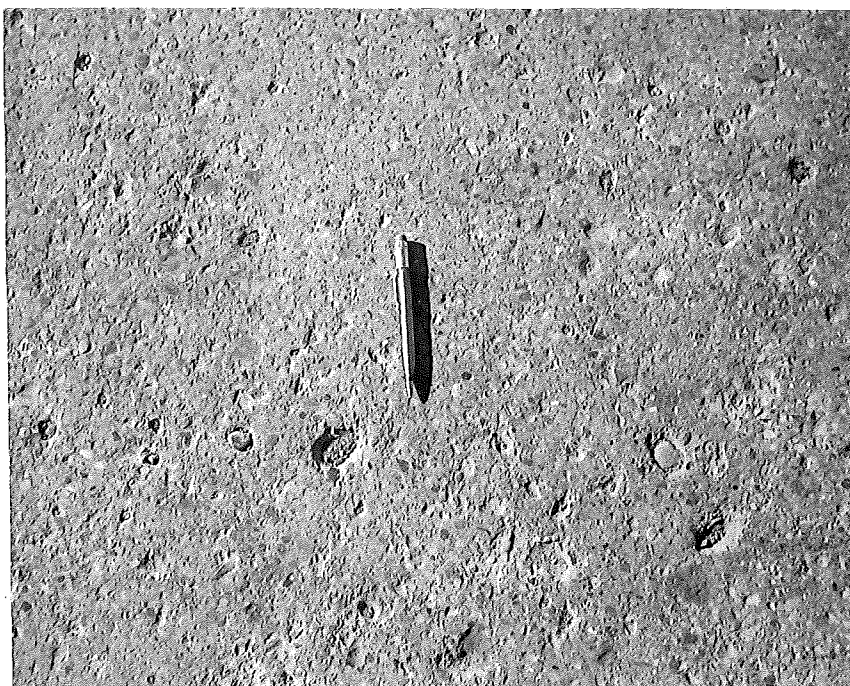
Test Area 27: This test area was also on Front Street in Traverse City, but on old bituminous concrete resurfacing project put down by the City in 1942. The coefficient of friction was 0.61. The texture of the surface was rough. See Figure 24.

Figure 24. Bituminous concrete resurfacing at Front Street, Traverse City. 800 block, laid in 1942. Test area 27. Note rough texture of surface.

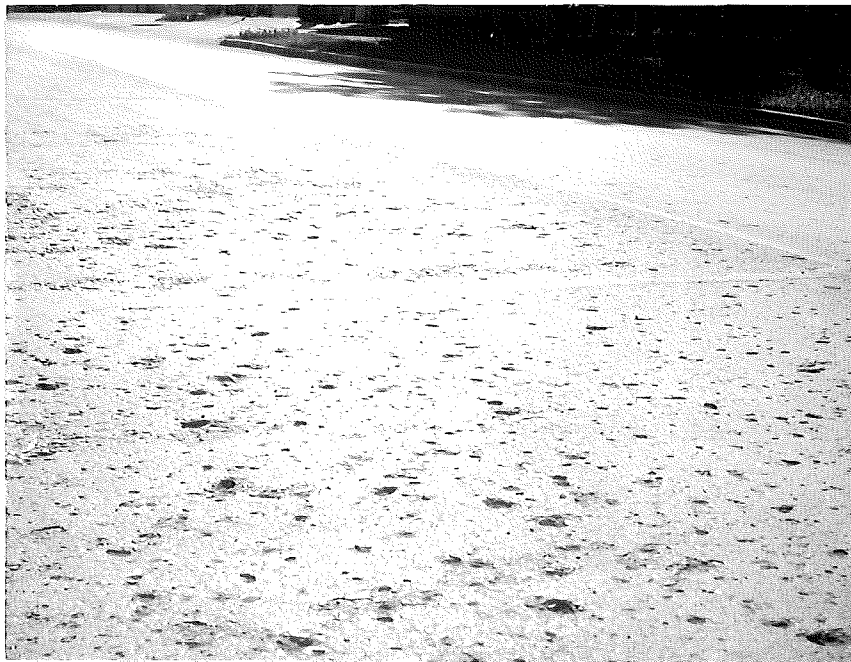
Test Area 29: At the suggestion of the Traverse City Police a skidding test was made on a natural sand project on East 8th Street at Garfield Road which they claimed was very slippery when wet. As may be seen in Figure 25 the surface is smooth and glossy. The average coefficient of friction for this Traverse City concrete project was 0.37.

Figure 25. Natural sand concrete surface on 8th St. in Traverse City. Test area 29, City Project.

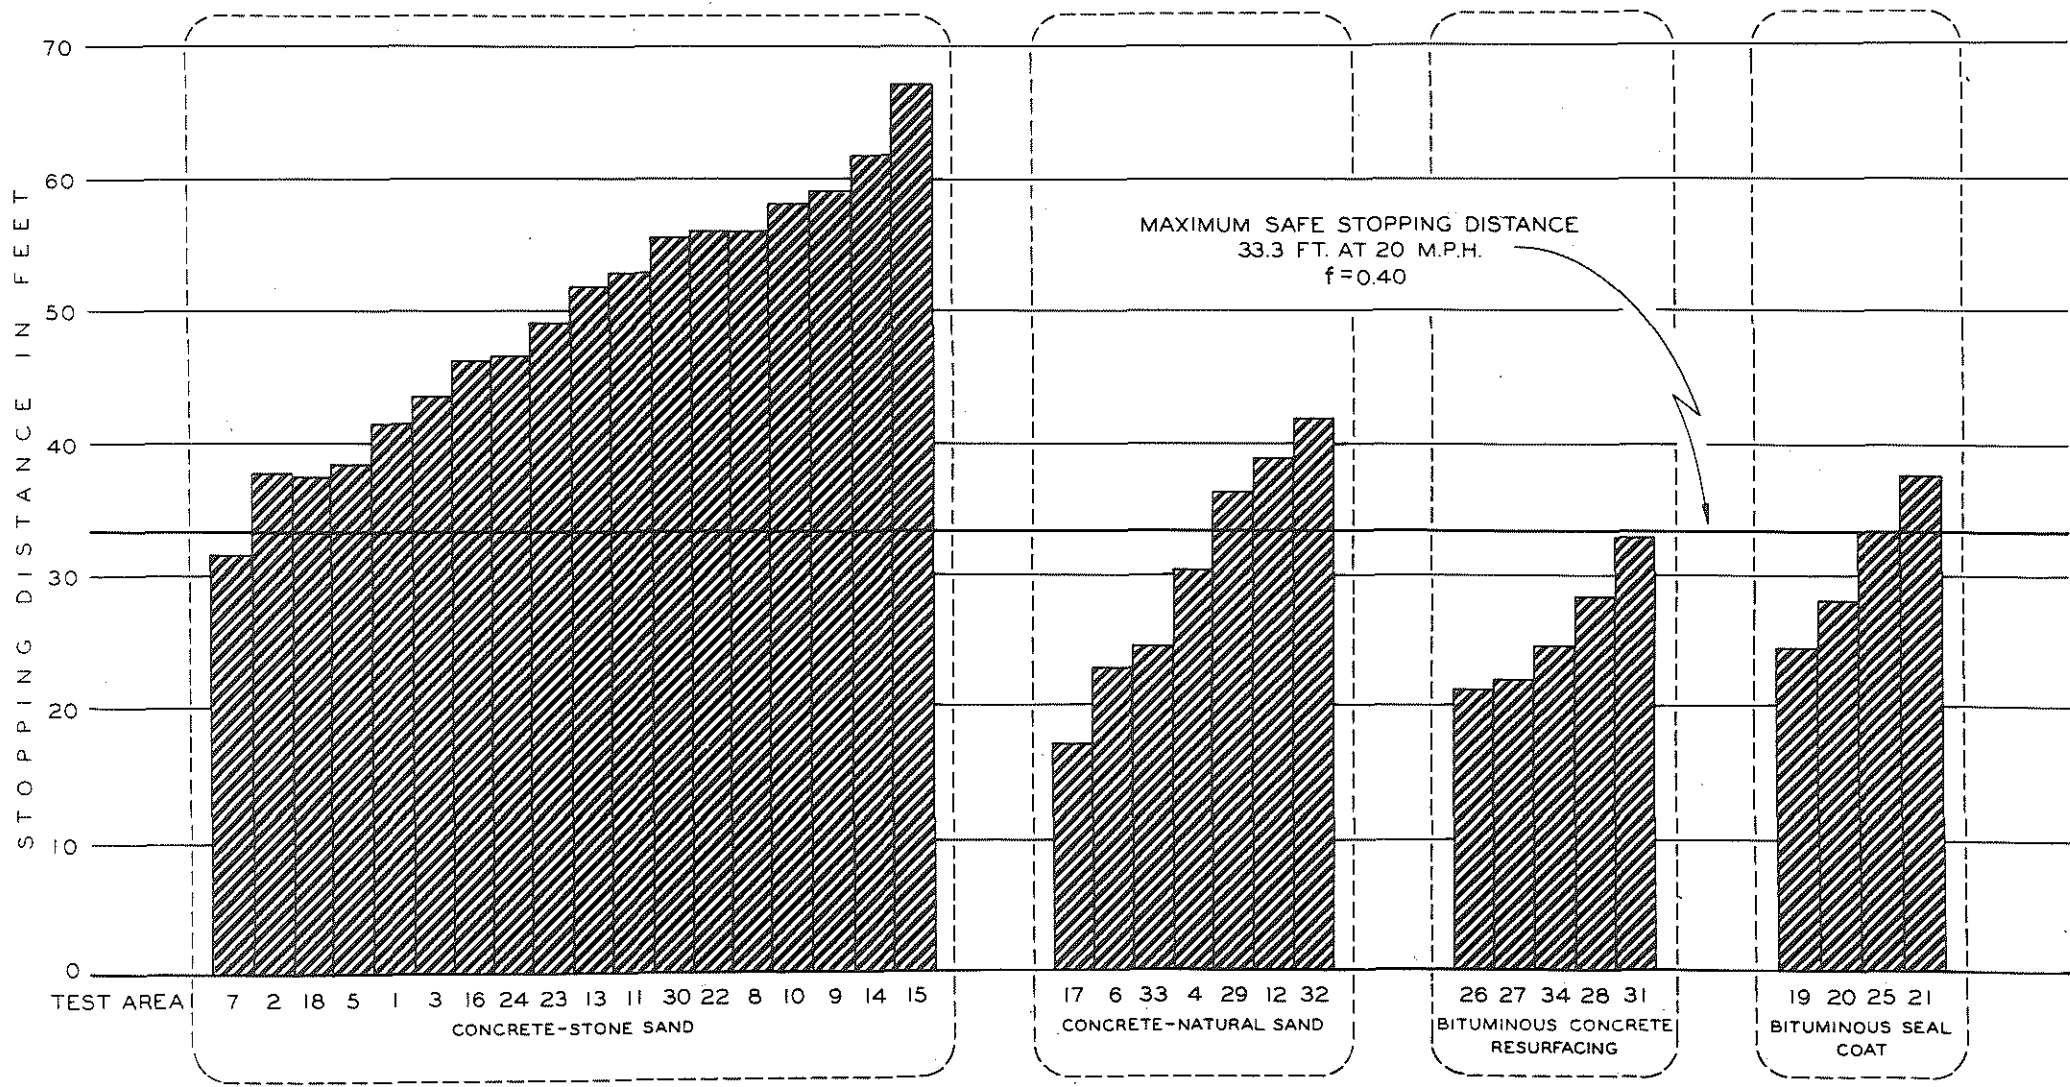
Figure 27

A graphical presentation of the average skid resistance by stopping distance measurements on all surfaces tested is given in Figure 27. Note that the bituminous concrete resurfacing material has very good resistant properties when wet which is contradictory to popular belief. Also note that natural sand concrete pavements are not totally immune to becoming exceedingly slippery when wet. However, as a group the stone sand projects greatly outweigh any other group of pavement surfaces in regard to being dangerously slippery when wet.

SKID RESISTANCE MEASUREMENTS ¹⁹⁷² VARIOUS PAVEMENT SURFACES CONTAINING INLAND LIMESTONE AGGREGATES

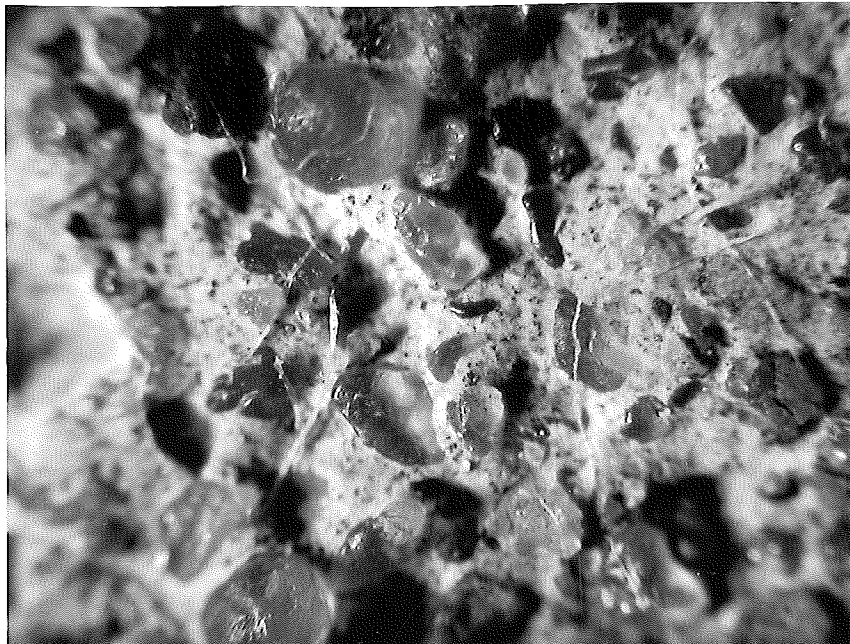
Figure 29. Texture of natural sand concrete surface. Project 49-28, C4. Core 671. Note rough, uneven surface and sand grains. Magnification, 24X.

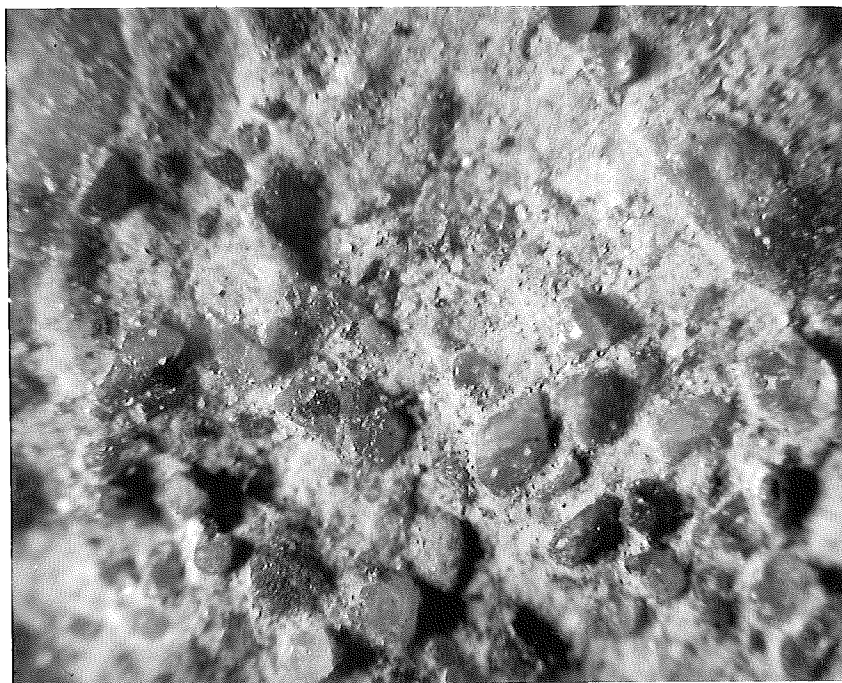
Figure 30. Texture of natural sand concrete surface. Project 75-6, C4. Core 637. Note rough, uneven surface and sand grains. Magnification, 24X.
