EVALUATION OF SAWED-SEALED LONGITUDINAL JOINTS
BETWEEN BITUMINOUS SHOULDERS AND RIGID PAVEMENT
AS A MEANS OF REDUCING
LONGITUDINAL SHOULDER CRACKING

MICHIGAN DEPARTMENT OF STATE HIGHWAYS

Research Laboratory Section
Testing and Research Division
Research Project 66 E-37
Research Report No. R-683

State of Michigan
Department of State Highways
Lansing, September 1969

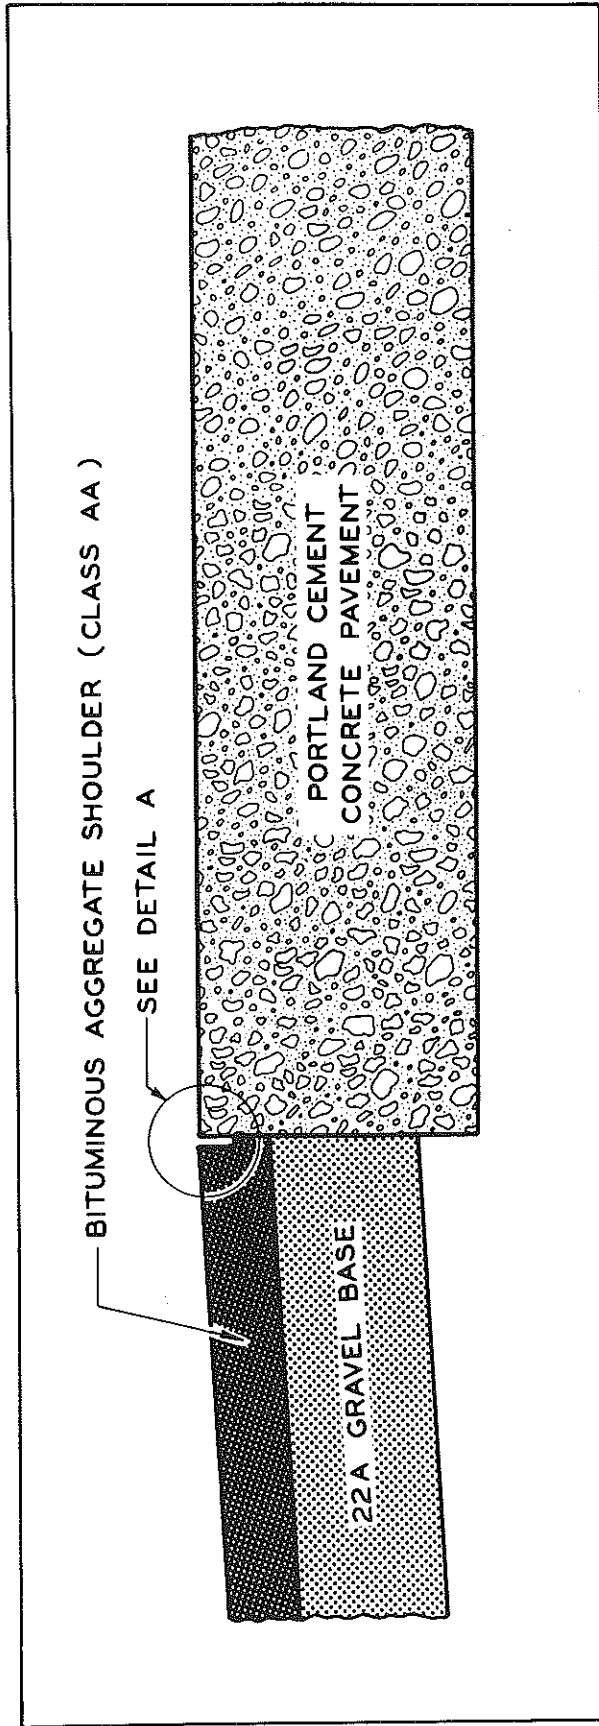
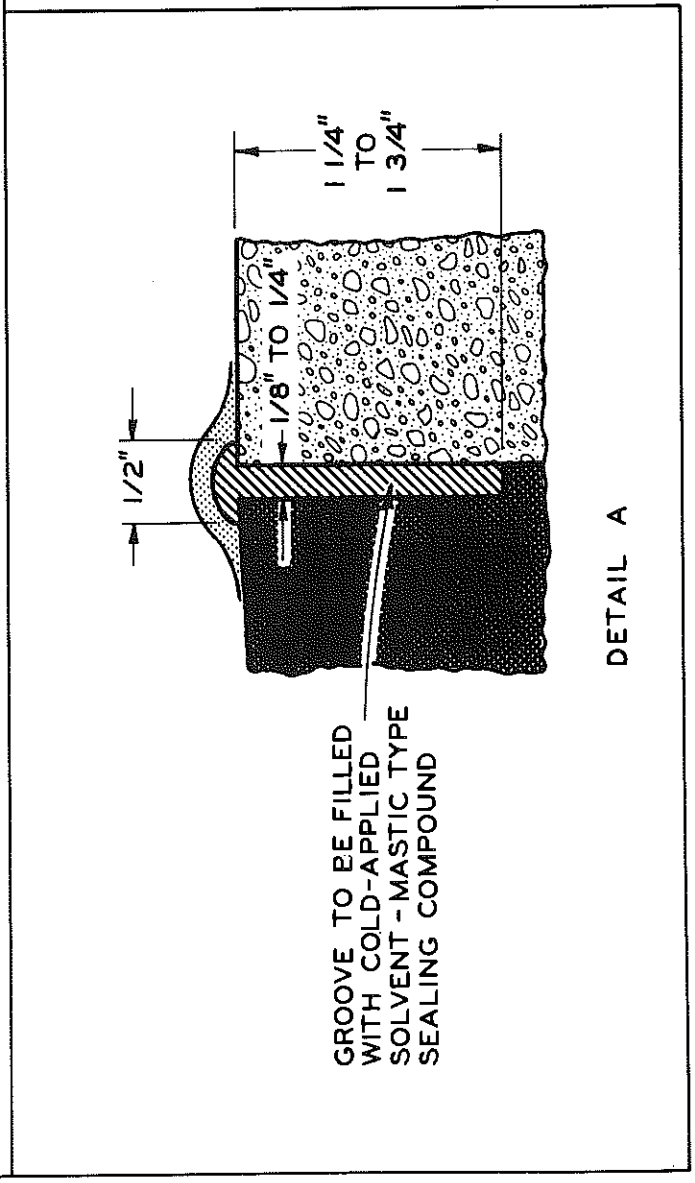
Figure 1. Seal-treated joint between bituminous aggregate shoulder and portland cement concrete pavement.

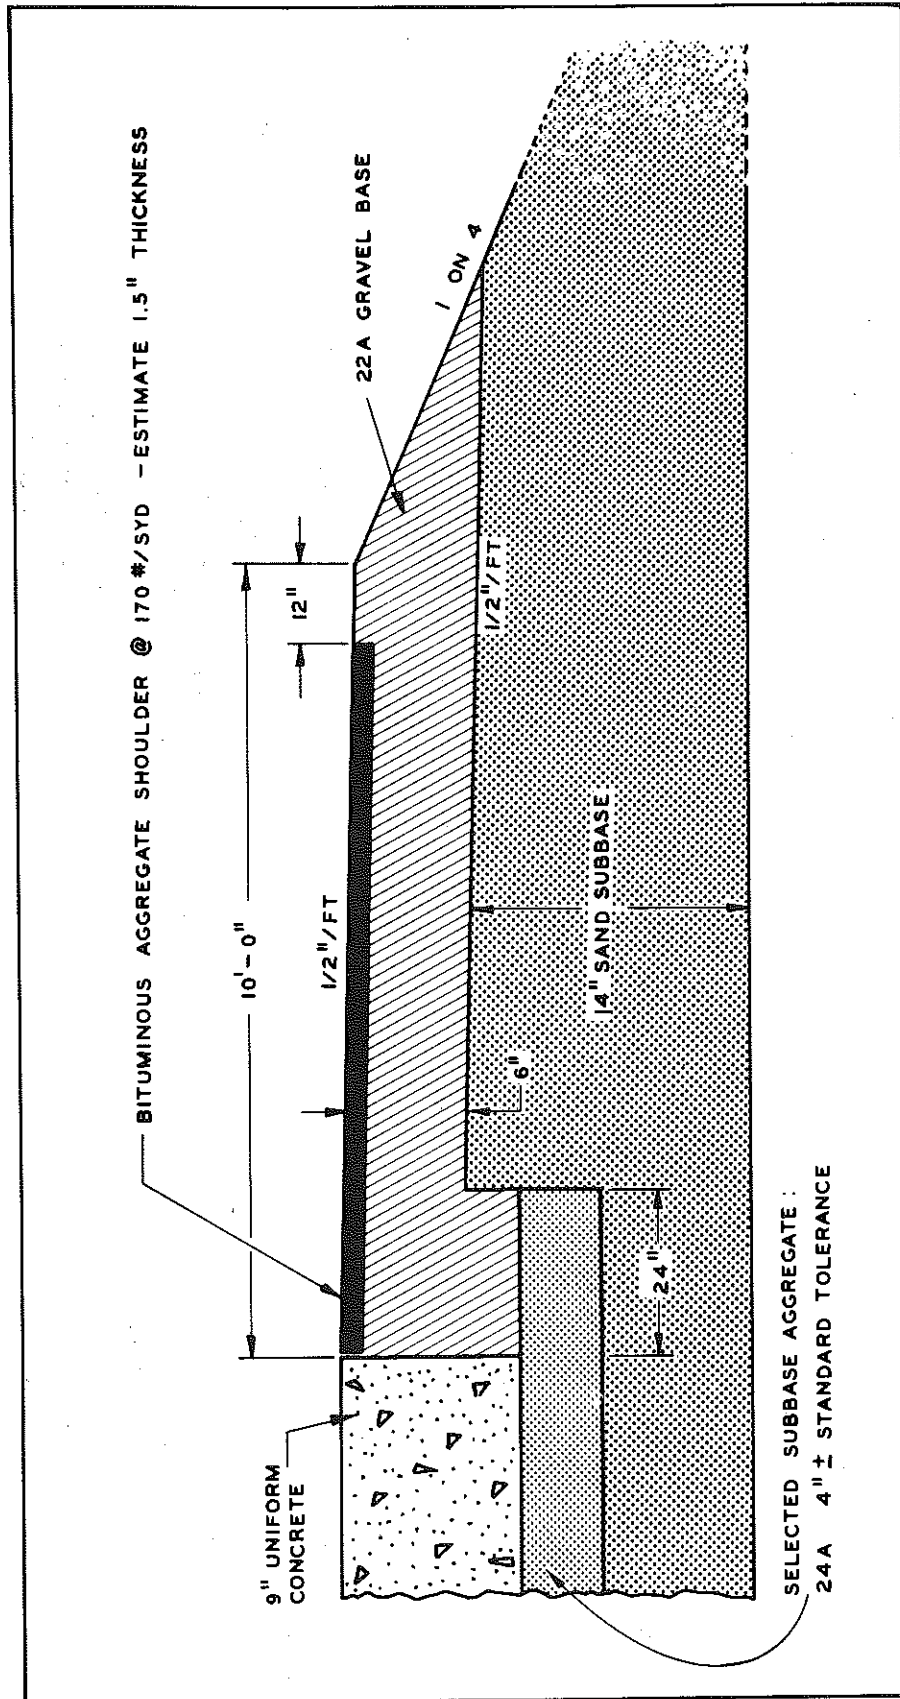
Figure 2. Typical cross-section of an outside (traffic lane) Class AA shoulder.

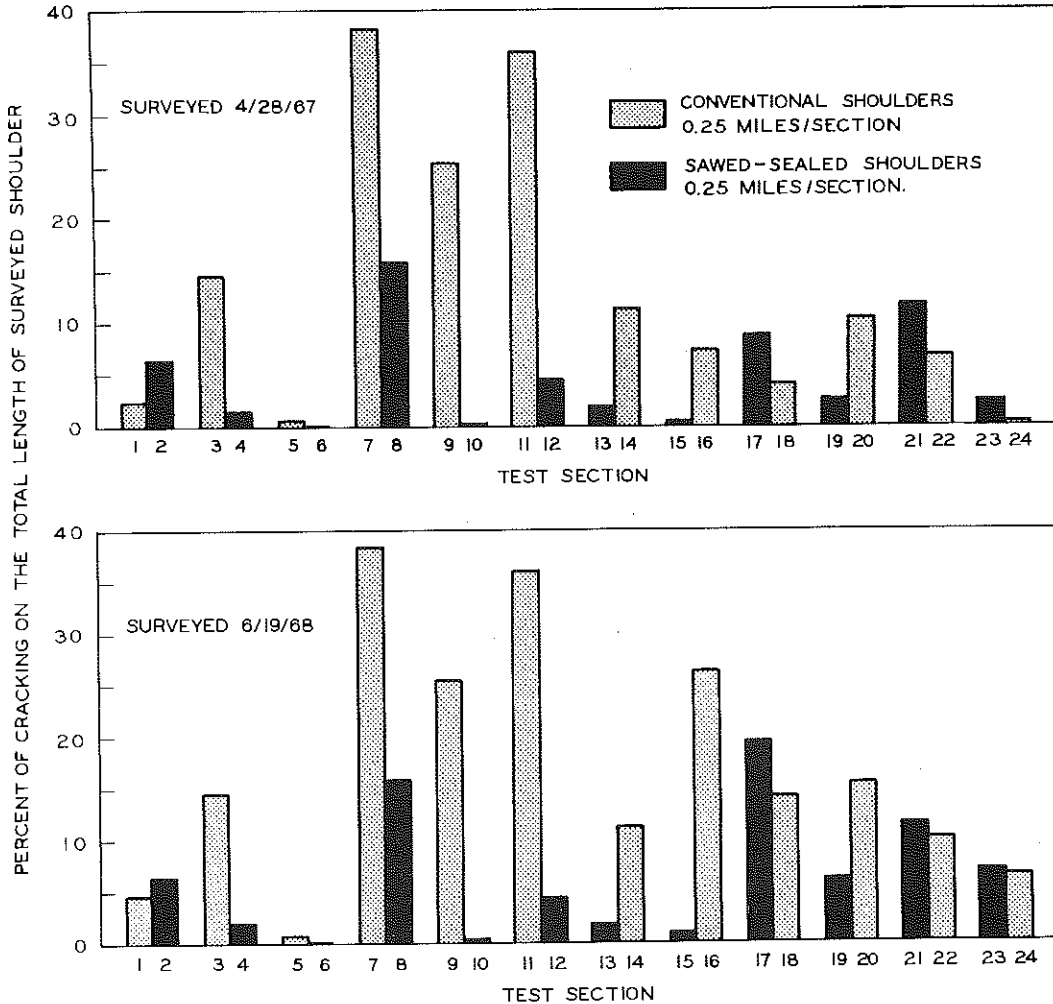
Results of longitudinal cracking surveys made in April 1967 and June 1968 over Project 5 are shown in Table 1 and summarized in Figure 5.

Figure 5. Crack formation in test project 5.

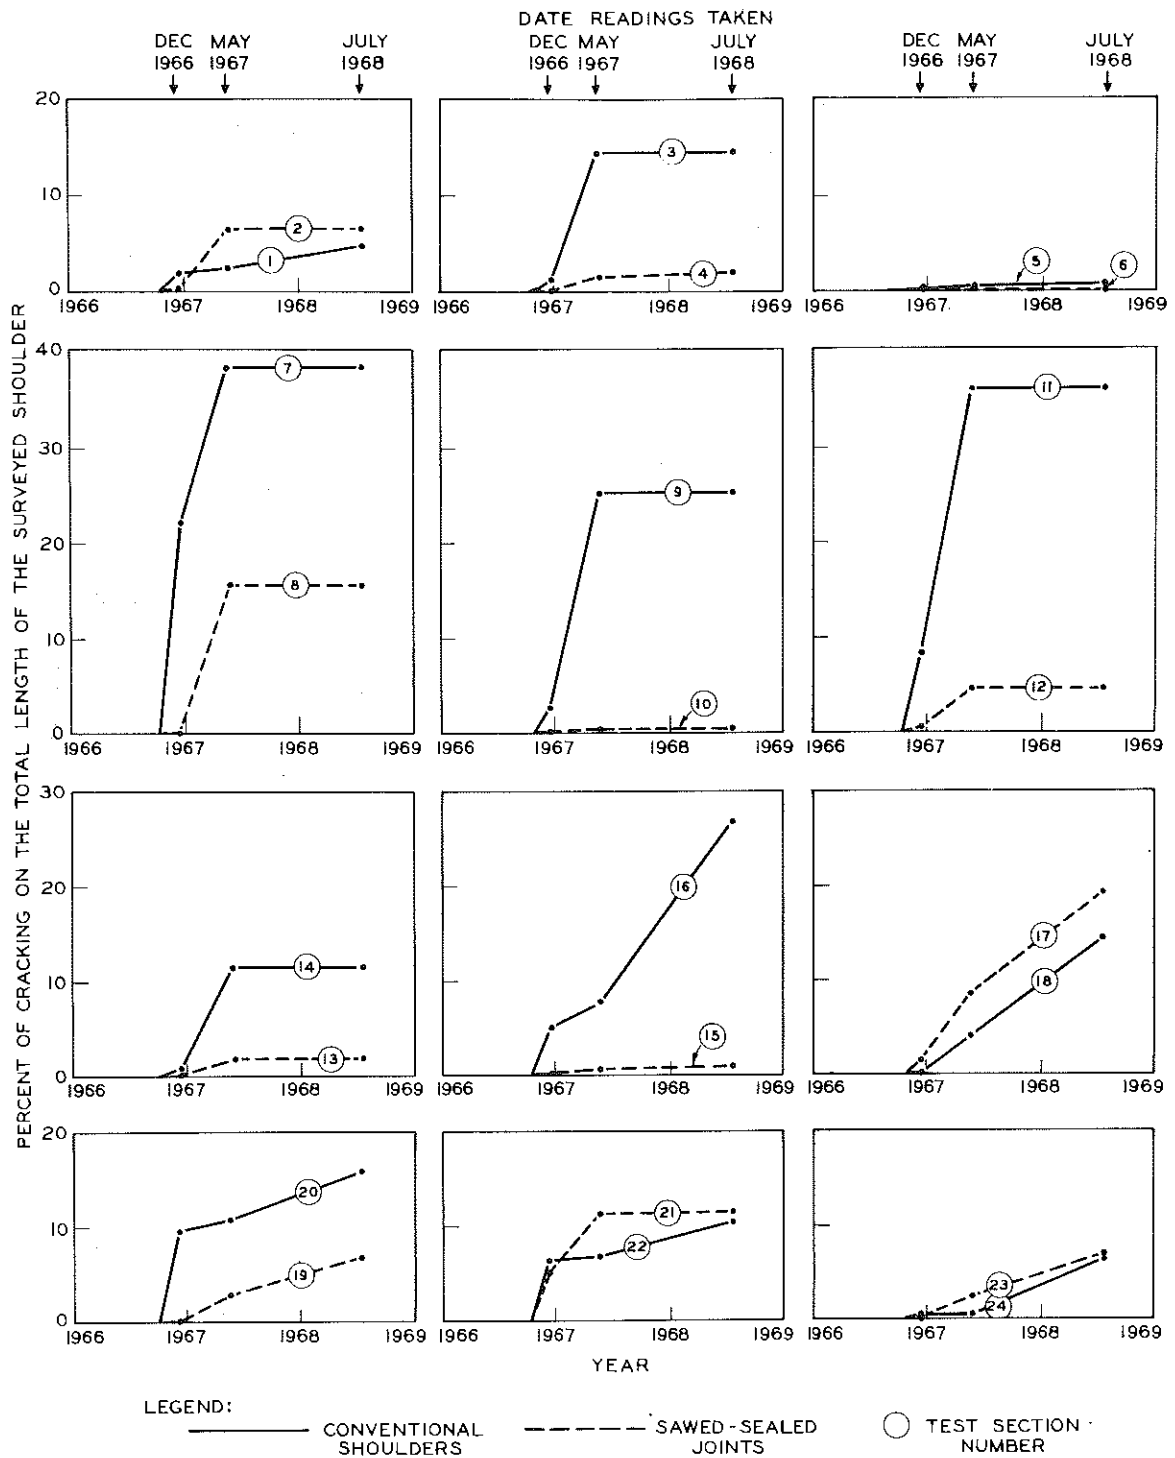
Progressive longitudinal cracking, after 20 months of shoulder service, varies markedly from section to section as shown in Figure 6. Longitudinal cracking increased sharply at an average annual rate of 6.6, 6.2, and 4.4 percent for conventional test sections 7, 11, and 9, respectively, and then

Figure 6. Crack formation progression, test project 5.

stabilized 13 months ago. Seven of the sealed test sections are currently showing better crack control than the conventional ones with which they are paired. For the other five pairs, the conventional shoulders show less cracking. Figure 6 shows that the typical curve of progressive longitudinal cracking consisted of two distinct periods. The first period is characterized by rapid crack development, especially during winter months, probably as a result of tensile stresses at the joint, settlement, or frost heave. The second period is characterized by a reduced rate of crack formation during warm weather, probably due to structural stability of the shoulders during this period.

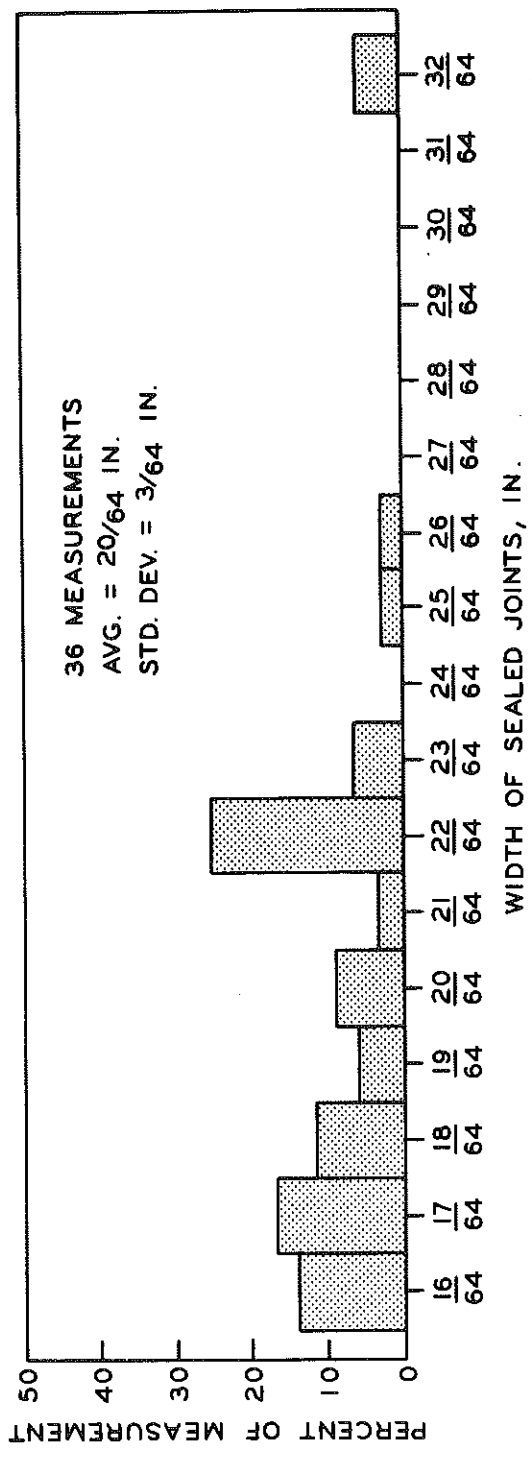
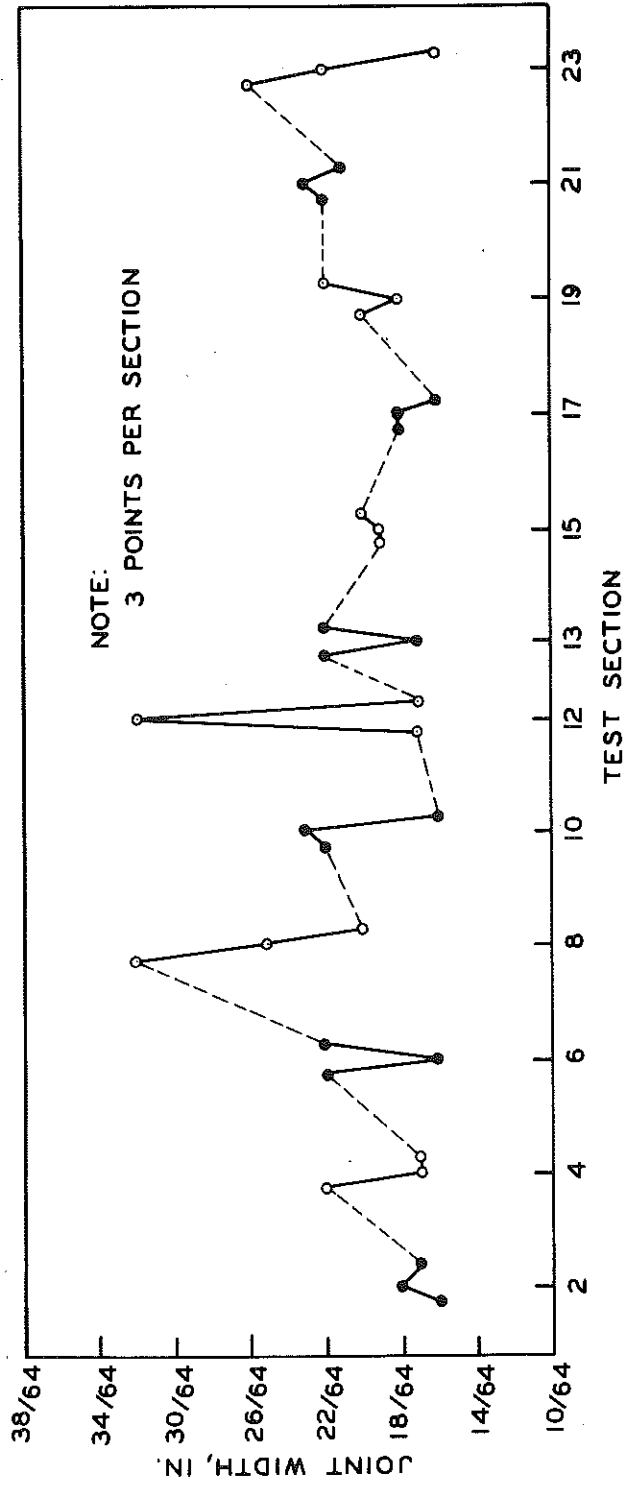
Figure 7. Lateral movement of sealed joint. March 1968 survey (test Project 5).

To evaluate the effects on the sealer of tensile stresses due to seasonal changes in temperature and humidity, lateral movements of the experimental joints of Project 5 were measured with a slide caliper at three random locations per test section. Results of these 36 random measurements recorded to the nearest 1/64 in. show a distribution with an average joint width of 20/64 in. and a standard deviation of $\pm 3/64$ in. There has been a 122-percent stretch in the sealing material caused by lateral movement. This is about 2.5 times the 50-percent limit specified for sealing materials. A graphical record of the horizontal movement of the joints from test section 2 through 23 show two single measurements whose values are greater than three standard deviations from the average (Fig. 7). This could very likely be the result of joint spalling at those random locations.

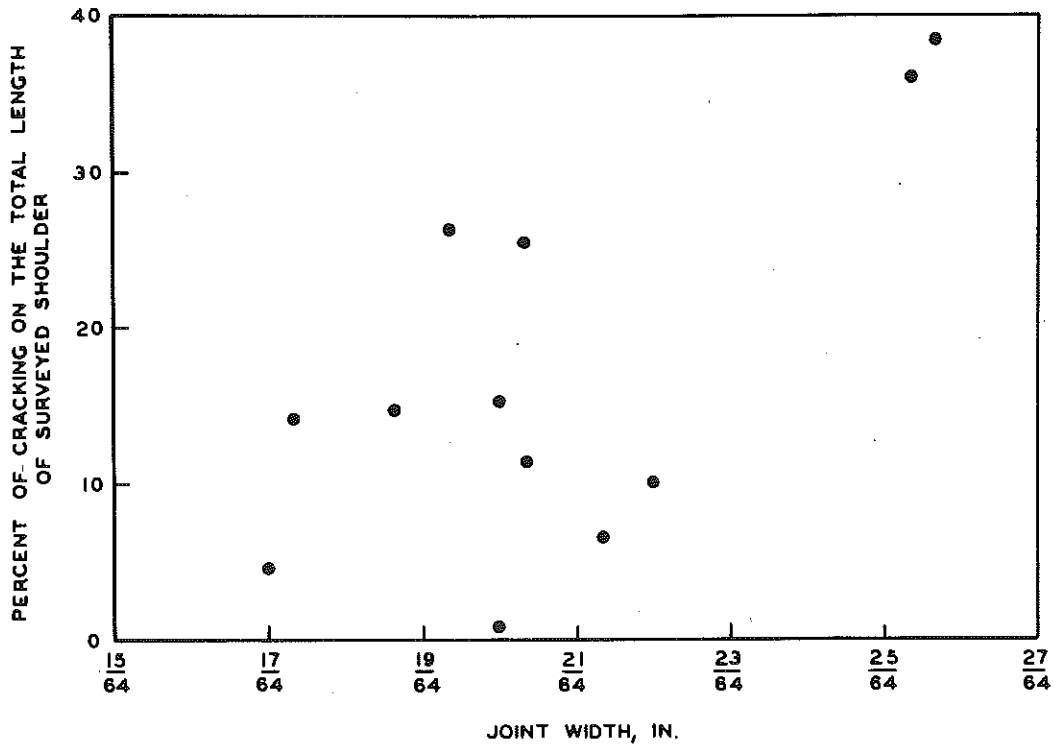
To determine whether longitudinal cracking of the bituminous shoulders and lateral movement of the joints were related, results were plotted on a scatter diagram (Fig. 8). Although the correlation coefficient for the data is $r = 0.66$, which is statistically significant at the 0.05 level, the strength of this correlation depends mainly on the two single measurements falling

outside the three standard deviations from the average width of 20/64 in. (Fig. 7). By neglecting these two "wild" points (a reasonable practice) located at the upper right corner of the scatter diagram, the two variables being compared give little or no indication of being associated.

Figure 8. Scatter diagram of relationship between cracking and joint width, test Project 5.

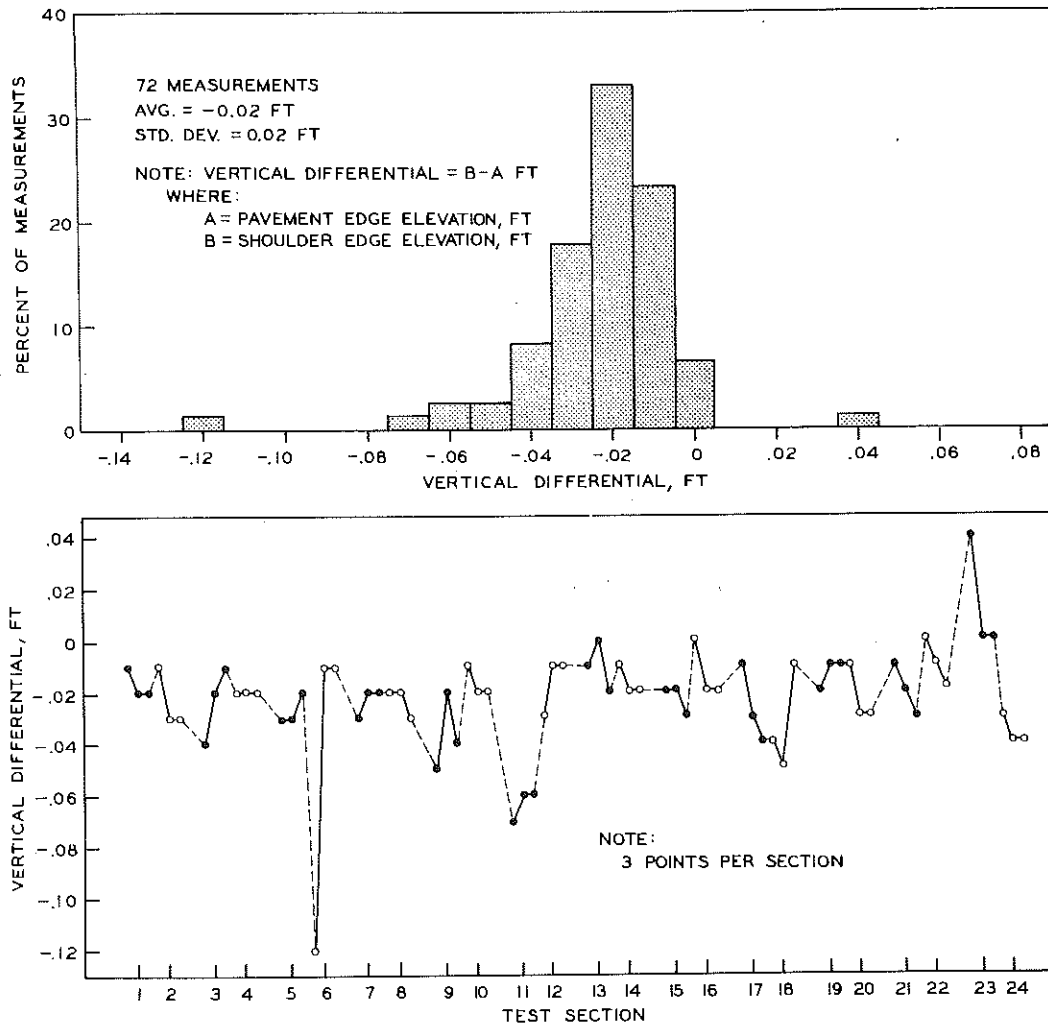
A graphical record of the elevation differentials from test sections 1 through 24 shows two extreme values, one falling more than three standard deviations below the average and another exactly on three standard deviations above the average (Fig. 9). These extreme values could be the result of frost action at those random locations.

Figure 9. Vertical differential at joint between bituminous shoulder and pavement. February 1968 survey (test Project 5).

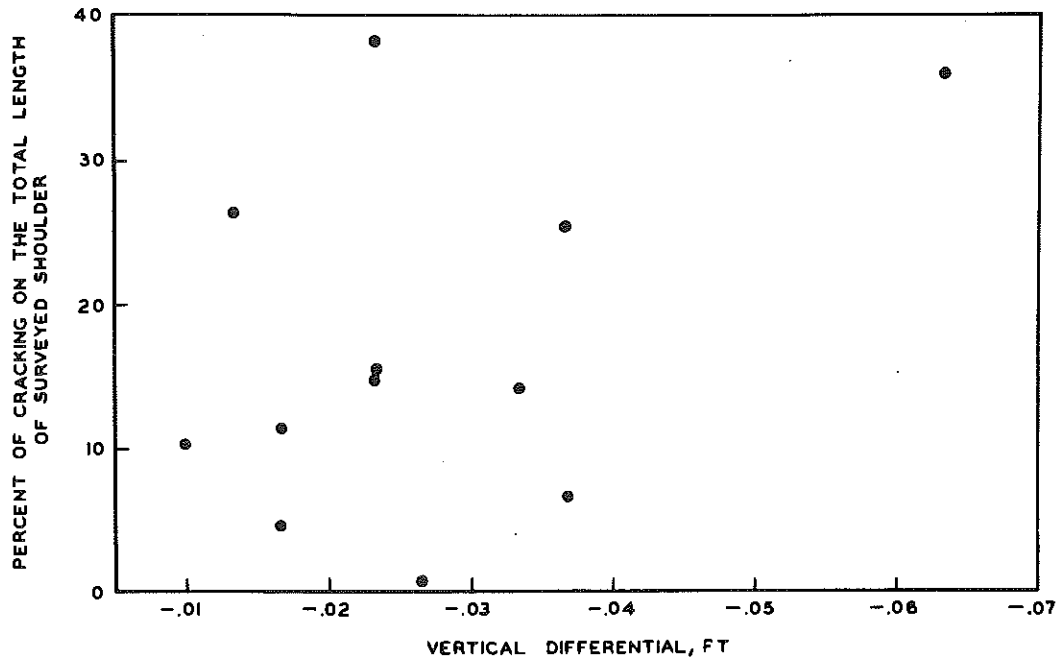
To determine whether longitudinal cracking of the shoulders was related in some manner to elevation differential, measurements were plotted on a scatter diagram (Fig. 10). The resulting points are so scattered that the two variables being compared give no indication of being associated.

Figure 10. Scatter diagram of relationship between cracking and vertical differential, test Project 5.

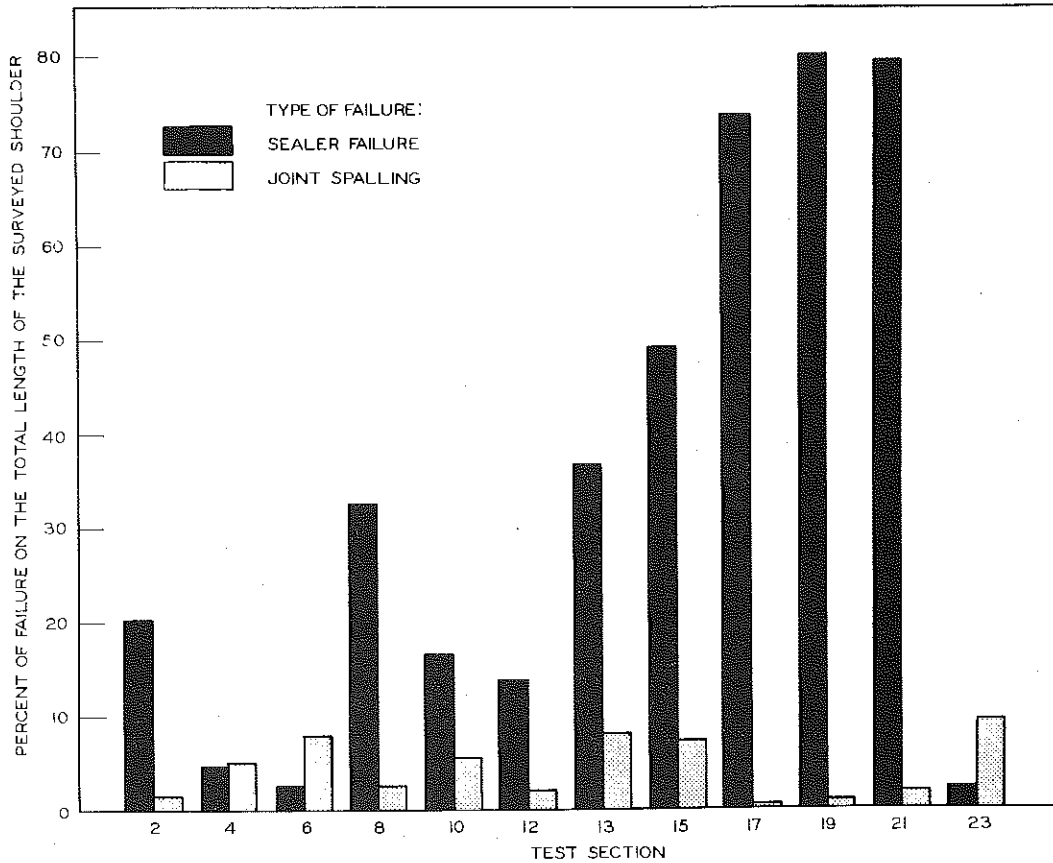
The extent of joint failure (in percent) of shoulder length surveyed in June 1968 is given in Table 1 and summarized in Figure 13. Here, the data display a percentage of sealer failure ranging from 2.4 to 79.9 percent and averaging 34.2 percent. However, there is no apparent correlation between this rising trend in percent of sealer failure and extent of longitudinal cracking over the same test sections. Similarly, when results of joint spalling and longitudinal cracking are compared, no relationship is obtained between the two sets of data.

Figure 13. Sealer failure and joint spalling on test project 5.

Sawing or cutting and sealing of shoulder-pavement interfaces should be discontinued. Even though, in some cases, the seal-treated joint is effective in reducing shoulder cracking by a small percent, the effectiveness is soon lost because of joint sealer failure. Consequently, the additional cost of this operation is not justified.

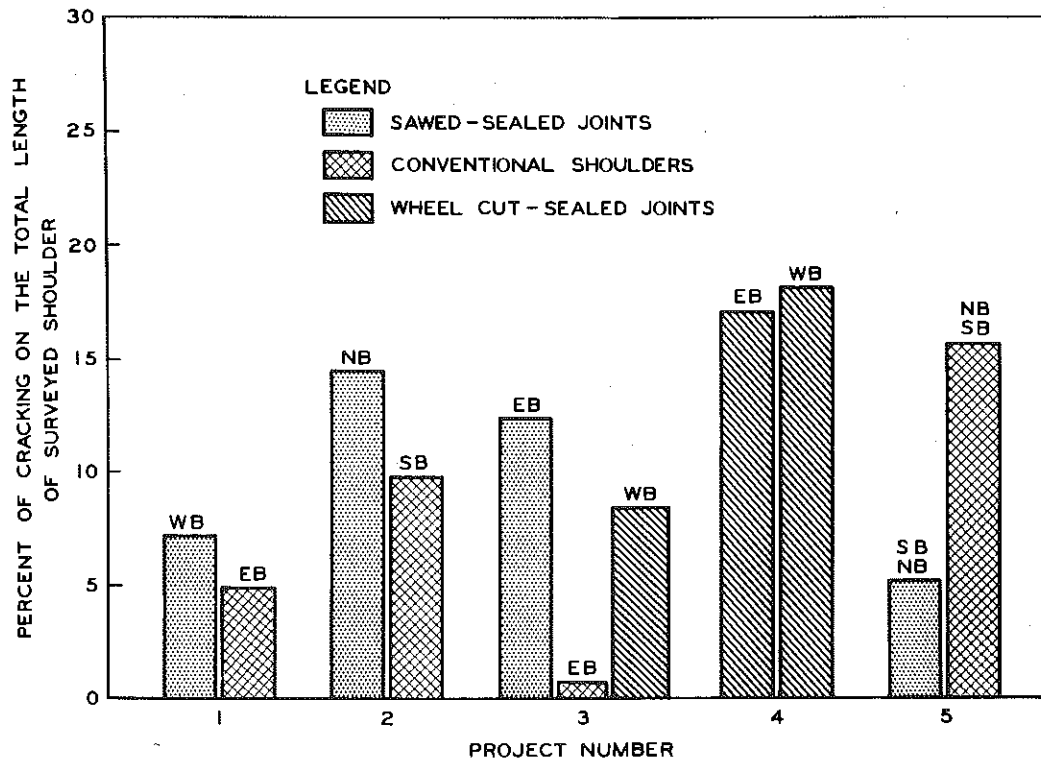
In addition to Project 5, investigations were made of 11 other construction projects with sawed-sealed shoulder interface joints which were not controlled experiments and thus provide only scant information. Table 2 and Figure 14 contain data obtained from recent field observations of four seal-treated joint projects (referred to as Projects 1 through 4) constructed prior to Project 5 and listed in the First Progress Report. Projects 1 through 3 incorporated lengths of conventional shoulder construction and comparison data are given in Table 2. Although the conventionally constructed shoulders showed cracking over a length proportionally less than the seal-treated area, no statistically sound conclusions can be drawn. A comparison between the two types of joints tested in these projects, sawed-sealed and wheel cut-sealed joints, shows no superiority of one over the other in controlling shoulder cracking. Among projects with sawed-sealed

joints, the percentage of length which showed cracking ranges from 1 to 35 percent, while among the other projects with wheel cut-sealed joints, from 2 to 41 percent.

Figure 14. Longitudinal cracking of seal-treated and conventional (unsealed) shoulders. May 1968 survey.

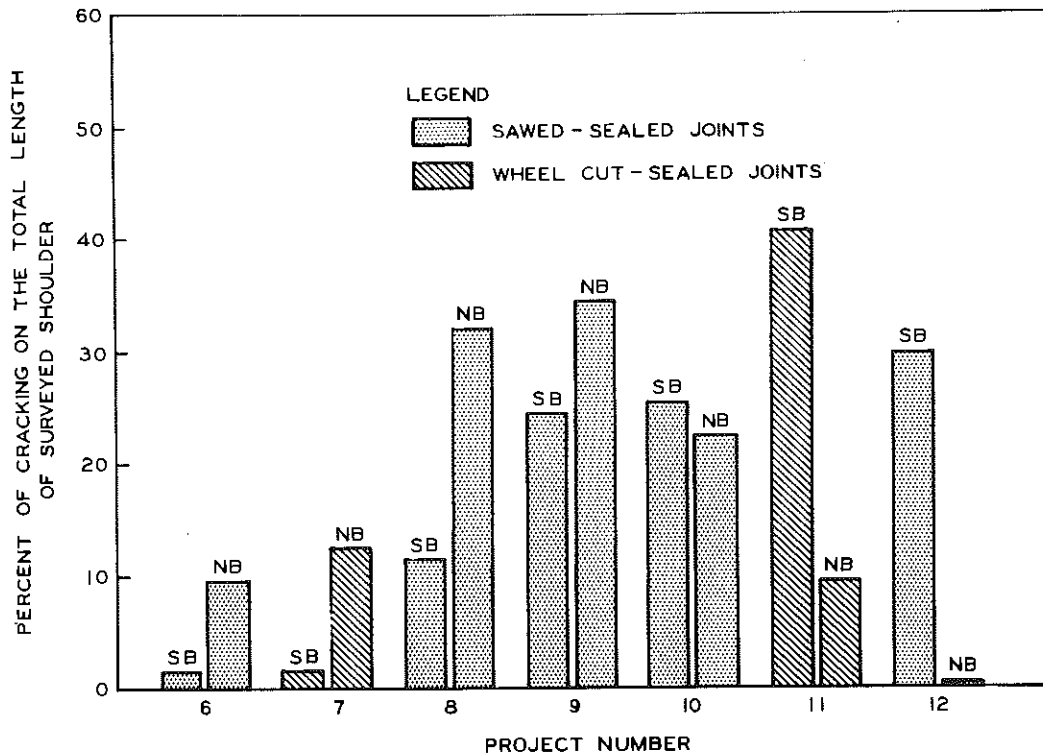
Extensive longitudinal cracking of the shoulders was observed within a few months after construction. A very significant observation was made on Project 12; the southbound shoulder, opened to traffic, showed cracking over 30 percent of its length, while the northbound, not opened to traffic,

had almost no cracking. During the first winter after construction, heaving of Project 6 through 12 shoulders exceeded 1/2 in. in some areas.

In summary, it seems that the type of longitudinal cracking under study is caused by frost heave followed by traffic loading. Further, since longitudinal cracking developed over 30 percent of the length of four of the projects, it can be concluded that seal-treated joints do not always prevent extensive cracking.

Figure 15. Longitudinal cracking of seal-treated shoulders, I 69 S of Marshall. June 1968 survey.

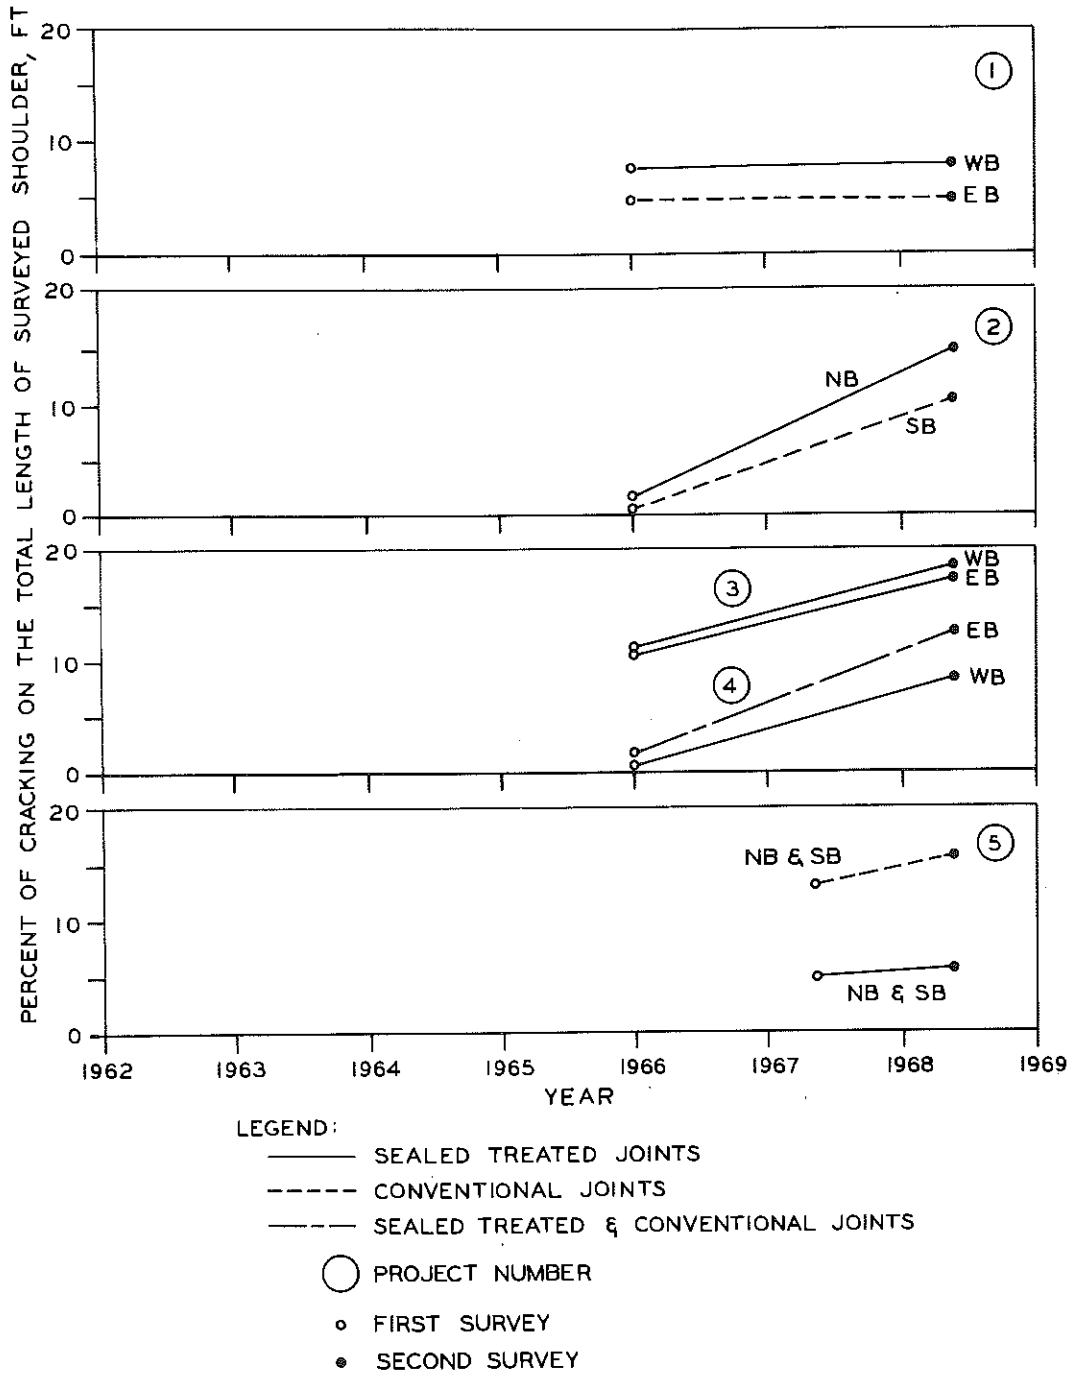
Increase of longitudinal cracking with respect to age is shown in Figures 16 and 17. The graphs show the different rates at which longitudinal cracking increased after the projects were opened to traffic. However, for Projects 1 through 4, nothing can be said about early cracking since surveys were not made until two to three years after construction.

Figure 16. Relationship between longitudinal cracking and length of service in years.

In Project 1, after three years, longitudinal cracking was observed over about 6 percent of the total length and did not increase during the next two years. In Projects 2 and 3, after showing only moderate cracking during the first two or three years, cracking increased sharply at an average annual rate of 11 to 13 percent over the following two years. In Project 4, cracking has also increased during the two year survey period.

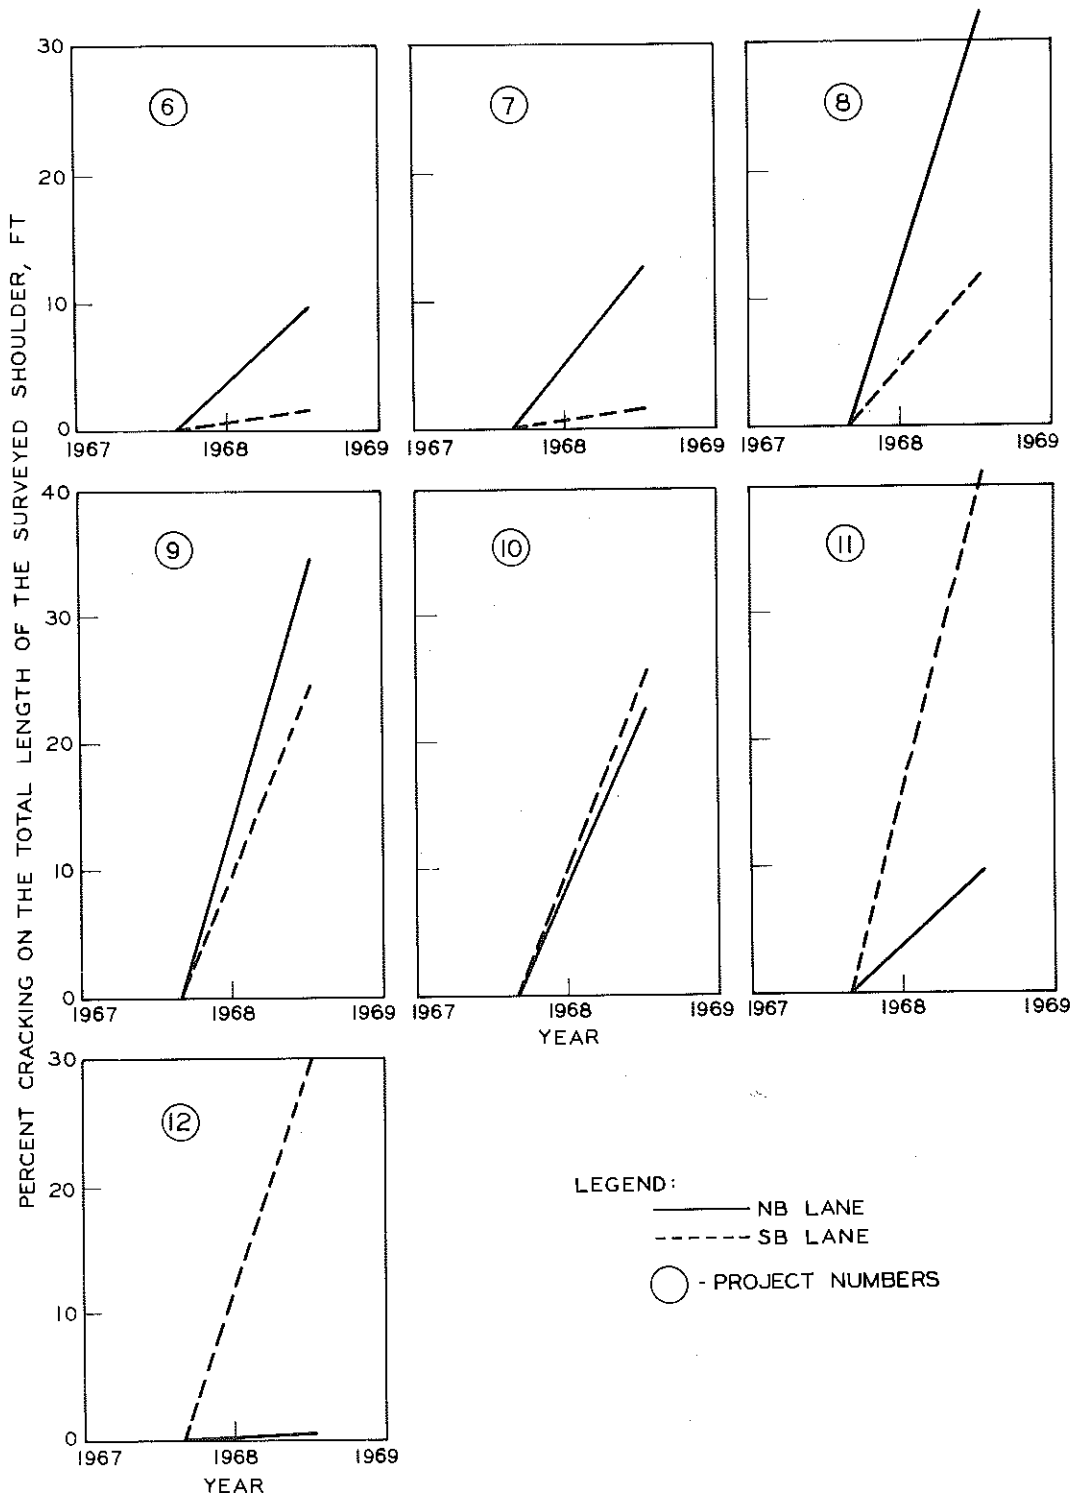
Figure 17. Relationship between longitudinal cracking and length of service in years.
