CONSTRUCTION AND IMPACT TESTING OF
A SHORT SECTION OF EXPERIMENTAL CONCRETE
GLARE SCREEN

MICHIGAN DEPARTMENT OF STATE HIGHWAYS

Research Laboratory Section
Testing and Research Division
Research Project 73 F-135
Research Report No. R-879

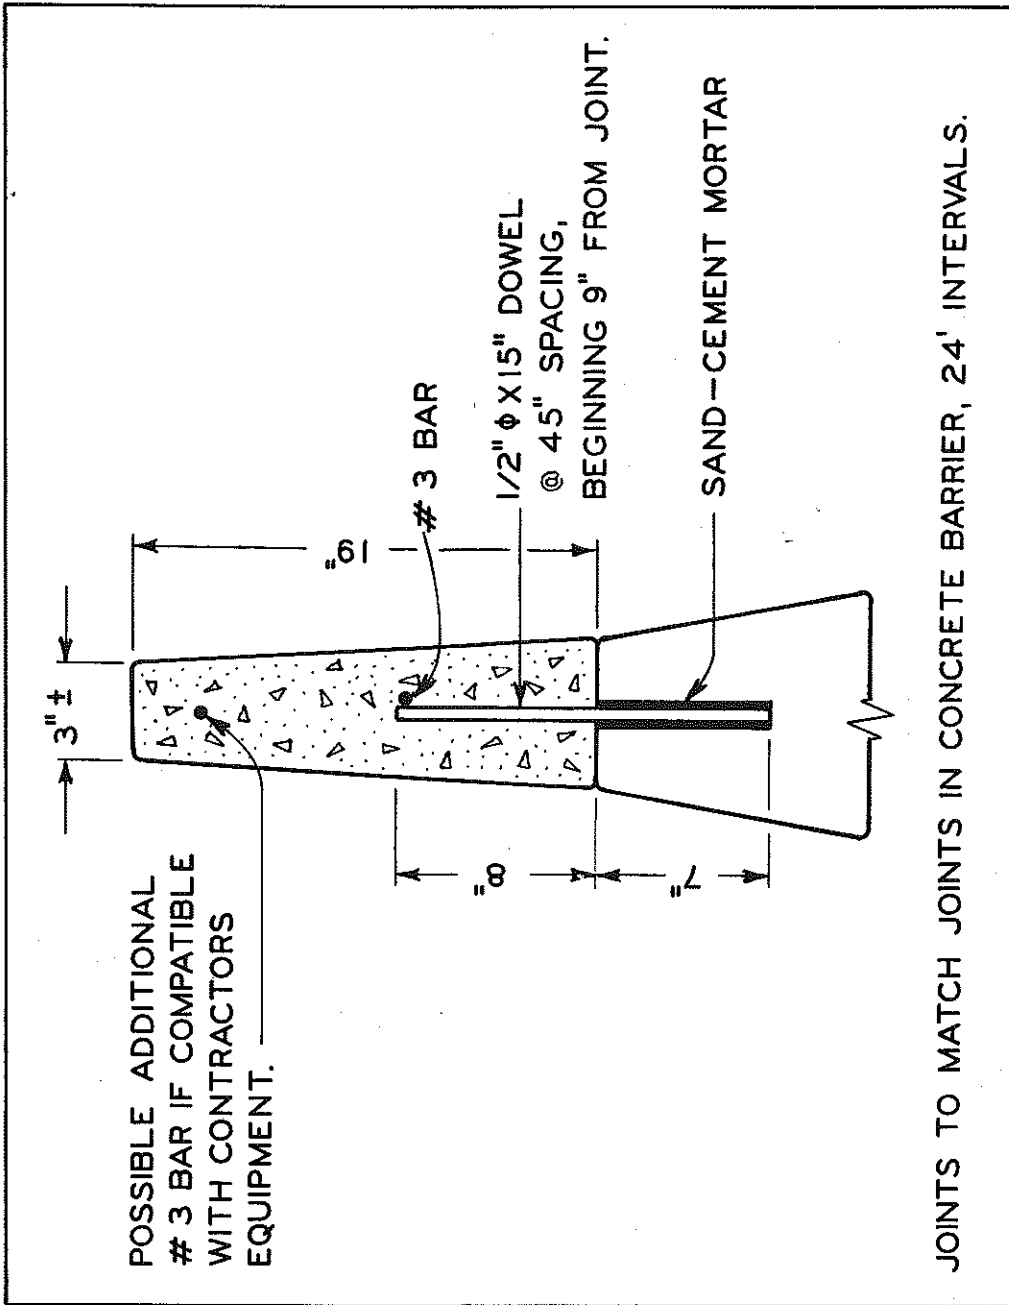
Figure 1. Proposed concrete glare screen to be placed on previously constructed concrete median barrier.

A meeting was held on June 13, 1973, in which representatives of the FHWA and the MDSH Divisions of Construction, Design, Testing and Research, and Traffic and Safety, discussed the proposal. The discussion resulted in a tentative plan for the glare screen as shown in Figure 1.

The vertical tiebars secure the screen to the barrier, and the longitudinal reinforcement was included to prevent flying pieces of concrete in case of vehicle impact into the screen.

It was found during construction that the second No. 3 longitudinal rebar proposed for addition near the top of the barrier (Fig. 1) could not be placed effectively. The bar tended to travel with the machine, causing tearing of the top portion of the screen. Also, due to the small cross-sectional area near the top, it was very difficult to maintain correct alignment of the bar. Therefore, the final section that was placed for testing had only one longitudinal bar, approximately 8 in. above the top of the barrier.
