ALLEGED DAMAGE TO THE RESIDENCE OF S. D. FRALICK  
DUE TO TRAFFIC INDUCED VIBRATIONS

MICHIGAN DEPARTMENT OF STATE HIGHWAYS

Research Laboratory Section  
Testing and Research Division  
Research Project 70 F-120  
Research Report No. R-773

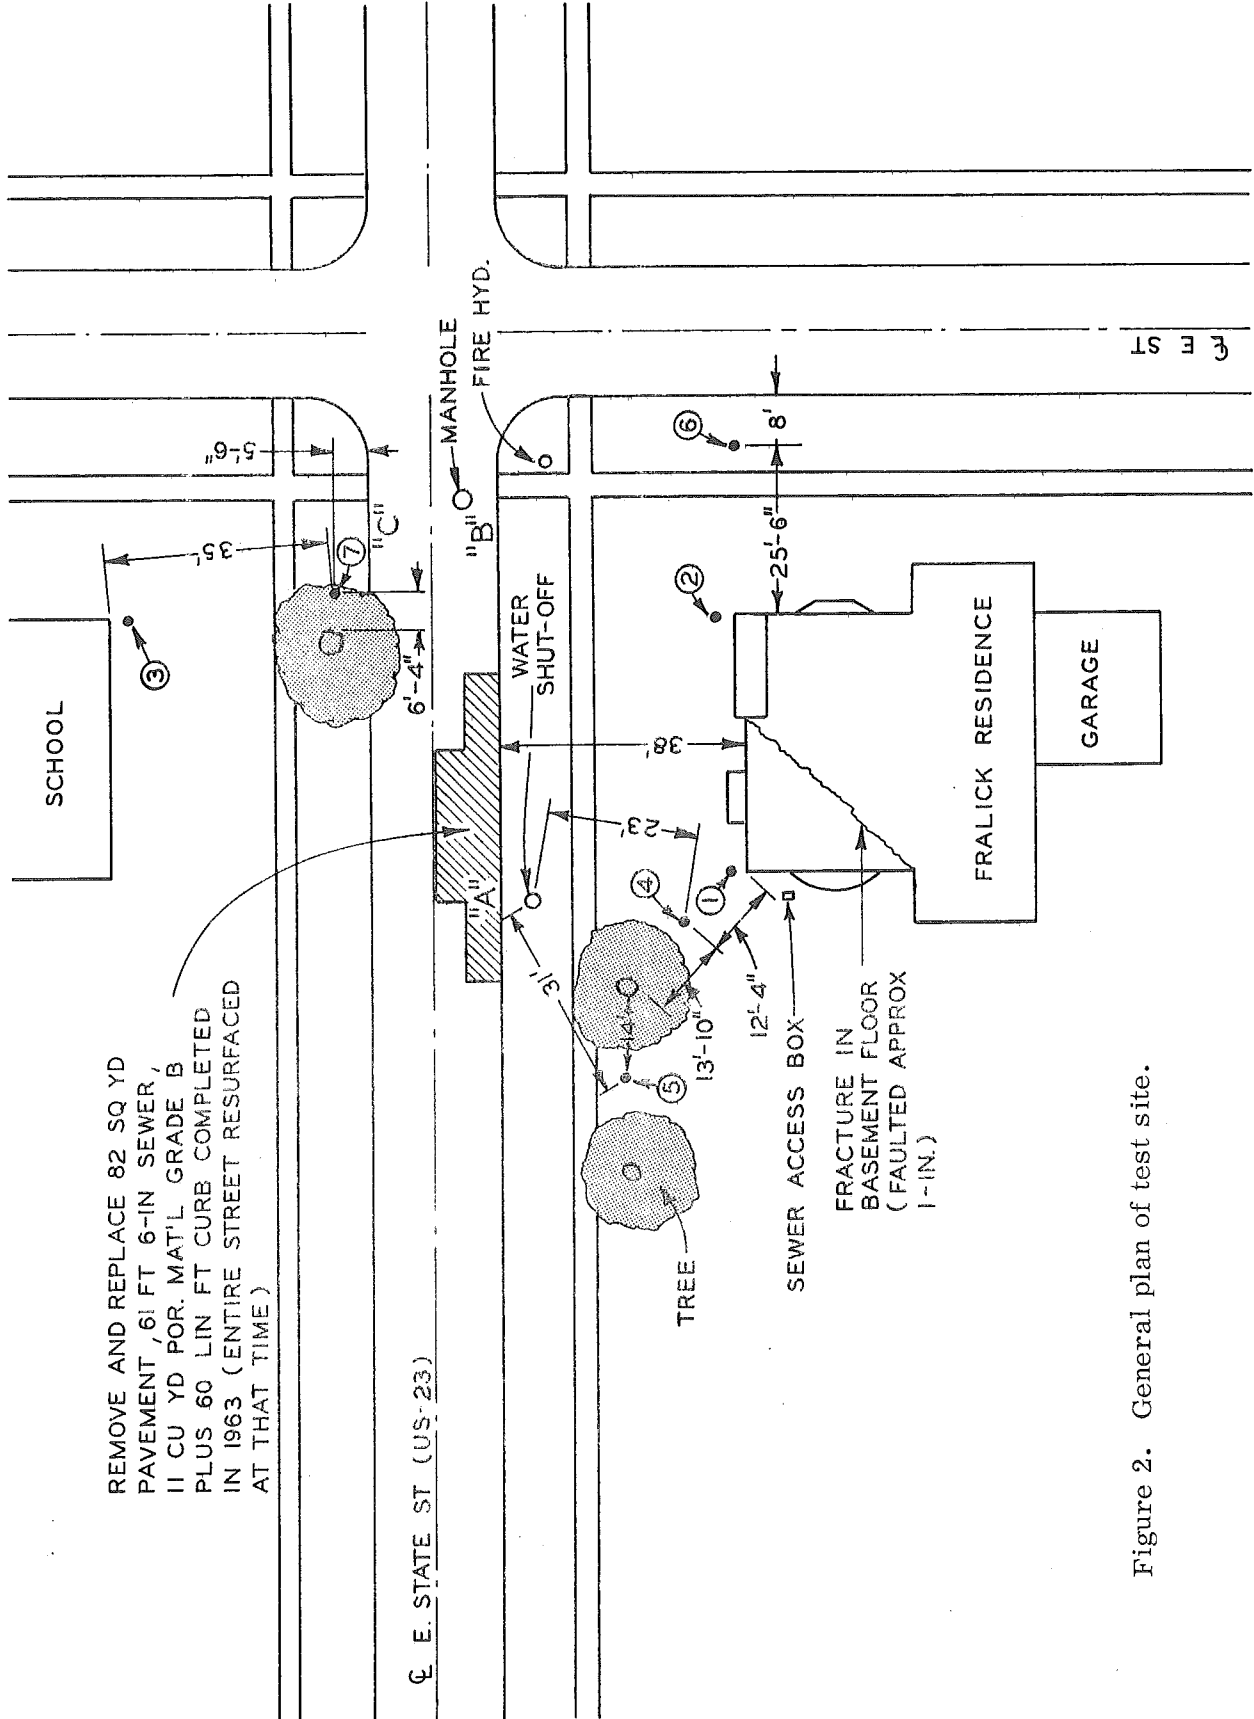
Figure 2. General plan of test site.

Initial tests were made with both accelerometers attached to the stake at location ①, (Fig. 2) and similar tests were conducted at location ②. Then one accelerometer was attached to the porch adjacent to location ②, to check whether the structure and ground were indeed reacting in the same manner. Results indicated that they were. The last eight test runs were made with the accelerometers at location ③ near the corner of the large brick school building across the street from the Fralick house. Results of the tests are shown in Table 1. In addition it was found that a man walking across the yard 8 ft away from the accelerometer caused readings of about 0.02 g. A man walking near the instruments caused readings of 0.06 g, and by jumping lightly on the ground, a man could generate 0.07 to 0.10 g output.

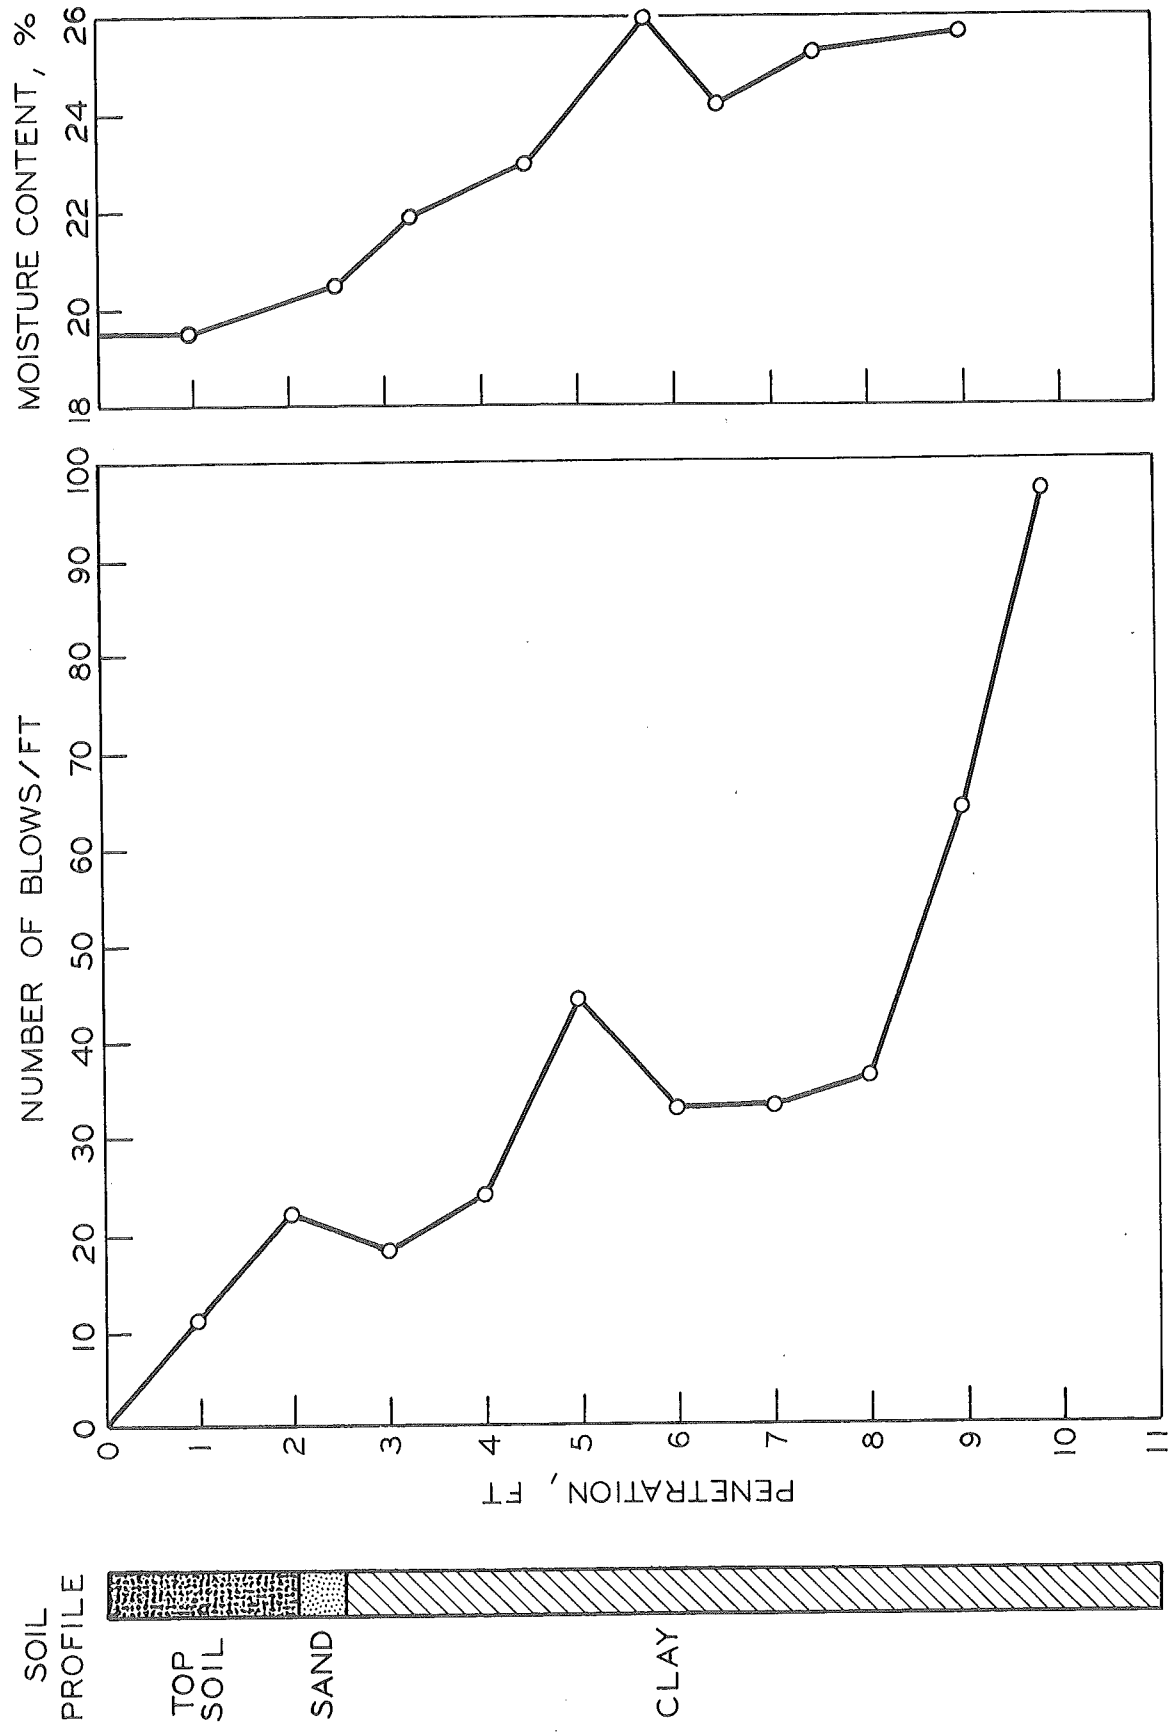
Figure 4. Penetration of point (4).

Soil borings were made at locations marked ④ through ⑦ in Figure 2. A penetration record was kept for all test borings to a depth lower than the foundation level. Continuous samples were recovered from borings at locations ④, ⑤, and ⑥ on the Fralick's property. A Sprague-Henwood type sampler was used to conduct the penetration test and to recover 1-in. diameter, relatively undisturbed samples. A penetration record in terms of number of blows per foot<sup>1</sup>, soil profile, and moisture content for the borings at locations ④, ⑤, and ⑥ are shown in Figures 4, 5, and 6, respectively. A penetration record and soil profile for boring ⑦ are shown in Figure 7. In general, the blow counts do not indicate a stronger soil condition at the school. The soil profile in the vicinity of the house consists of 2 ft of sandy top soil and 5 ft of soft red silty clay over red plastic clay. The penetration record indicates non-homogeneous subsoil with varied strength in different locations of the site. The ground water table was estimated to be located at a depth of 4 to 5 ft.
