EVALUATION OF THERMOPLASTIC PAVEMENT MARKINGS  
APPLIED IN THE LANSING AREA IN 1968 AND 1969

A. J. Permoda  
A. R. Gabel

Research Laboratory Section  
Testing and Research Division  
Research Projects 47 G-36 (21a) and (22a)  
Research Report No. R-813

Michigan State Highway Commission  
Charles H. Hewitt, Chairman; Louis A. Fisher, Vice-Chairman  
Claude J. Tobin; E. V. Erickson; Henrik E. Stafseth, Director  
Lansing, April 1972

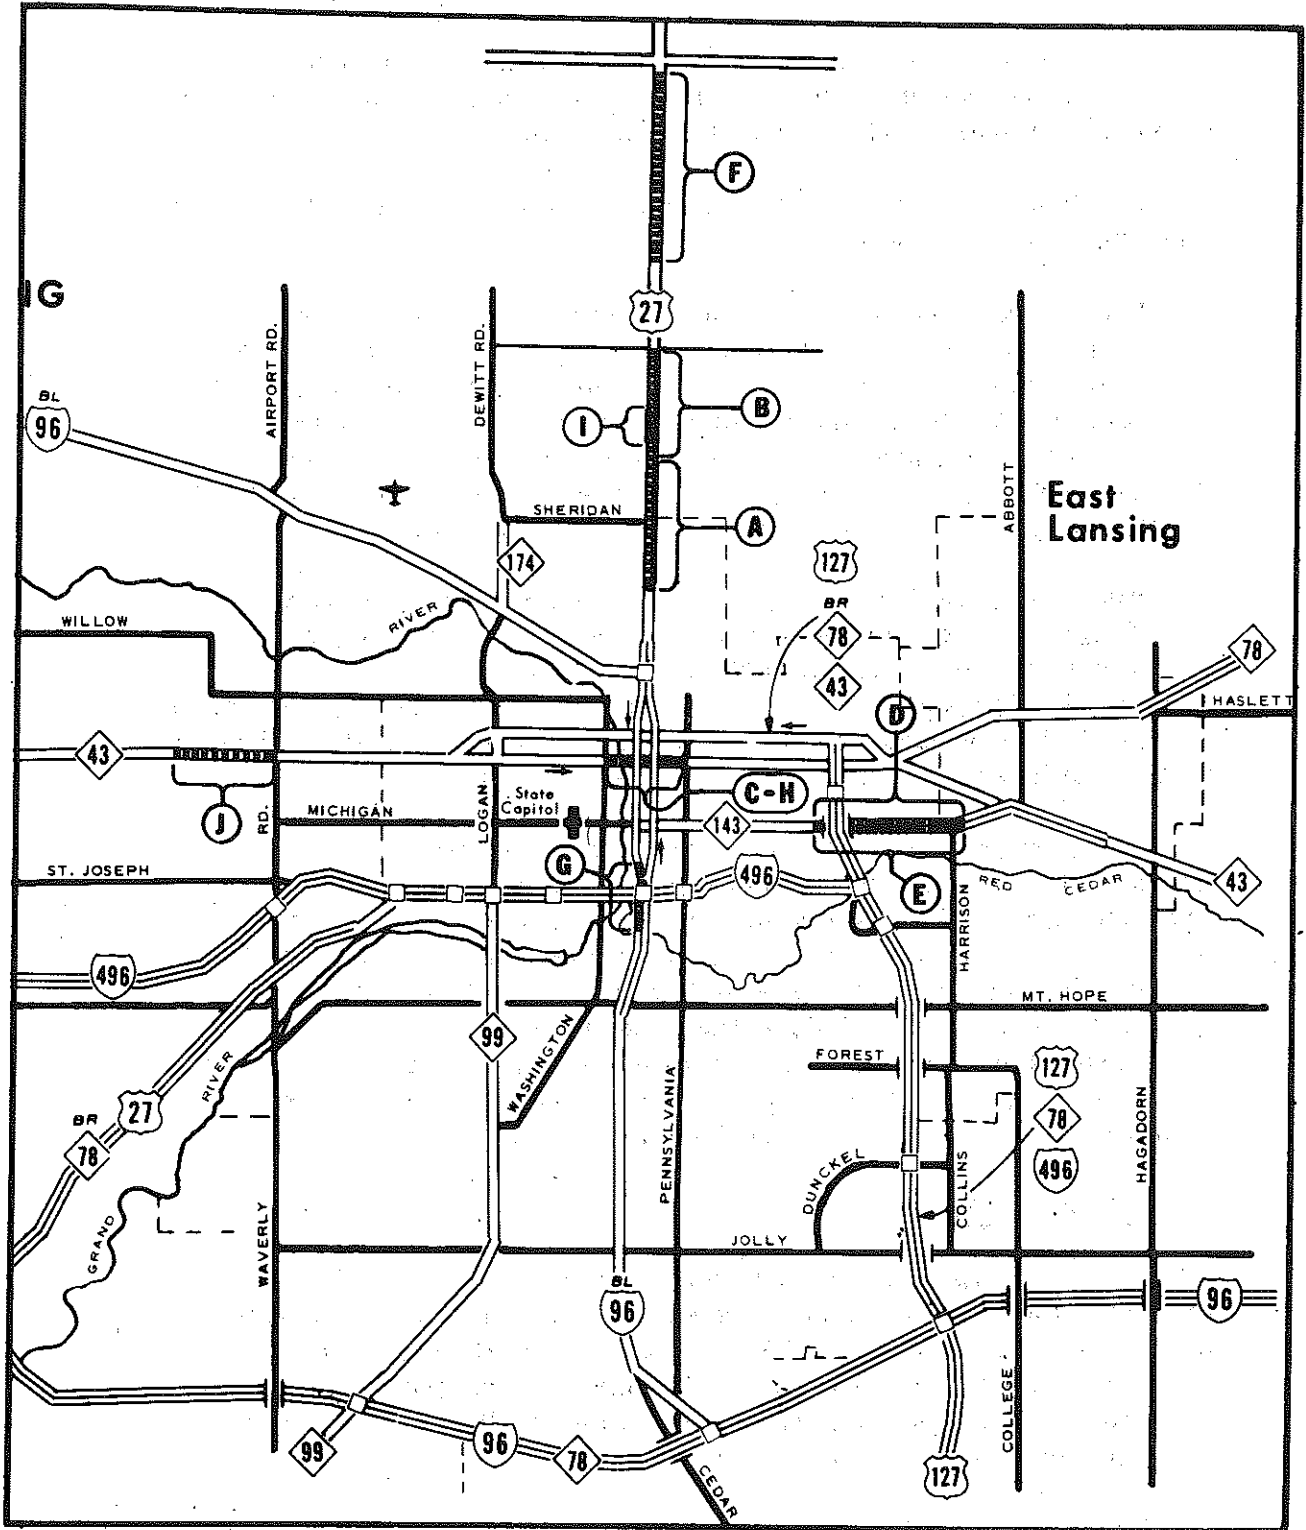
Figure 1. Lansing-area map showing locations of thermoplastic striping. Identifying letter codings correspond with those in the report's tabulations and sketches.

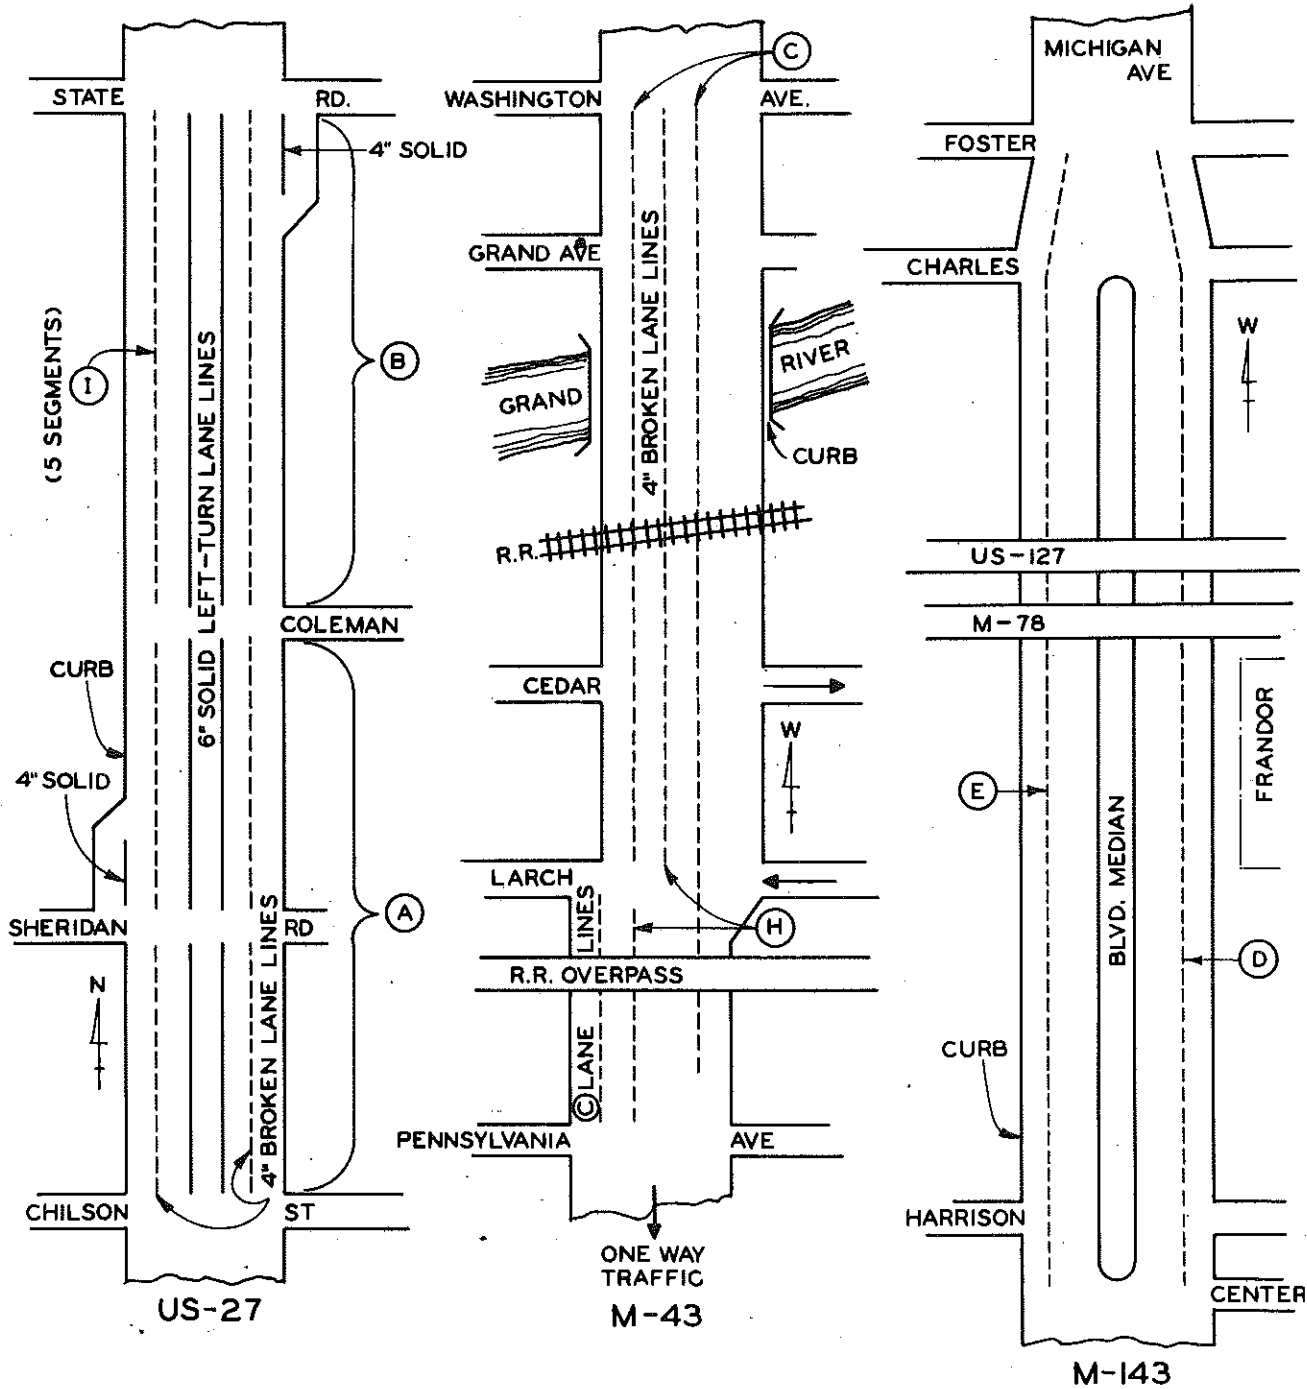
Figure 2. Sketches showing markings of indicated producers in test locations. Except for (h) and (i), all are 1968 applications.

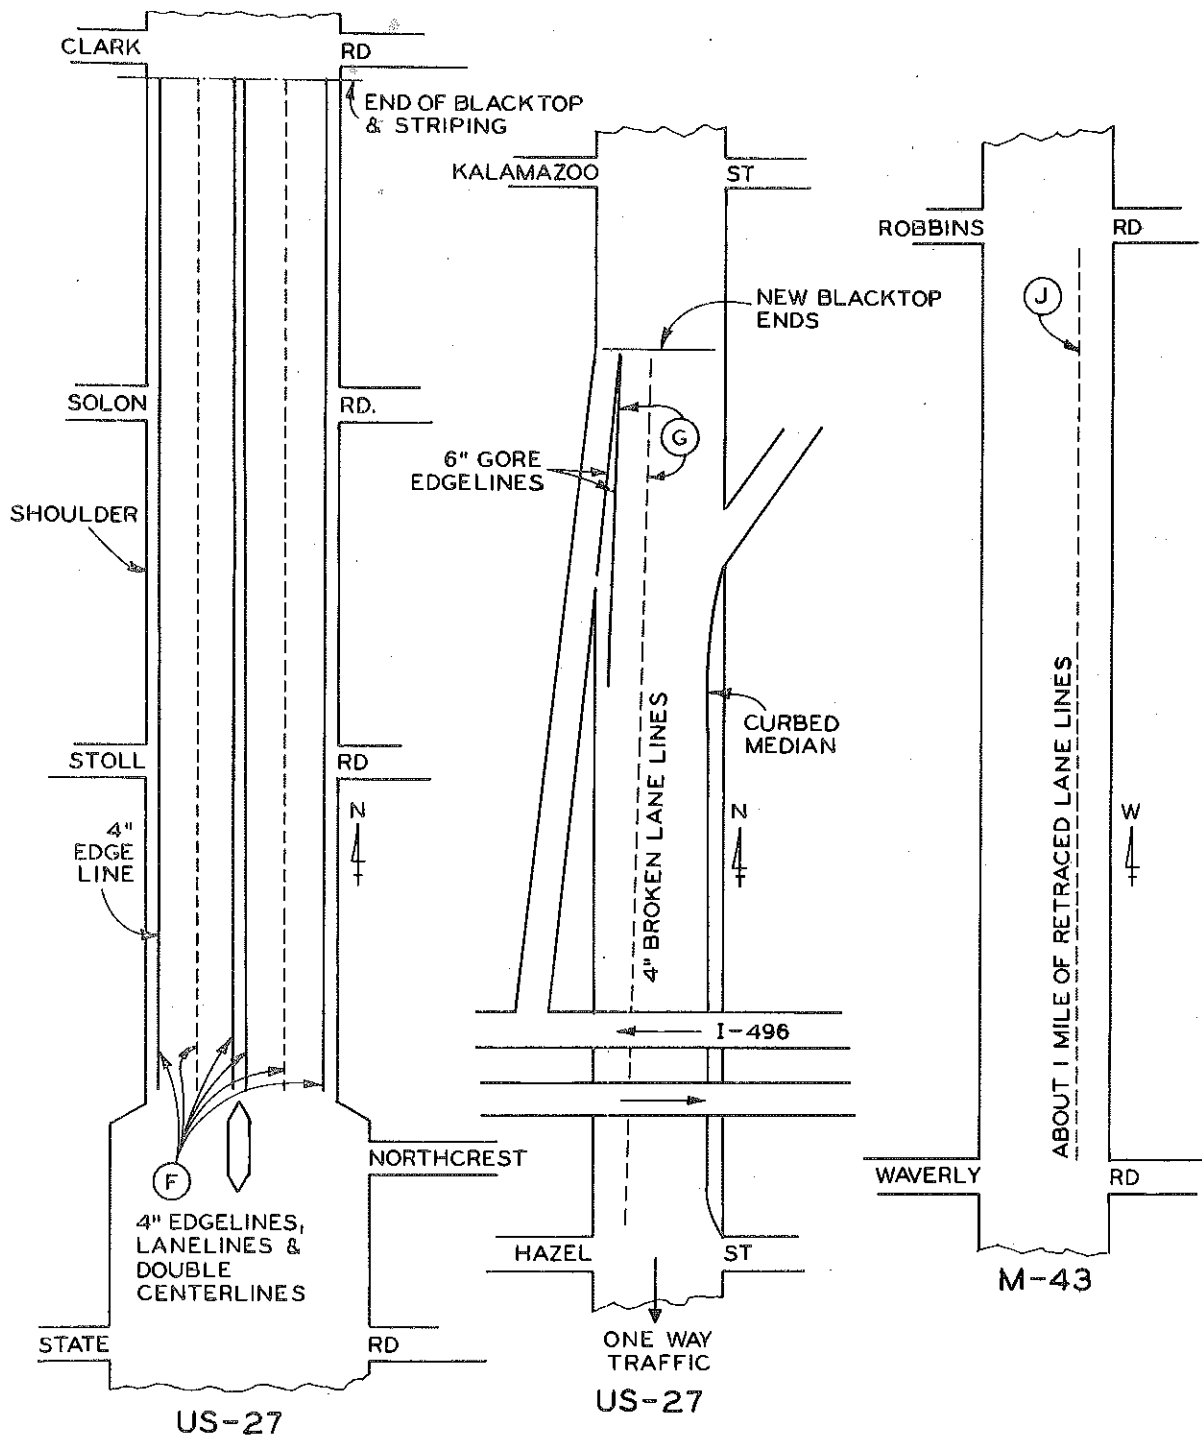
Figure 3. Sketches showing markings of indicated producers in test locations--1969 applications.
