PERFORMANCE OF  
MAYARI R WEATHERING STEEL (ASTM A242)  
IN BRIDGES

EIGHT MILE ROAD

JOHN LODGE EXPRESSWAY

DETROIT, MICHIGAN

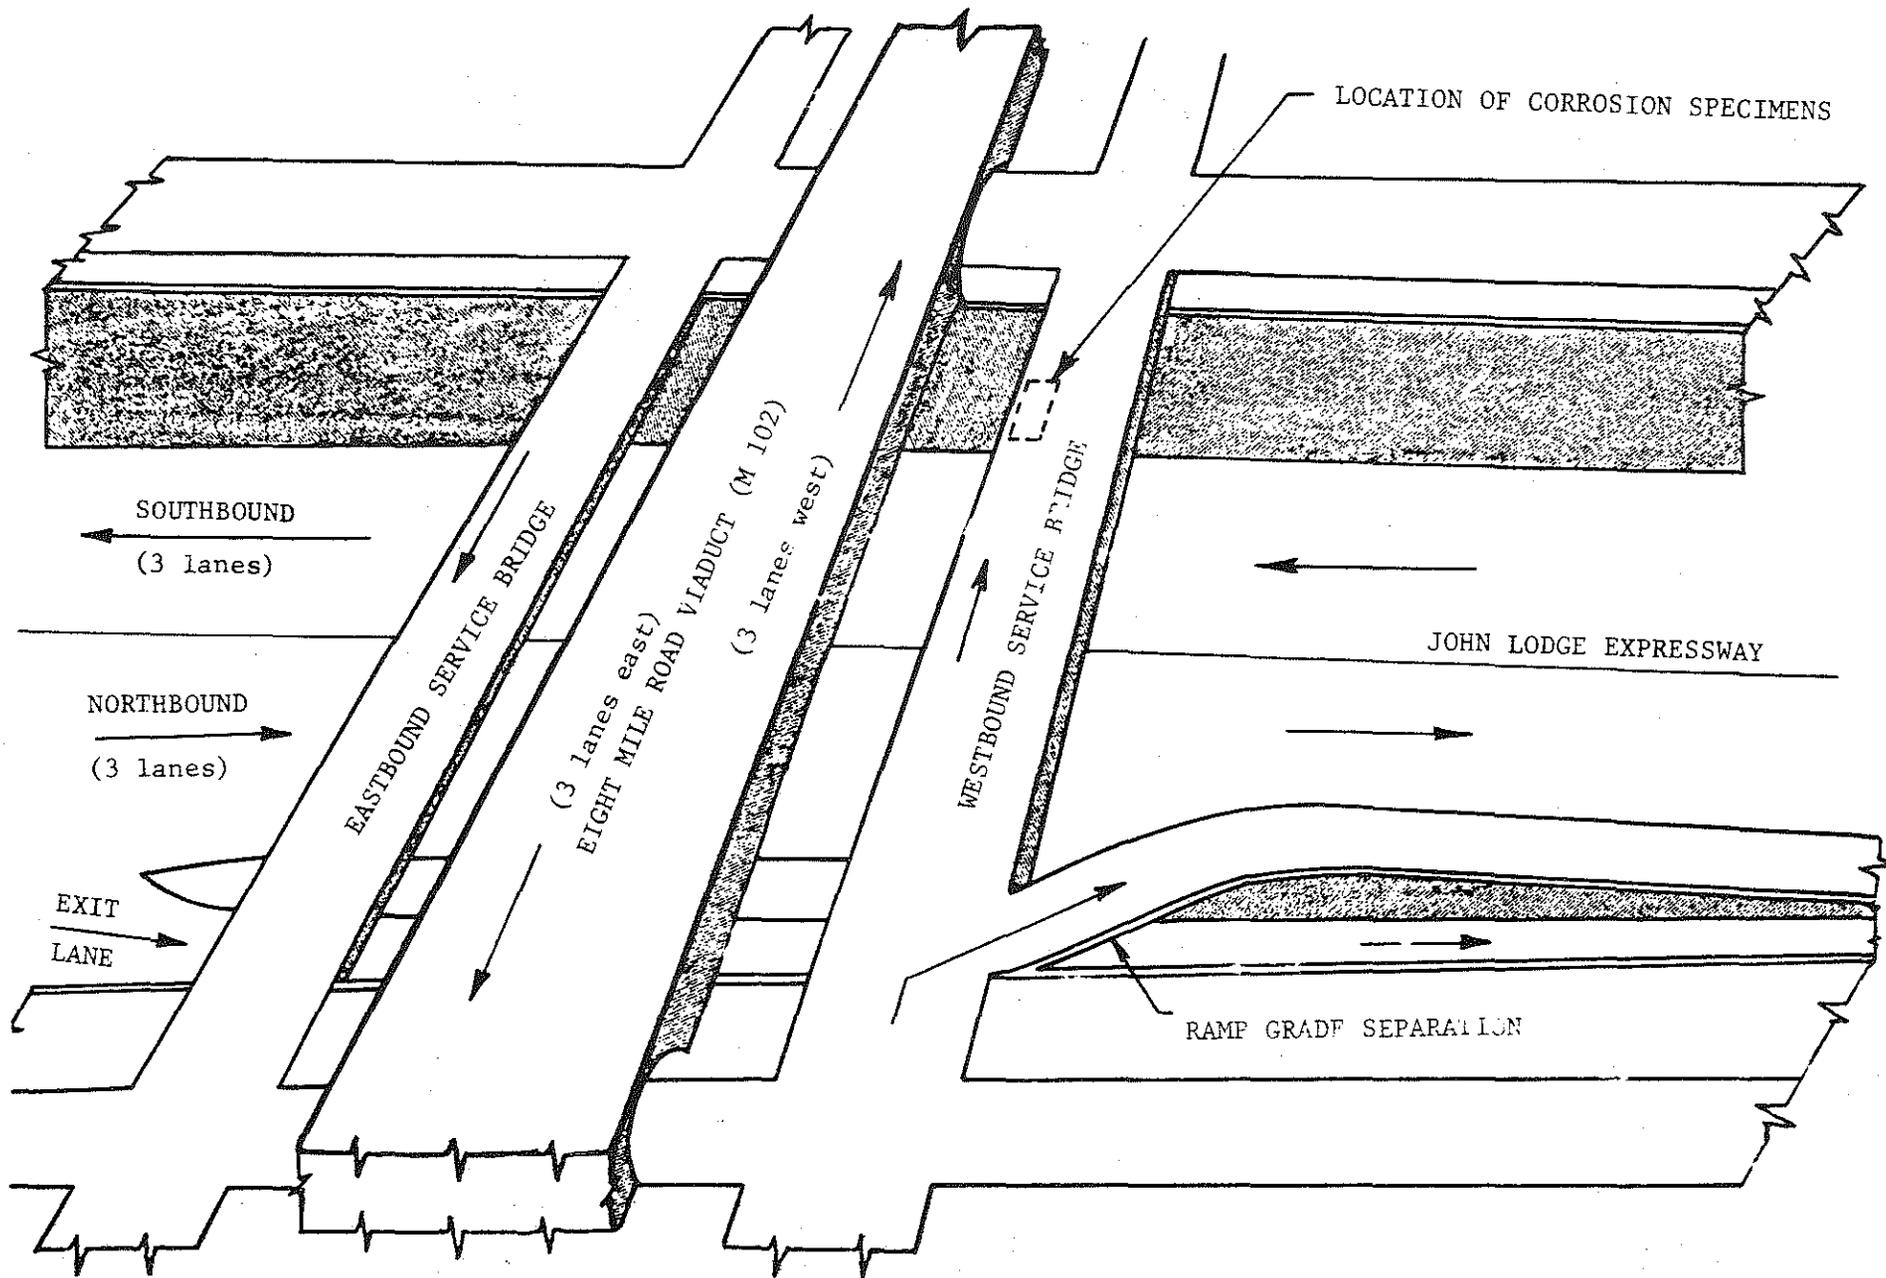
FIGURE 1

FIGURE 1. COMPLEX INTERSECTION AT THE EIGHT MILE ROAD AND THE JOHN LODGE EXPRESSWAY; NOTE LOCATION OF CORROSION SPECIMENS.

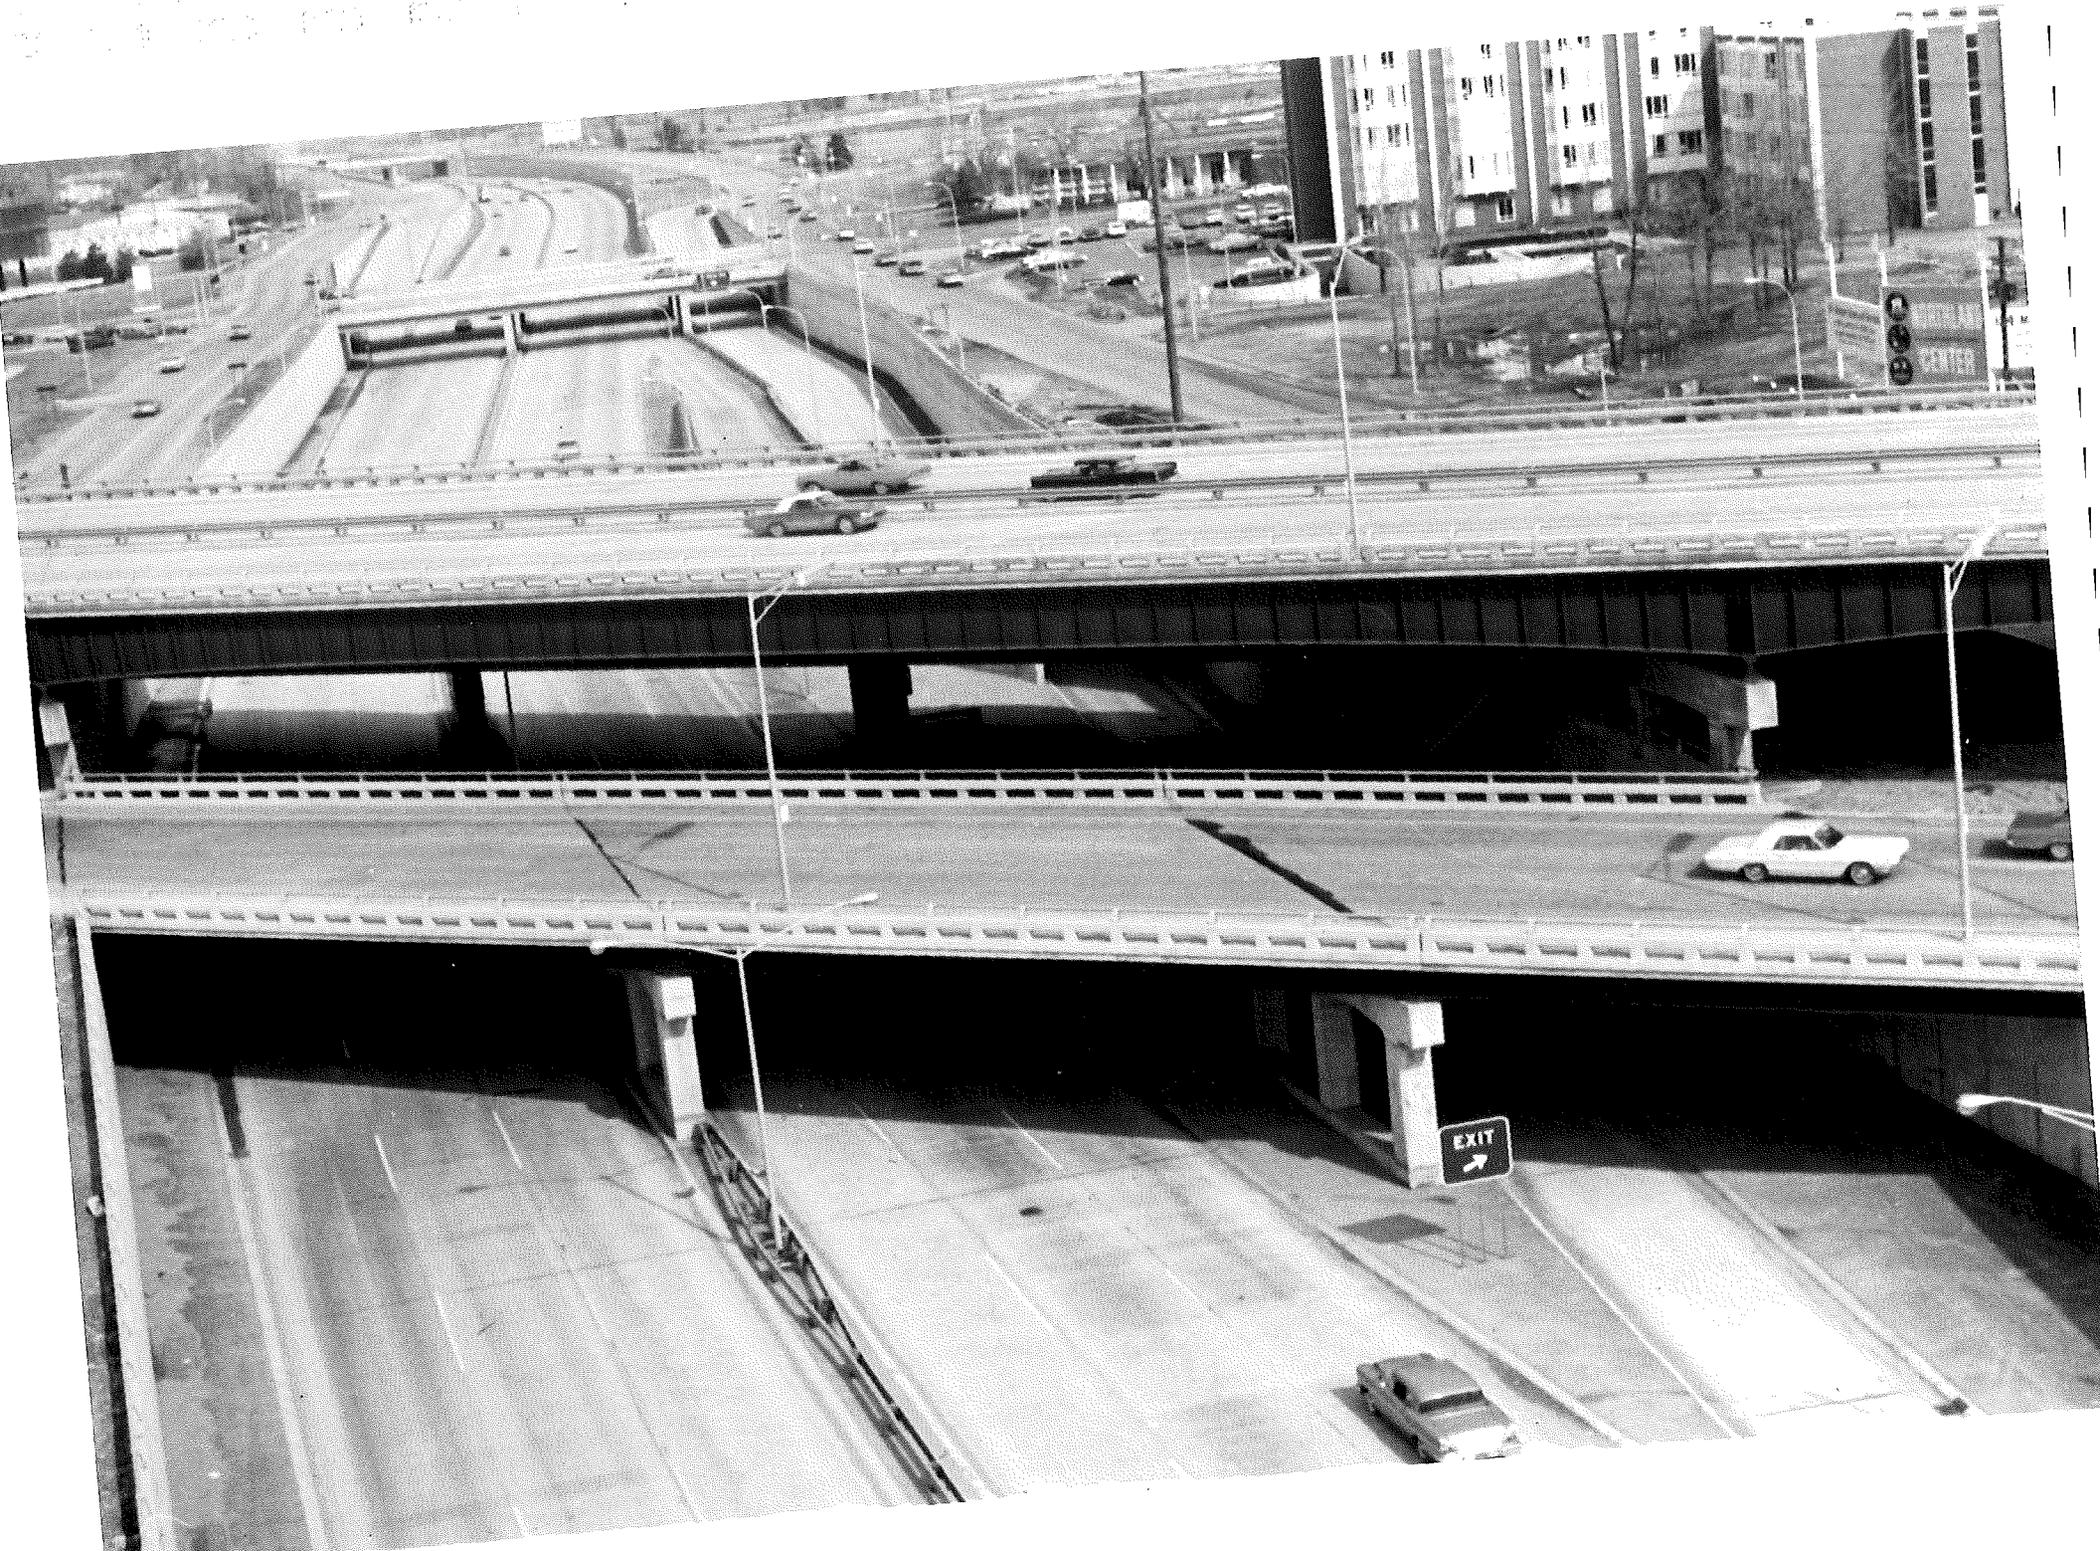
AN OVERALL VIEW OF THE NORTH SIDE OF THE COMPLEX  
ABOUT A YEAR AFTER OPENING TO TRAFFIC

Note that the eastbound service bridge and the Eight Mile Road viaduct are clearly visible but not the westbound service bridge adjacent to the viaduct. Notice the accumulation of dirt along the southbound lane (left of photograph). Our corrosion specimens are located above the southbound lane of the westbound service bridge shown later in the report.

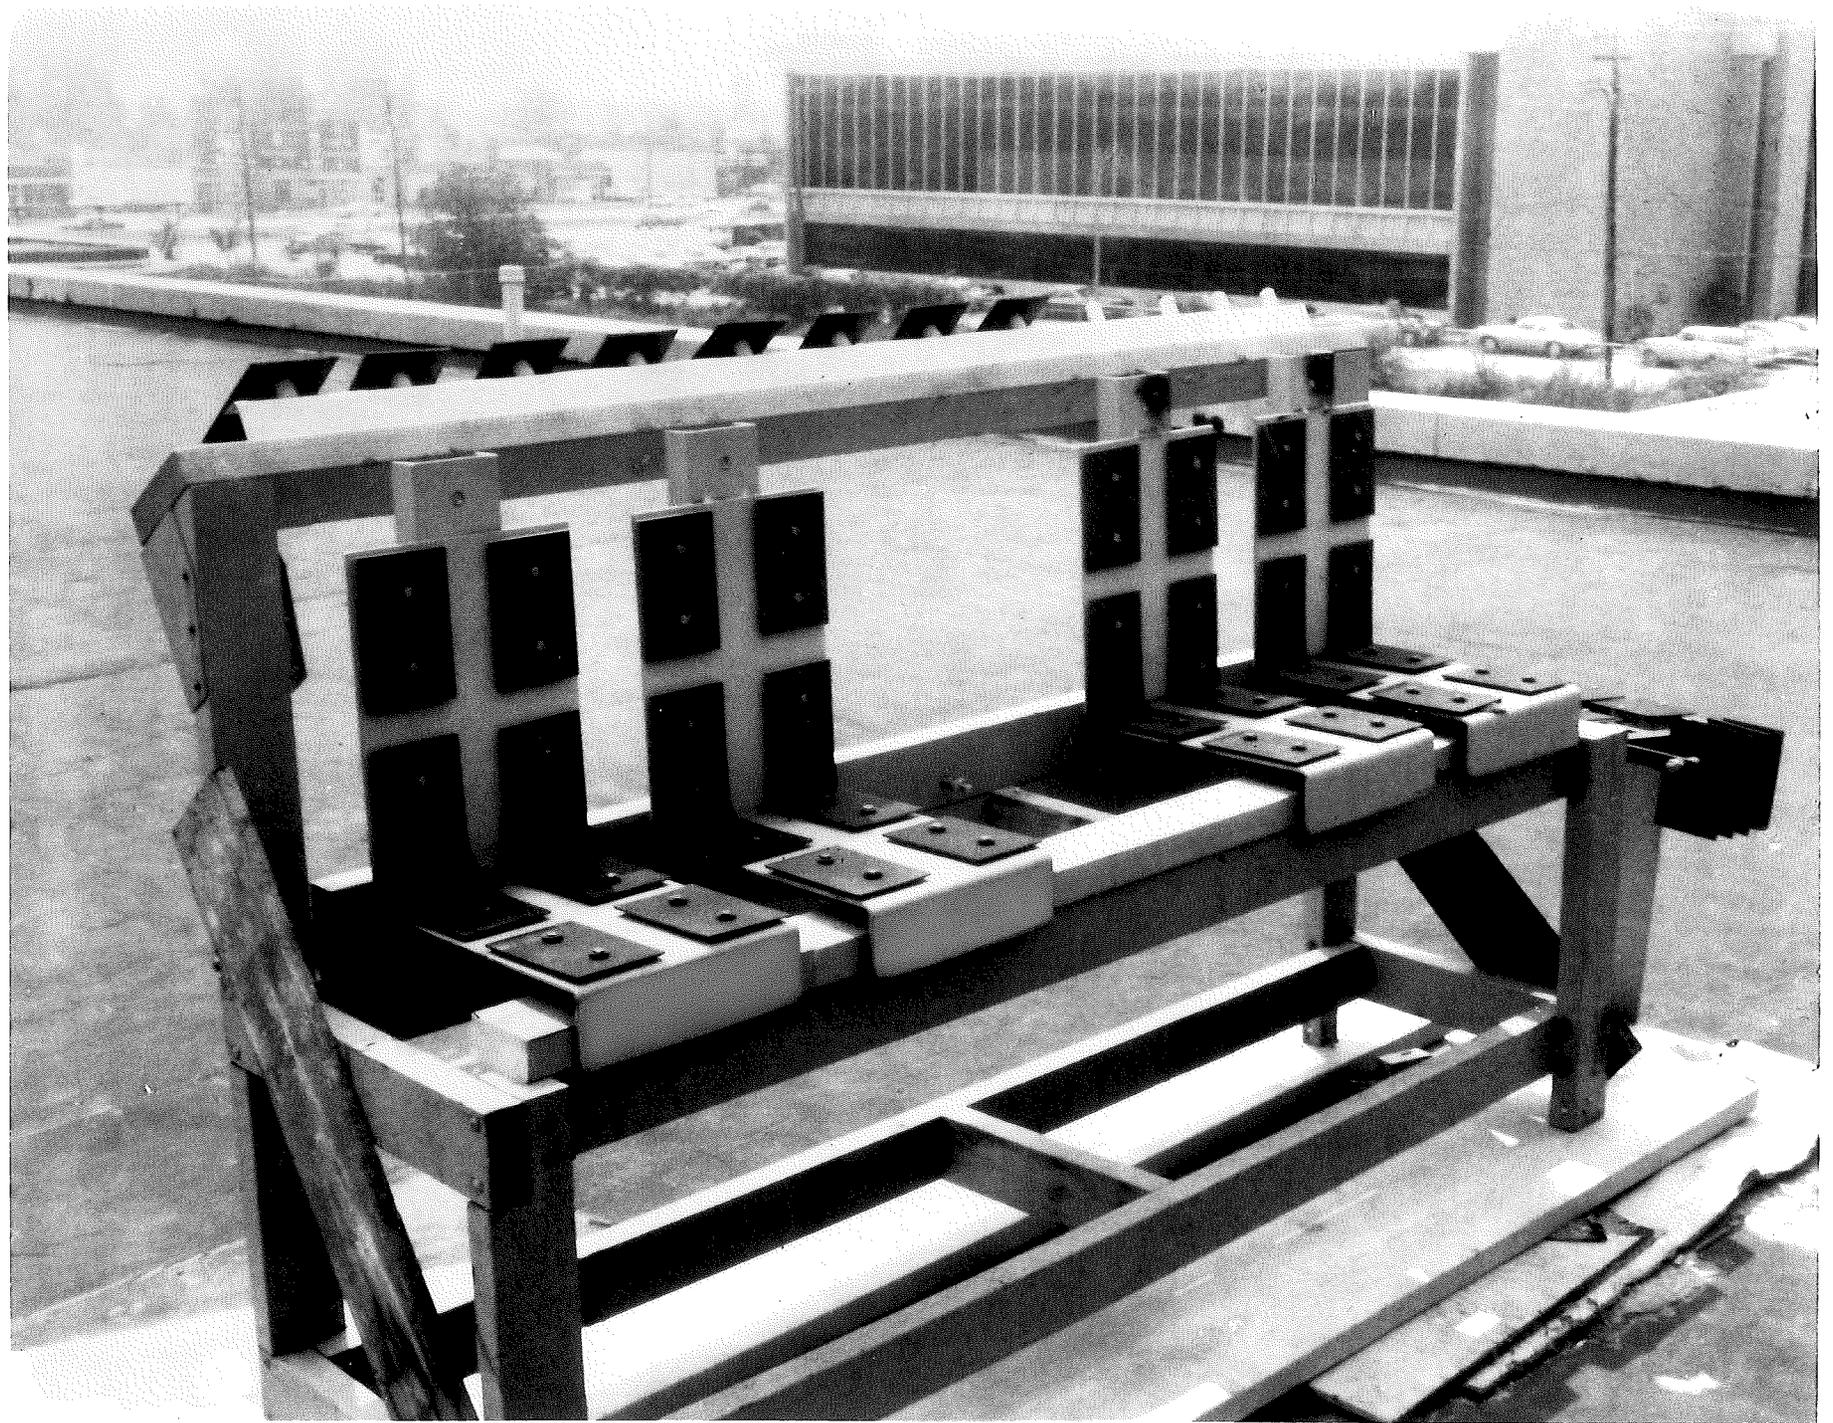
FIGURE 8

CORROSION SPECIMENS ON THE NATIONAL GUARD ARMORY ROOF

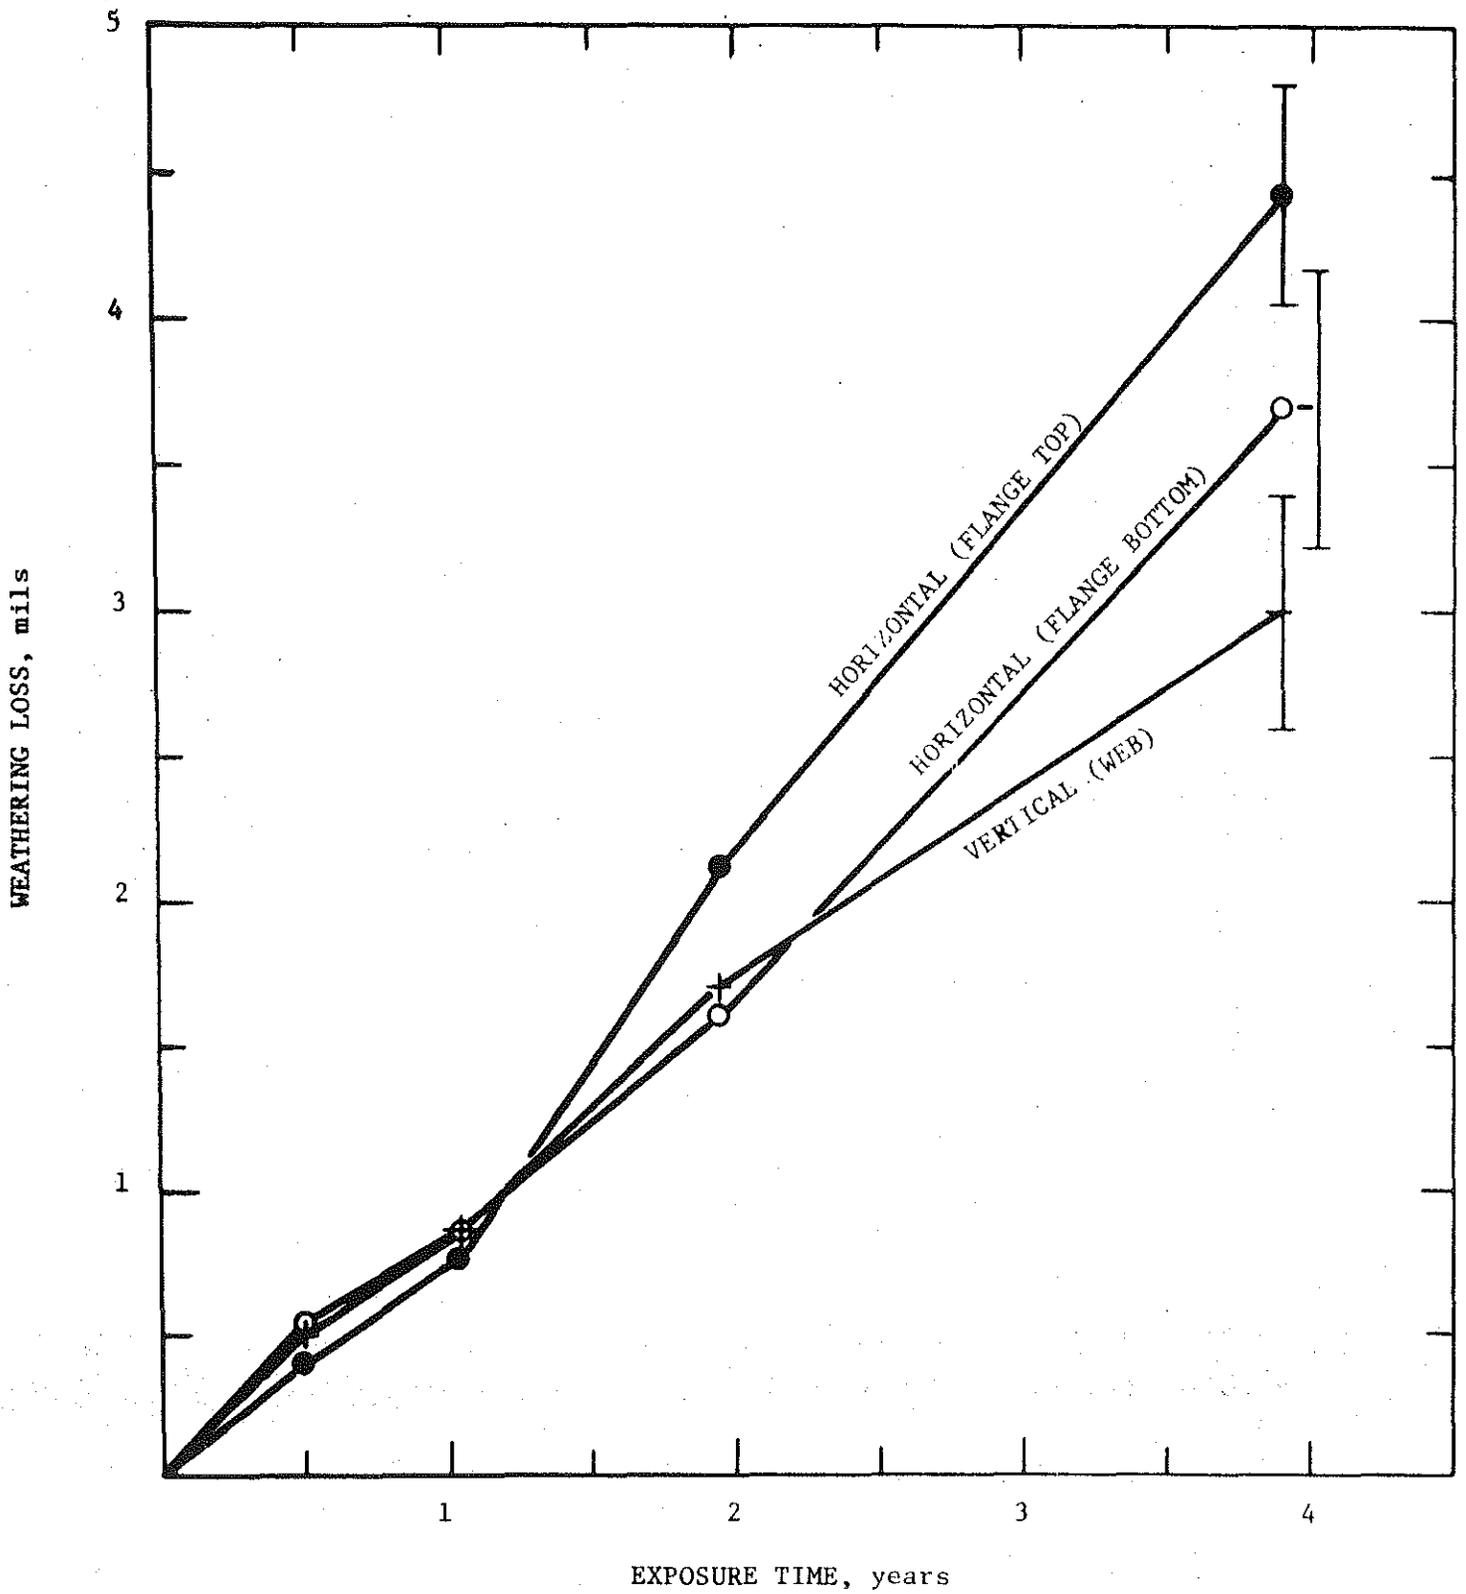
FIGURE 9

FIGURE 9. WEATHERING-TIME CURVES OF MAYARI R STEEL SPECIMENS BENEATH THE WESTBOUND SERVICE BRIDGE, DETROIT, MICHIGAN

Error bands are  $\pm 1\sigma$  (standard deviation)

Based on Table 1 and Figure 9, a comparison of corrosion of the vertical surface representing webs and the horizontal surfaces representing the top and bottom of flanges show that the vertical samples corroded less than the horizontal samples. Furthermore, the horizontal top panels, representing the top surface of the flange and ledges that tend to accumulate the most soil, showed the most corrosion. The total time of wetness may be significant here in that beam flanges which accumulate more caked dirt and rust, may not dry as readily as the webs. If the flanges remain wet for a greater proportion of the exposure time, they would be expected to corrode more. After 4 years' exposure, the weathering loss of the horizontal specimens was about 25 to 50% greater than that of the vertical panels.

Table 2 shows the amounts of chloride which accumulated on weathering steel specimens beneath the westbound service bridge. There has been a marked increase in the amount of chlorides with increasing time of exposure. Viewing Figure 9 shows that there is a linear increase in corrosion or weathering, but no sharp and abrupt increase in weathering with time even though there has been a marked upturn in accumulated chloride with time.

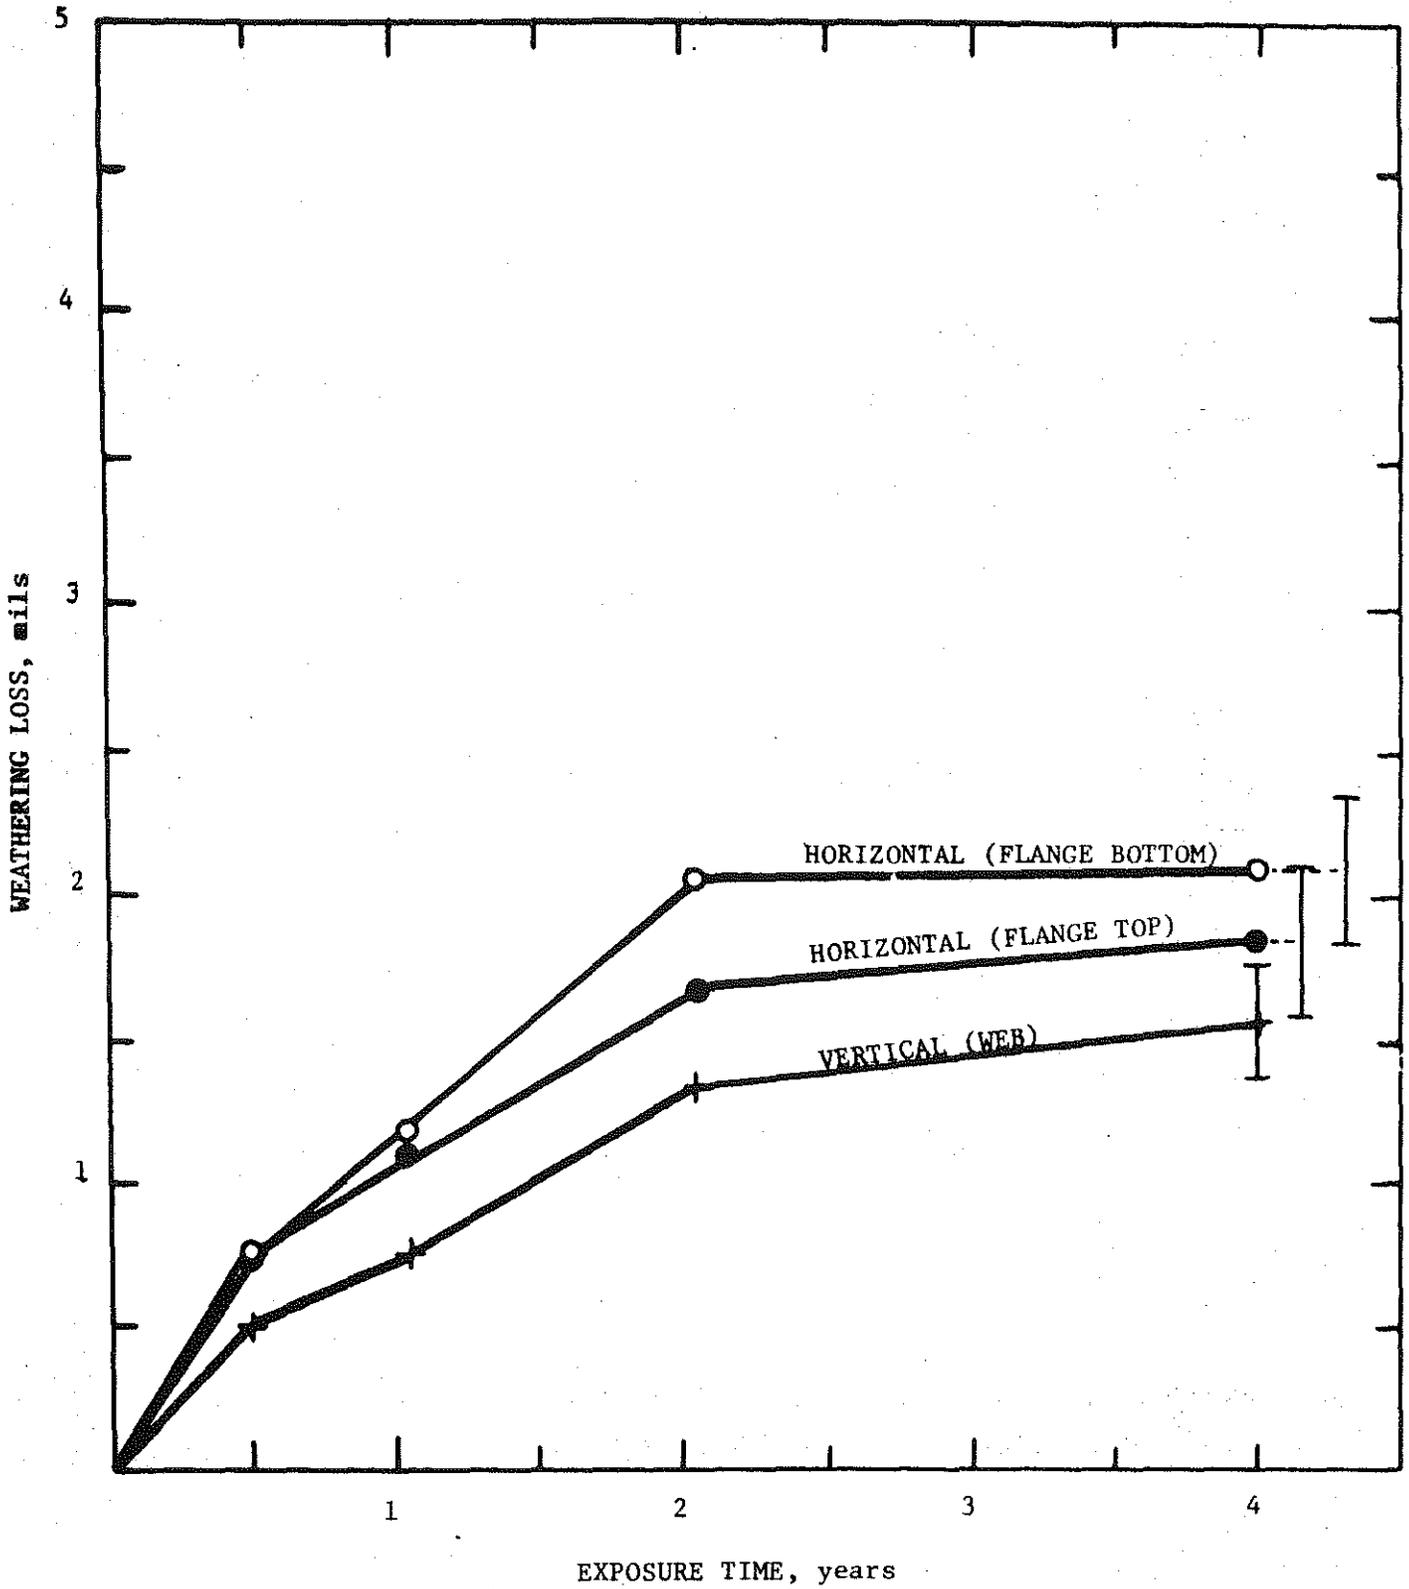
FIGURE 11

Table 3 gives the weathering data for specimens on the roof of a building in the vicinity of the Eight Mile Road Bridge. Figure 11 shows these data plotted as weathering-time curves. For all positions the curves show the typical turnover of the weathering rate with time. There is no flaking, only the usual dark russet layer seen on the right hand group of roof specimens in Figure 10.

We also studied the effect of specimen orientation on the corrosion behavior of Mayari R steel specimens on the building roof. The data are shown in Table 3 and in Figure 11. The effect of specimen orientation was somewhat less in case of the rooftop specimens than those beneath the bridge. The vertical specimens on the roof, that represent the web of beams, still have the least corrosion as was the case for specimens beneath the bridge. However, the order of superiority for horizontal top and bottom specimens on the rooftop was reversed as compared with those beneath the bridge, with the horizontal bottom rooftop specimens having the most weathering loss. After 4 years' exposure, the weathering loss of the horizontal specimens was about 15 to 35% greater than that of the vertical panels.

FIGURE 11. WEATHERING-TIME CURVES OF MAYARI R STEEL SPECIMENS ON THE BUILDING ROOF IN DETROIT, MICHIGAN

Error bands are  $\pm 1\sigma$  (standard deviation)
