Final Report RC-1526

Estimate of Cliff Recession Rates for the Baraga Cliffs

Michigan Department of Transportation

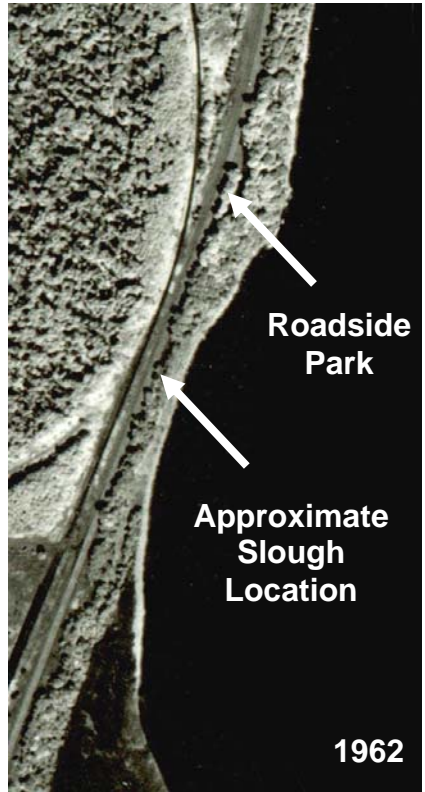
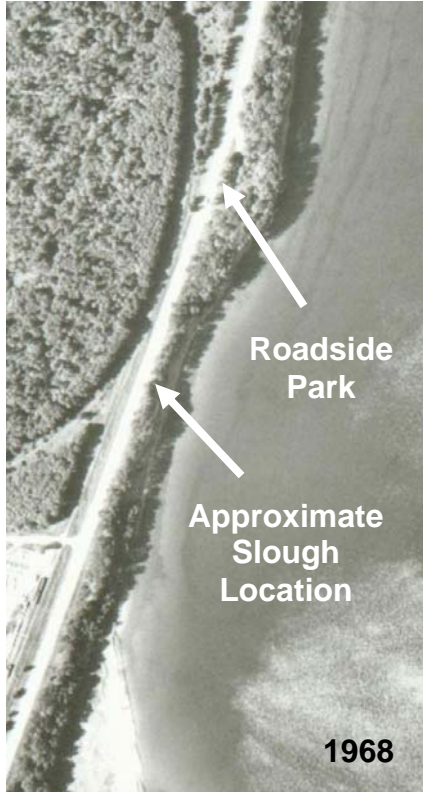
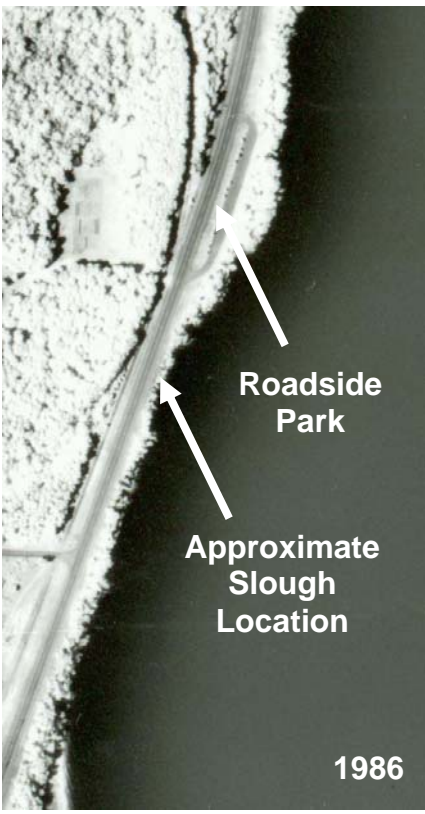
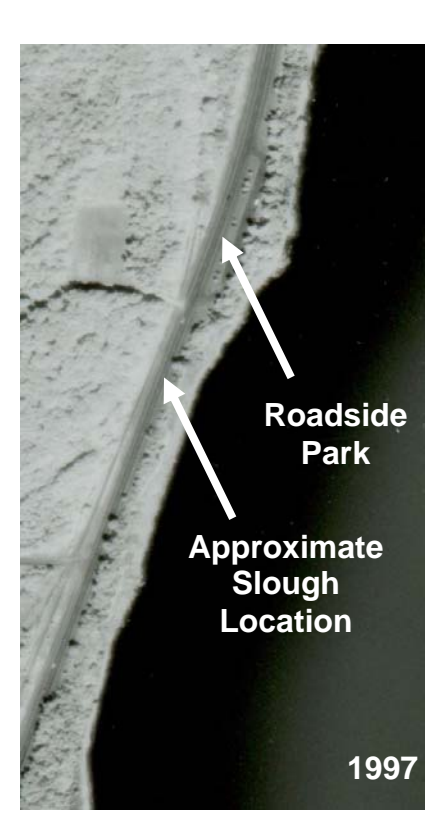
Figure 8: MDNR aerial photo showing the cliff in 1962, 1968, 1986, and 1997.

The historical aerial photographs shown in Figure 8 were used to estimate cliff recession. The aerial photographs, while not of a high resolution, did allow for a rough estimate of cliff recession for the 50 year period of approximately 1.5 in/yr. This estimate is in line with the resident estimate and the long term shore platform model.

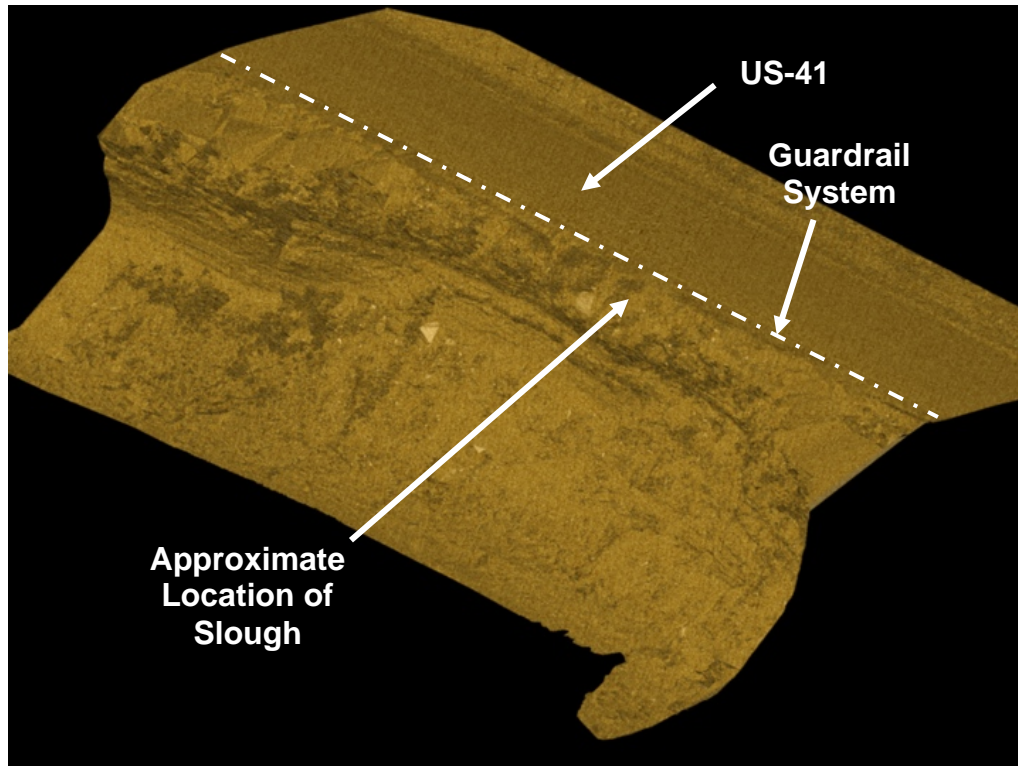
is shown in Figure 10. A cross-section from this data is shown in Figure 11. The cross-section is located in the vicinity of the slough that is affecting the highway.

Figure 10: Section of LiDAR Model of cliff and road.

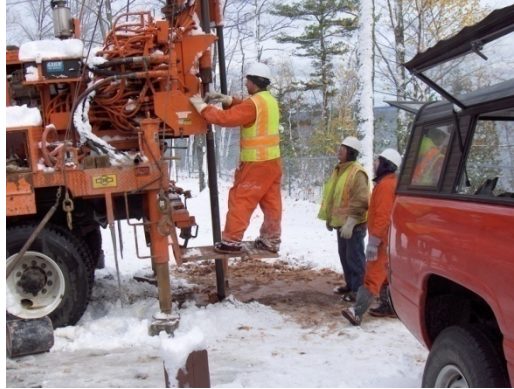
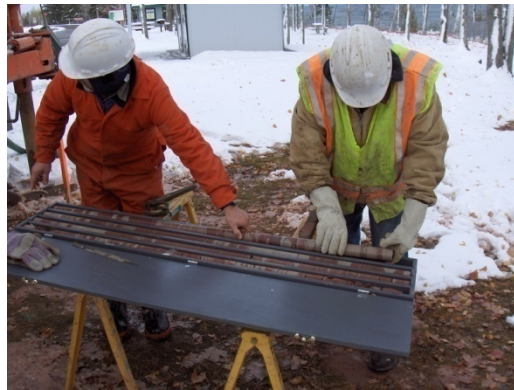
In the fall of 2006, MDOT personnel drilled three boreholes to investigate the condition of the cliff rock and to install an inclinometer at the site. The drill holes extended to a depth of about 90 ft. Figure 12 shows the drilling crew working in October to complete the drilling, while Figure 13 shows the core from borehole #2. Figure 14 shows the approximate location of the three boreholes; BH1 was located on the south end of MDOT Roadside Park, BH2 was located along the rail line, and BH3 was located at the southern end of the guardrail. The inclinometer was installed on the south end of the cliffs in borehole BH3.

Figure 12: Rock cores being drilled and placed in boxes.

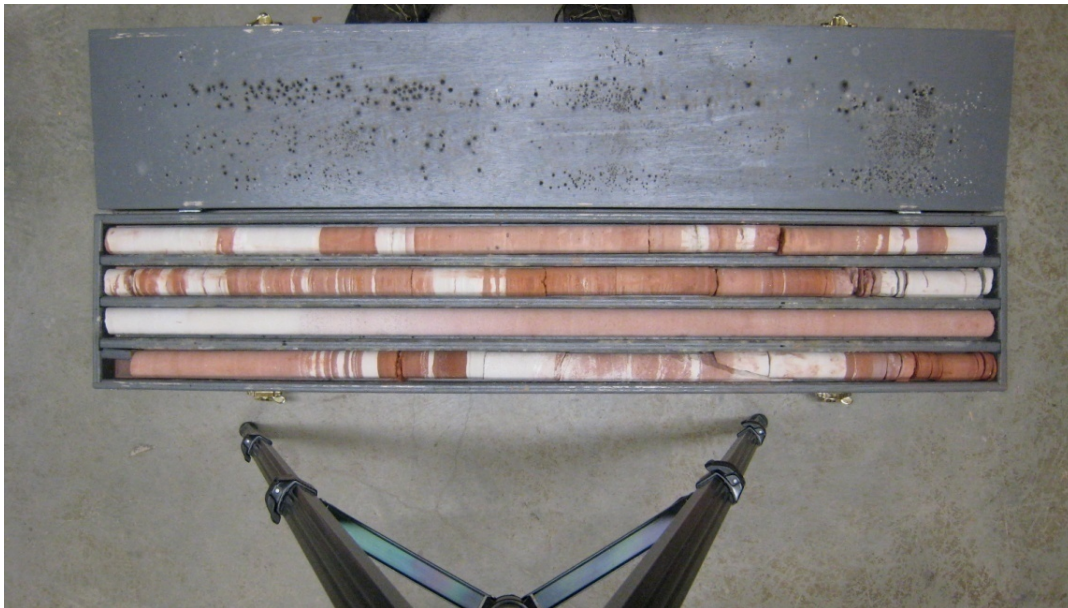
The cores were sent to Michigan Technological University Department of Civil & Environmental Engineering where they were tested for rock quality designation (RQD), rock mass rating (RMR), uniaxial unconfined compressive strength, and point load strength. The cores were photographed with an HD camera, and then the image was used to create a mosaic of the entire core depth.

Figure 13: Example of HD image used to create mosaic (TH2B2).

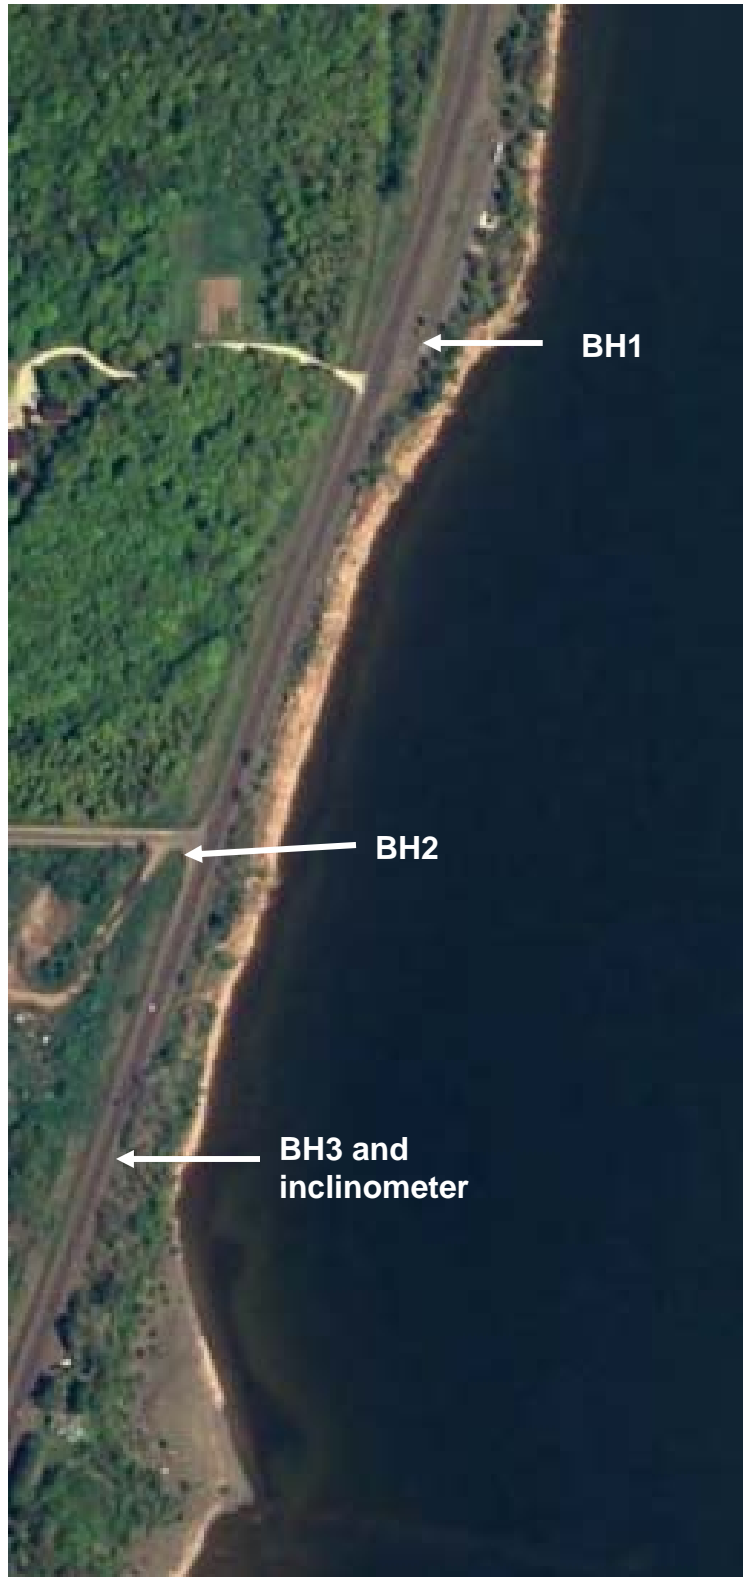
Figure 14: Approximate location of boreholes and inclinometer.

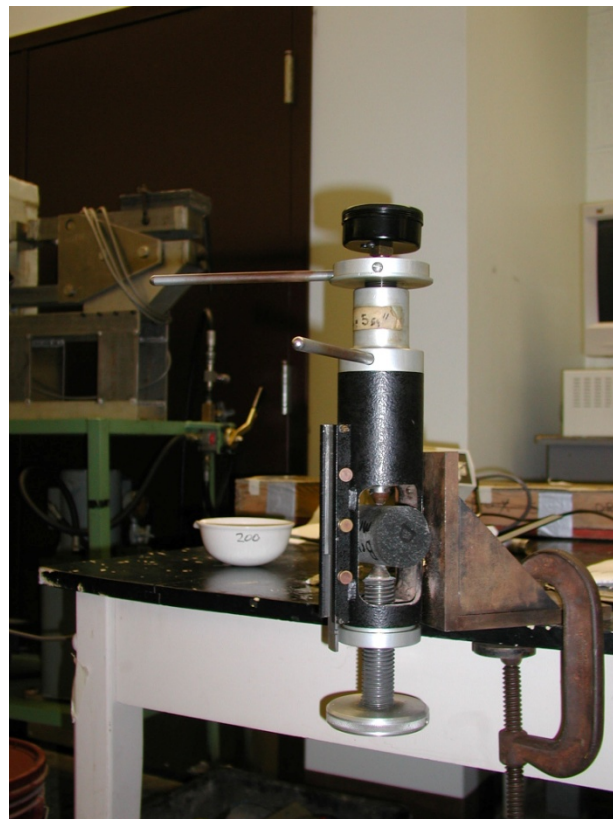
Samples were also tested in a point-load device to confirm the strength of the rock in sections where a uniaxial sample could not be taken. The point load device used to test these samples is shown in Figure 25. Results of the point-load test are provided in Table 3.

Figure 25: Point load test device

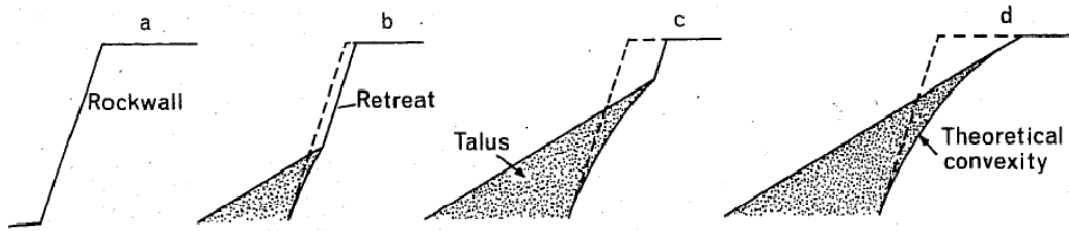
As illustrated in Figure 32, the formation of a stable talus slope assumes that the talus slope base will remain and not be removed by wave action or long-shore currents. The slope just to the south of the Baraga Cliffs appears to have recessed to a stable slope, due in part to the large amount of stamp sand that was deposited in front of the cliff as clearly shown in Figure 21. The stable talus slope on the south side of the Baraga Cliffs is estimated to be between 30° and 35° and is vegetated with young deciduous trees and underbrush. Soil cover over the rubblized rock is relatively thin but appears to be resistant to erosion. Although recession of this slope has essentially stopped, some minor erosion still is occurring due to surface runoff directed over the slope via storm runoff collection and discharge over this slope.

Figure 32: A theoretical cliff in which a convex rock slope forms under the talus slope. It is assumed that there is no talus removal from the base of the slope (After Selby, 1993).

Another solution would be to move the road back to a safe position and then allow the slope to naturally recess to a stable slope. However, this plan assumes that a natural stable slope will form, similar to that shown in Figure 32, and that Lake Superior will remain at its current level or lower.

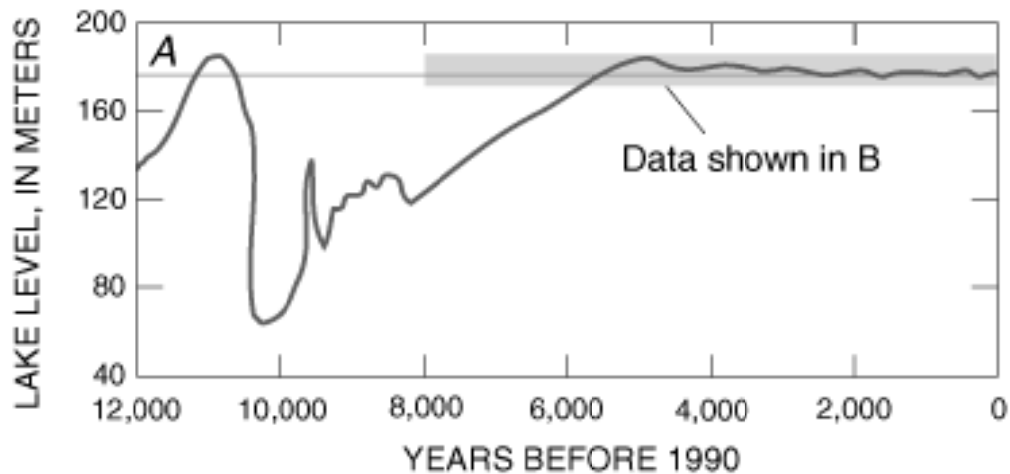
The U.S. Geologic Survey (1996) fact sheet on the state of Michigan concludes that lake levels have not dropped below 20 ft since 7,000-8,000 years ago. In Figure 34 it can be seen that lake levels rose starting about 8,000 years ago. Since Lake Superior was connected to both Lake Michigan and Huron during this time, it can be assumed that the data in Figure 34 can be used to roughly estimate a similar rise in lake levels for Lake Superior. This would place the recession rate at approximately 0.15 ft/year.

Figure 34: Historic levels of Lake Michigan and Huron (USGS, 1996)

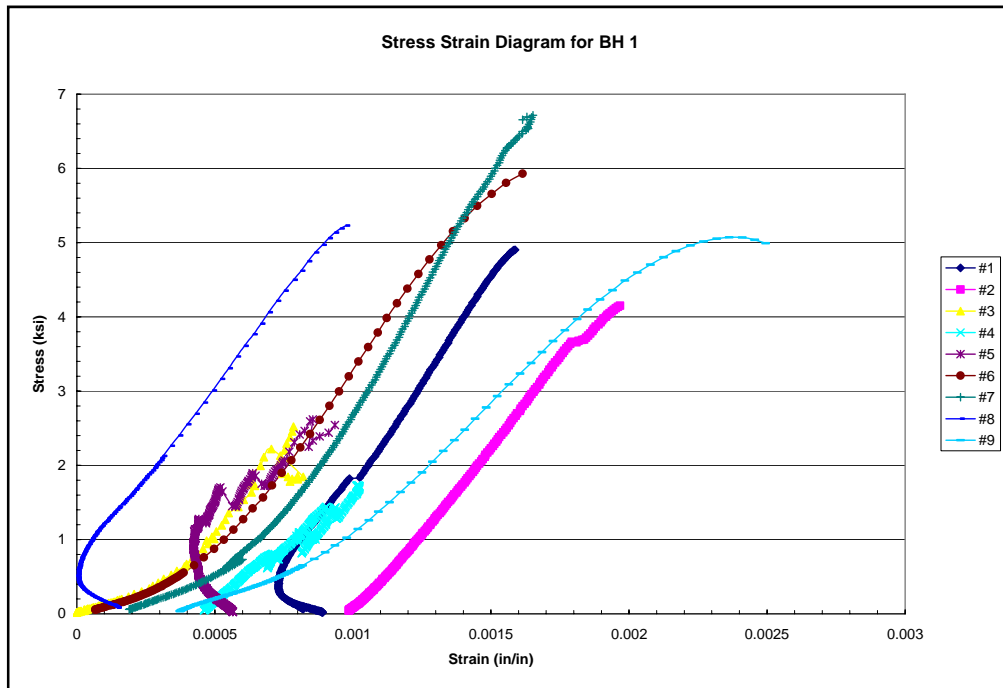
BH 1		
Depth (ft)	Stress at Failure (ksi)	Young's Modulus (ksi)
12	5.2	5800
24	3.9	4700
34	2.1	5500
40	2.0	3000
44	3.4	5000
50	6.2	5500
54	6.8	6800
57	5.3	4900
60	5.1	3700
Average	4.2	5000

Figure 36: Stress –Strain test results for the core from borehole BH1. The test numbers are consistent with the data in Table 2.

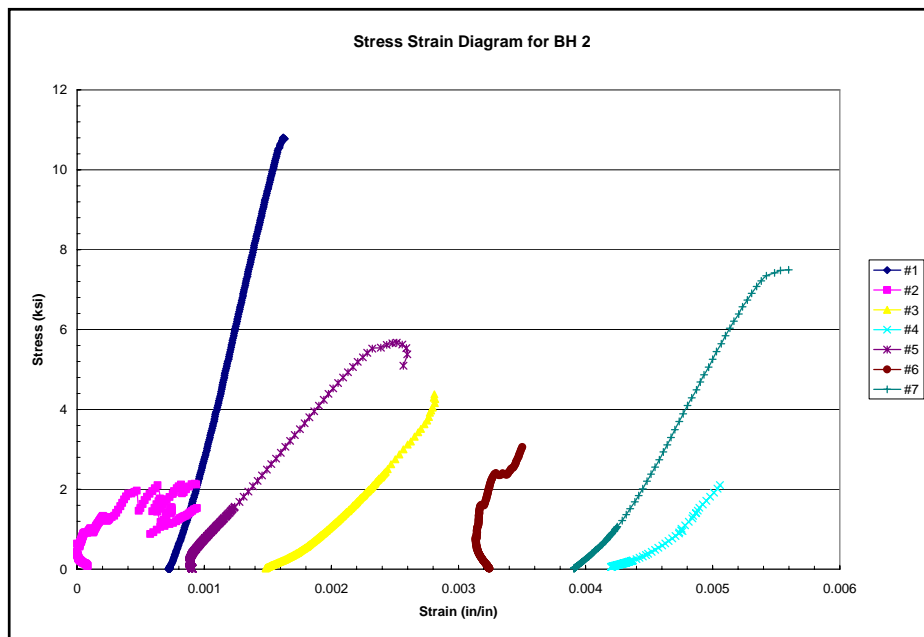
BH 2		
Depth (ft)	Stress at Failure (ksi)	Young's Modulus (ksi)
10	10.7	13400
17	2.1	3700
25	4.4	3800
39	2.1	3700
46	5.7	3900
52	3.2	10500
57	7.5	5900
Average	5.1	6400

Figure 37: Stress –Strain test results for the core from borehole BH2. The test numbers are consistent with the data in Table 2.

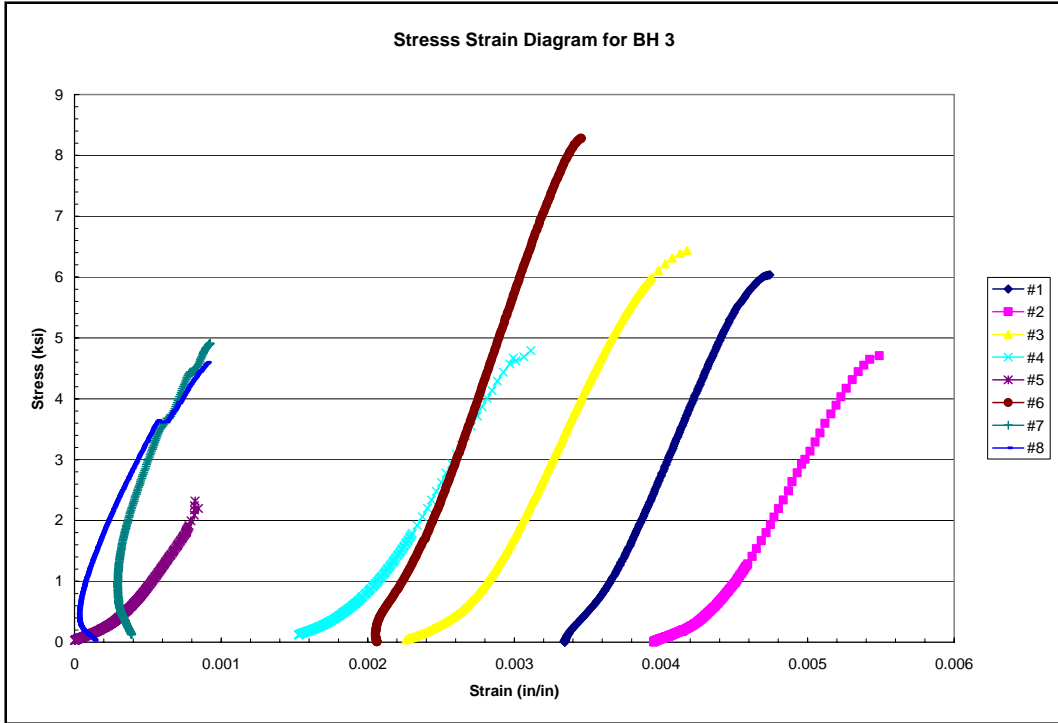
BH 3		
Depth (ft)	Stress at Failure (ksi)	Young's Modulus (ksi)
13	6.1	5600
19	4.7	4300
25	6.4	5000
32	4.8	4400
40	2.7	3700
47	8.3	6900
52	4.9	4800
57	4.5	5000
Average	5.3	5000

Figure 38: Stress –Strain test results for the core from borehole BH3. The test numbers are consistent with the data in Table 2.
