**CRASH TESTING OF MICHIGAN'S  
TYPE B (W-BEAM) GUARDRAIL SYSTEM**

**MIDWEST ROADSIDE SAFETY FACILITY**

MwRSF Research Report No. TRP-03-90-99

November 10, 1999

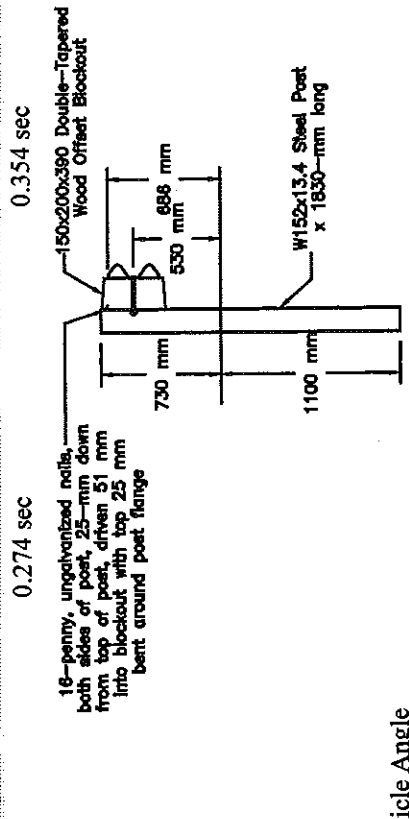
Figure 9. Summary of Test Results and Sequential Photographs, Test MIW-1

● Test Number	MIW-1	● Vehicle Angle	25.8 degrees
● Date	8/25/99	● Impact	25.8 degrees
● Appearance	Michigan's Type B (W-beam) guardrail system	● Exit	NA
● Total Length	53.34 m	● Vehicle Snagging	Minor wheel snagging on post no. 14
● Steel W-Beam (Nested) Thickness	2.66 mm	● Vehicle Pocketing	Minor
● Top Mounting Height	686 mm	● Vehicle Stability	Vehicle rollover
● Steel Posts	Post Nos. 3 - 27 W152x13.4 by 1,830-mm long	● Occupant Ridedown Deceleration (10 msec avg.)	Longitudinal 7.43 < 20 G's
● Wood Spacer Blocks	Post Nos. 3 - 27 150 mm x 200 mm by 360-mm long	● Lateral (not required)	12.98
● Soil Type	Grading B - AASHTO M147-65 (1990)	● Occupant Impact Velocity (Normalized)	Longitudinal 6.35 < 12 m/s
● Vehicle Model	1994 GMC 2500 2WD	● Lateral (not required)	4.33
● Curb	2,021 kg	● Vehicle Damage	Extensive
● Test Inertial	2,007 kg	● TAD <sup>10</sup>	NA
● Gross Static	2,007 kg	● SAE <sup>11</sup>	NA
● Vehicle Speed	99.8 km/hr	● Vehicle Stopping Distance	34.17 m downstream

● Impact	Exit NA	● Barrier Damage	10.97 m traffic-side face
		● Maximum Deflections	Moderate
		● Permanent Set	625 mm
		● Dynamic	1,002 mm

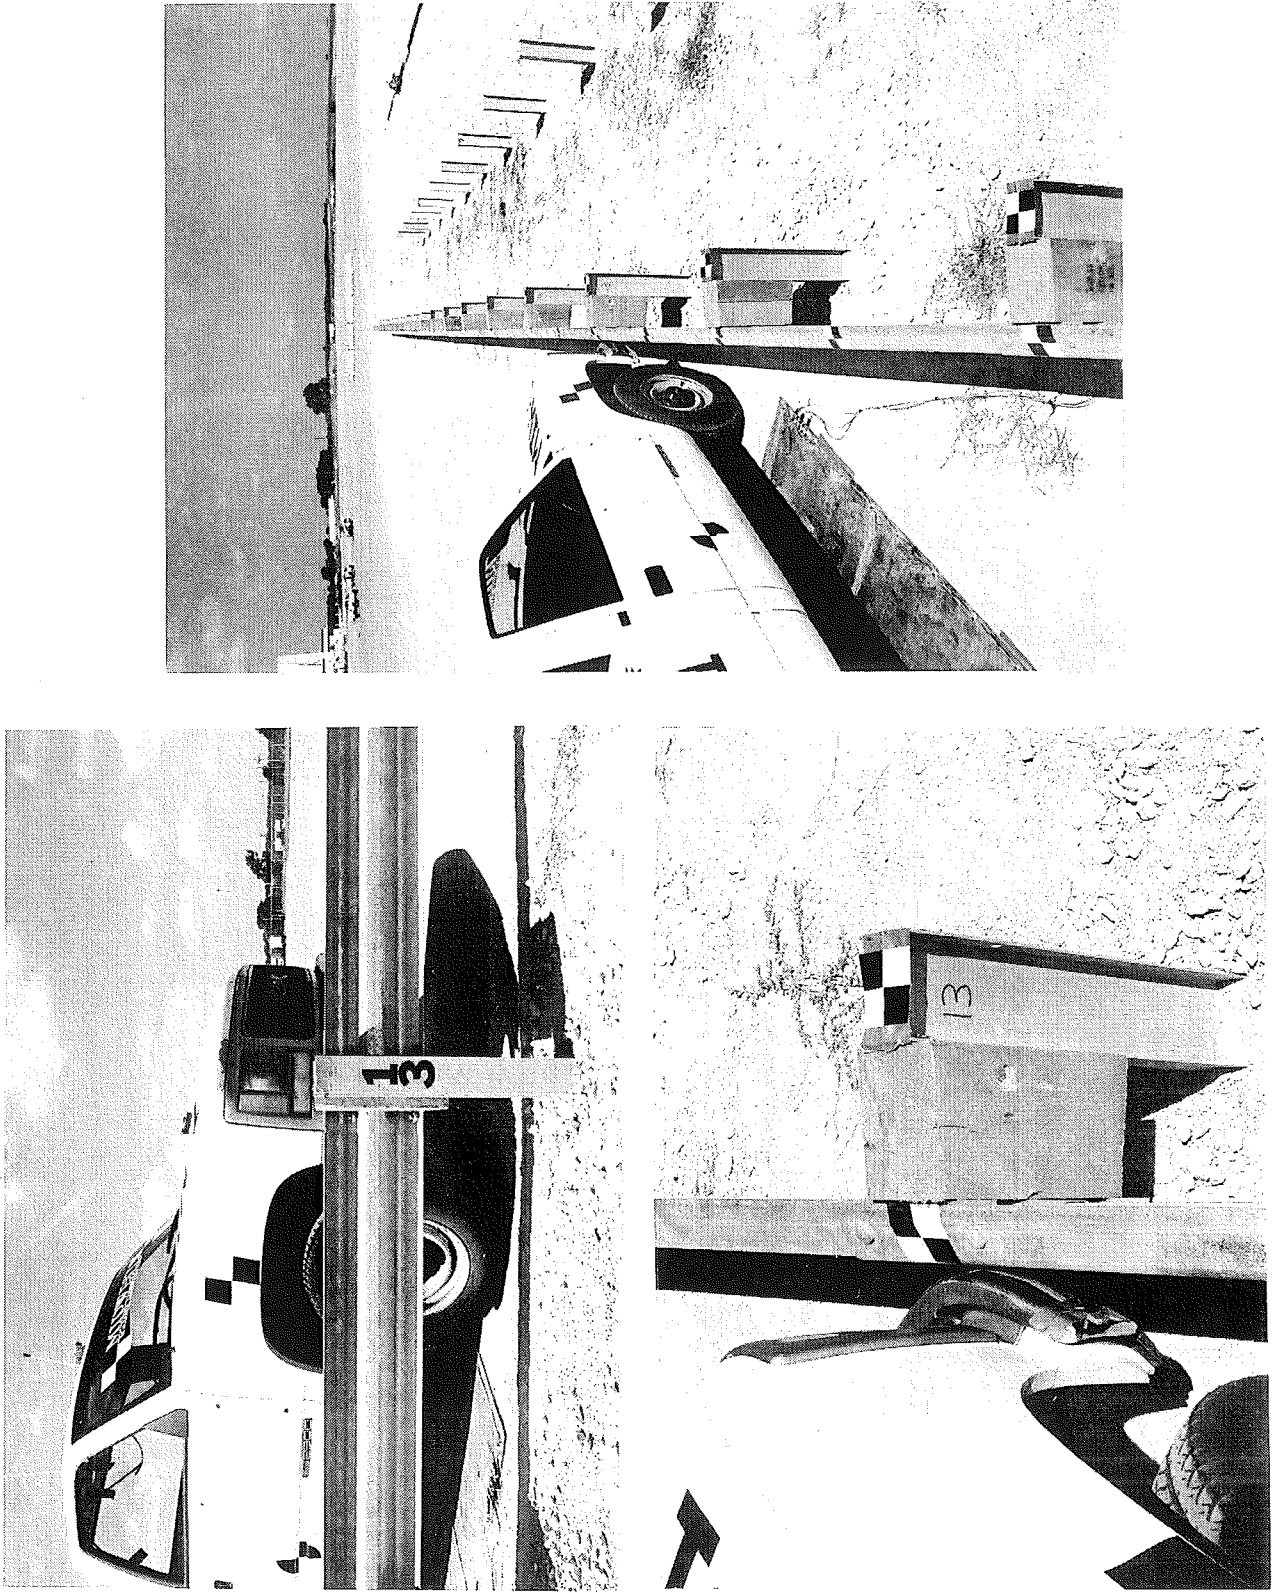
Figure 15. Impact Location, Test MIW-1

Initial impact occurred at the center of post no. 13, as shown in Figure 15. Upon impact with the guardrail, post no. 13 rotated backward. At 0.032 sec after impact, the right-front corner of the vehicle, which was at the midspan between post nos. 13 and 14, crushed inward except for the engine hood which protruded over the top of the guardrail. By this time, post no. 13 had moved backward and post no. 14 was twisted but without translating backward. At 0.057 sec, the right-front tire collapsed under the guardrail. At 0.060 sec, post nos. 13 and 14 had rotated backward about the same distance. At 0.072 sec, the right-front corner of the vehicle was at post no. 14, which continued to rotate backward. At this same time, post no. 15 began to show movement. At 0.123 sec, there was very little, if any, vehicle redirection with the right-front corner slightly past the midspan of post no. 14 and 15. During this same moment, a majority of the right-front fender was protruding over the guardrail. At 0.153 sec, the right-front corner of the vehicle was at post no. 15, and the test vehicle, with the right-side door frame cracked open, began to redirect. At this same time, post nos. 14 and 15 had rotated backward about the same distance, and post no. 16 continued to rotate. At 0.207 sec, the vehicle's right-front corner was positioned at the midspan between post nos. 15 and 16. In addition, the left-front tire was airborne with the rear-end yawed counter-clockwise (CCW)

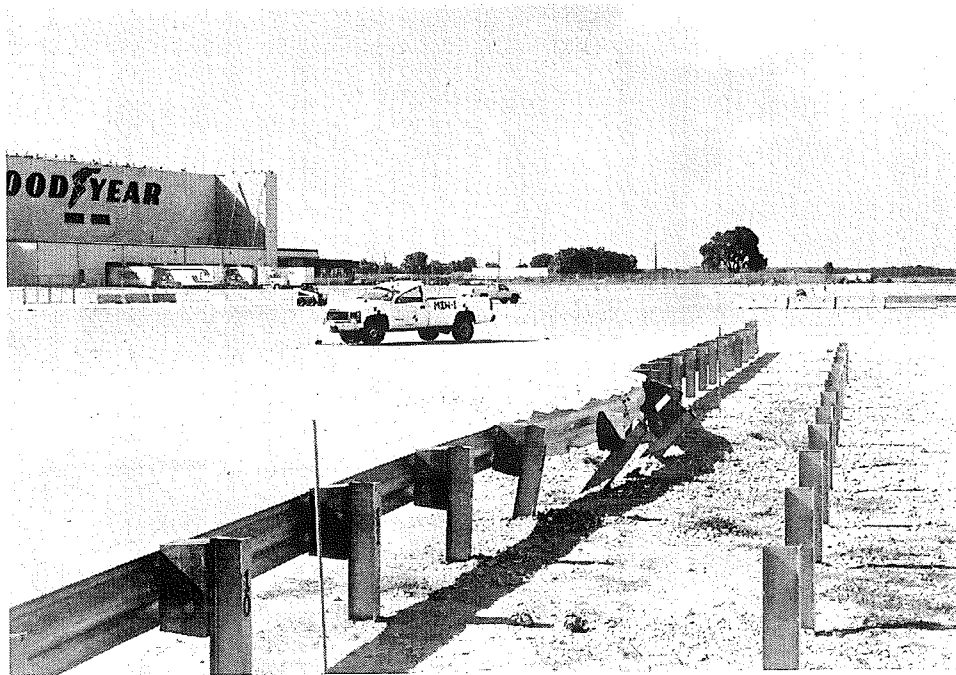
Figure 16. Final Vehicle Location, Test MIW-1

The analysis of the test results for test MIW-1 showed that the W-beam guardrail contained the vehicle but inadequately redirected the vehicle, since the vehicle did not remain upright after collision with the guardrail. Detached elements and debris from the test article did not penetrate or show potential for penetrating the occupant compartment. Deformations of, or intrusion into, the occupant compartment that could have caused serious injury did not occur. After collision, the vehicle's trajectory intruded slightly into adjacent traffic lanes but was determined to be acceptable. In addition, the vehicle's exit angle was less than 60 percent of the impact angle. Therefore, test MIW-1 conducted on MDOT's Type B (W-Beam) Guardrail System was determined to be unacceptable according to the NCHRP Report No. 350 criteria.
