METHODS FOR EVALUATING DETERIORATION
OF IN-SERVICE REFLECTIVE SHEETING SIGNS

M. H. Janson
G. M. Smith

Research Laboratory Section
Testing and Research Division
Research Project 68 G-160
Research Report No. R-692

State of Michigan
Department of State Highways
Lansing, April 1969

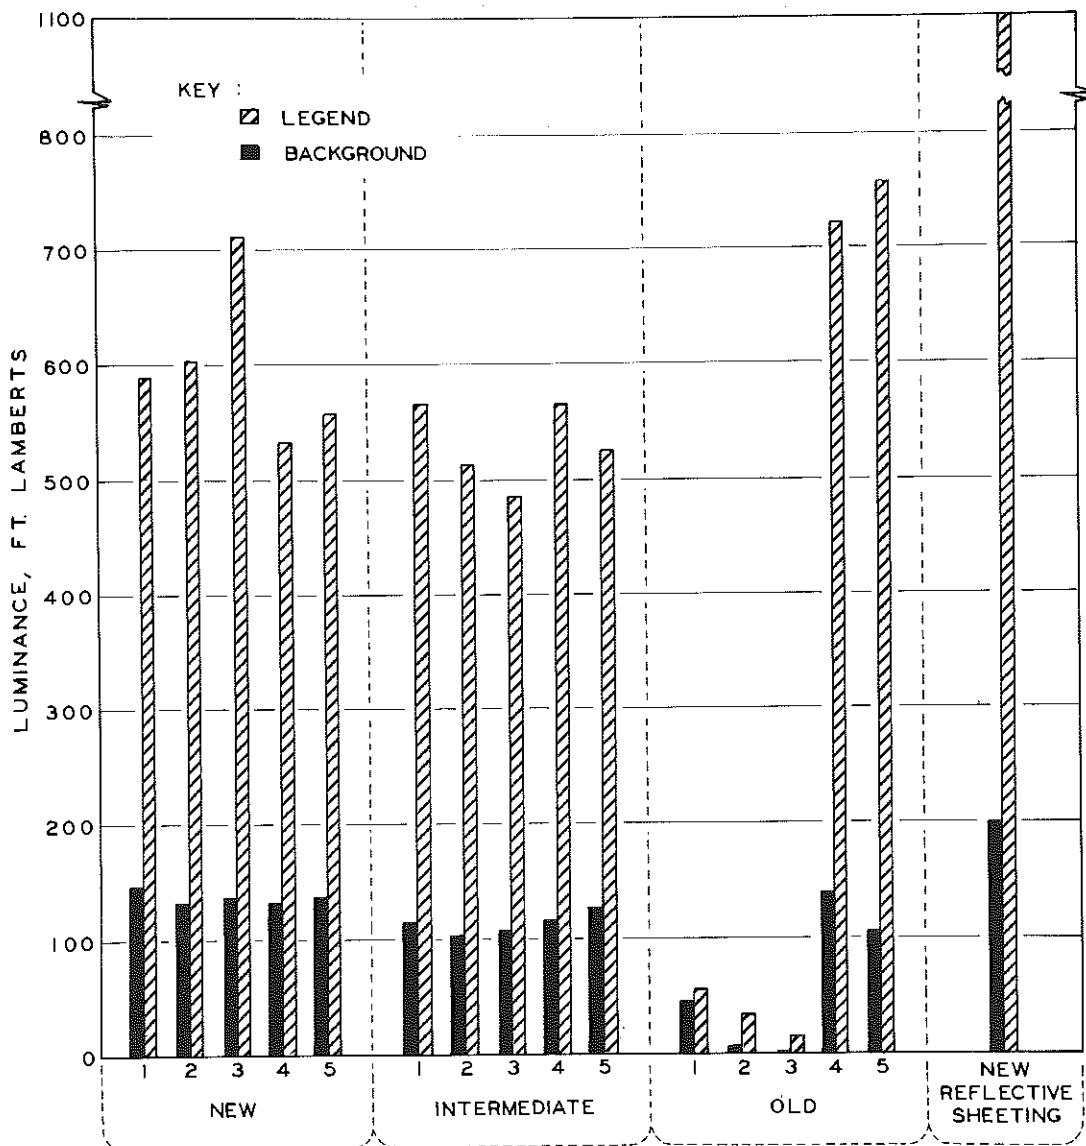
Figure 2. Sign luminance values, I 96.

Figure 2 shows the luminance values for the I 96 signs and new reflective sheeting as a comparison. Figure 3 depicts typical "New" and "Intermediate" signs on I 96. It was found that even though the I 96 "Intermediate" signs had cracks in the legend sheeting, legend and background luminances were not significantly lower than those of the "New" signs on I 96. Figure 4(a) shows a typical letter from "Old" signs on I 96. Luminances for these "Old" signs are numbered 1, 2, and 3, in Figure 2. Figure 4(b) shows a letter typical of the other "Old" signs on I 96, numbered

4 and 5 in Figure 2. The legend and background luminance values of the above numbered 1, 2, and 3, "Old" signs were approximately 5 to 40 percent of the values for "New" and "Intermediate" signs. These luminances were considered too low for nighttime legibility. The luminance values of the above signs numbered 4 and 5 were as high as values for "New" signs.

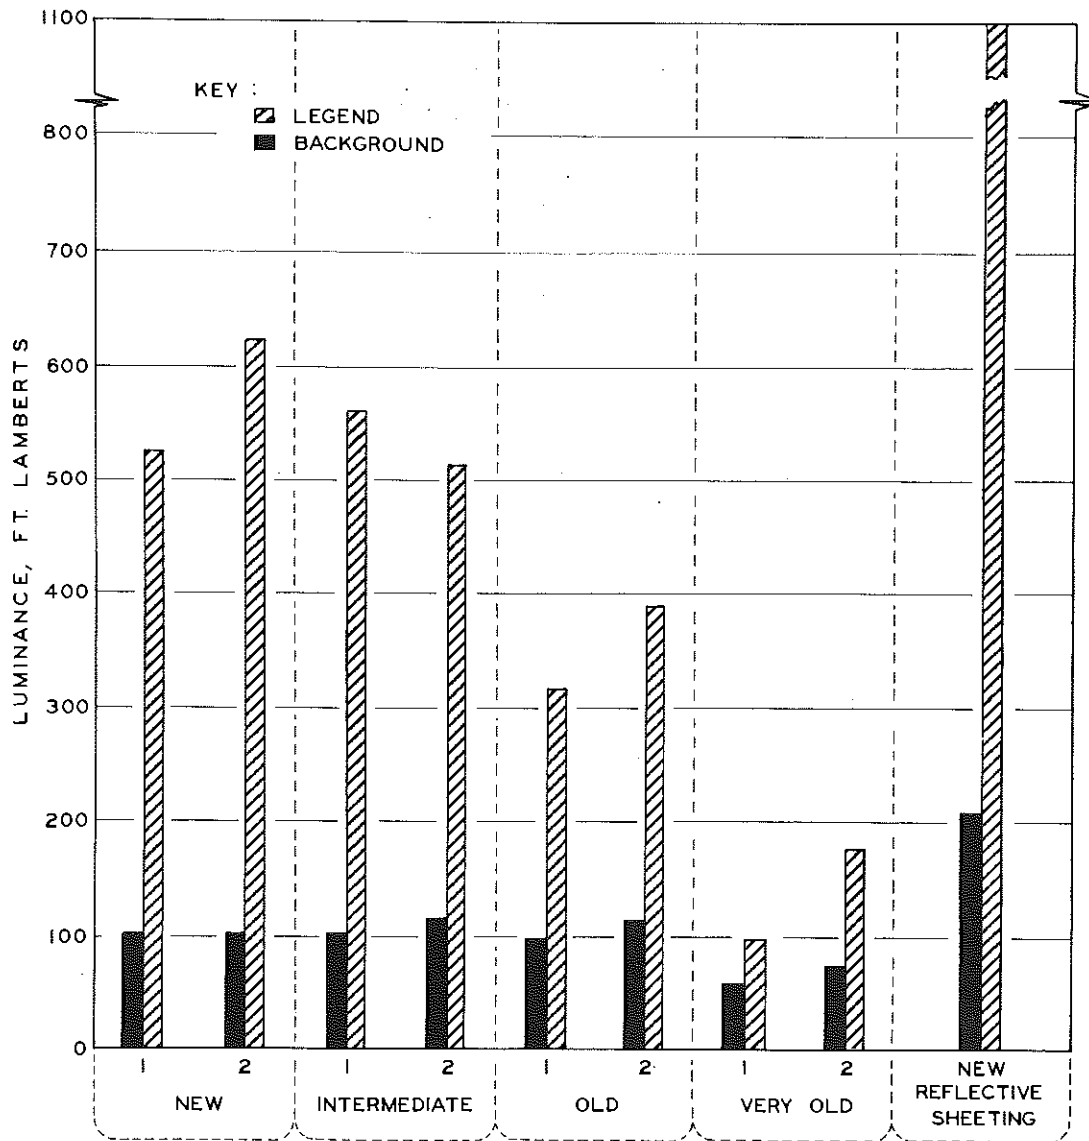
Of the signs on I 94 classified by nighttime appearance, the "Intermediate" signs were nearly as bright as the "New" signs even though the "Intermediate" sign surfaces exhibited occasional cracks and some discoloration. Figure 5 shows the luminance values for the I 94 signs as compared to new reflective sheeting. Typical examples of "New" and "Intermediate" I 94 signs are shown in Figure 6. Two stages of severe surface deterioration were identified and classified as "Old" and "Very Old" (Fig. 7). Figure 8 shows a detailed view of surfaces classified as "Very Old." The luminance values for the "Old" and "Very Old" signs ranged from 20 to 50 percent of the luminance values for "New" and "Intermediate" signs.

The luminance of the "Very Old" signs was too low for legibility at an adequate distance (greater than 300 ft). The condition of the "Very Old" signs on I 94 was similar to the "Old" signs on I 96, that is, they exhibited numerous and extensive cracks on both the legend and background.

Figure 5. Sign luminance values, I 94.

2. The "Old" signs on I 94 appeared to be similar in luminance to the reference panel. Clearcoating is recommended and sign replacement in one to two years is indicated.

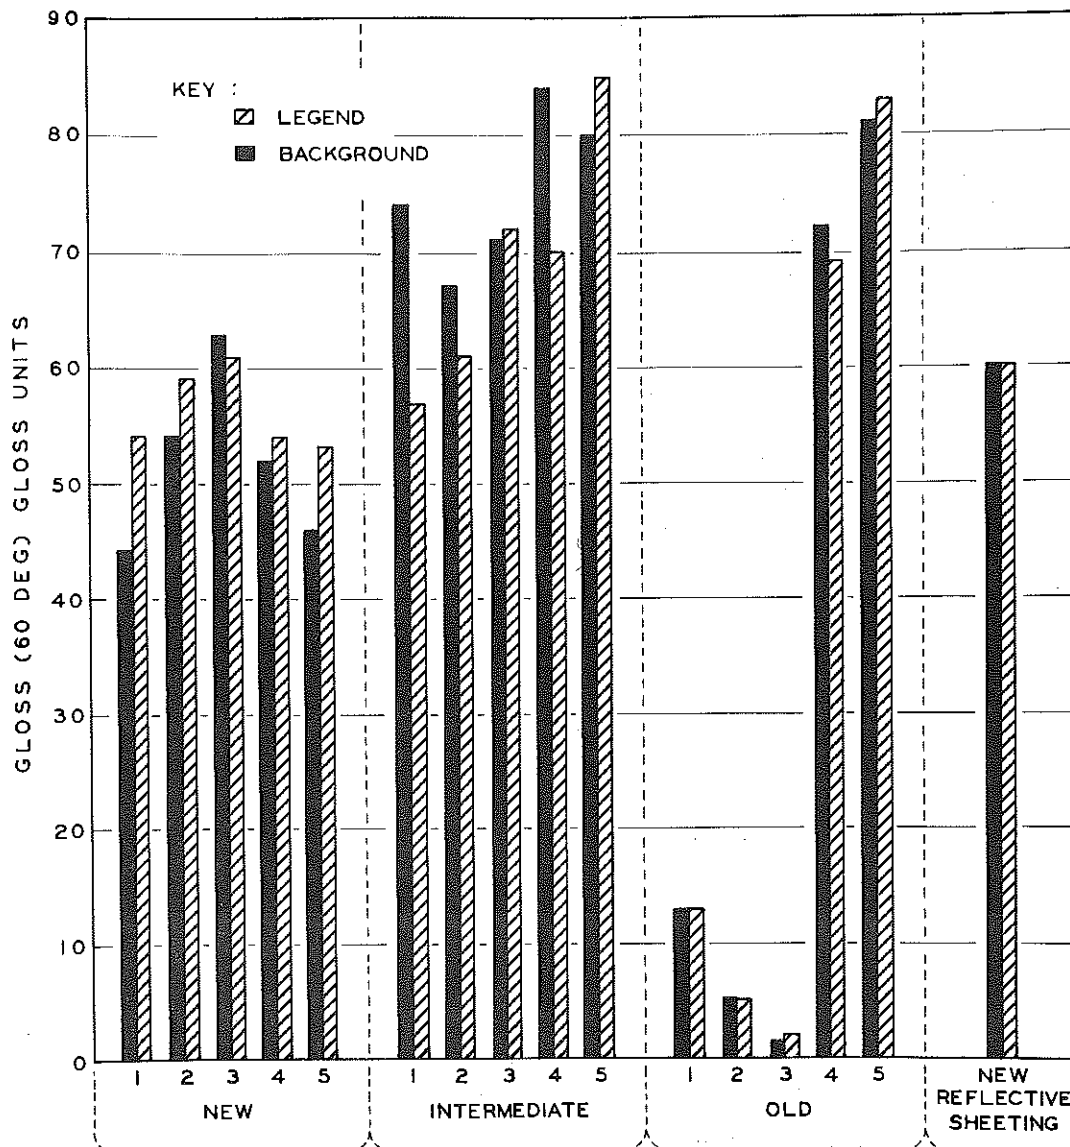
Figure 9. Gloss values of I 96 signs.

on the sign, and clearcoating is recommended either on the basis of memory of a sign's age or as surface appearance warrants the coating. The reason for the high gloss values on the I 96 signs was the clearcoating maintenance about one month prior to our measurements.

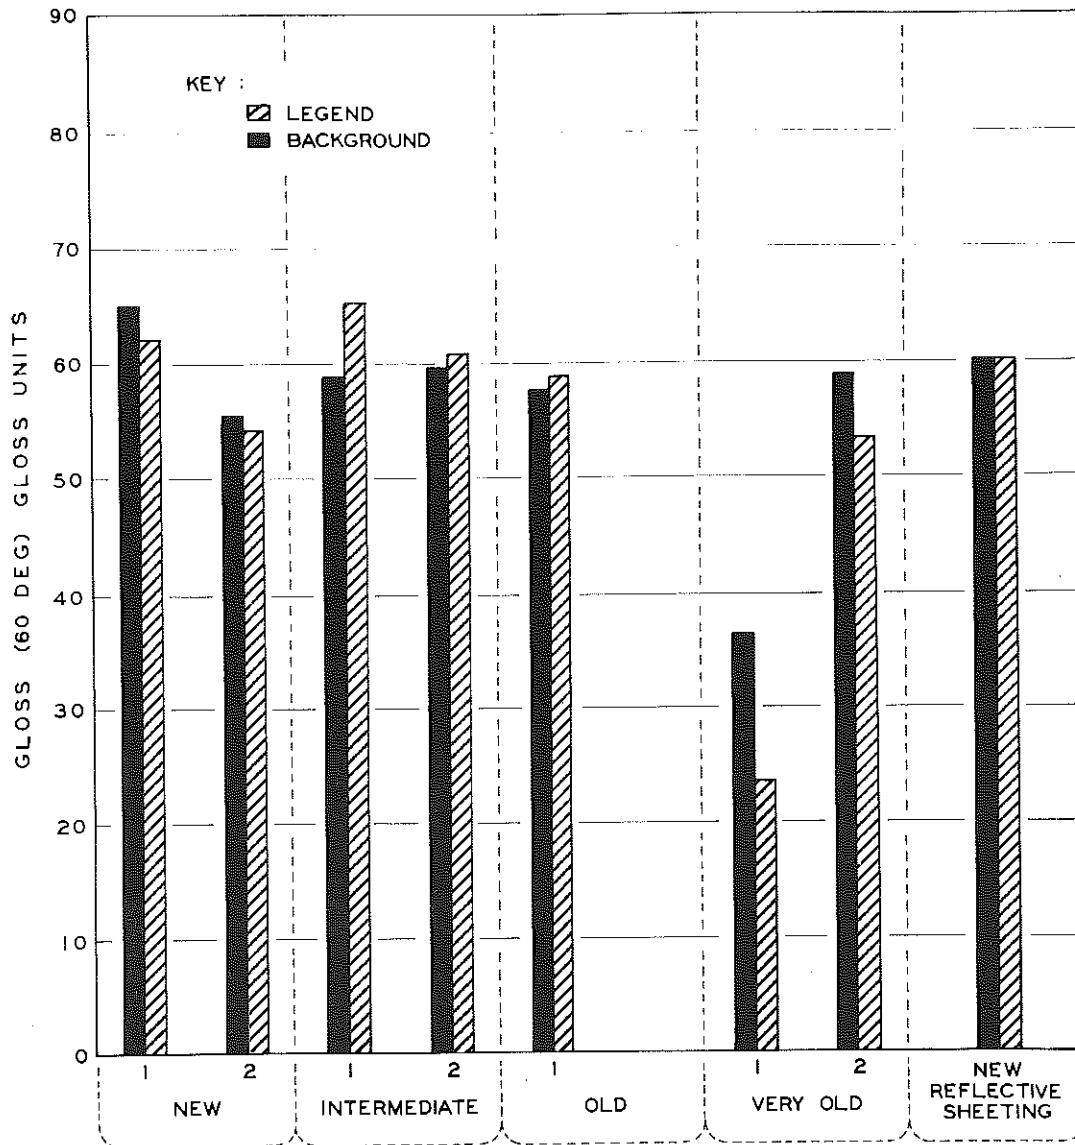
Gloss values might be expected to be closely related to surface deterioration but this was not true; except on those signs with severe deterioration. Clearcoating interfered with any possible age-to-gloss relationship because it raised gloss values on most of the treated signs to values higher than those values on new signs. Investigation of the reasons for the unexpected high gloss values on the I 96 "Intermediate" signs showed that the exact age for highway signs cannot be determined. Dates of sign installation and replacement or overlay maintenance are not recorded or marked

Figure 10. Gloss values of I 94 signs.
