CRASH TESTS OF R4 RETROFIT
AND OPEN PARAPET BRIDGE RAILS

MICHIGAN DEPARTMENT OF TRANSPORTATION CONTRACT
88-0815-DAB

FINAL REPORT

February 1992

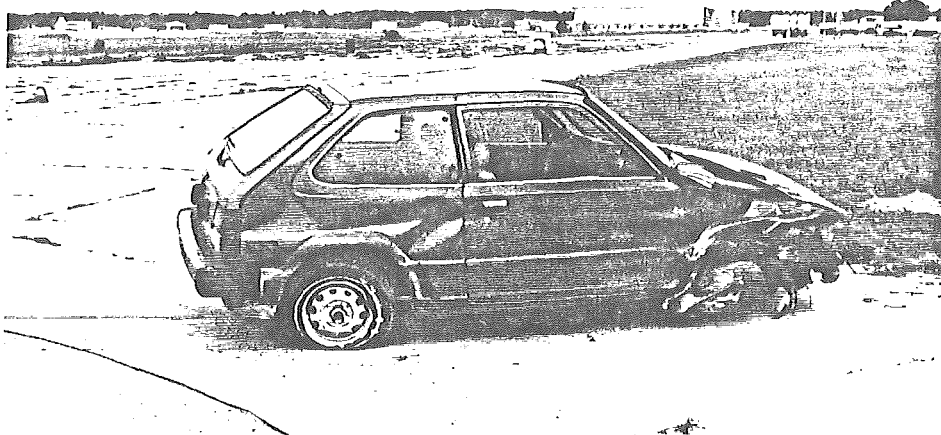
Figure 8. Posttest photographs of test vehicle, test 1952-1-89.

Damage occurred to the right front wheel and suspension, the right rear wheel, hood, bumper and entire right side of the vehicle. The passenger side door window was broken and the door was wedged out 2 to 3 in by the dummy impact. Posttest photographs of the vehicle are shown in figure 8.

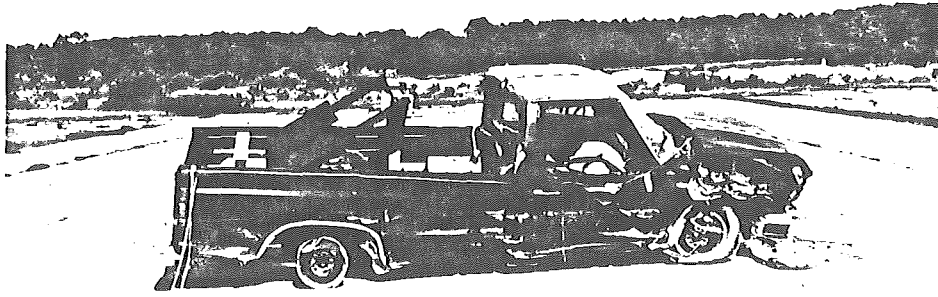
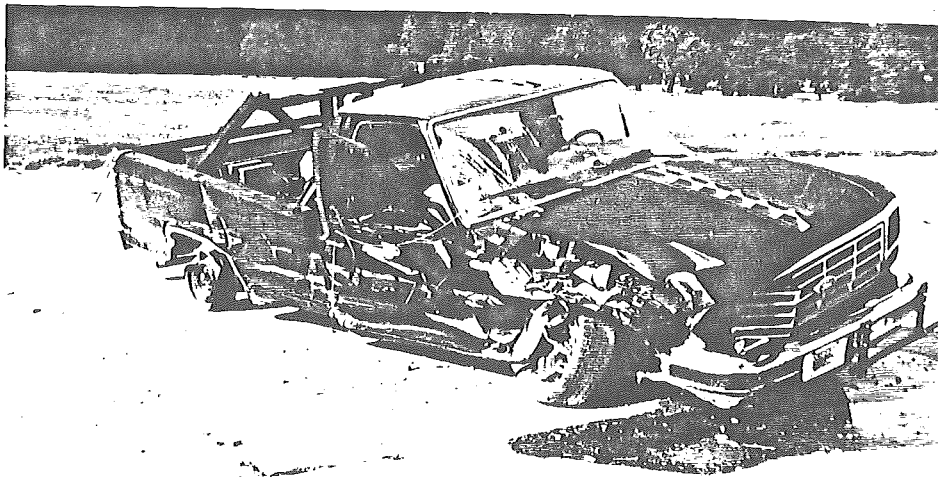
Figure 15. Posttest photographs of test vehicle,
test 1952-2-89.

Damage occurred to the right front wheel and suspension, the right rear wheel, hood, bumper and entire right side of the

vehicle. The passenger side door window was broken and the door was wedged out by the dummy impact. The impact caused the vehicle to bend toward the driver side. The front of the truck was pushed 17 in out of line. Posttest photographs of the truck are shown in figure 15.

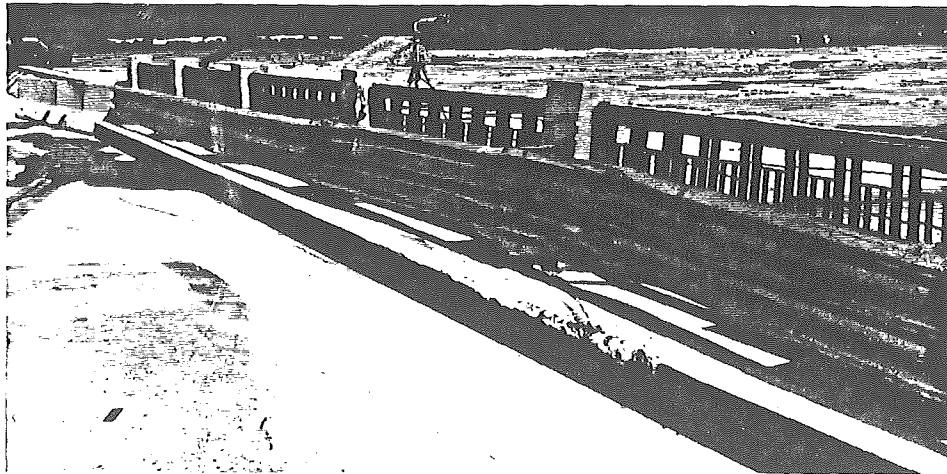
Figure 16. Posttest photographs of bridge rail system, test 1952-2-89.

The bridge rail suffered major structural damage during this impact. Posts 3 and 4 were pushed back approximately 8 and 4 in, respectively, at the top of the post. Damage to the brushblock and deck occurred at post 3 and damage occurred to the brushblock at post 4. In both cases, the damage pattern was semicircular around the post.

The damage at post 3 consisted of cracking in the brushblock and deck. The brushblock was damaged 30 in before and 35 in past the post. The deck suffered damage 30 in before and 6 in after the post. The deck was cracked for 6 in back under the edge.

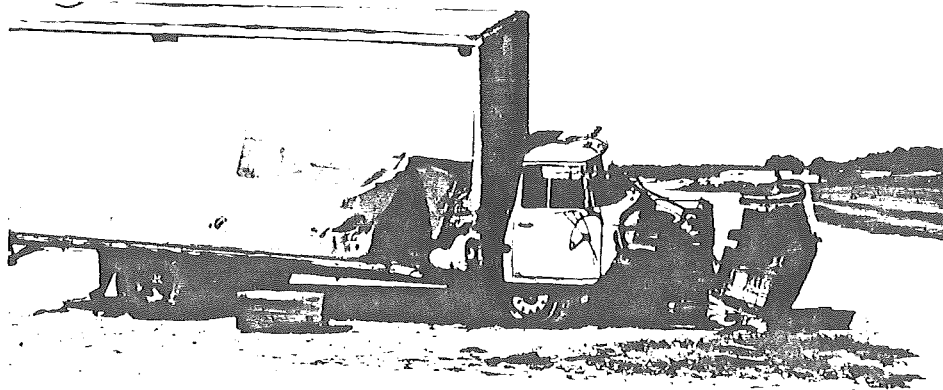
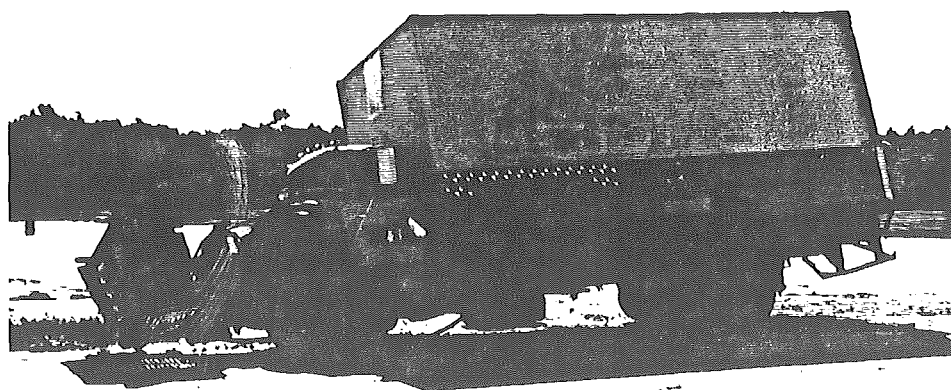
Figure 22. Posttest photographs of test vehicle,
test 1952-3-89.

The chassis at the front of the truck was damaged and twisted. The hood came open and the front axle was torn from the frame and pushed under the truck. However, the occupant compartment was not intruded. The rail side of the vehicle was damaged from impacting the rail, posts and blockouts during the impact event. A 4-ft by 4-ft hole was torn in the impact side corner of the box of the truck. Minor truck parts, ballast and debris were wedged between the posts, blockouts and rail. All tires on the impact side were deflated from contact with the brushblock and the wheels were damaged. Posttest photographs of the truck are shown in figure 22.

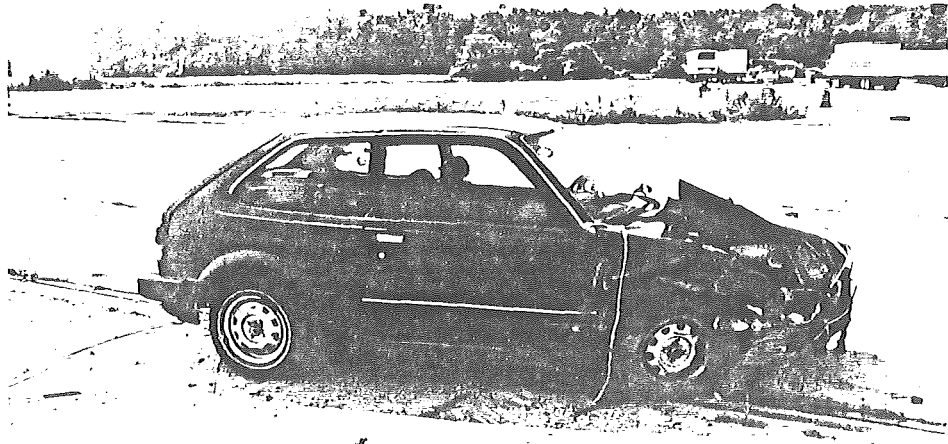
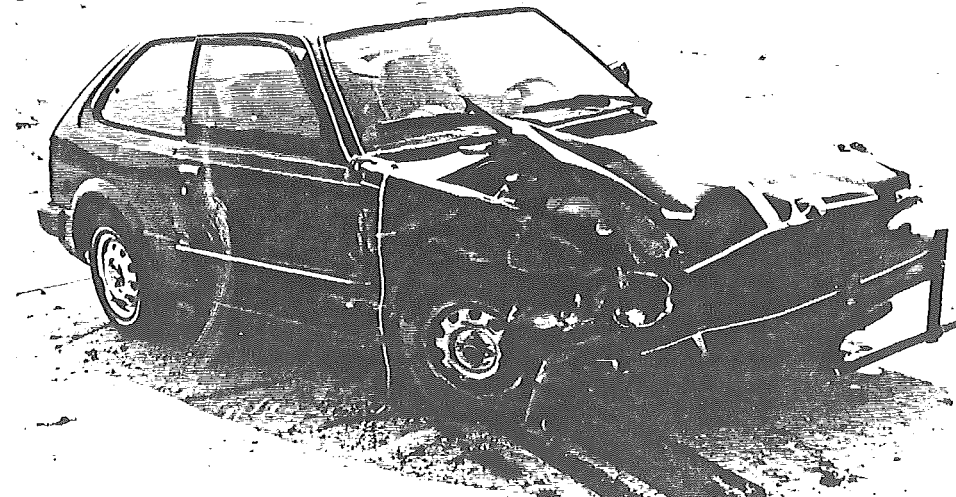
Figure 30. Posttest photographs of test vehicle,
test 1952-4-90.

Damage occurred to the right front wheel and suspension, the hood, bumper and entire right side of the vehicle. The passenger side door was wedged out by the dummy impact. Posttest photographs of the vehicle are shown in figure 30.

AASHTO Guide Specifications for Bridge Railings: **TEST FAILS.** No electronic data was recorded. Criterion G cannot be evaluated.

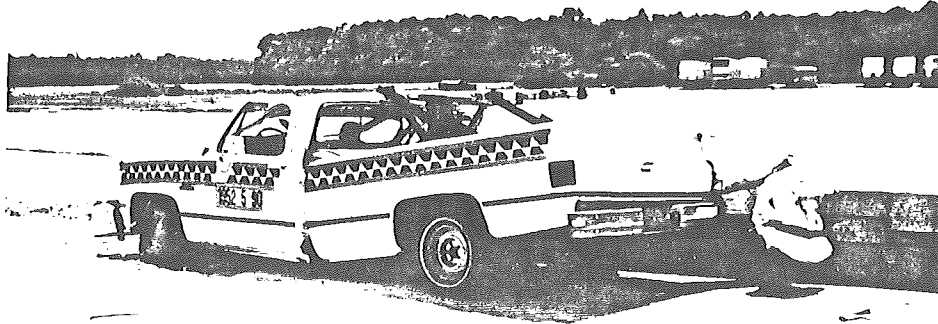
Figure 37. Posttest photographs of test vehicle,
test 1952-5-90.

Damage occurred to the front and entire right side of the vehicle. The hood was pushed into the occupant compartment. The occupant compartment was severely deformed. The right front fender was torn from the truck. The passenger side door was deformed. The right panel of the truck box was torn from its welds and wrapped around the rear of the vehicle. The front suspension was damaged. The truck buckled at the front of the bed due to the loss of structural integrity. Posttest photographs of the truck are shown in figure 37.

TEST ARTICLE FAILS DUE TO OCCUPANT COMPARTMENT INTRUSION.

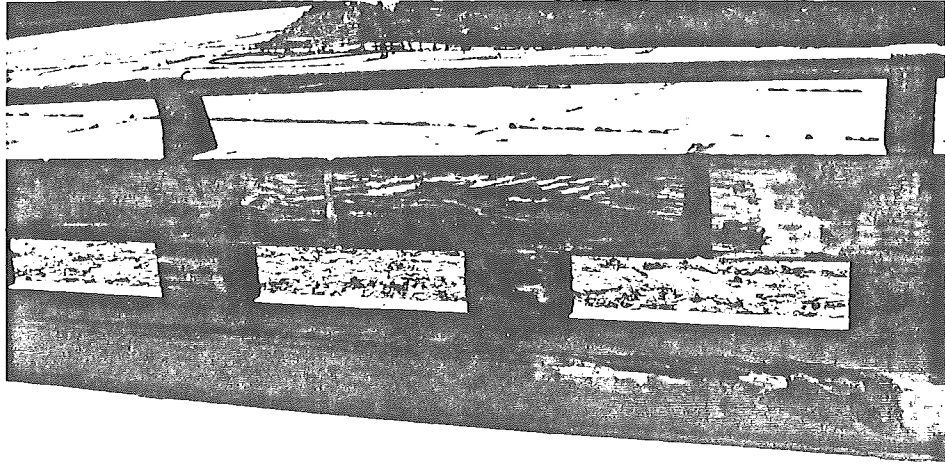
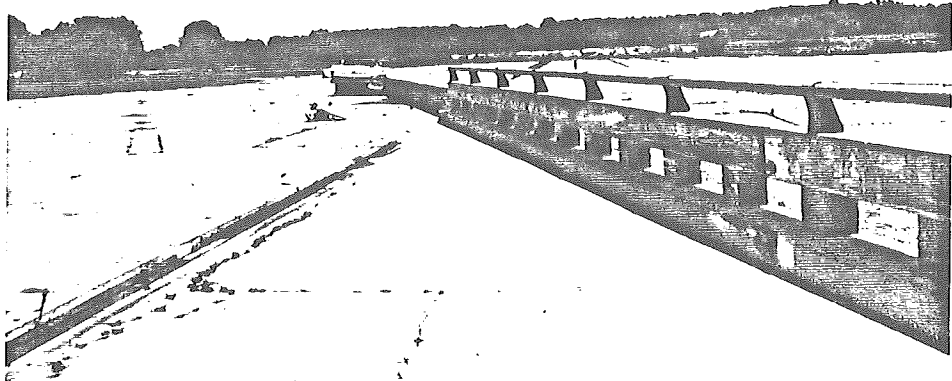
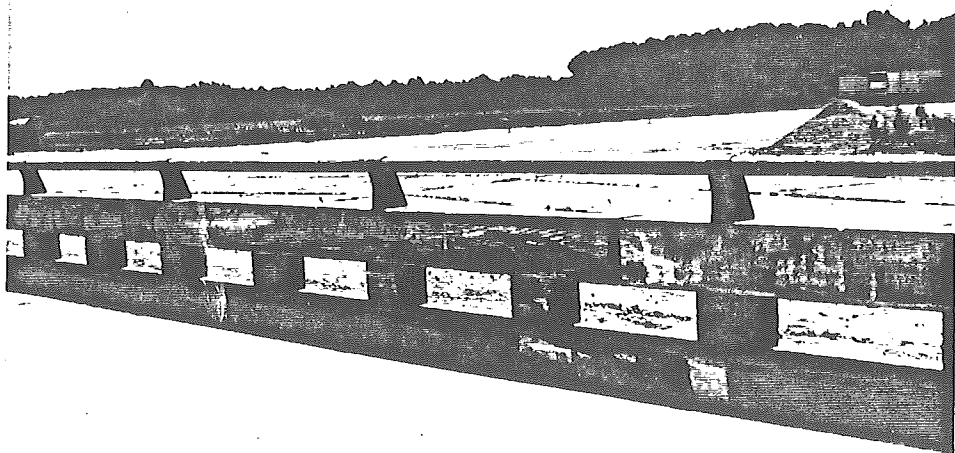
Figure 38. Posttest photographs of bridge rail system, test 1952-5-90.

The bridge rail suffered considerable cosmetic damage but no major structural damage during this impact. There was scrub on the brushblock from 2.5 ft before impact to the end of the system. There was major scrub on the rail for 13 ft beginning 1 ft upstream of impact. Minor scrub on the rail continued for another 47 ft. There was major scrub on posts 6 through 9 and minor scrub on the rest of the downstream posts. Spalling occurred to the brushblock, posts 6 and 7 and the front bottom corner of the rail. Tube railing posts 4 and 5 were impacted by the hood and front fender and the tube railing was scraped for 30 ft beginning at impact. Posttest photographs of the bridge rail are shown in figure 38.

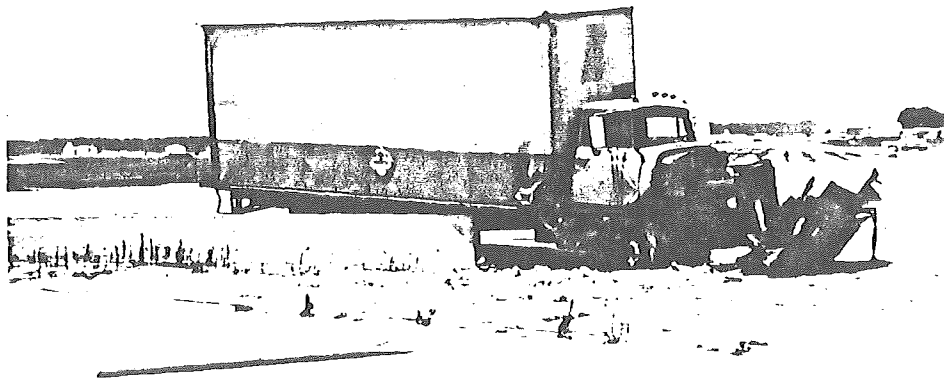
Figure 44. Posttest photographs of test vehicle,
test 1952-6-90.

front corner of the box was damaged due to impacts with the tube railing posts. Posttest photographs of the truck are shown in figure 44.

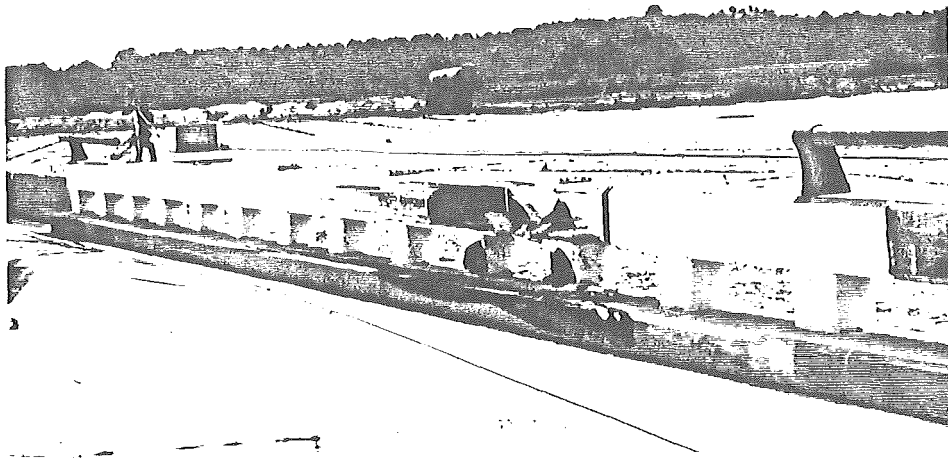
Figure 45. Posttest photographs of bridge rail system, test 1952-6-90.

The bridge rail suffered major spalling for 7 ft beginning at the impact point. One 30-lb chunk was spalled from the bottom of the rail between the impact point and post 7. The aluminum tube railing was mostly destroyed. Tube railing posts 4 through 8 were sheared off above the bolts and tubes 3 through 7 were scattered away from the bridge rail. Other than the major spalling and the destruction of the tube railing, the remaining damage was cosmetic in nature. There was scrub on the brushblock from 2 ft prior to impact to the downstream end. There was scrub on the rail for 17 ft beginning at impact and minor spalling occurred between posts 7 and 8. There was scrub on and spalling occurred to concrete posts 7 and 8. Slight spalling also occurred to the brushblock prior to impact. Posttest photographs of the bridge rail are shown in figure 45.

TEST ARTICLE FAILS DUE TO DETACHED ELEMENTS OF ALUMINUM TUBE RAILING SHOWING POTENTIAL FOR PENETRATION OF THE OCCUPANT COMPARTMENT AND CREATING A HAZARD TO OTHER TRAFFIC.

The reaction of the aluminum tube rail to the impact of the 5400-lb pickup truck and the 18,000-lb straight truck was the main reason for the failure of the MDOT Open Parapet Bridge Rail. For this reason, the test device was modified by the removal of the aluminum tube rail from the top of the bridge railing. Figure 46 shows the test site layout. Figure 47 shows pretest photographs of the bridge rail system.

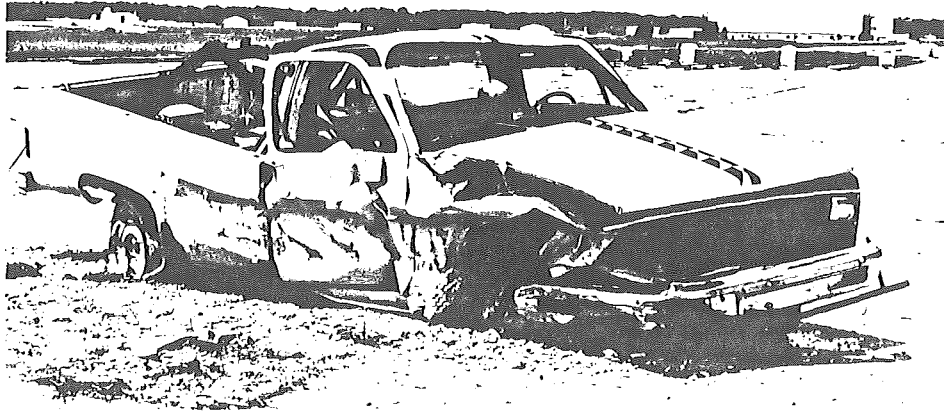
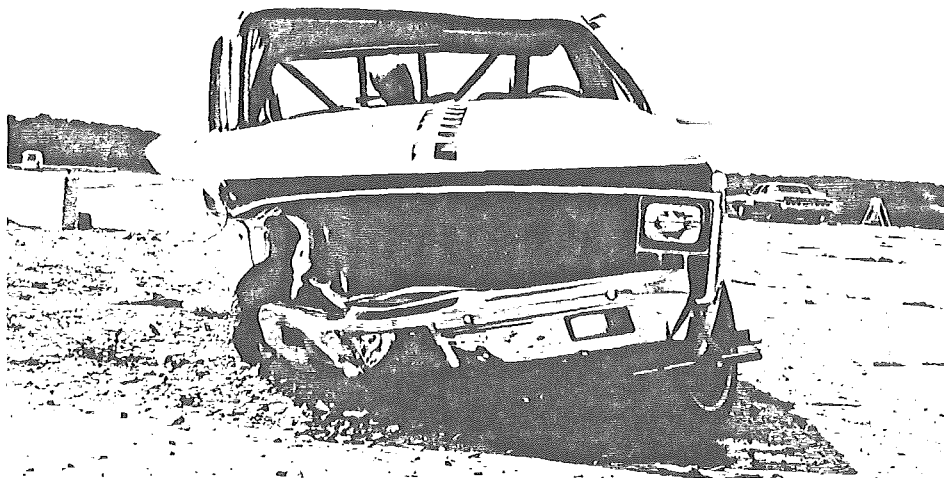
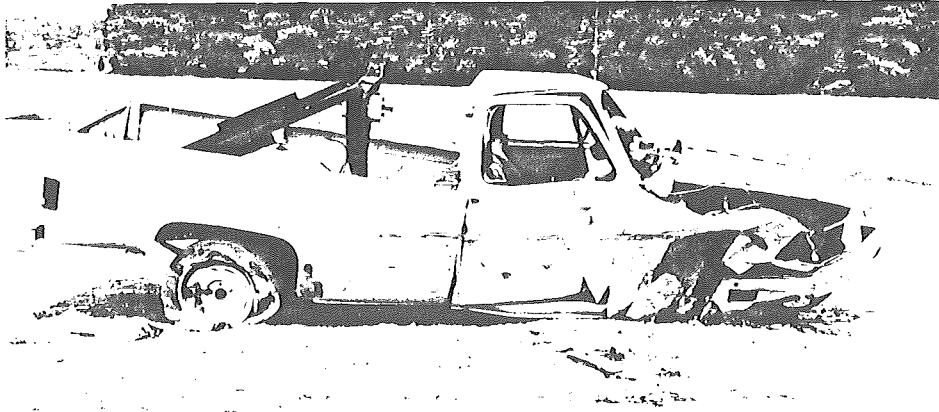
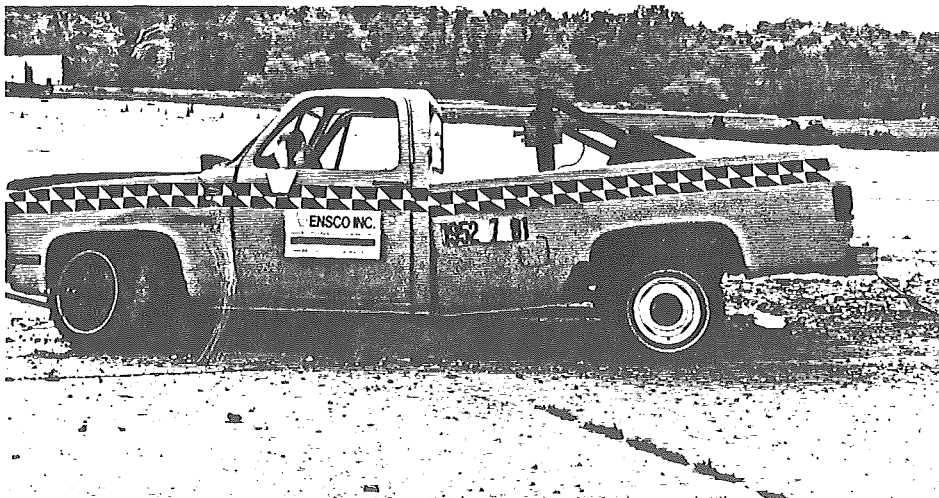
Figure 51. Posttest photographs of test vehicle,
test 1952-7-91.

Damage occurred to the front and entire right side of the vehicle. The bumper and front fender were pushed into the engine compartment. The front suspension and wheel/tire were pushed back and deformed the occupant compartment. The windshield had popped out due to deformation of the cab. The passenger side door was deformed and the passenger side window had been punched out by the impact of the dummy's head. Posttest photographs of the truck are shown in figure 51.

TEST ARTICLE FAILS DUE TO OCCUPANT COMPARTMENT DEFORMATION.

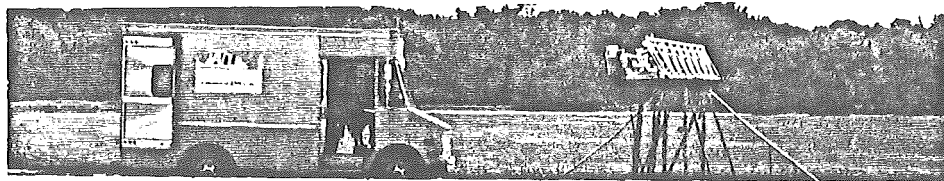
Figure 52. Posttest photographs of bridge rail system, test 1952-7-91.

The bridge rail suffered some cosmetic damage but no structural damage during this impact. There was scrub on the brushblock for 40 ft beginning 2.5 ft before impact. There was major scrub on the rail for 15 ft beginning 1.5 ft upstream of impact. Minor scrub on the rail continued for another 30 ft. There was major scrub on posts 6 through 8. Spalling occurred to the brushblock, rail and posts 6 through 8. The patch on the underside of the midspan posts 7 and 8 rail was spalled off in this impact. Posttest photographs of the bridge rail are shown in figure 52.
