Re-Examination of the 1994 and Subsequent Sewer and Culvert Installations of Various Pipe Types, Sizes and Depths

Final Report RC-1569

February 12, 2014

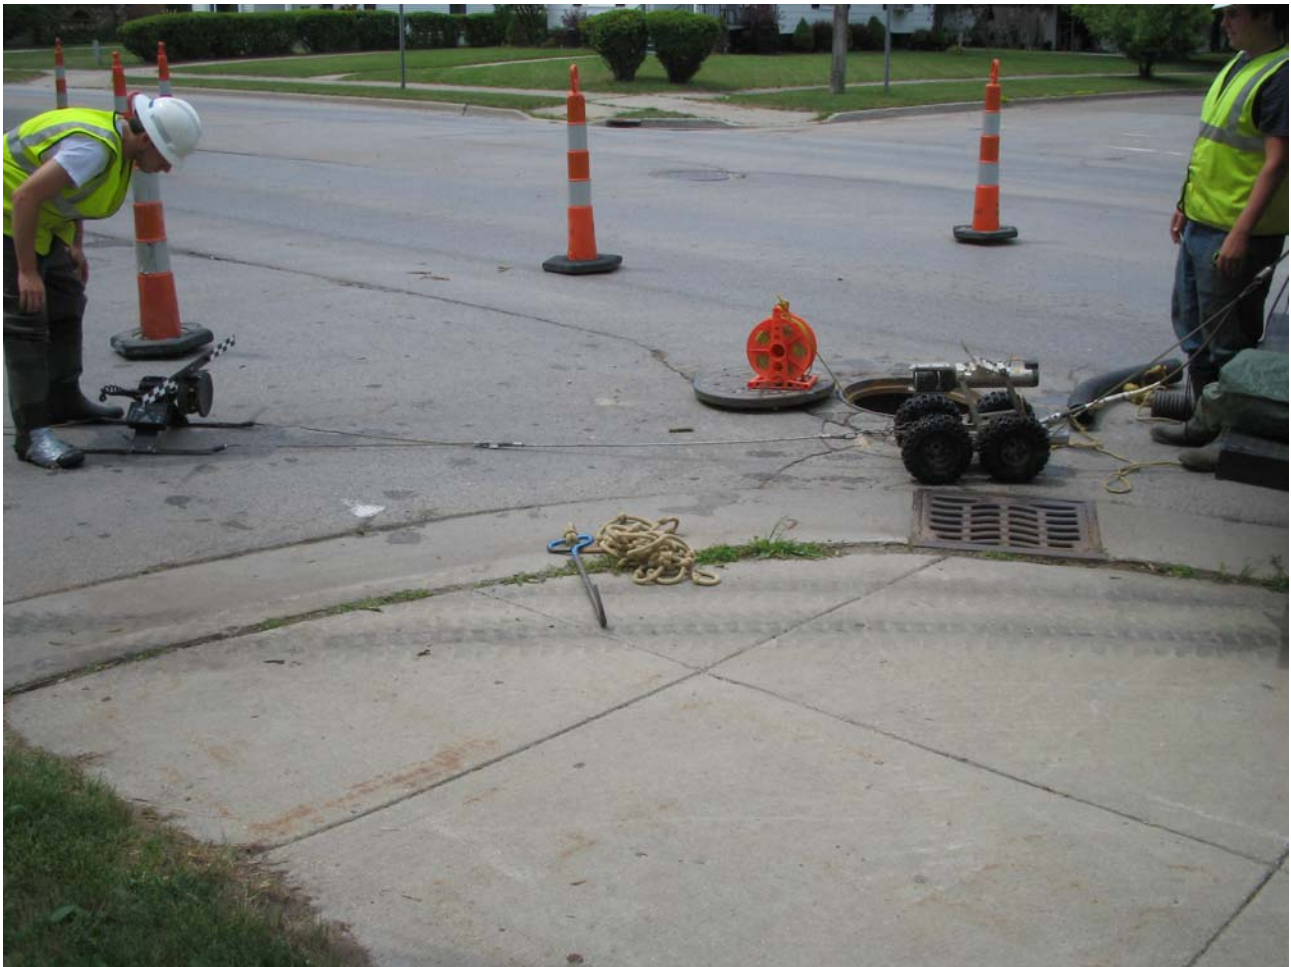
Figure 2 Field Calibrating the Cues/Cleanflow CCTV and Laser System

The laser profiler unit was field calibrated after each pipe run. The micrometer was field calibrated before the beginning of each of the four field work task mobilizations. **Figure 2** shows the Cues/Cleanflow system calibration after inspection of a 36 inch diameter pipe.

The CCTV camera performed purely visual inspection. The micrometer anomaly measuring device utilized visual software assisted distance estimates that were based on comparison to the distance of projections from two laser diodes incorporated in the camera head. The laser profiler utilized the laser light from a laser profiling device projected over the pipe inside walls. The location of the laser profiler light projections was recorded by the CCTV camera and processed by special laser profiling software to determine the shape along the length of the pipe.

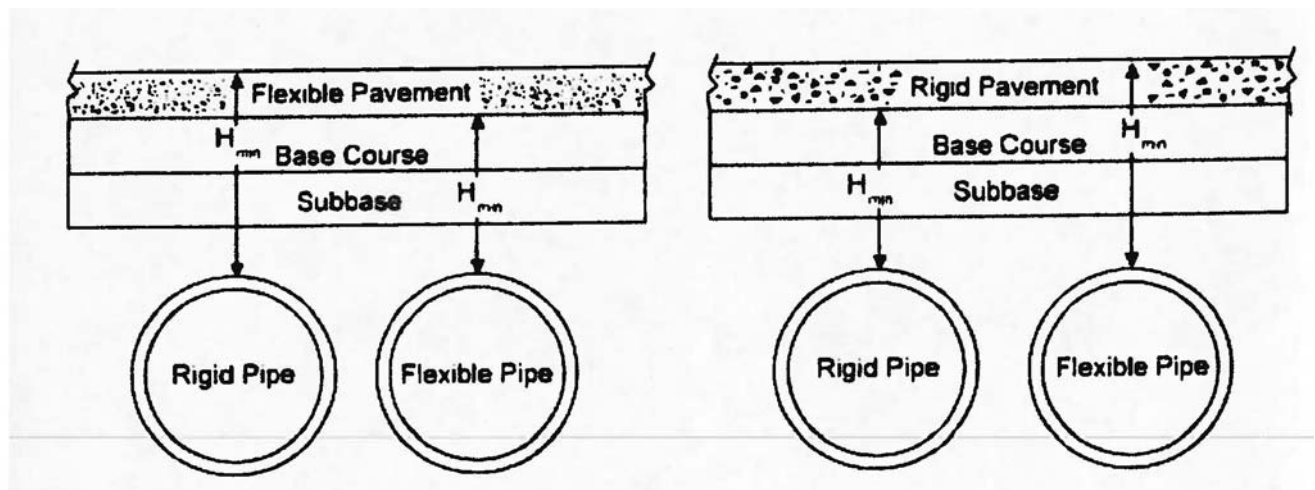
Figure 5 Minimum Cover Orientation

Article 12.6.6.3 of Section 12: Buried Structures and Tunnel Liners of the AASHTO LRFD Bridge Design Specifications (Spring 2012 Edition) specifies minimum cover for pipe of different size and material type. The minimum cover is measured (see **Figure 5.**) from the top of rigid pavement for metal and plastic pipe, from bottom of rigid pavement for concrete pipe, from top of flexible pavement for concrete pipe and from bottom of flexible pavement for plastic and metal pipe. The minimum cover for structural requirements needs to be calculated by following directions of *Section 12 of the AASHTO LRFD Bridge Design Specifications*, and is dependent on the pipe type characteristics, soil material used in the trench, traffic loads and other listed factors.

(from *AASHTO LRFD Bridge Design Specifications, Spring 2012 Edition*)

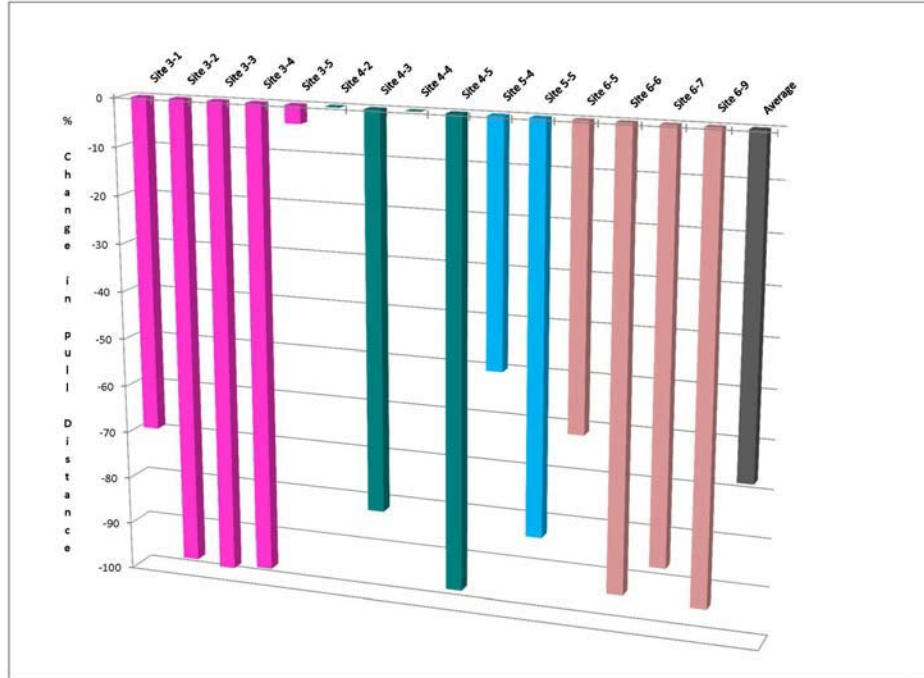
Figure 9 1994 vs 2011 Study Mandrel Pull from MH A Percent Change

The percentage changes between the 1994 and 2011 inspections of the pull distances in the mandrel tests derived from data included in **Figures 7 and 8** are presented on **Figure 9** and **Figure 10**.

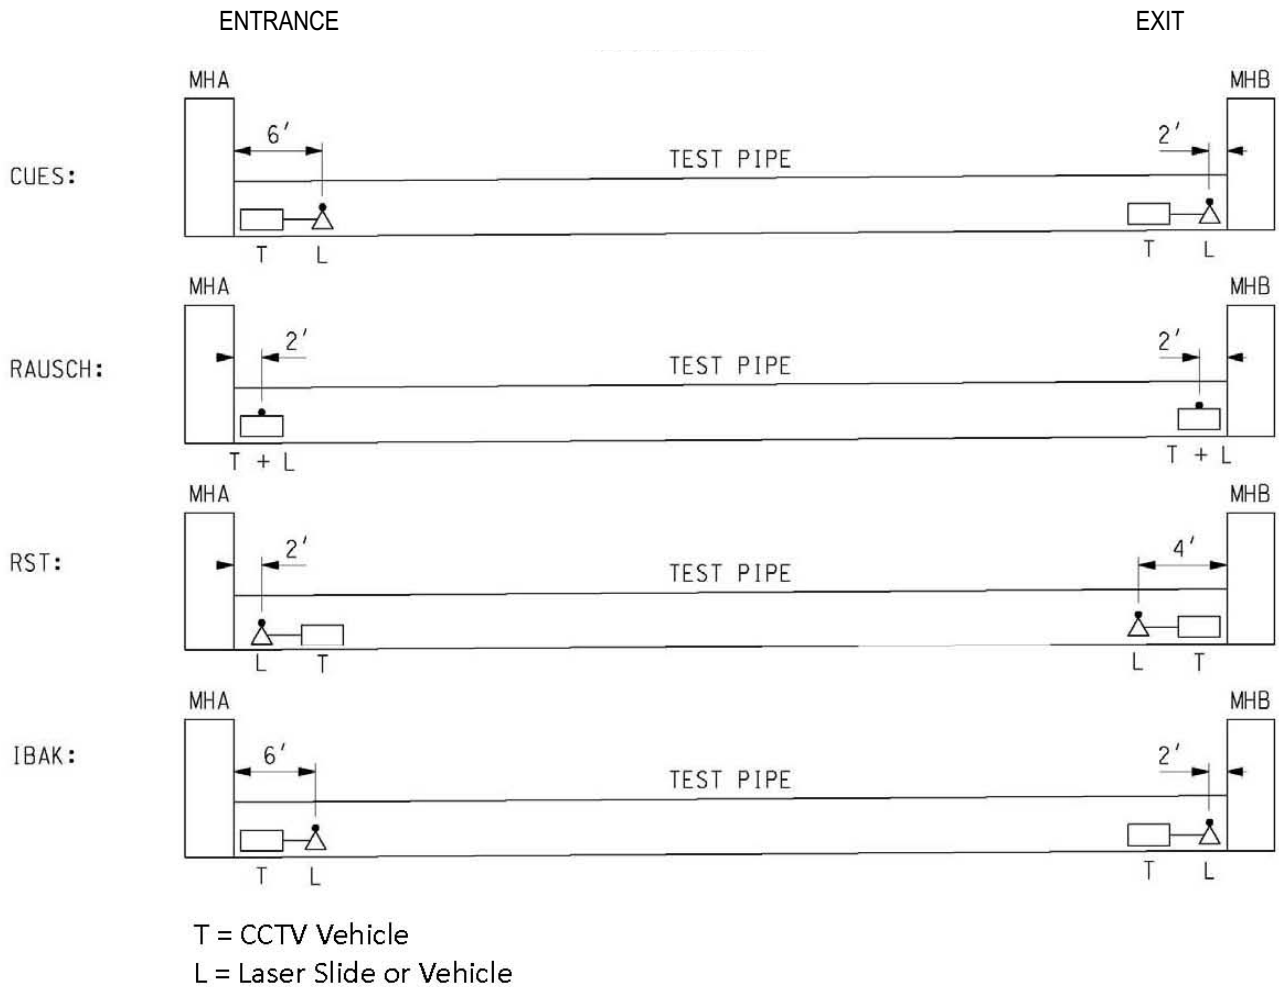
Figure 11 Approximate Zone Lacking Laser Information

The current laser profiler systems cannot gather information at beginning and end of the pipe runs. This is due to need for set up space and offset distance between camera and laser device, because of viewing angle limitations of the continuous ring lasers. **Figure 11** and **Figure 12** present the approximate zone that will lack in information.

- **Cues** – loses 6 feet (+/-) at entrance, 2 feet (+/-) at end of pipe
- **Rausch** – loses 2 feet (+/-) at entrance, 2 feet (+/-) at end of pipe
- **RST** – loses 2 feet (+/-) at entrance, 4 feet (+/-) at end of pipe
- **IBAK** – loses 6 feet (+/-) at entrance, 2 feet (+/-) at end of pipe

The comparison details are as follows (“**match**” indicates that both sets of data show pipe shape deformation greater than 5 percent, “**no match**” indicates that the two sets of deflection data differ and do not both show pipe shape deformation greater than 5 percent, A and B designate the points at each end of the pipe, “no laser data” refers to the no laser zones at end of pipes, as presented on **Figure 11** and **Figure 12**):

* laser profiling was not possible adjacent to the access manholes due to technology limitations as presented on **Figure 11** and **Figure 12**, see paragraph below:
