NURail Research Project: *Highway-Rail Grade Crossing Surface Material Performance*

Final Report

Project Number: 2010-0295

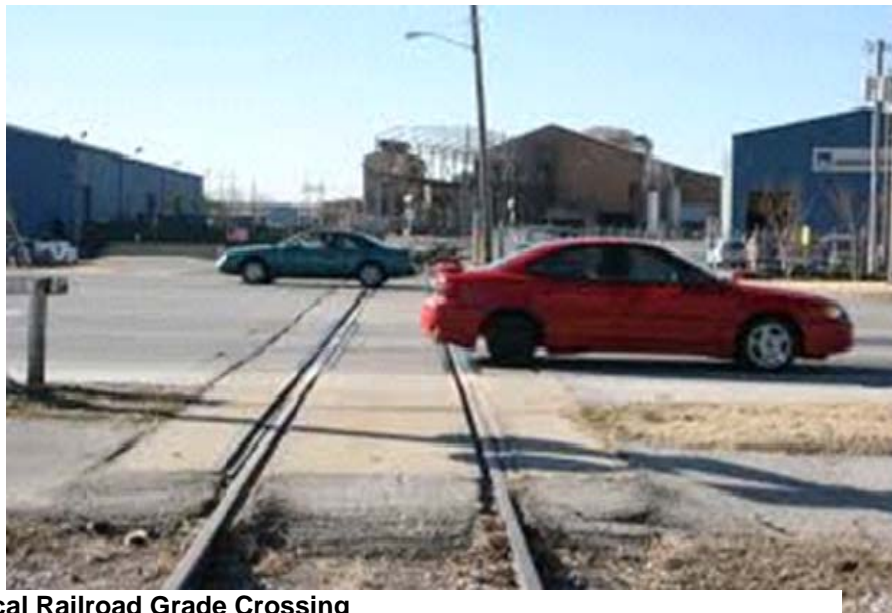
Figure 1 - Typical Railroad Grade Crossing

A typical railroad crossing is made up of several components. Starting from the bottom:

- Ballast, this is composed of rougher and larger size particles, typically 1-2 inches in diameter, and is intended to support and surround ties. This layer also provides voids for proper drainage.

- The rail ties or sleepers, the rail, and connecting hardware. The top layer includes the crossing surface material. The crossing surface can be made of different materials, but this project focusses on four: asphalt, concrete, rubber, and timber. It often sits directly atop the crossties and ballast but may include spacers. Examples of the various materials can be seen in Figure 2 through Figure 5. A flange way clearance is maintained on the inside of each rail through the crossing. Other composite materials have been developed but were not considered in this project.

Highway-Rail Grade Crossings (Figure 1) are a vital part of the transportation network, allowing train traffic to cross highways. Without these crossings trains would have no cost effective routes to deliver the massive tonnage of freight they carry. Another alternative to a Highway-Rail grade crossing is a grade separation, with either the highway going over or under a railroad. However, grade separations are expensive, and often exceed DOT budget limitations.

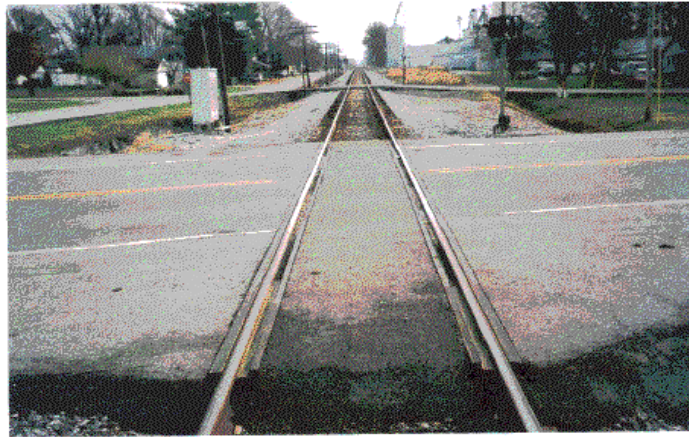
The report did state that there was no observed correlation between crossing surface material type and the performance of the crossing structure; all materials performed well using the asphalt underlayment method. Figure 8 shows a table of asphalt underlayment vs. no underlayment and the settlement measured from the report.

Figure 2.1f US 60 (Stanley) crossing with underlayment.

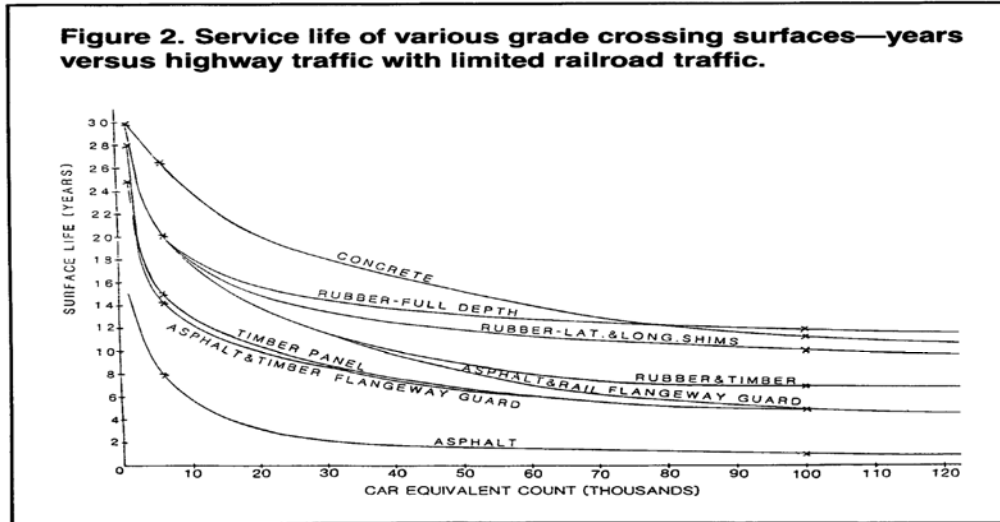
Figure 11 – Service life of crossing surface materials, Burns[7].

The section on determining surface life was the main interest of this article. Using data points from the Highway-Railroad Grade Crossing Material Selection Handbook the author was able to develop a graph showing service life compared to something he calls car equivalency count (CEC). The CEC is determined by multiplying the number of trucks by 100 and then adding that to the number of cars. This is done because trucks wear road components significantly more than cars. Figure 11 shows the average service life of crossing materials, according to Burns. It should be noted that this graph is based on limited rail traffic.

Based on the service life graph, Burns developed a service life table, shown in Figure 12.

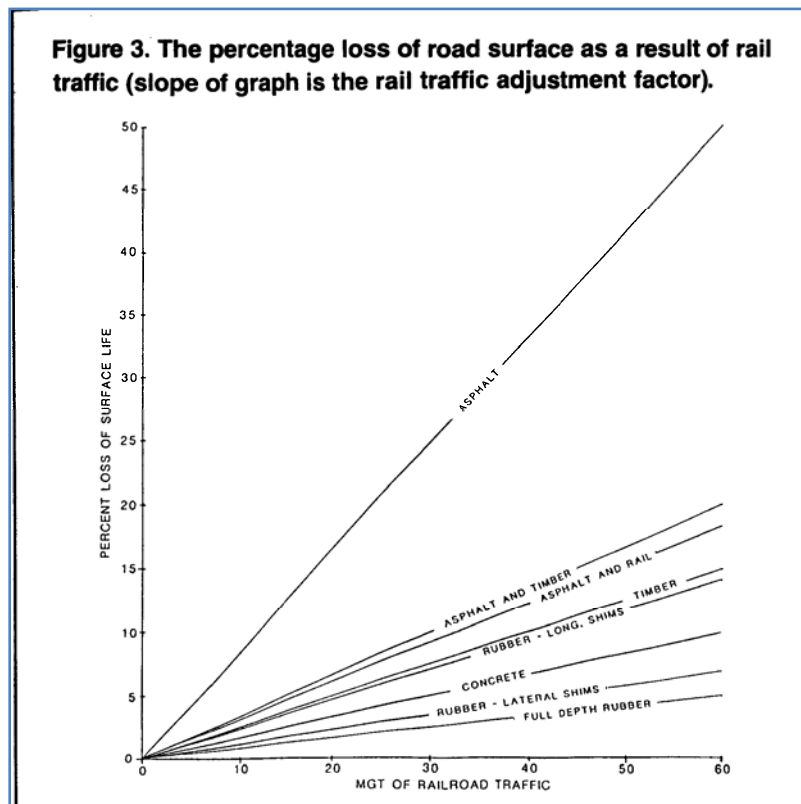
Figure 13 – Crossing Surface Life Expectancy Correlated to Rail Traffic Volume

Finally, the author created a graph (Figure 13) that shows the effect of rail traffic on surface life. He determined this by looking at the dominant failure mechanisms inherent in each type of surface and correlating it to information in the same Material Selection Handbook.

All the above information was put together based on information on the “typical” crossing in the United States and therefore may not account for various local factors such as the freeze thaw cycle. Despite the limitations this information seems to answer some of the biggest problems presented. A simple look at the table can show which type of crossing should last the longest for any given traffic levels. Then percent loss due to rail traffic can also be determined.

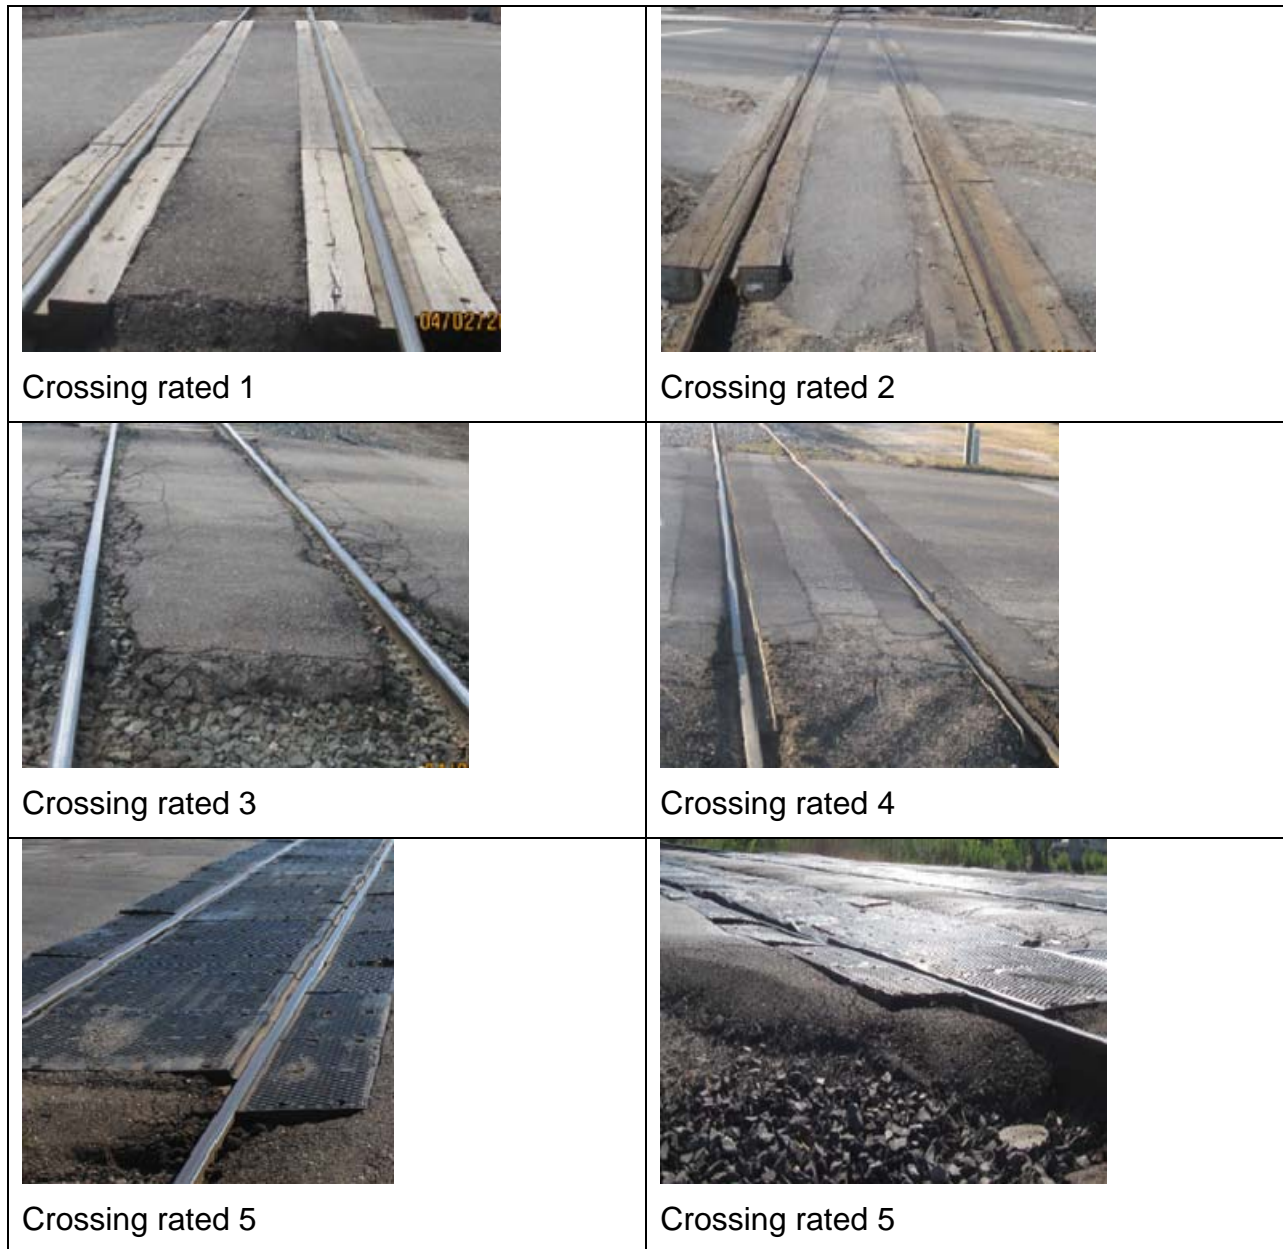
Figure 21 - Examples of Crossing Condition Rating

for documentation as seen in figure 20. These photos document the conditions of the crossings, highlighting what needs to be corrected or what can stay the same. Among this information is a grade for the overall performance of the crossing. The grading scale is 1-5 with 1 being the best and 5 being the worst and in need of immediate repair. According to the inspectors, crossings do not stay at a classification of 1 for long. Shortly after the track is opened to traffic wear and tear begin to take effect thus lowering the grade of the crossing. A crossing with a grade of two or three is acceptable and is safe for public use. When a grade of 4 is given to a crossing, recommendations are made to the owner of the track for improvements. A grade of 5 requires immediate action to return the rating to an acceptable grade of 1, 2 or 3. In these cases MDOT will issue a repair order to the railroad responsible for the crossing.

Figure 21 shows different grade crossings that each are rated 1 - 5. The explanation of how each figure received their rating from a MDOT inspector is as followed:

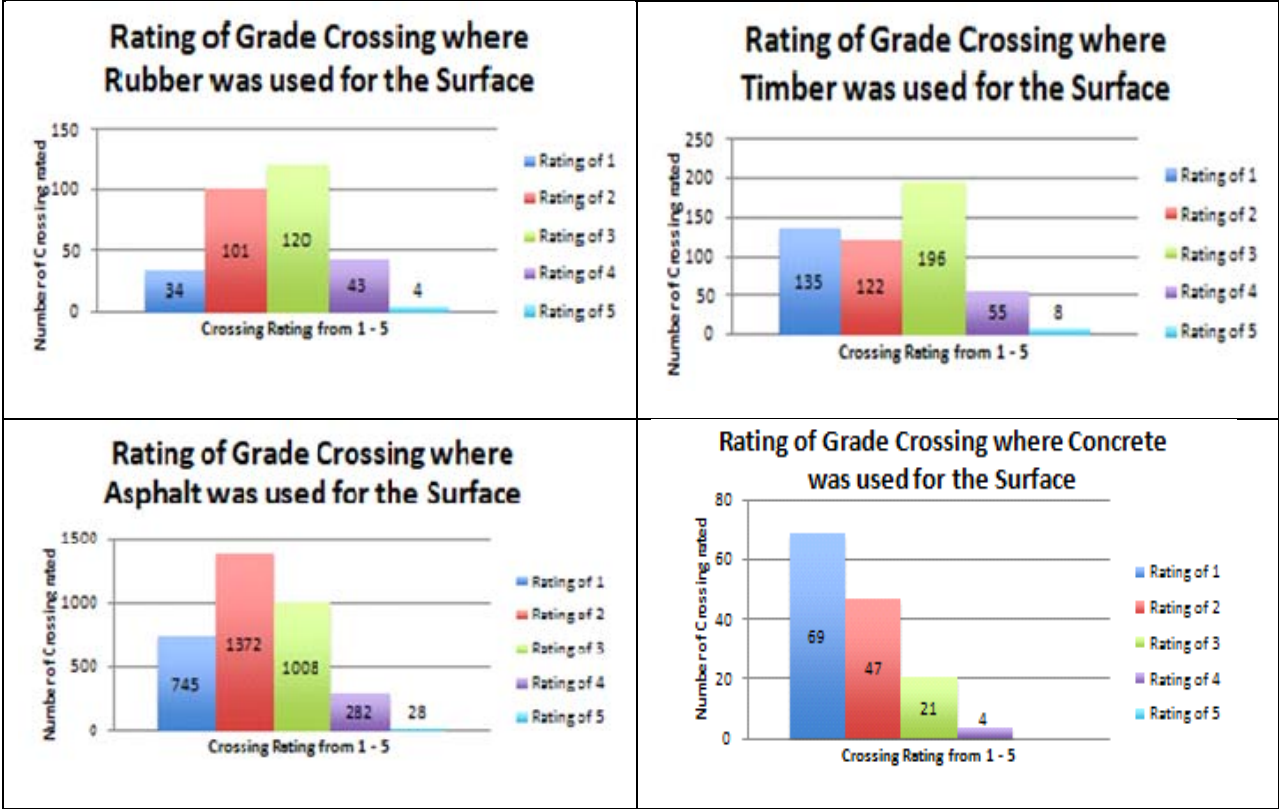
Figure 22 - Snapshot of crossing condition during study period

Once the combined spreadsheet was created and the problems addressed, it made it possible to develop graphs of the crossing data showing a relationship between the surface material and the crossing surface rating. Figure 22 shows a set of graphs that were created from the current data correlating the surface material type against the grade it received along with how many crossings of the type received the grade. This gives a snapshot of crossing conditions in Michigan during the study. The average condition rating for rubber crossings was 2.6, for timber it was 2.4, for asphalt it was 2.3, and for concrete the average rating was 1.7.

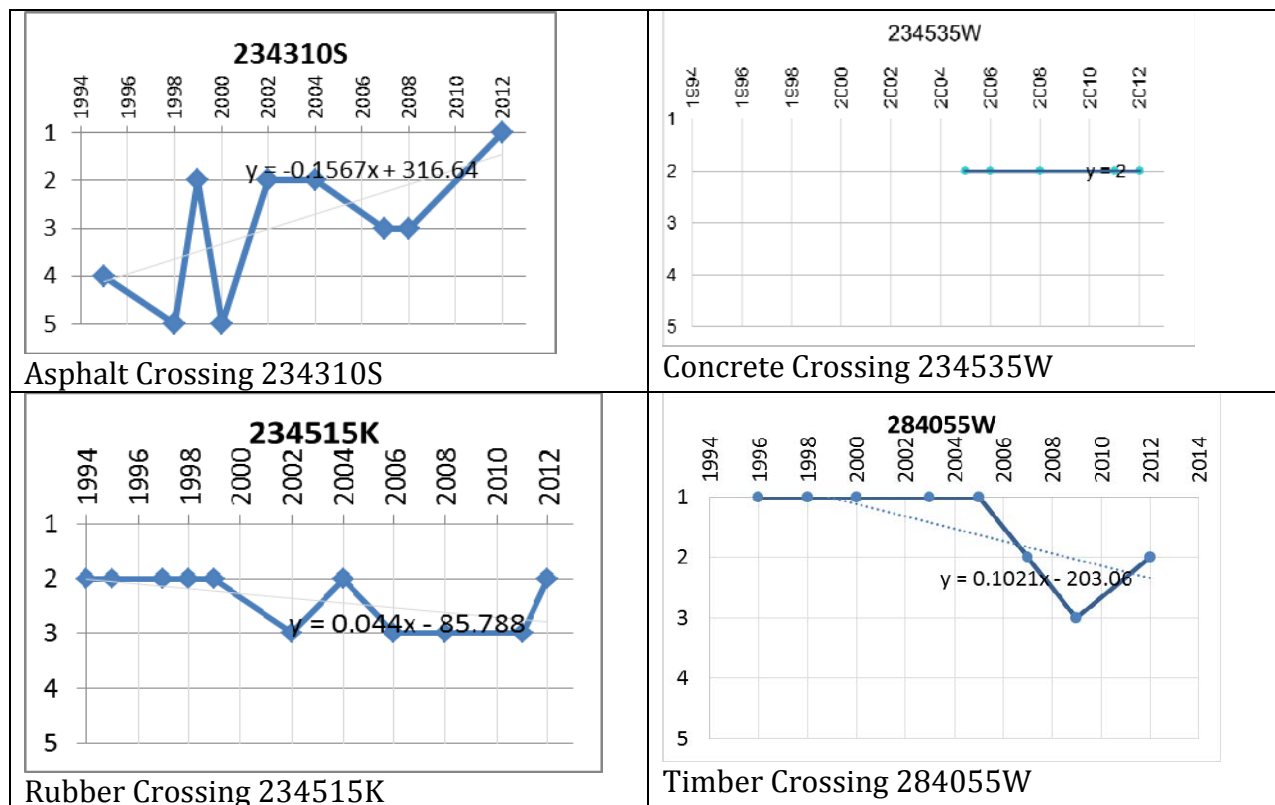
Figure 23 - Examples of Crossing Rating Graphs

An example of the data and graph for Asphalt Crossing 234310S is shown in Table 2 and Figure 22 shows examples of the four different crossing materials included in the study. The complete data set and graphs are in Appendix D rating spreadsheets

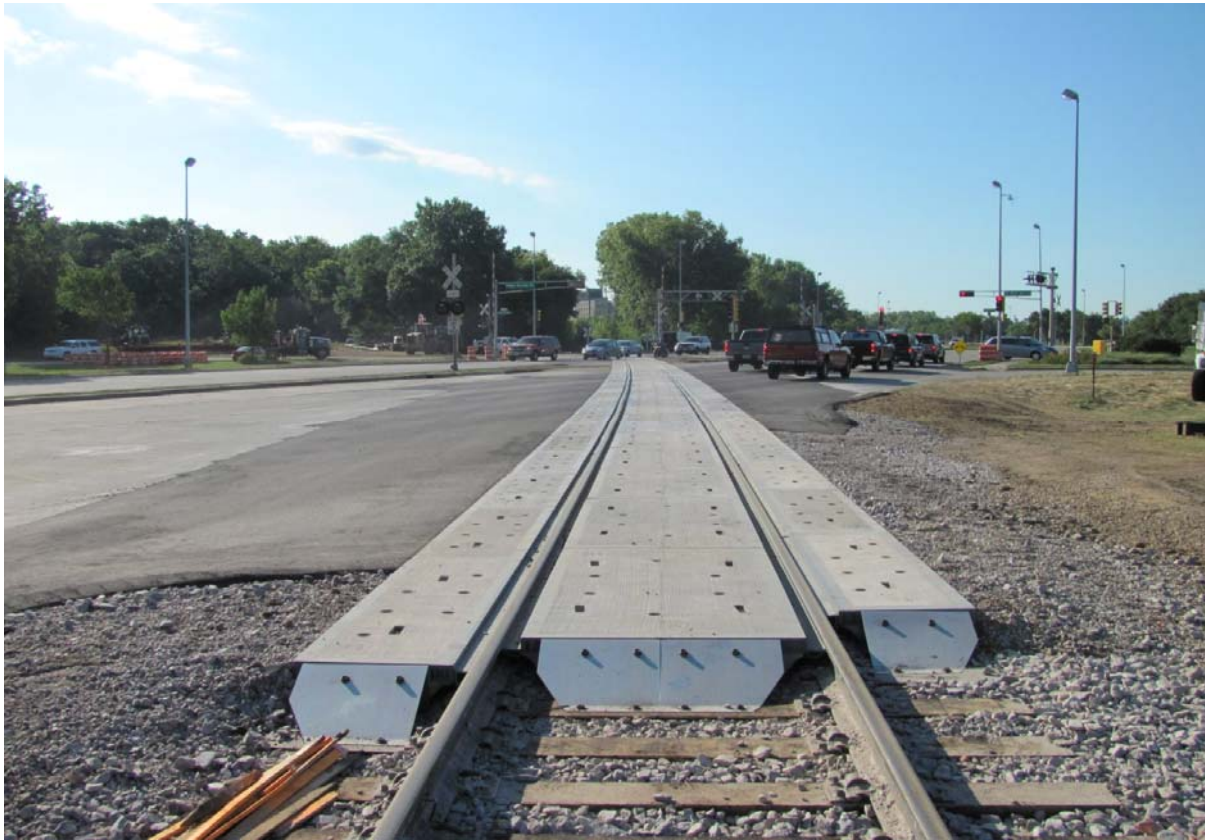
- Concrete Panel – Depends on the year the panels were made and the manufacturer. Early installations of these had issues with quality control and they were not well engineered. Currently, the spec for the concrete has improved and the panels have steel angle channel at the edges to eliminate the breakage of the concrete at the panel edge. Current panels also have been properly reinforced, prior panels just had any old amount of steel put in them, if at any all... They get taken out and can be broken up at a quarry for the concrete and separate out the steel for recycling. Other uses are to put them in parking lots to park on or to use as fill in embankments.

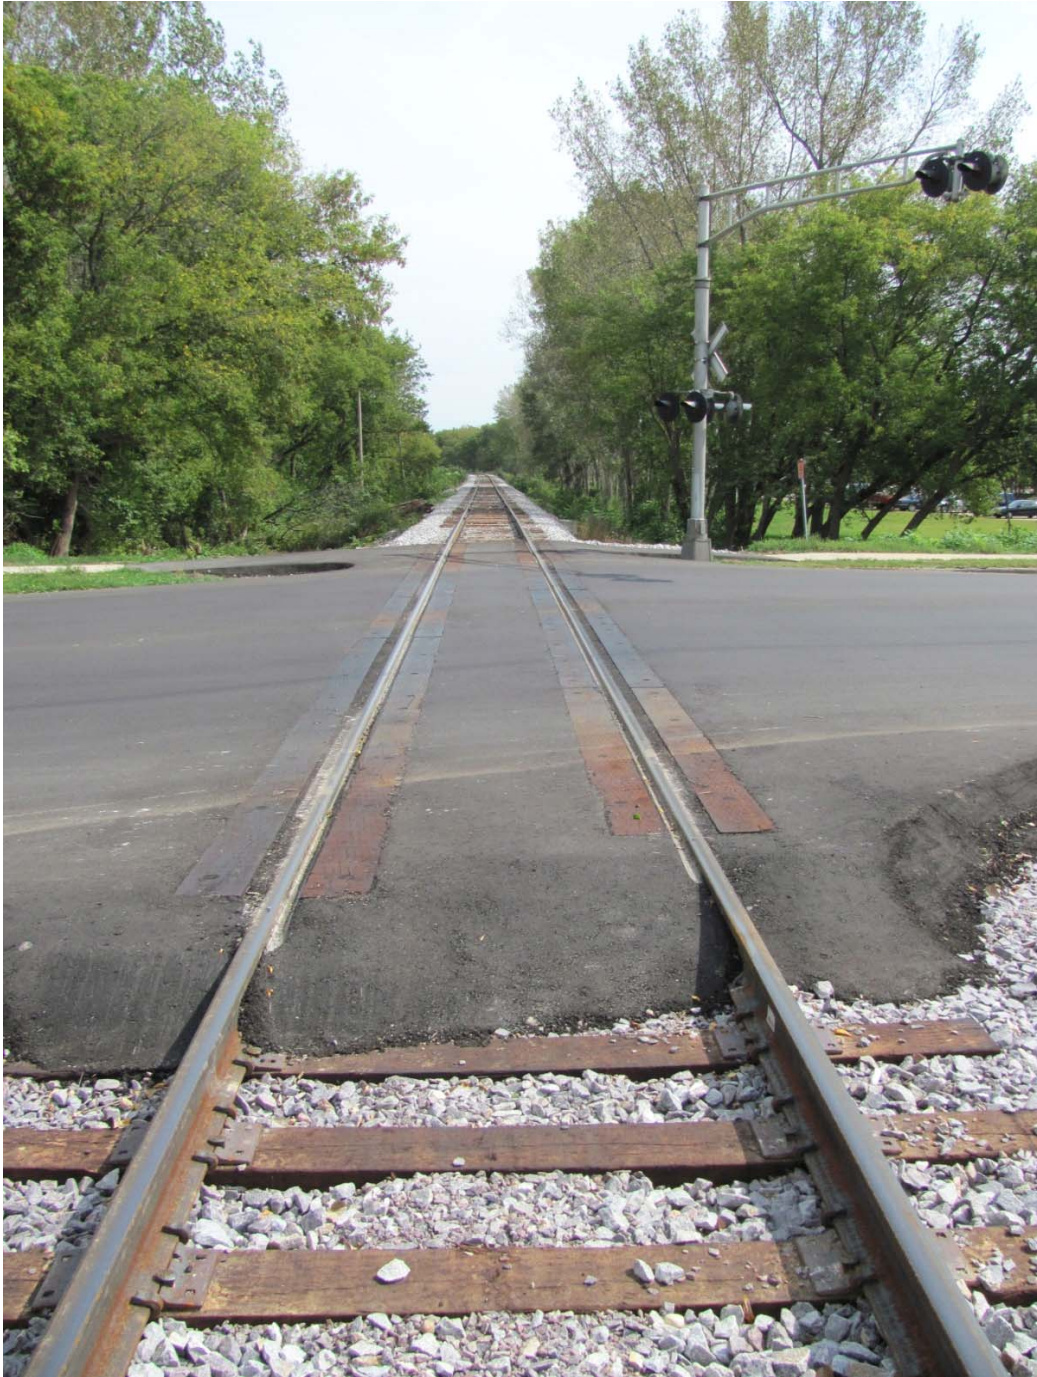
- Timber/Asphalt – This one is hard to say it's a manufacturer's defect because it's pretty tough to screw up a timber, when they show up and are out of spec they get sent back. Asphalt is usually whatever is left in the plant when the contractor makes the call, unless it is a state job and has a spec for it. These crossings wear out when the timber wears off from the vehicles going over it and plows shaving it off, the asphalt eventually cracks if it is thin enough and then plows start to catch it. Asphalt is easy to recycle and the timbers are disposed of with old ties.

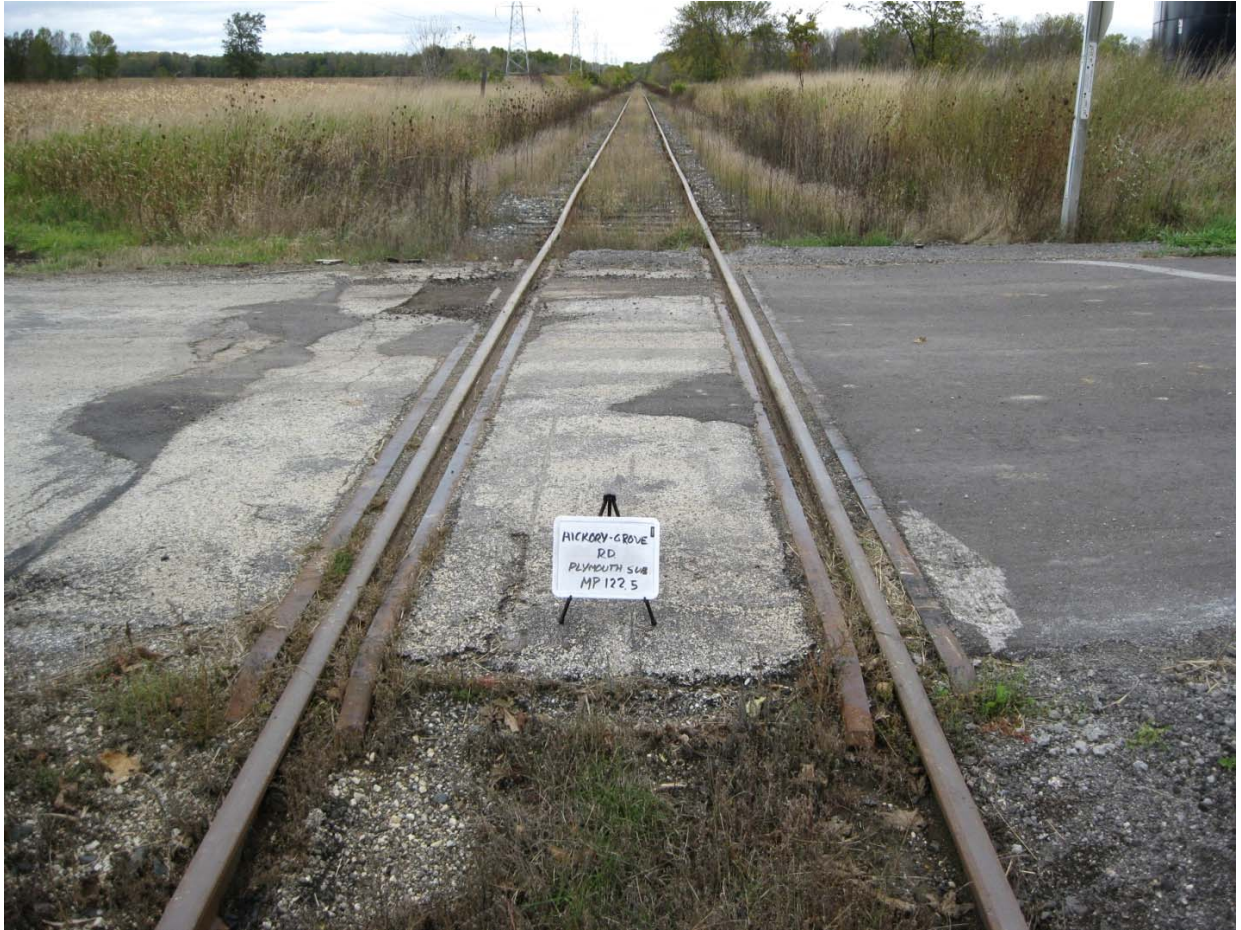
- 3 Rail (Mud Rail) – This one is an inherited crossing type that we no longer install. There is a rail on the field and gage side to keep the asphalt back and also create a flangeway. The rails will cause damage to plows and they are very hard to repair when something goes wrong with them. Scrap rail is also much more valuable than it had been, so we sell it for scrap rather than stick it in 3 rail crossings anymore...

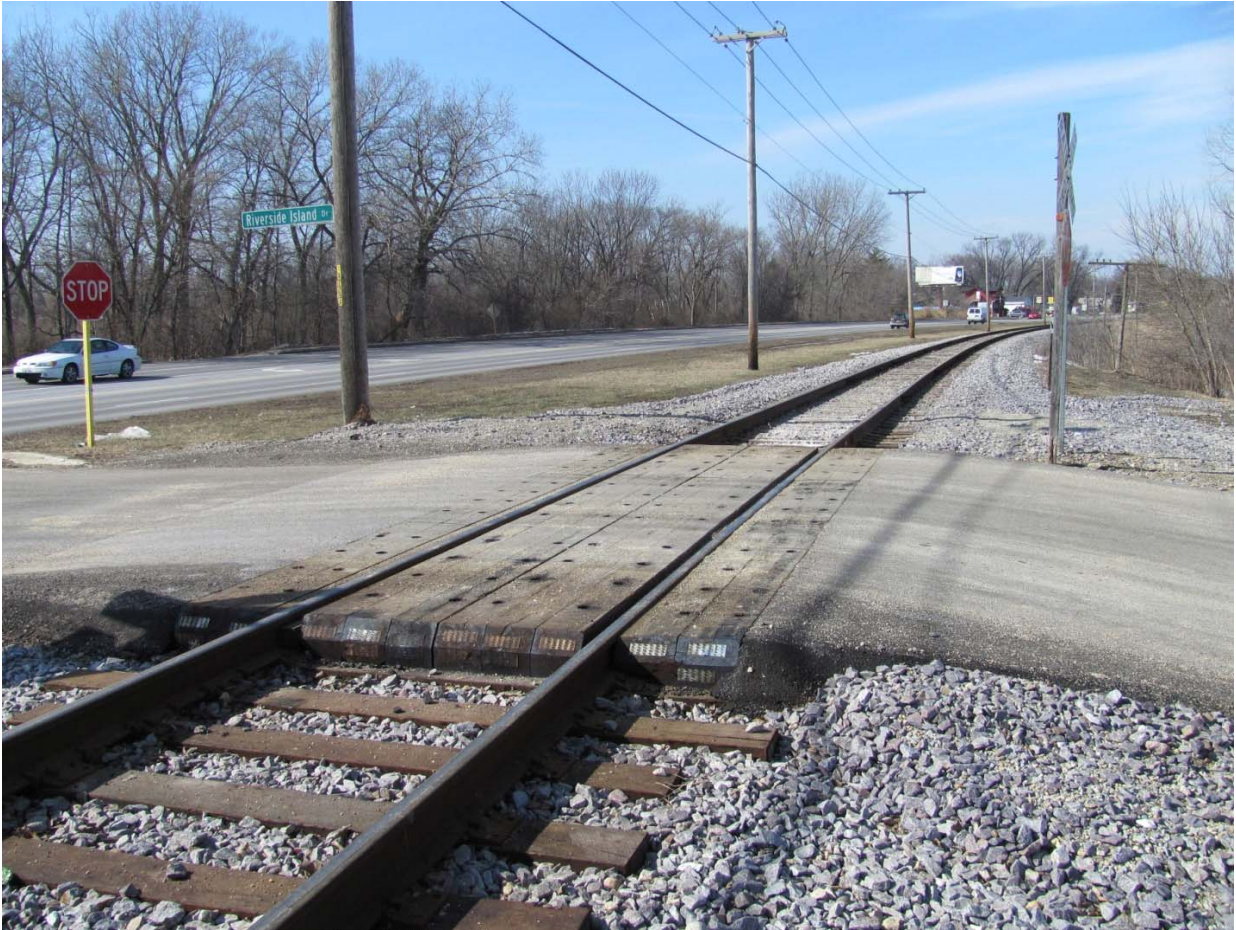
- Full Timber – Timber panels that install like a concrete panel crossing. These had been installed in years past and we have begun to install them again where they are specified. The state of Illinois has this as their standard crossing, so we install them down there rather than the timber/asphalt crossings we usually install. Disposal of the timber panels can be done with ties as well.

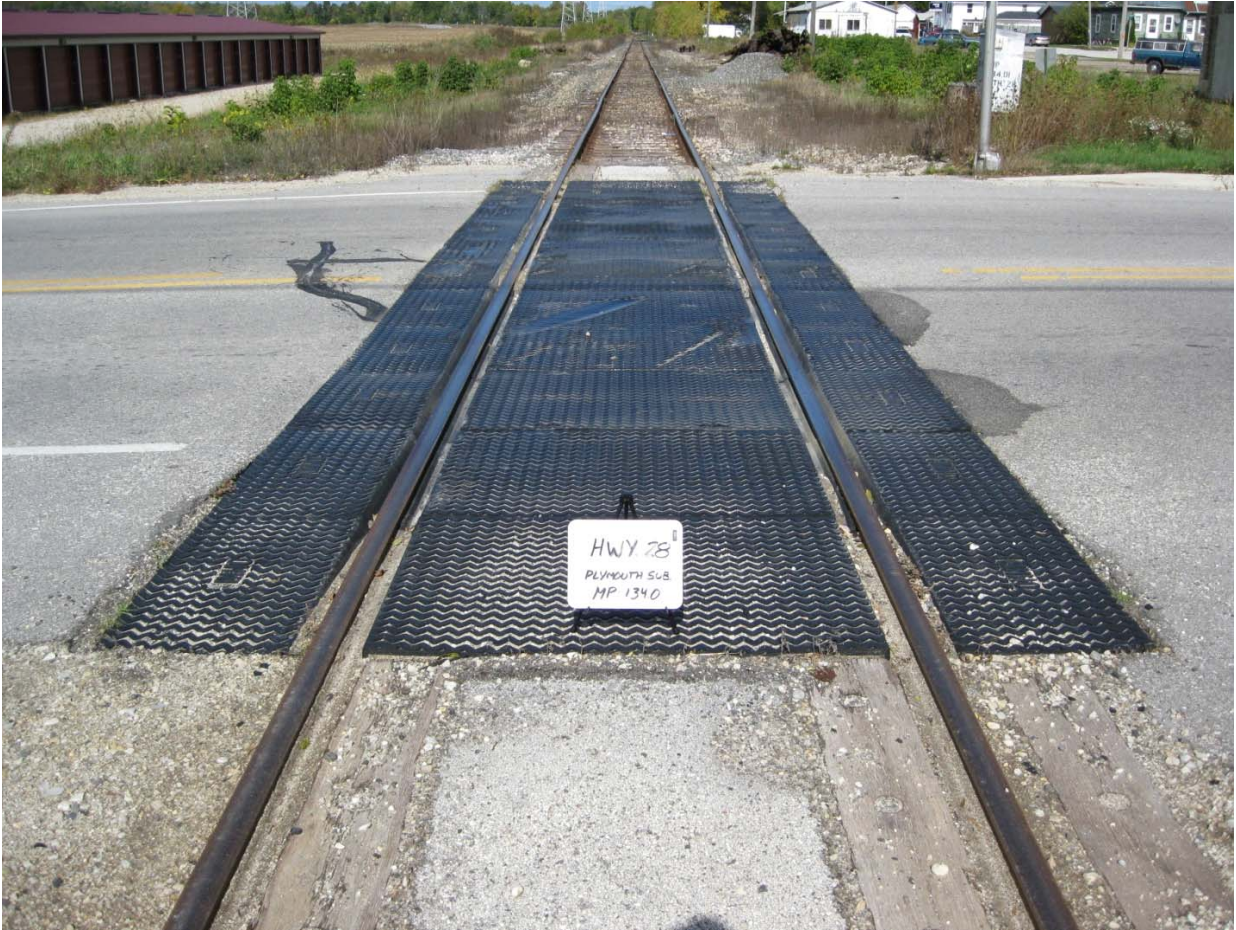
- Rubber Panel – In the past these were made out of recycled rubber. Now some are made of virgin rubber. We had bad experiences with them in years past and have not installed them since. They eventually would let loose and start to move around under traffic. Section crews had a very hard time keeping them secured. Also, they are quite costly to dispose of, they are worth nothing once they are used up and have to be disposed in the landfill.
