**EFFECTS OF MULTIPLE DAMAGE-HEAT
STRAIGHTENING REPAIRS ON THE STRUCTURAL
PROPERTIES OF BRIDGE STEELS**

FINAL REPORT

**Report No. RC-1456
Sponsored by Michigan Department of Transportation**

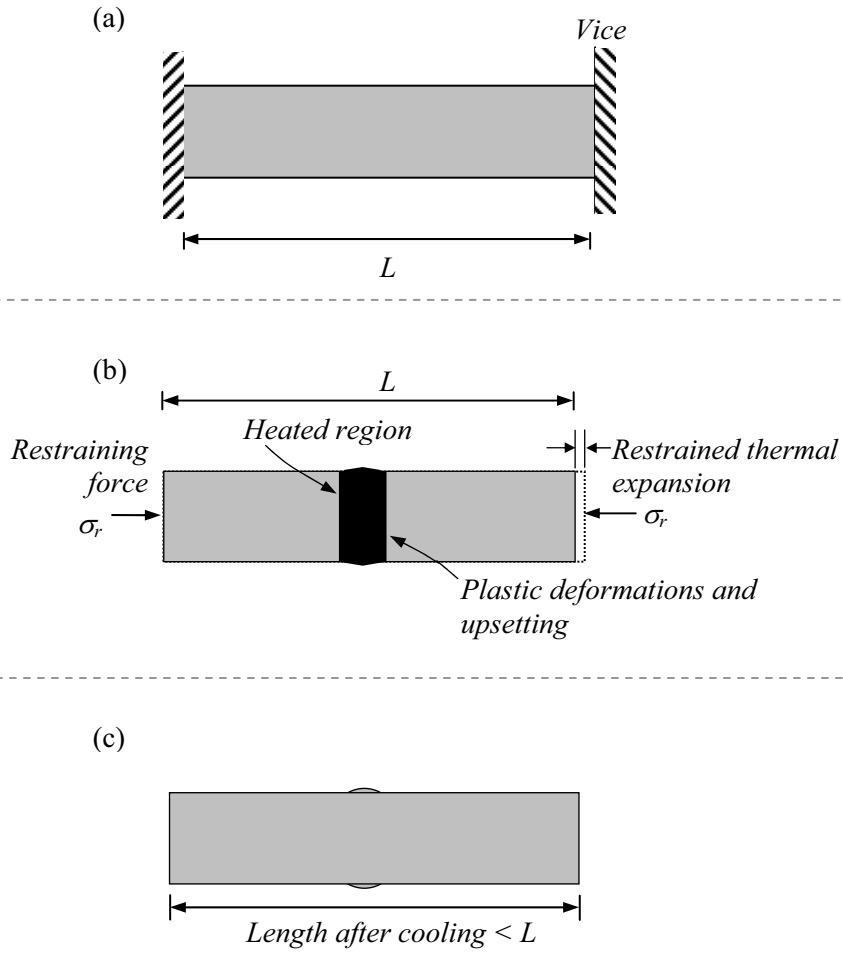
Figure 1.3
Conceptual example of heat straightening: (a) Initial specimen; (b) Heated specimen; (c) Specimen after cooling

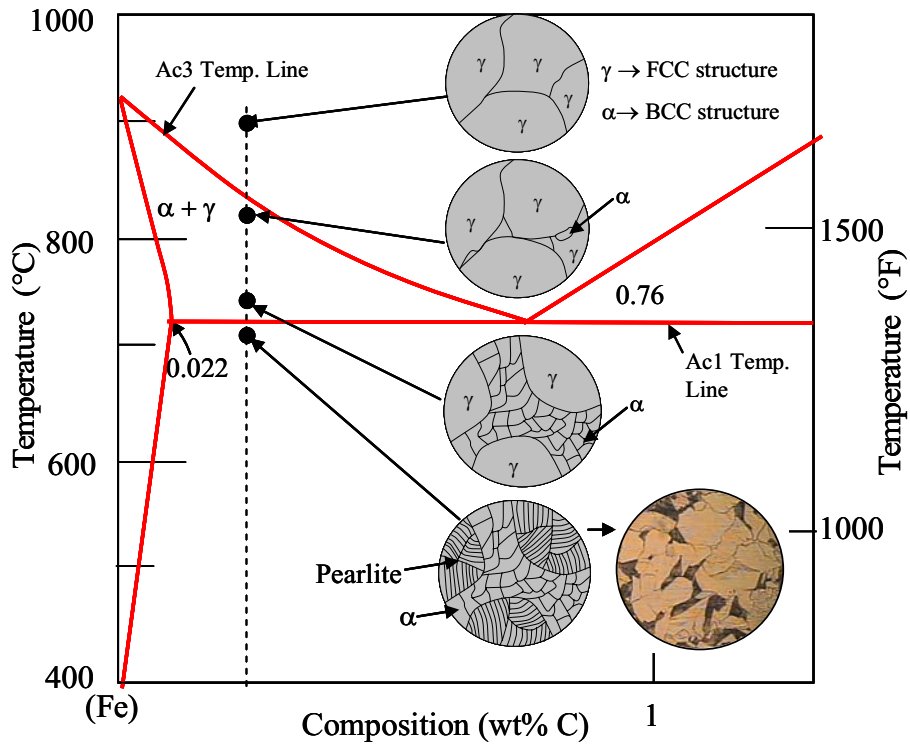
Figure 2.8
Transformation of hypo-eutectoid plain-carbon steel with slow cooling [51]

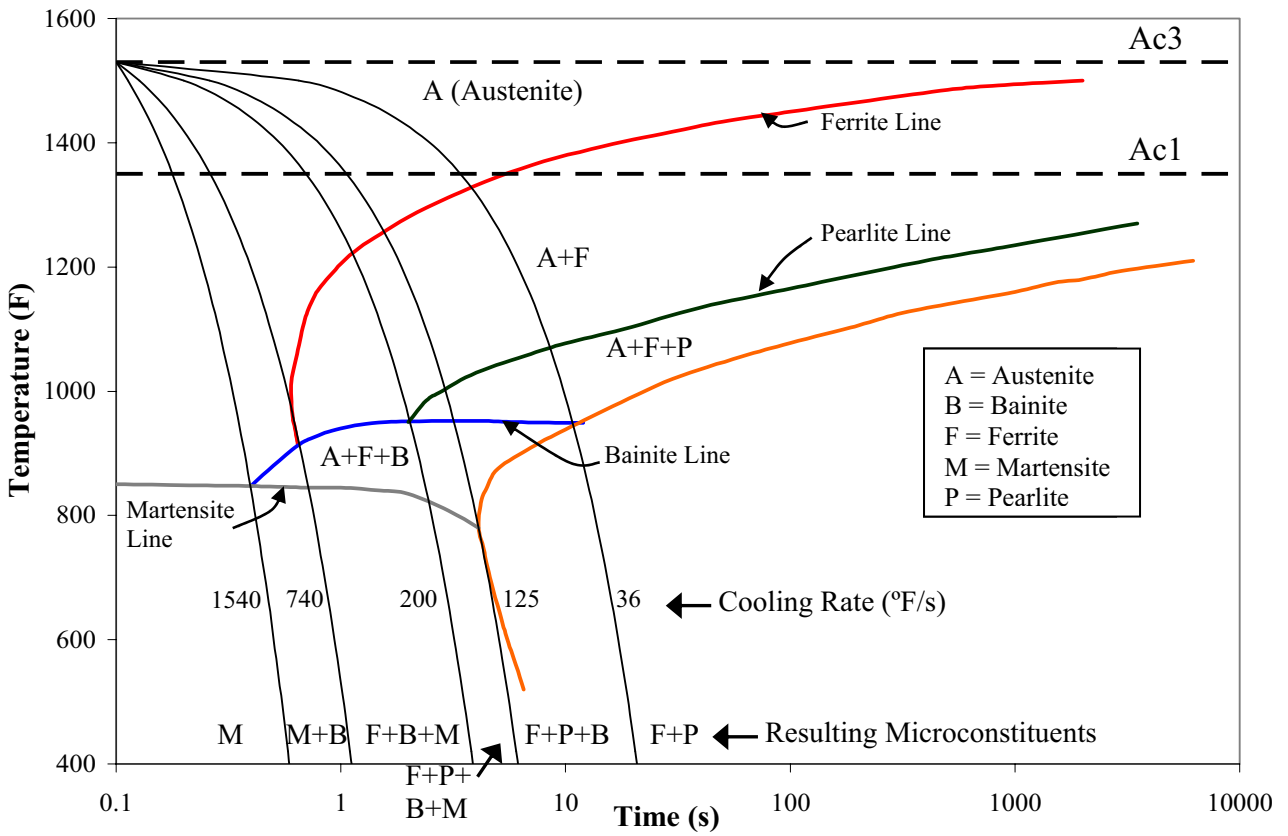
Figure 2.10
Superimposed continuous cooling diagram of a AISI (0.12%C) steel

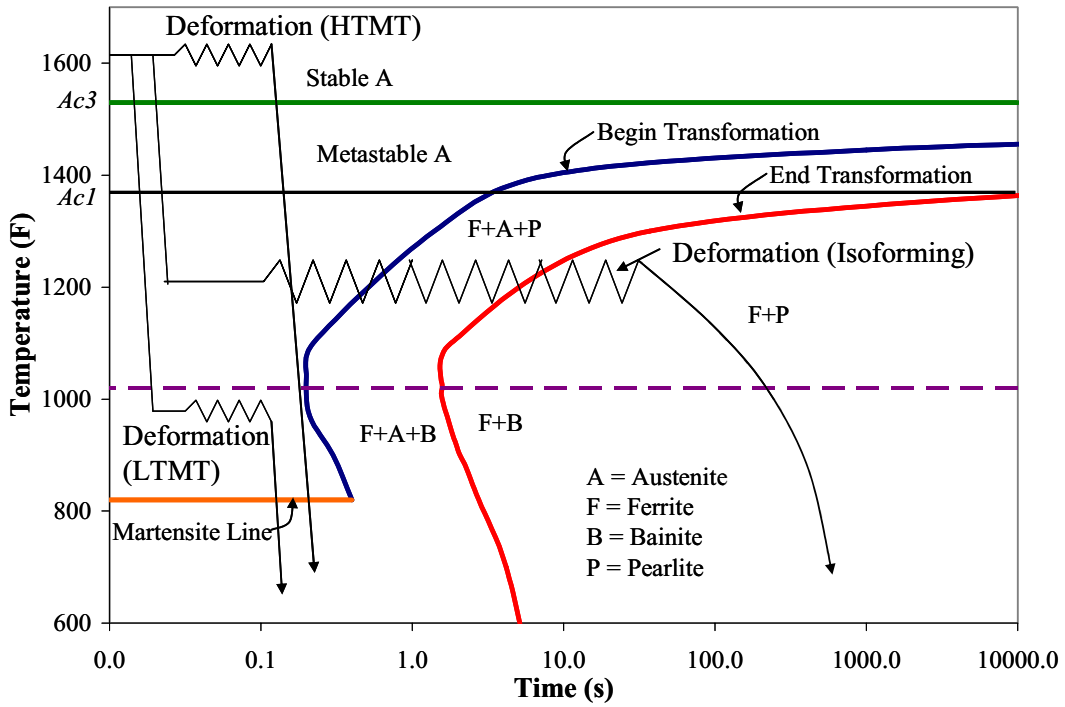
Figure 2.12
Thermomechanical treatments on an isothermal transformation diagram [56]

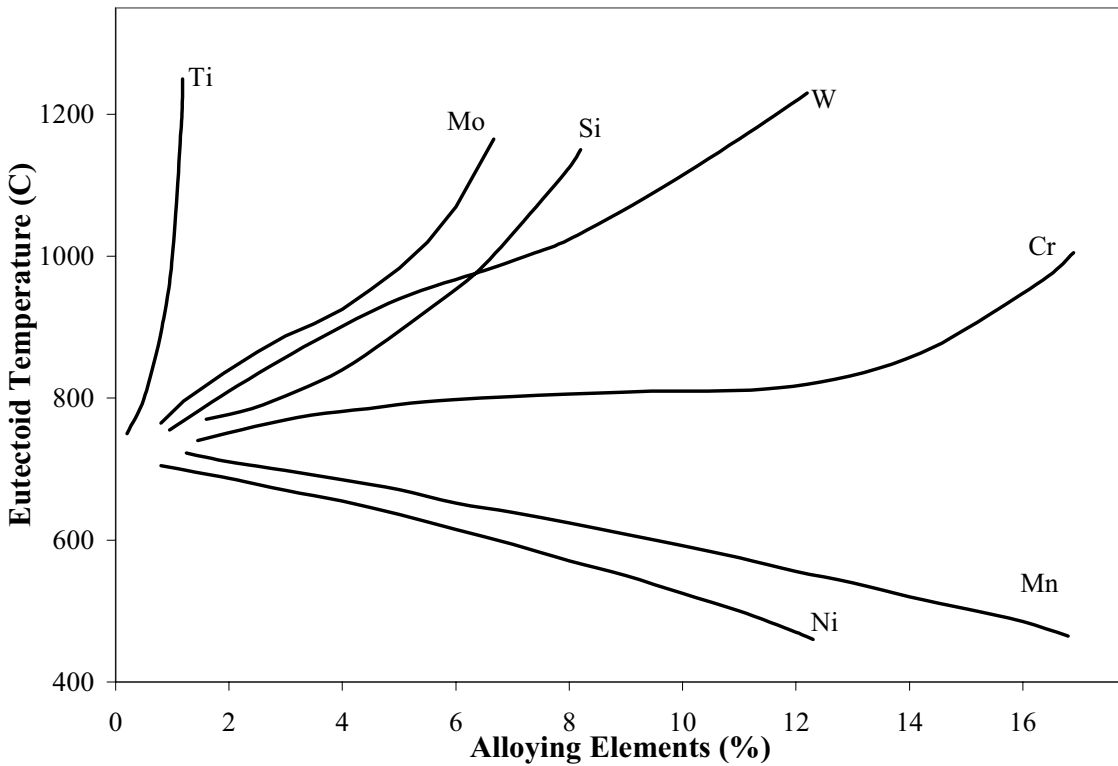
Figure 2.13
Effect of alloying elements on the eutectoid transformation temperature A_{c1} [49]

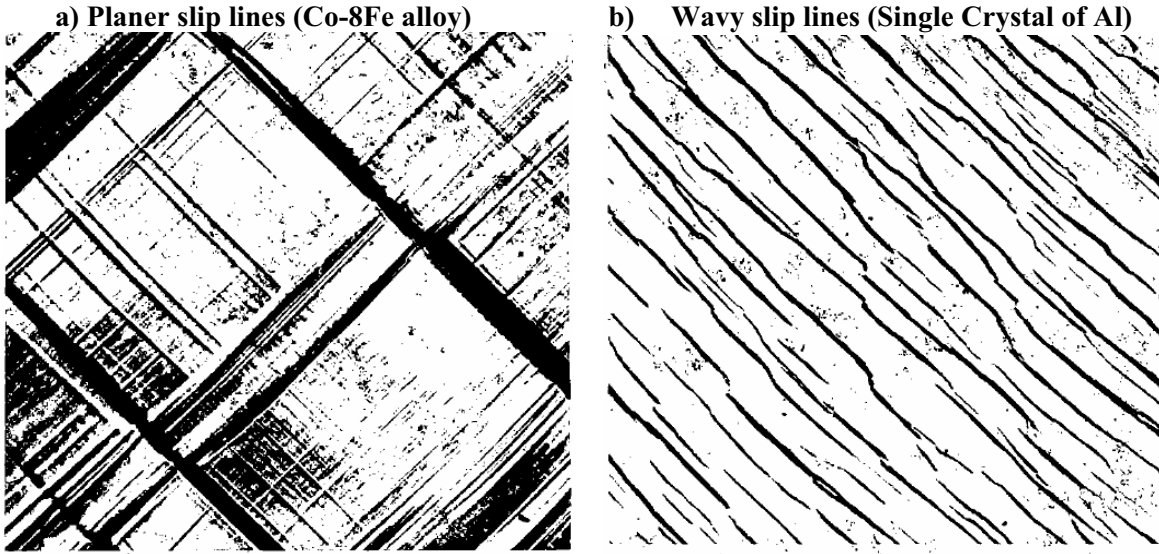
Figure 2.14
Comparison of (a) planer slip lines and (b) wavy slip lines at 250X [57]

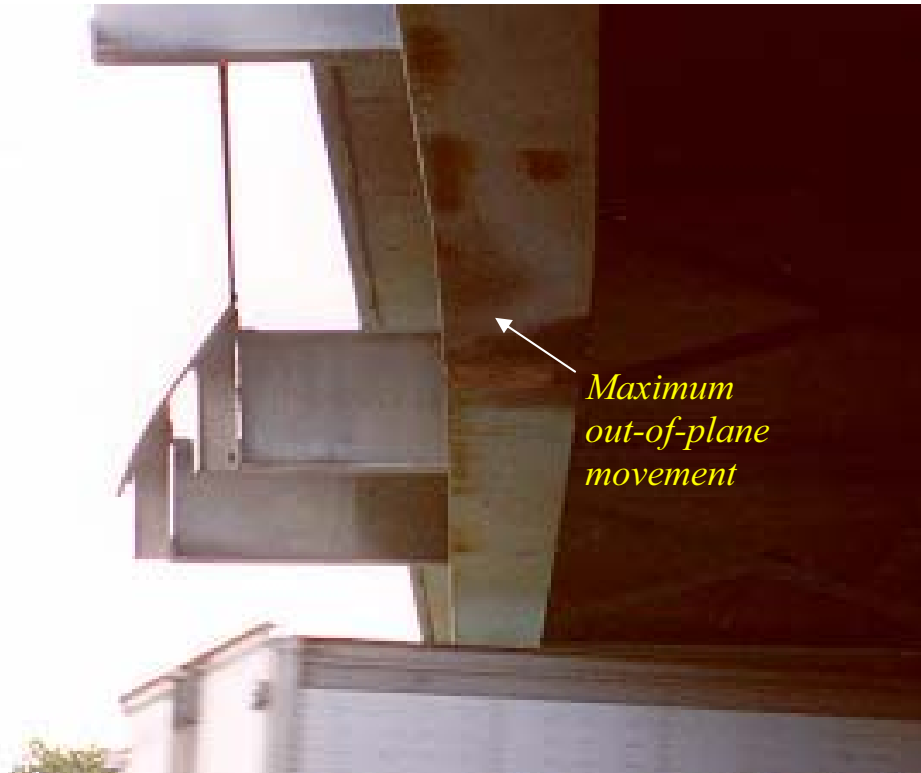
*Maximum
out-of-plane
movement*

Figure 3.1
Out-of-plane movement of the Lake Lansing Road Bridge north fascia beam

location of several of the intermediate stiffeners, stiffeners 12-W to 20-W from the beam end at the west abutment, the web has "smiley face" hair-line cracks and torn at about 1 in. from the bottom flange. The beam was struck by an over-height truck causing about 4 in. out-of-plane deformation of the bottom flange as shown in Figure 3.1.

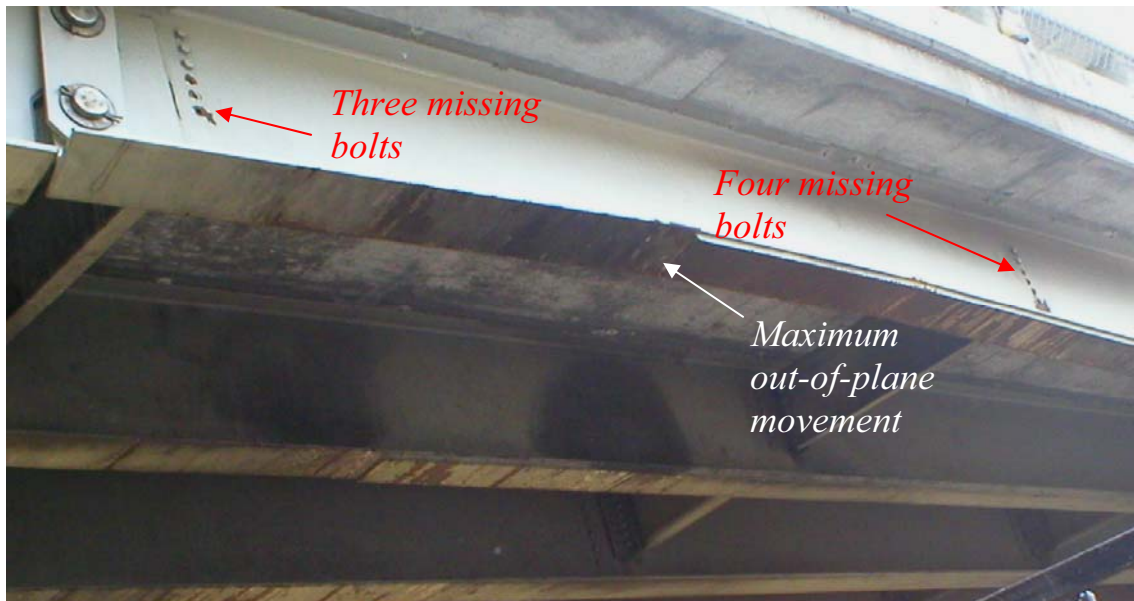
*Three missing
bolts*

*Four missing
bolts*

*Maximum
out-of-plane
movement*

Figure 3.2
Damage on the south side of the Lansing Road Bridge west fascia beam

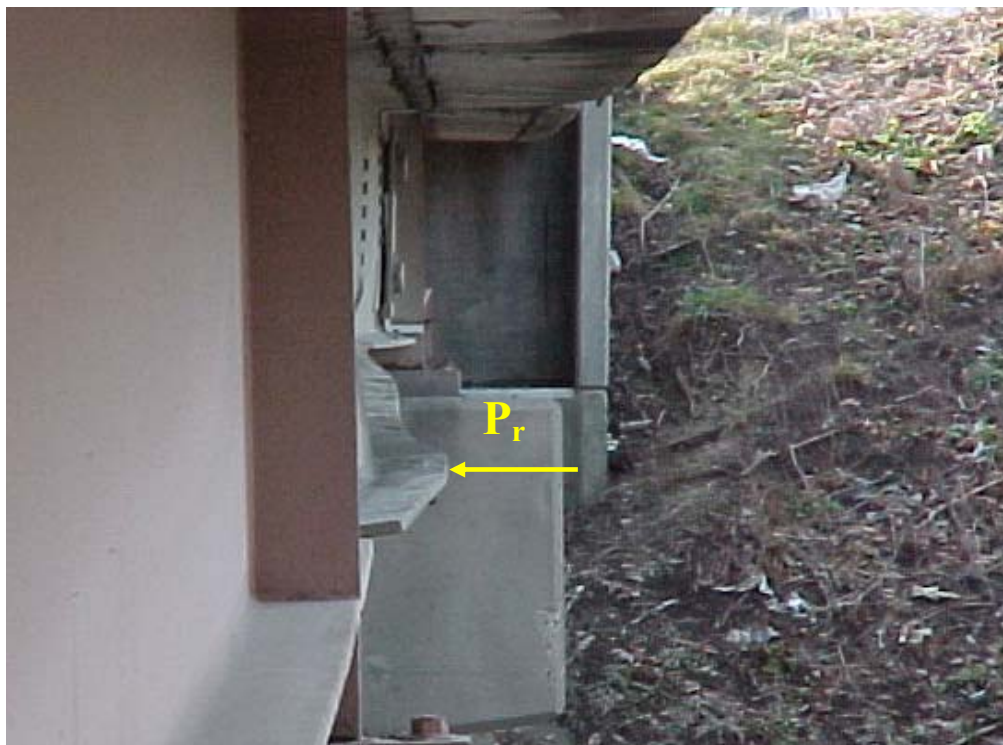
Figure 3.3
Out-of-plane movement of the Lansing Road Bridge west fascia beam

The composite beam was hit by an over-height truck causing out-of-plane deformation of the bottom flange, which extended approximately 25 ft. of the beam. The maximum out-of-plane displacement was approximately 8 in. The impact location was approximately 17 ft. south of the north pier over the right lane. The beam-to-diaphragm connections close to the damage location were also damaged. Three bolts had fractured in the beam-to-diaphragm connection north of the damage location and closer to the pin-hanger detail. Four bolts fractured in the beam-to-diaphragm connection south of the damage location. Figure 3.2 shows a photograph of the damaged beam. Maximum out-of-plane deformation of the bottom flange occurred at the end of the cover plate, which is seen more clearly in Figure 3.3 (close-up photograph of damaged region).

The SBC used a 30-ton (60 kips) jack corresponding to a hydraulic pressure of 10,000 psi to apply the restraining forces. Figure 3.4 shows the equipment and setup for applying the pulling restraining force. Considering the flange deformations shown in Figure 3.3, the restraining force was applied to pull the bottom flange towards the interior beam represented by P_R .

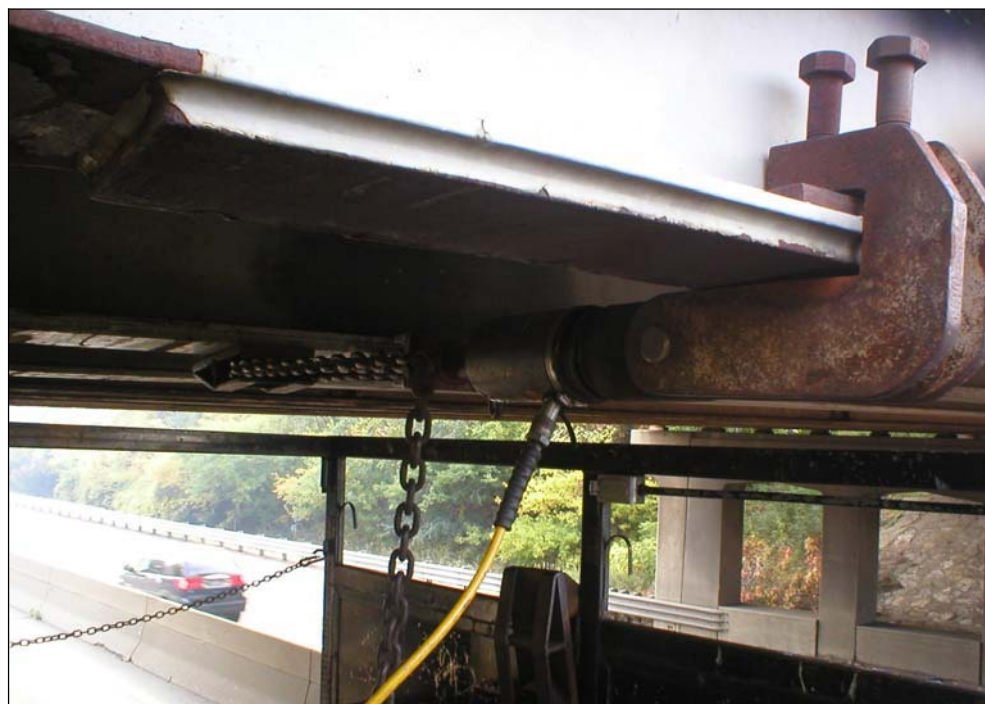
Figure 3.4
Restraining force apparatus

Two heating cycles were conducted in the presence of the MSU research team. These two heating cycles produced most of the deformations (approximately 80%) required to repair the beam. The methods used to repair this beam were very similar to those used to repair the Lansing Road Bridge. The restraining forces were applied using the same 30-ton as which was shown in Figure 3.4.

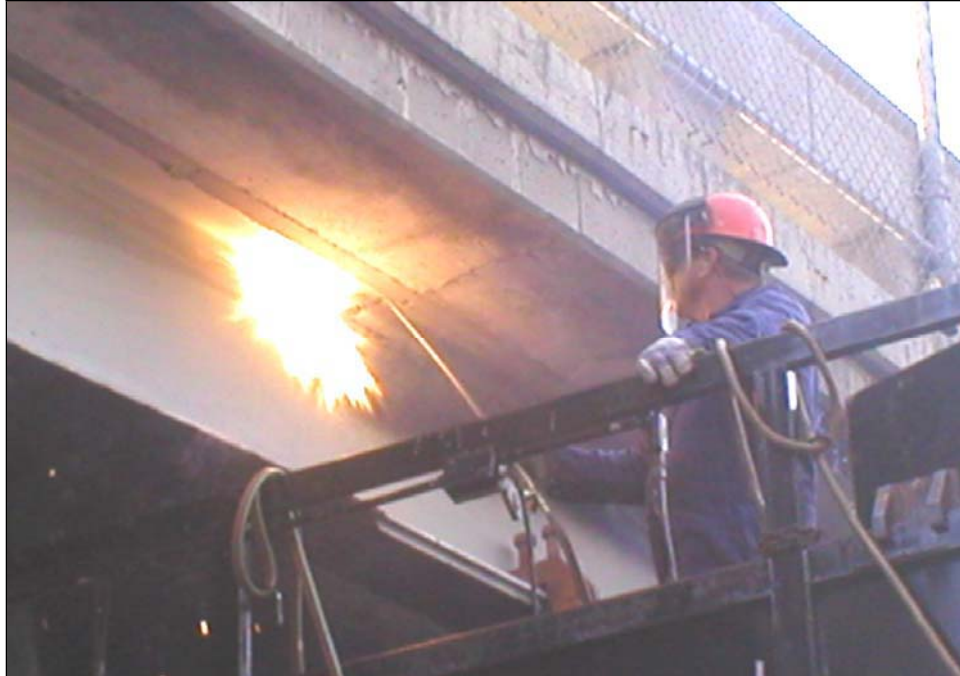
Figure 3.5
Photograph of the strip heat applied to the web

In the first heating cycle, the crew applied a strip heat to the web, which extended from the point of damage to the pin-hanger detail. The strip heat was applied in a 5 in. band slightly below (1-2 in.) the concrete deck slab. While heating the web, the pressure in the jack was approximately equal to 1000 psi, which corresponds to a restraining force of 6 kips. The pressure in the jack decreased gradually as the web was heated. However, the crew maintained the pressure around 1000-1200 psi (6-7.5 kips). According to the SBC, this strip heating of the web makes the steel at the slab-to-beam connection softer. This reduces the forces induced at the shear connection when the flange Vee heats are applied. The strip heat also rotates the web plate about its weak axis. Figure 3.5 shows a photograph of a crew member applying the web strip heat.

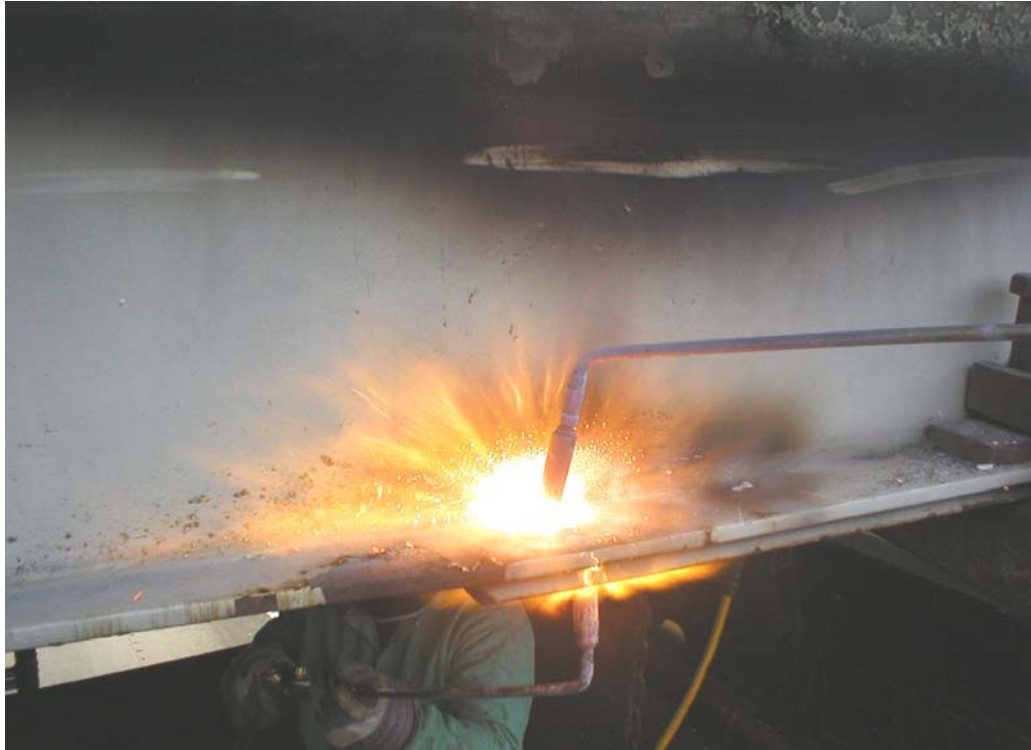
Figure 3.7
Vee-heat of the bottom flange and cover plate using two torches

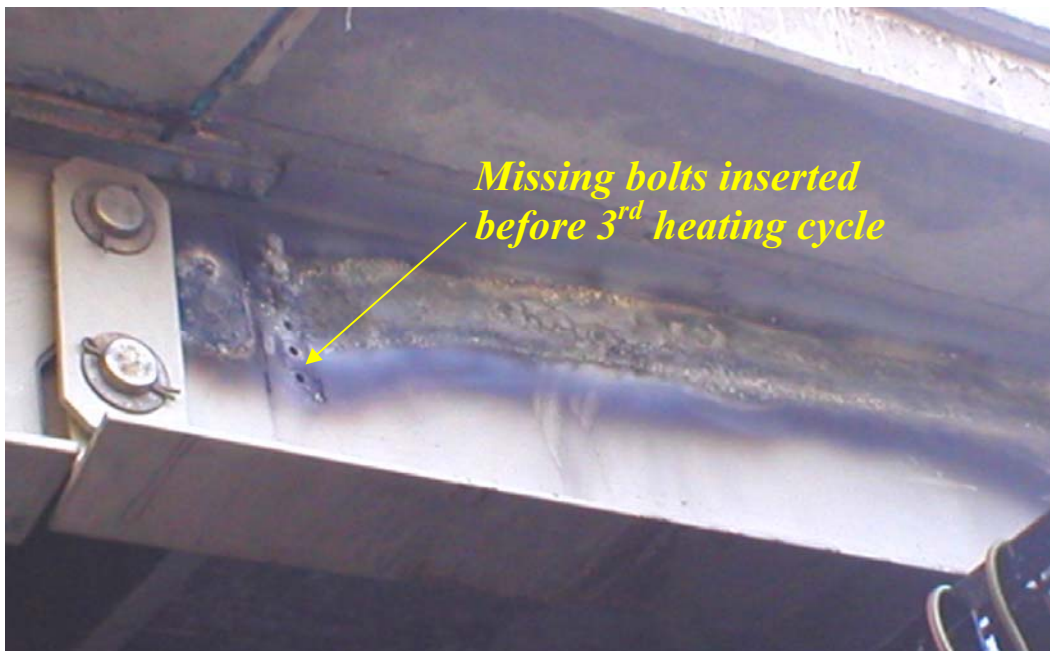
Figure 3.8
Appearance of the Lansing Road bridge girder after two heating cycles

The second heating cycle was applied in the same fashion as that of the first heating cycle. Heating temperatures remained close to about 1200 °F. Figure 3.8 shows a photograph of the beam after two heat straightening repair cycles.

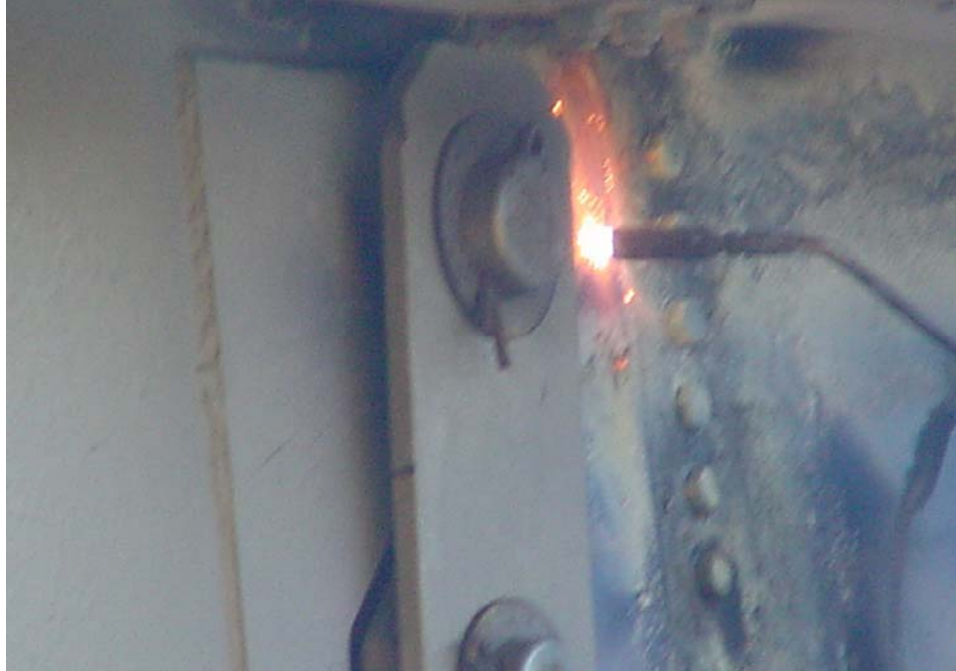
Figure 3.9
Strip heat applied close to the pin-hanger detail

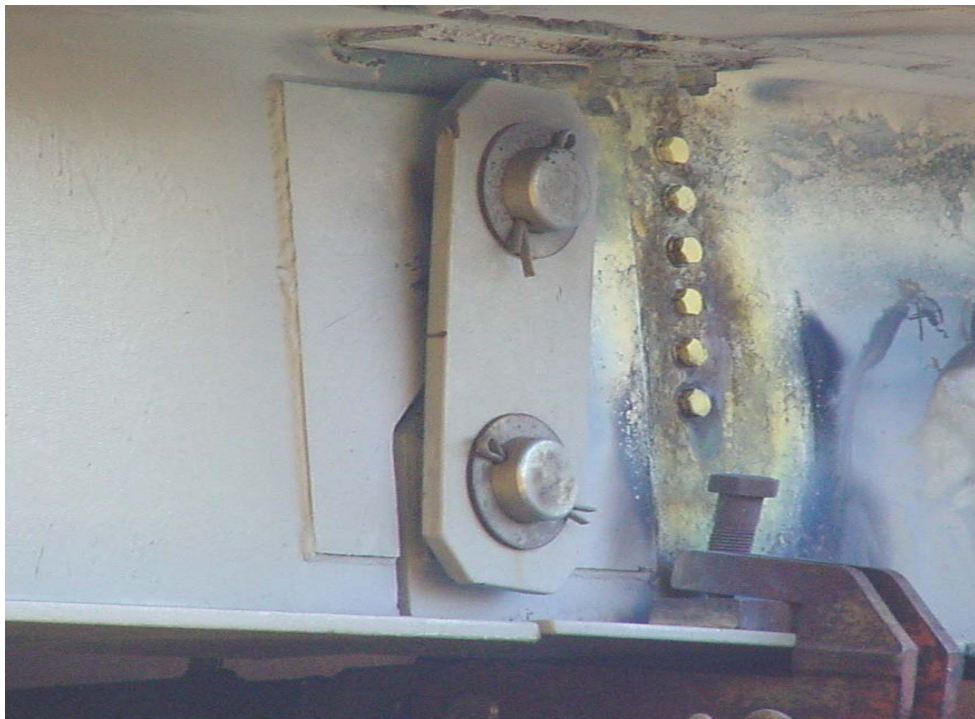
Figure 3.10
Condition of bridge girder after applying strip heat close to pin-hanger detail

For the six and final full heating cycle, the restraining force location was moved much closer to the pin-hanger detail. The web strip heat extended from the diaphragm north of the damage location to the pin-hanger detail only. Two Vee heats were applied to the bottom flange. The crew applied a strip heat in between the diaphragm connection and the pin-hanger detail starting close to the concrete slab and moving down in a serpentine motion towards the bottom flange. The SBC attempted to hammer the diaphragm connection together while the beam was still warm. Figure 3.9 shows a photograph of the strip heat being applied close to the pin-hanger detail. Figure 3.10 shows the condition of the pin-hanger detail after the sixth heating cycle.

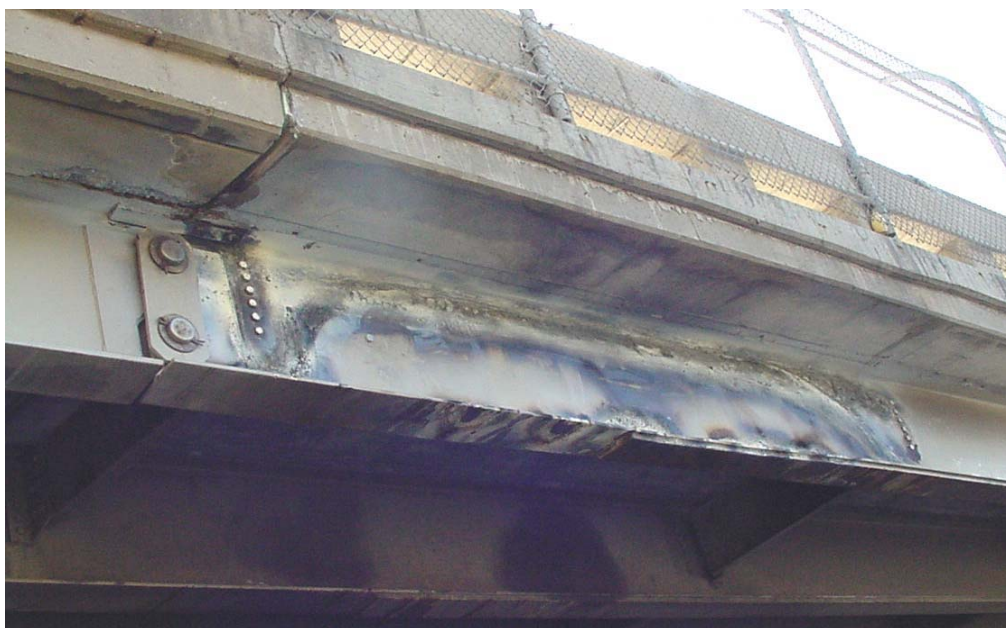
Figure 3.11
Condition of bridge girder after heat straightening repair procedure

After cooling, it was found that the sixth heating cycle produced significant movement and the beam was almost straight. A further heating cycle was conducted to make small improvements but its impact was quite insignificant. A photograph of the repaired beam is shown in Figure 3.11.

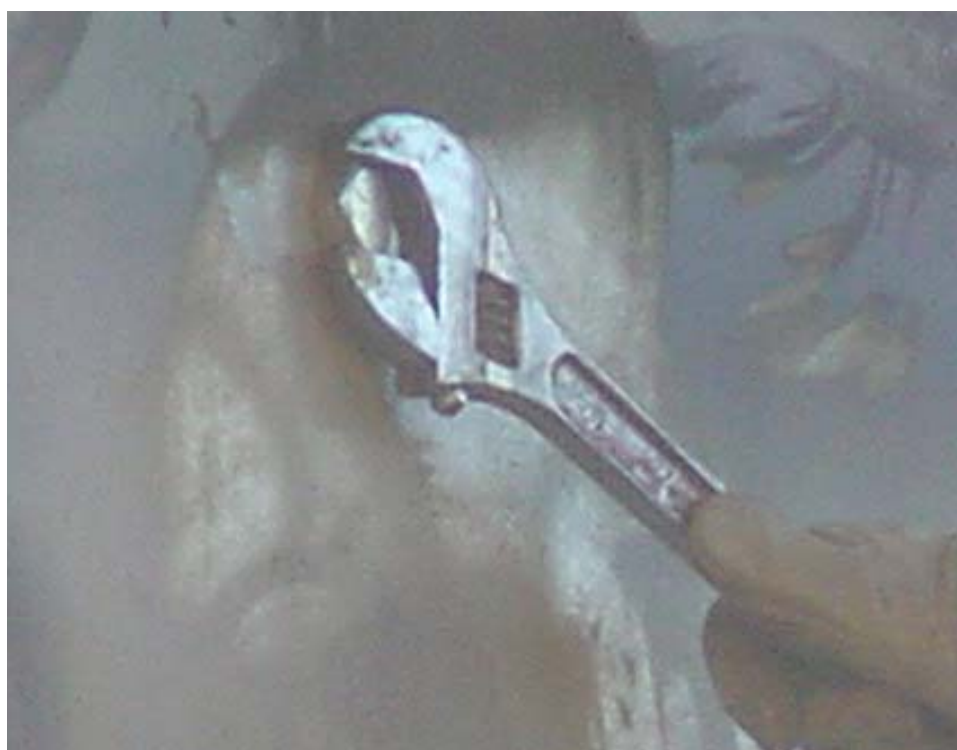
Figure 3.12
Replacement of the removed steel cores using galvanized steel bolts

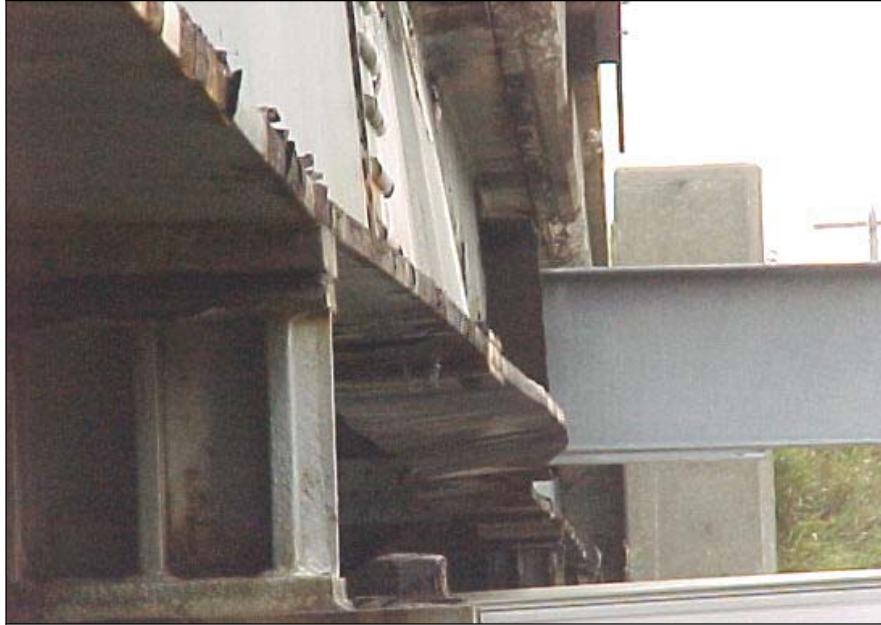
Figure 3.13
Out-of-plane movement of the Elm Road Bridge west fascia beam

The composite beam was hit by an over-height truck causing out-of-plane deformation of the bottom flange, which extended approximately 20 ft. of the beam. The maximum out-of-plane displacement was approximately 3 in. The impact location was approximately 20 ft. south of the north pier over the right lane. The impact also fractured the diaphragm-to-beam connection. Figure 3.13 shows the out-of-plane movement of the bottom flange and Figure 3.14 shows the fractured diaphragm-to-beam connection.

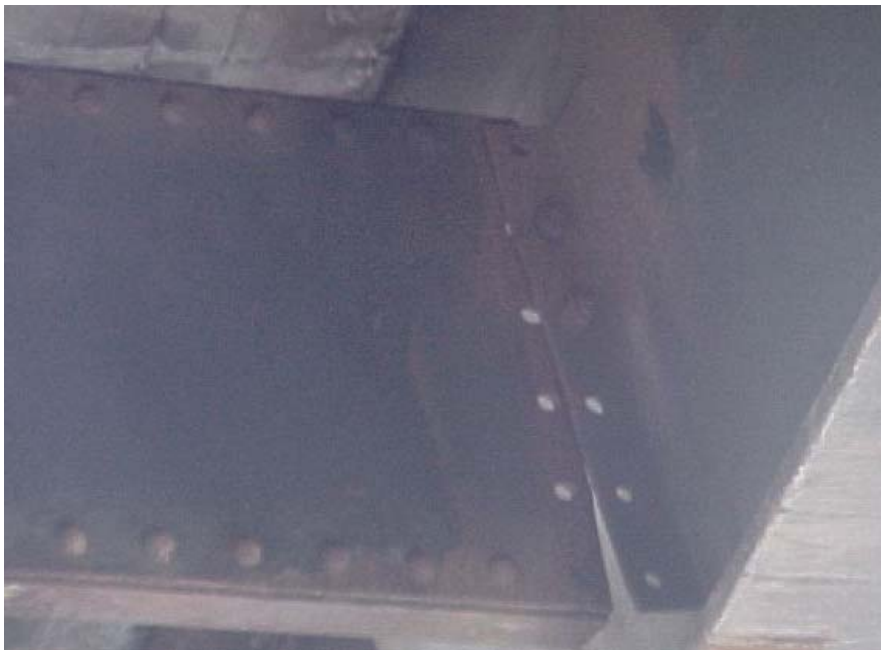
Figure 3.14
Fractured diaphragm-to-beam connection

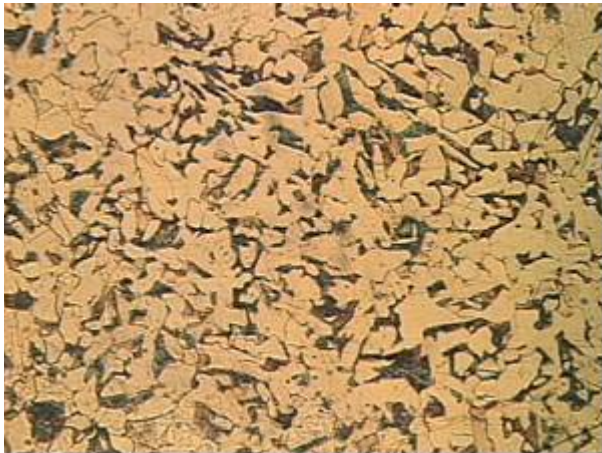
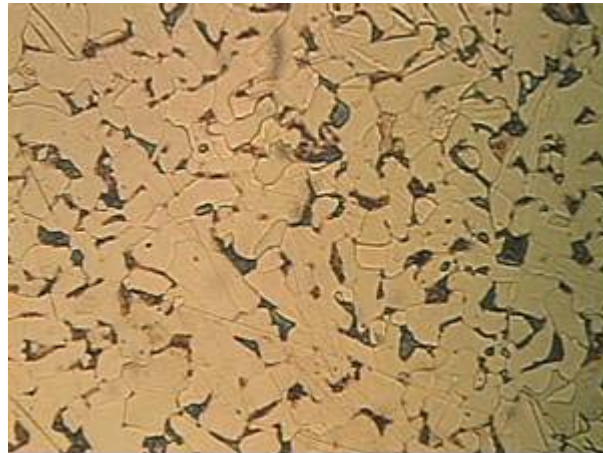
a) Unheated 480X

b) Heated 480X

Figure 3.16
Microstructure of heated and unheated sections of the Lake Lansing Road Bridge

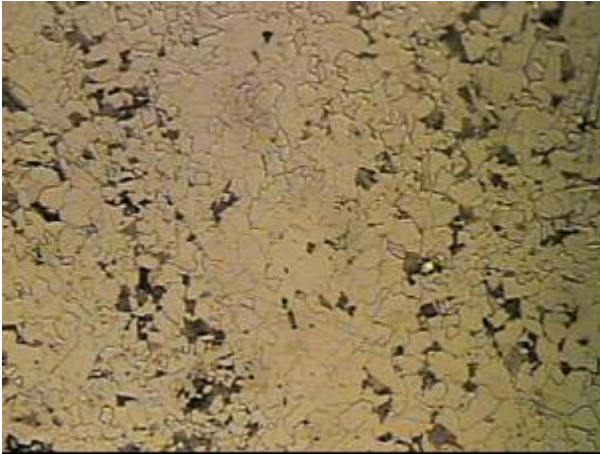
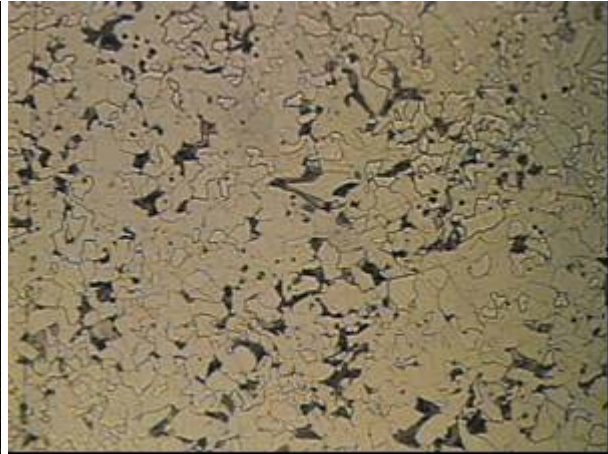
a) Unheated 480X

b) Heated 480X

Figure 3.17
Microstructure of heated and unheated portions of the Lansing Road Bridge

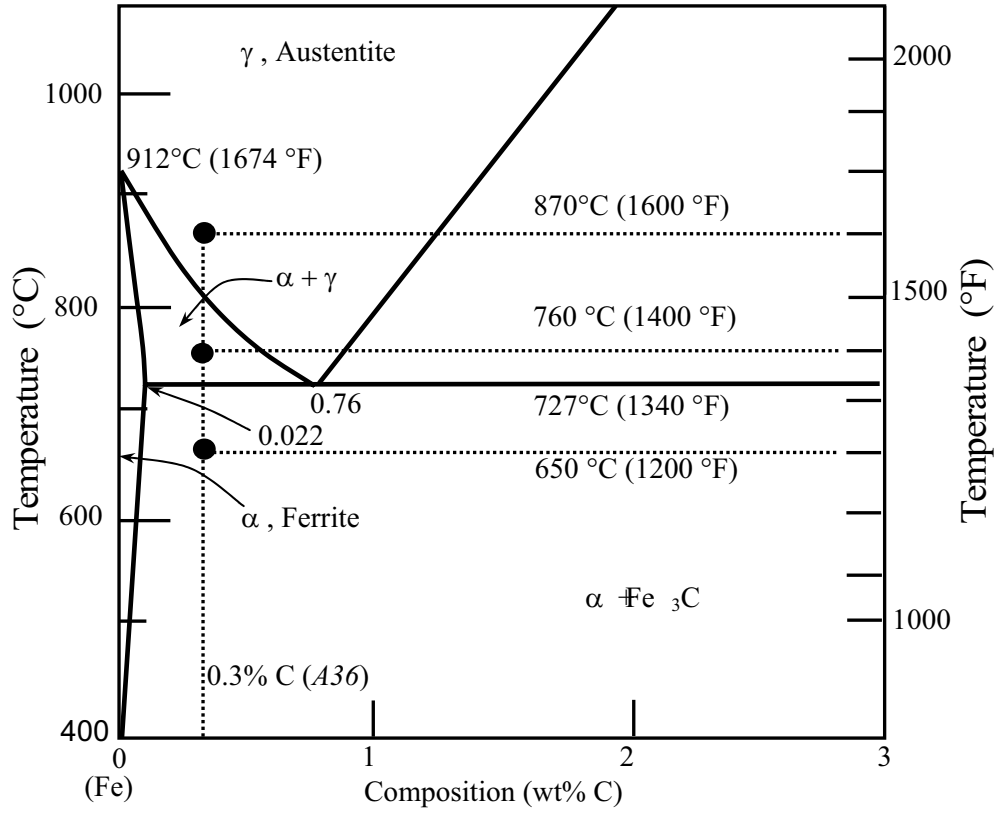
Figure 4.3
Temperatures located on the iron-iron carbide phase diagram for 0.3% carbon steel

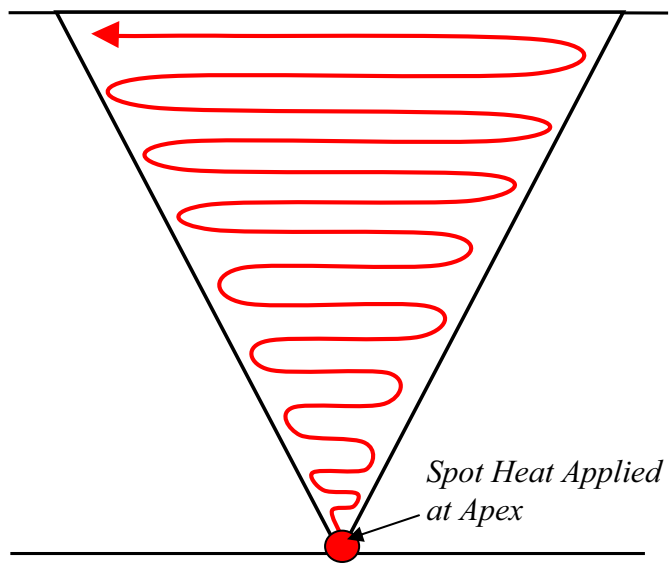
Figure 4.9

Spot Heat Applied at Apex

Serpentine movement of a Vee heat applied to a damage steel plate

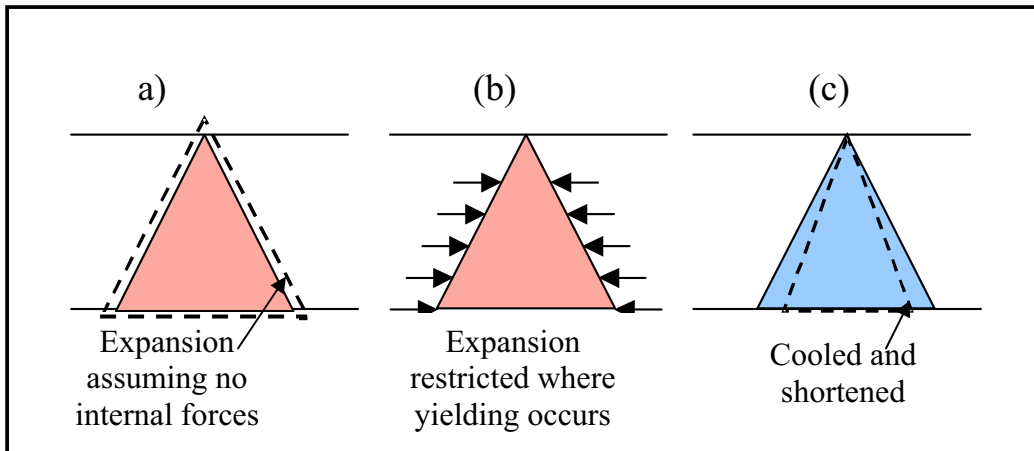
Figure 4.10
Fundamental mechanics of Vee heated steel

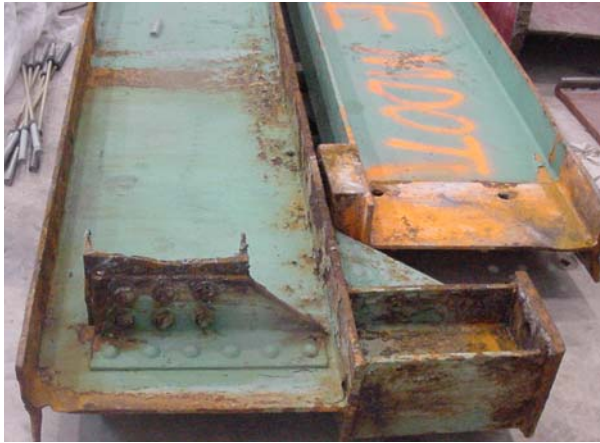
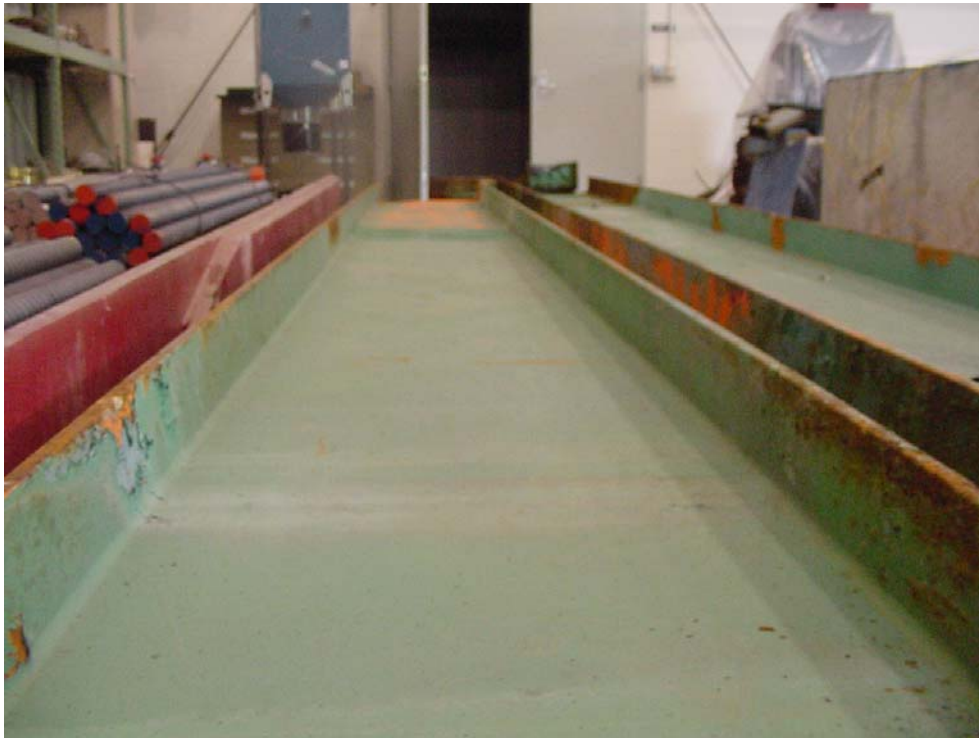
a) End conditions

b) Dents in the flange.

c) Beam used for the fabrication of small scale experimental tests.

Figure 4.14
Condition of W24 x76 A7 steel beams as received by the MSU researchers

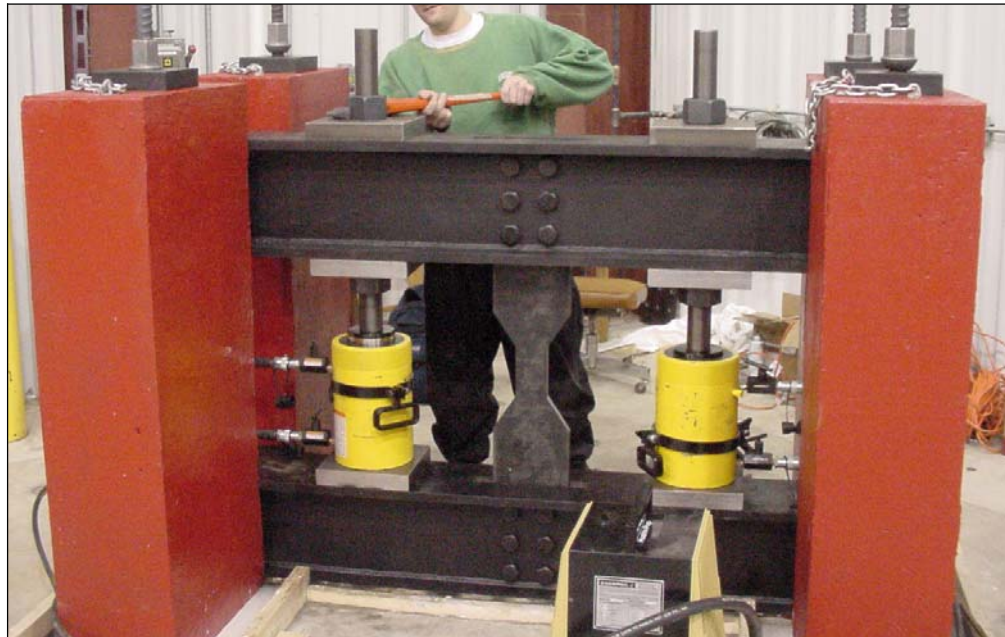
Figure 4.22
Photograph of test setup being assembled

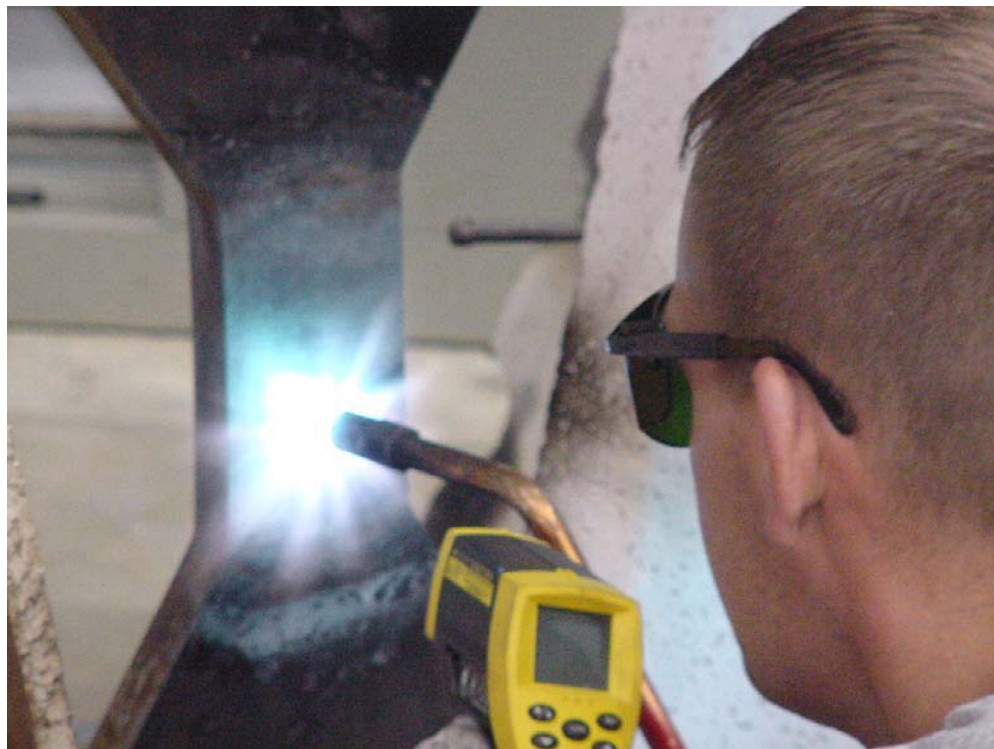
Figure 4.32
Application of the strip heat to the test area

Heating cycles were performed using 5/8 in. diameter oxy-acetylene heating torches. Two researchers used two oxy-acetylene torches and applied heat to both sides of the test specimens. The temperature at the surface of the steel was monitored using an ST80 infrared temperature gun. Heat straightening practice was conducted monitoring the temperature of the surface of application between $1100 \text{ }^\circ\text{F}$ and $1200 \text{ }^\circ\text{F}$. MDOT among other DOTs limit heat straightening practices to $1200 \text{ }^\circ\text{F}$ and this upper limit was enforced in the research project with the exception of the overheated A36 steel specimens. Heat straightening was conducted using a strip pattern moving from side to side over the rectangular test area as described in Section 4.4. The bottom is generally heated first to allow the heat to rise within the test region. Figure 4.32 shows a heat straightening repair cycle being conducted. Figure 4.33 shows how temperature is monitored using the infrared temperature gun. The bright red is the infrared ray pointed on the steel.

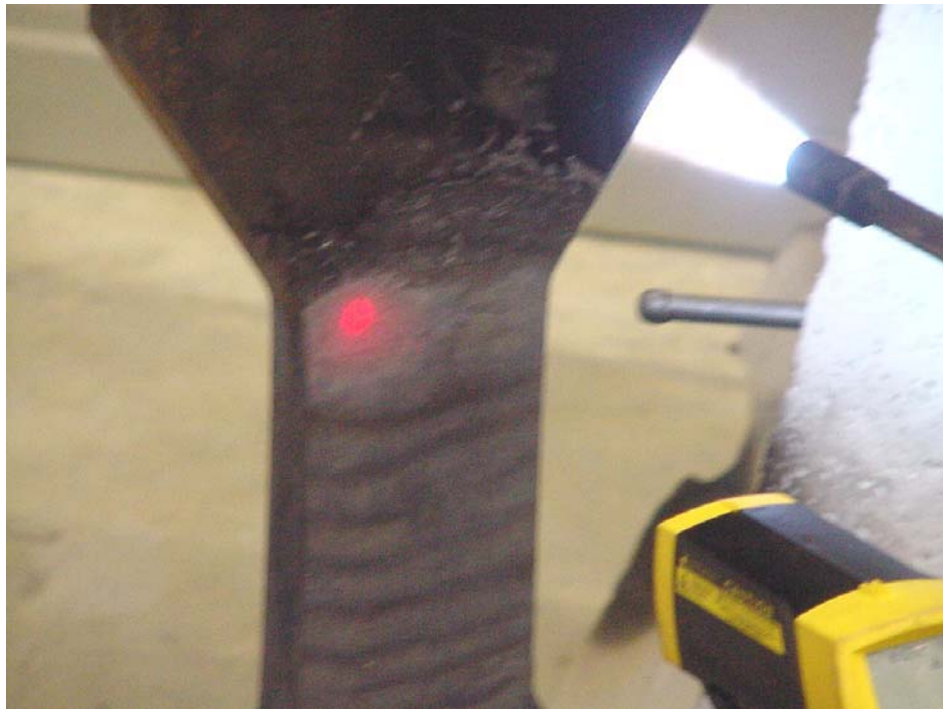
Figure 4.33

Photograph of how the temperature at the surface of the steel was monitored

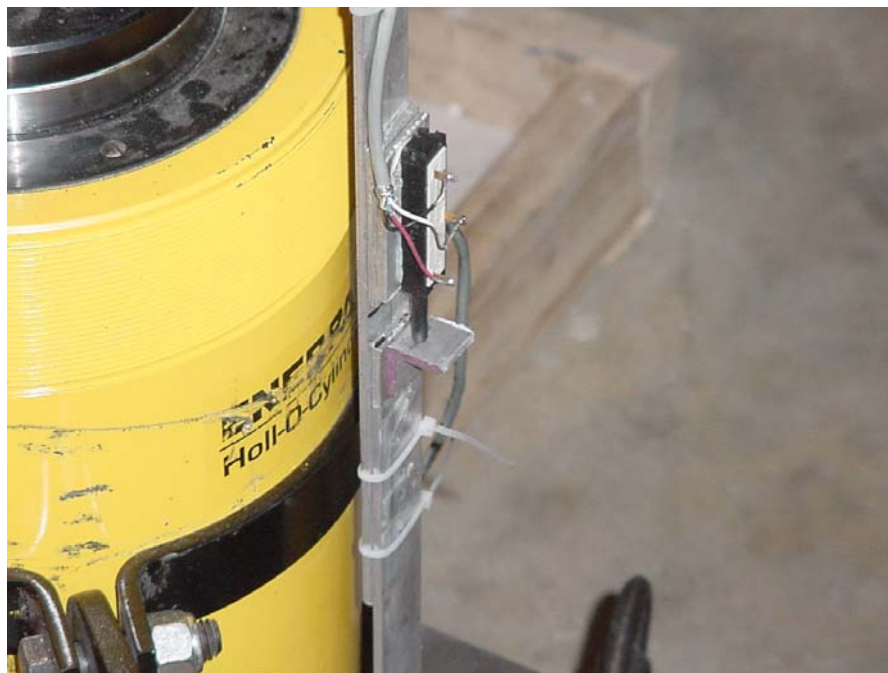
Figure 4.34

1.5 in. displacement transducer measuring the movement between the top and bottom beams

Two 1.5 in. displacement transducers were used to measure the displacements between the top and the bottom beam close to the hydraulic actuators. Aluminum bars are tied together and allowed to slide up and down with respect to each other. The displacement transducers were attached to aluminum brackets glued to the top beam and flat supports were attached to the aluminum bracket glued to the bottom beam. The transducers were used to estimate the expansion and shortening of the test area vs. temperature and pressure over time. A 1.5 in. displacement transducer is shown in Figure 4.34. The locations with respect to the test setup are highlighted in Figure 4.35.
