**EFFECTS OF MULTIPLE DAMAGE-HEAT
STRAIGHTENING REPAIRS ON THE STRUCTURAL
PROPERTIES OF BRIDGE STEELS**

FINAL REPORT

**Report No. RC-1456
Sponsored by Michigan Department of Transportation**

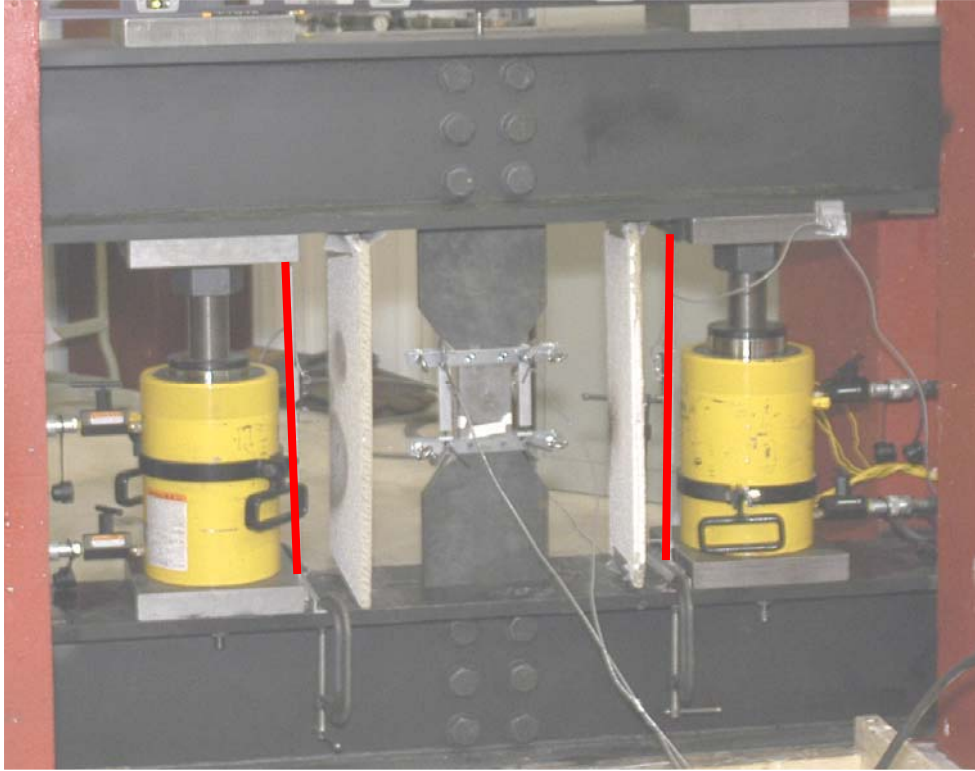
Figure 4.35
1.5 in. displacement transducer locations in respect to the test setup

Two 1.5 in. displacement transducers were used to measure the displacements between the top and the bottom beam close to the hydraulic actuators. Aluminum bars are tied together and allowed to slide up and down with respect to each other. The displacement transducers were attached to aluminum brackets glued to the top beam and flat supports were attached to the aluminum bracket glued to the bottom beam. The transducers were used to estimate the expansion and shortening of the test area vs. temperature and pressure over time. A 1.5 in. displacement transducer is shown in Figure 4.34. The locations with respect to the test setup are highlighted in Figure 4.35.

The temperature of the steel while heating was monitored using the infrared temperature gun as shown in Figure 4.35. When reaching elevated temperatures of 1100 °F and 1200 °F, a reddish glow would appear on the surface of the steel. This reddish glow is shown for 1100 °F and 1200 °F in Figure 5.9 (a-b). These photographs were taken while repairing Specimen A36-90-50-4.

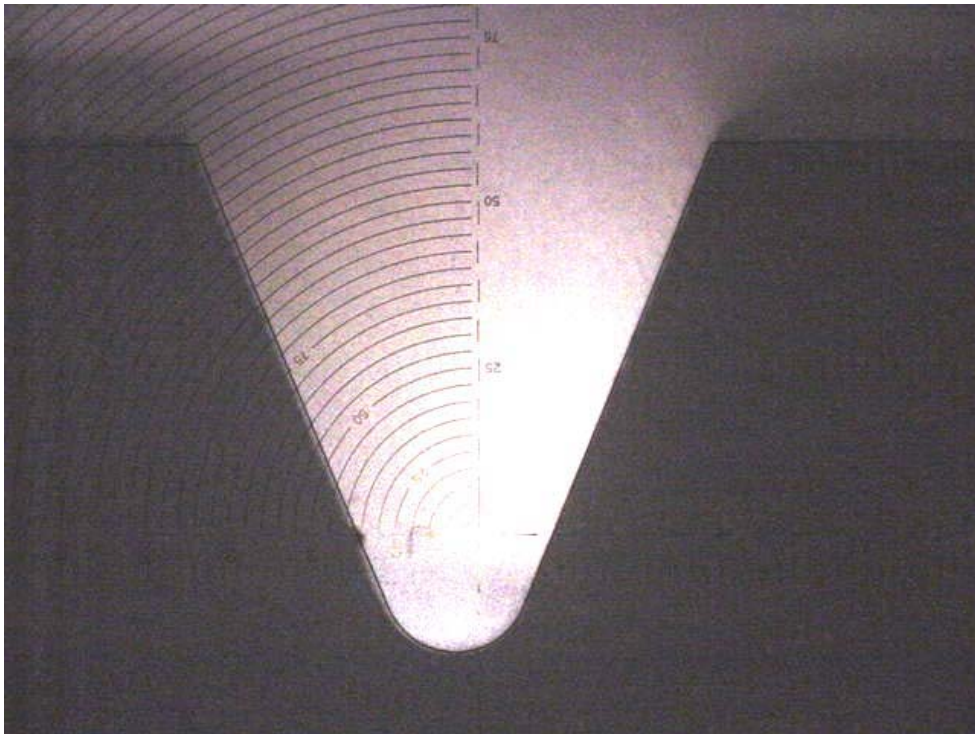
Figure 5.4
Notch of Charpy specimen fabricated by MDOT machinist

The specimen fabrication technique was verified by comparing the notches of six specimens made by the MSU machinist and seven companion specimens made by the MDOT machinist. All thirteen specimens were tested using the MDOT NIST certified machine. Table 5.4 presents the fracture toughness values of specimens fabricated by the MSU machinist and Table 5.5 presents the fracture toughness values of specimens fabricated by the MDOT machinist. As shown in Tables 5.4 and 5.5, the fracture toughness of charpy specimens fabricated by the MSU machinist was significantly lower. This is attributed to the poor condition (notch radius) of the notches machined by the MSU machinist. Figures 5.3 and 5.4 compare the notches of the specimens made by the MSU and MDOT machinists, respectively. These pictures were taken using an optical comparator. The MSU machinist was using a cutting tool to machine the notches, while the MDOT machinist was using a broaching tool. The MSU machinist's cutting tool was wearing down too quickly and producing the poor quality notch radius seen in Figure 5.3.

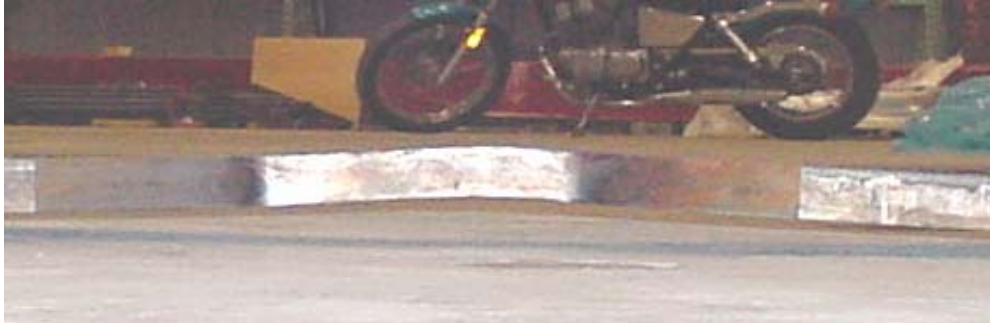
Figure 5.14
Single curvature in the test area of Specimen A36-30-40-1 when complete

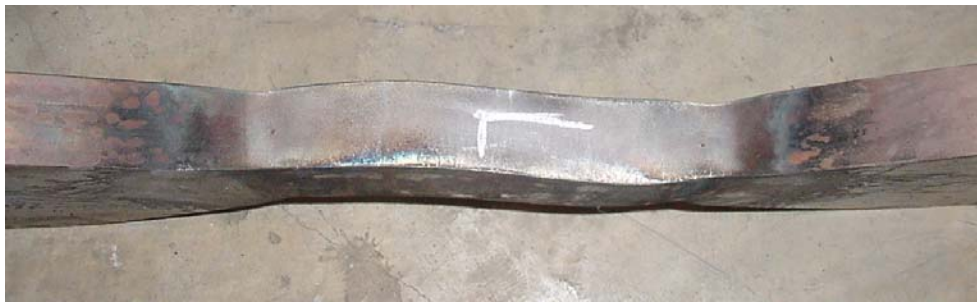
Figure 5.15
Double curvature in the test area of Specimen A36-90-25-5 when complete

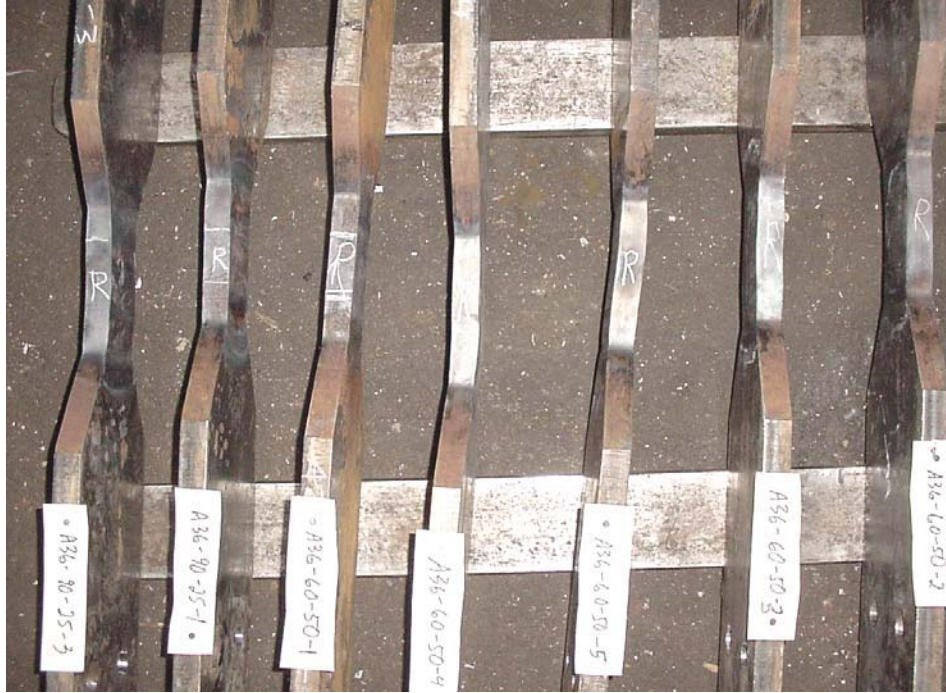
Figure 5.16
A36 test specimens after experimental investigations

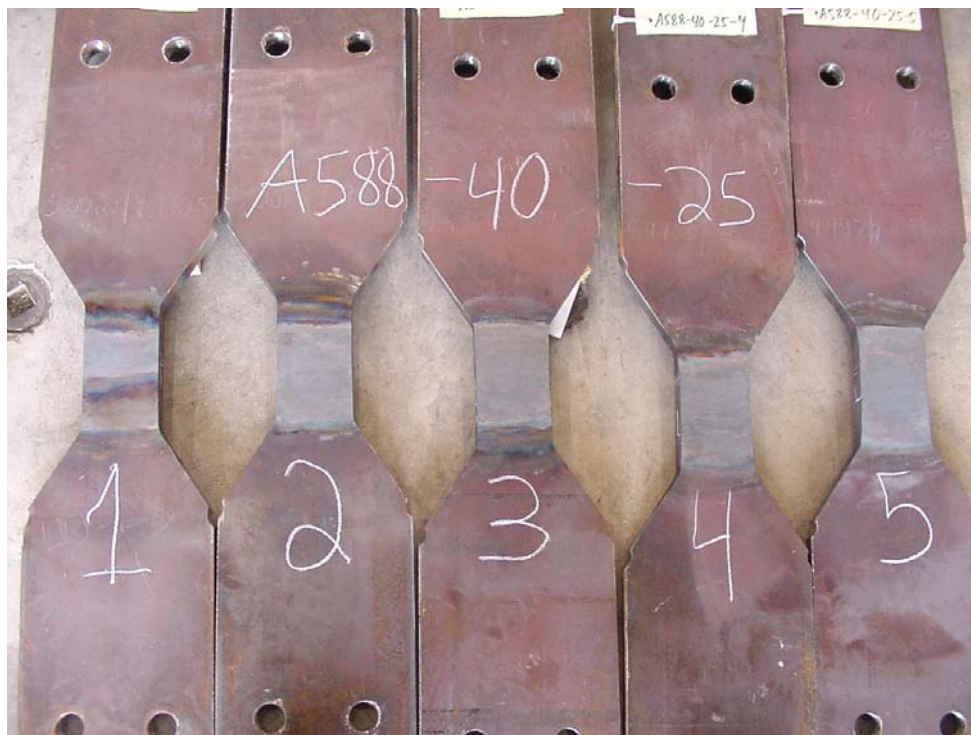
Figure 5.25
Frontal view of A588-40-25 specimens after experimental investigations

The A588 steel specimens were found to be in better conditions after experimental investigations as opposed to the A36 steel specimens. The frontal and side views of the specimen series A588-40-25 are shown in Figures 5.25 and 5.26.

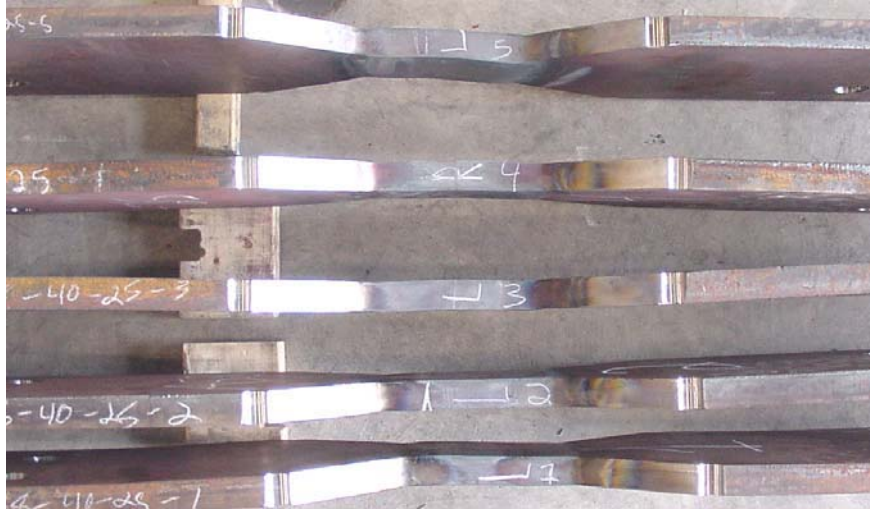
Figure 5.26
Side view of A588-40-25 specimens after experimental investigations

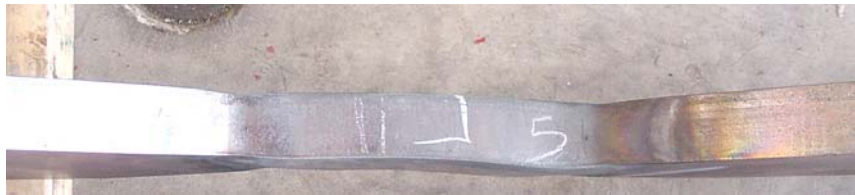
Figure 5.27
Test area of Specimen A588-40-25-5 after experimental investigations

The specimens showing significant curvature in the test area were A588-40-25-5, A588-60-25-1 and A588-60-25-4. Close-ups of the test areas are shown in Figures 5.27, 5.28, and 5.29, respectively. Specimen A588-60-25-1 exhibited the most severe curvature in the test area.

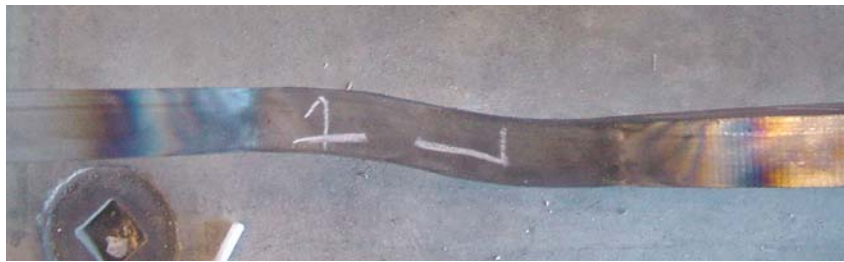
Figure 5.28
Test area of Specimen A588-60-25-1 after experimental investigations

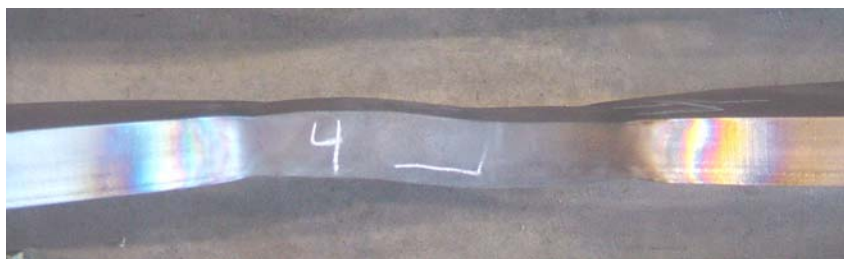
Figure 5.29
Test area of Specimen A588-60-25-4 after experimental investigations

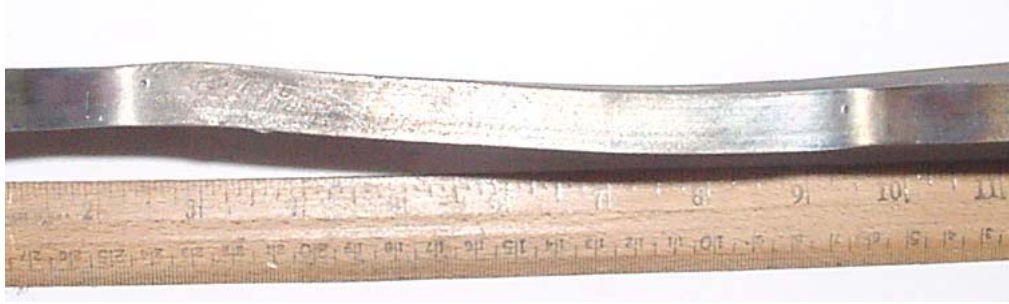
Figure 5.46
Induced curvature in the test area of Specimen A7-90-25-1

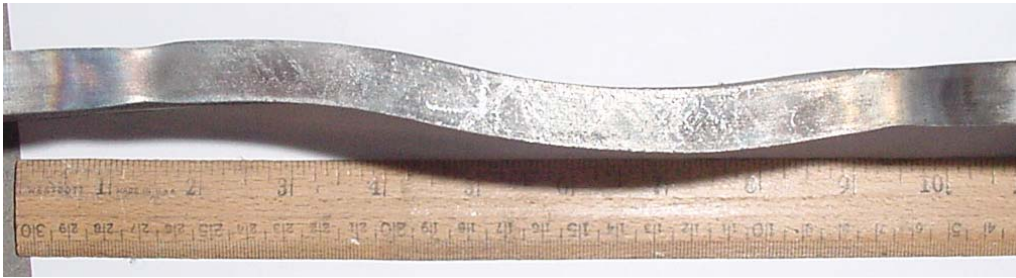
Figure 5.47
Induced curvature in the test area of Specimen A7-90-25-3

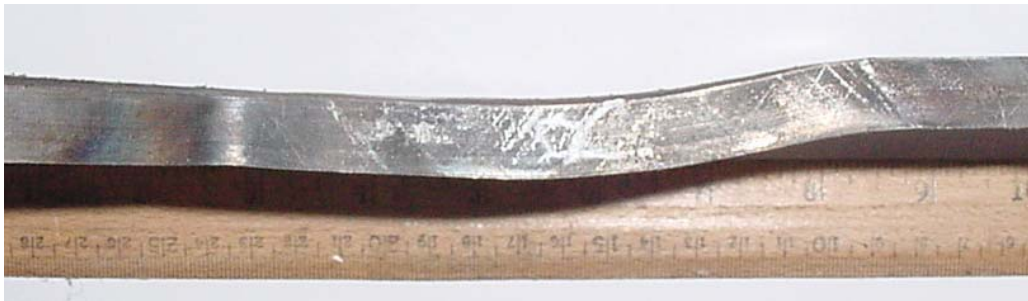
Figure 5.48
Induced curvature in the test area of Specimen A7-90-40-1

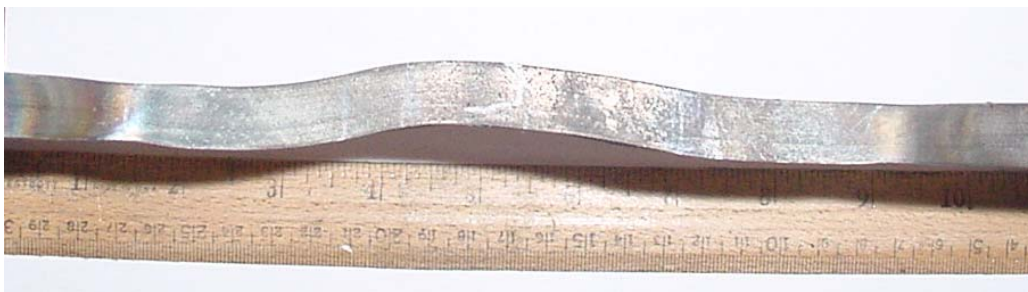
Figure 5.49
Induced curvature in the test area of Specimen A7-90-40-3

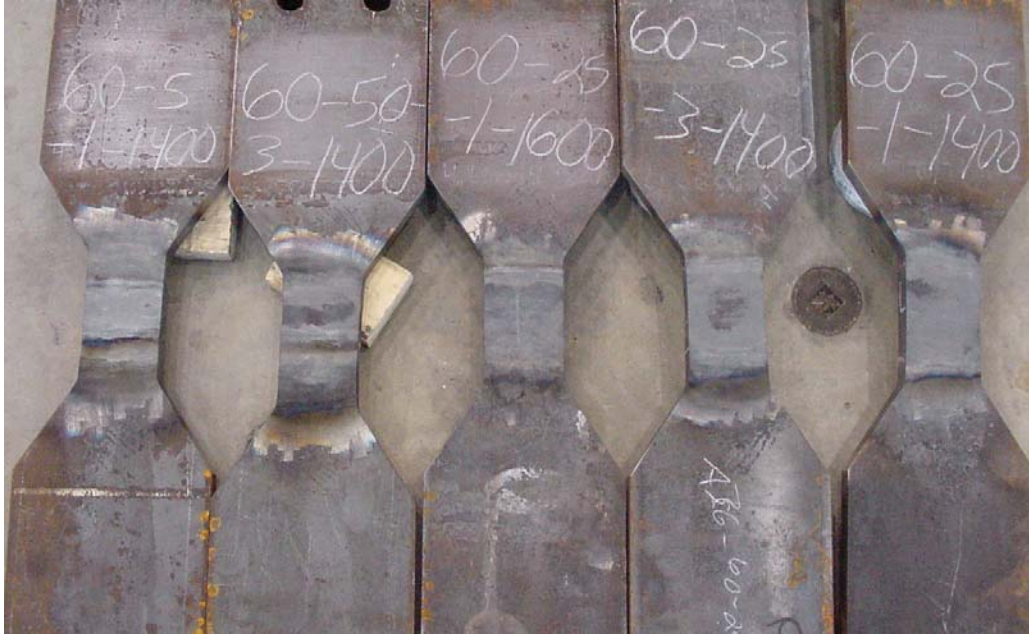
Figure 5.65
Frontal view of overheated A36 specimens after experimental investigations

Significant curvature was not seen in any of the overheated A36 steel specimens after the experimental investigations. All of the possible causes of curvature in the test setup were accounted for while testing the original A36 and A588 steel specimens. Photographs were taken from the front and side views of all overheated specimens. A front view of specimens damaged to 60 ϵ_y is shown in Figure 5.65. Figures 5.66 and 5.67 show side views of the resulting specimens.

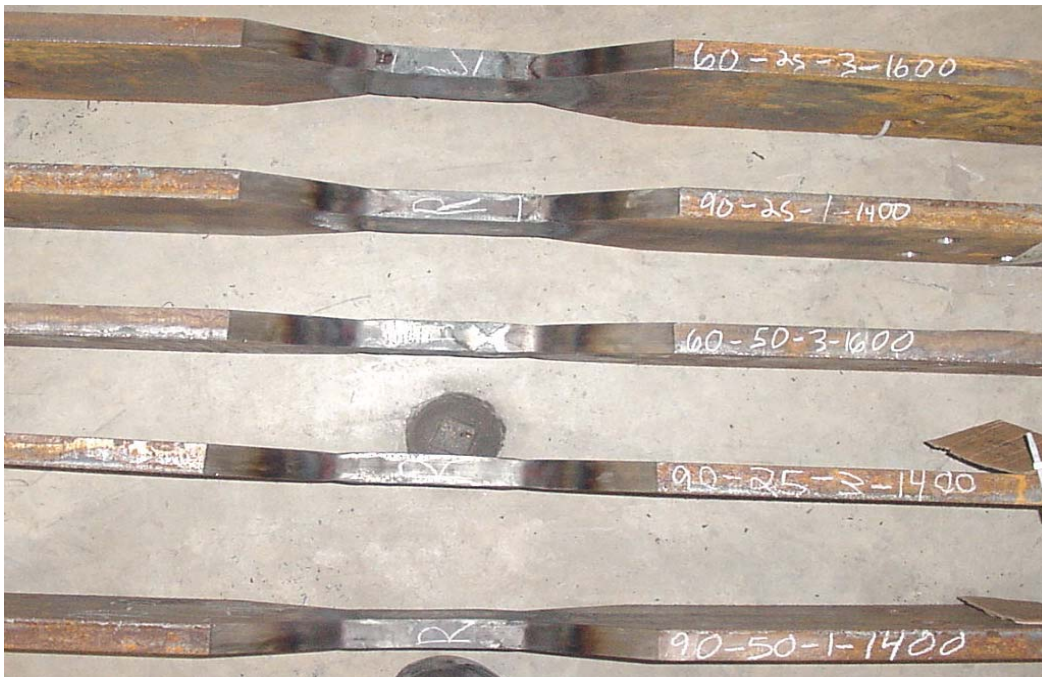
Figure 5.66
Side view of overheated A36 specimens after experimental investigations

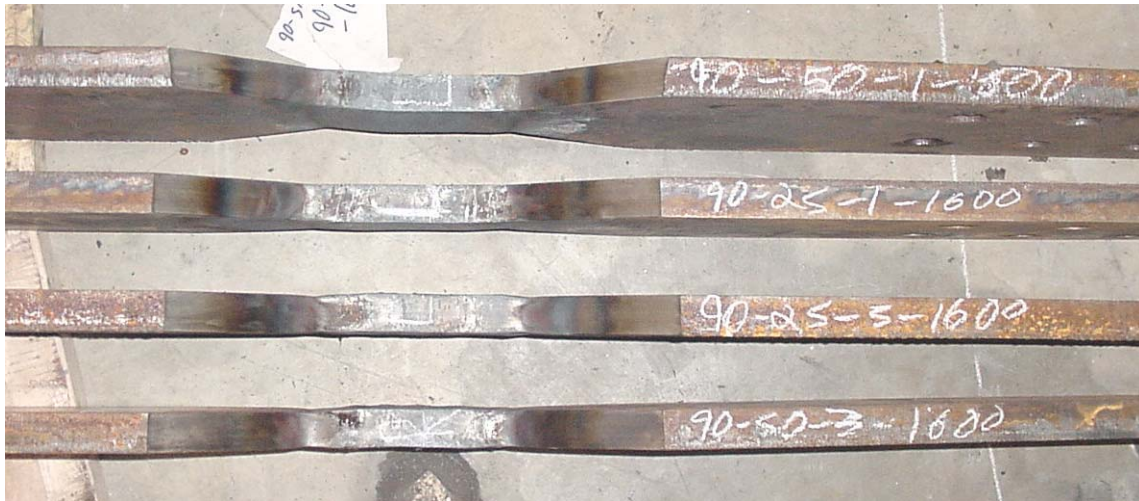
Figure 5.67
Side view of overheated A36 specimens after experimental investigations

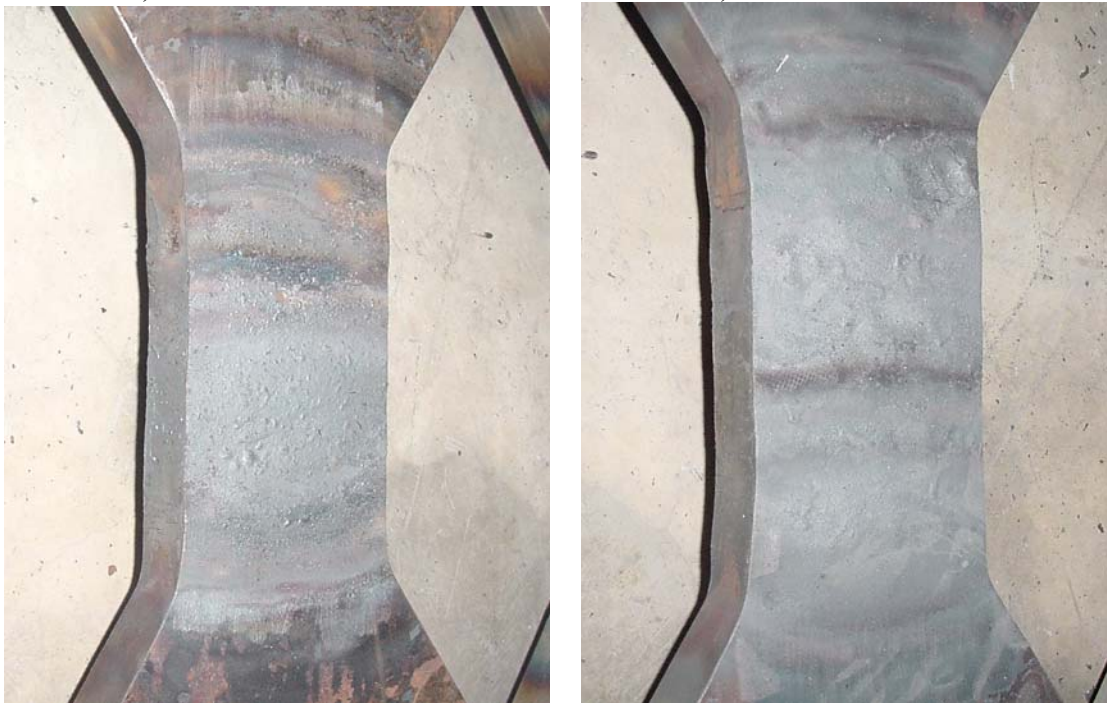
a) A36-90-50-3-1600

b) A36-90-25-3-1600

Figure 5.68
Surface conditions of A36 steel after being repaired with $T_{max} = 1600$ °F

The surface conditions of Specimens A36-90-50-3-1600 and A36-90-25-3-1600 are shown in Figure 5.68(a, b). The condition of the steel as shown in Figure 5.68 is similar for all specimens heated to maximum temperatures of 1600 °F.

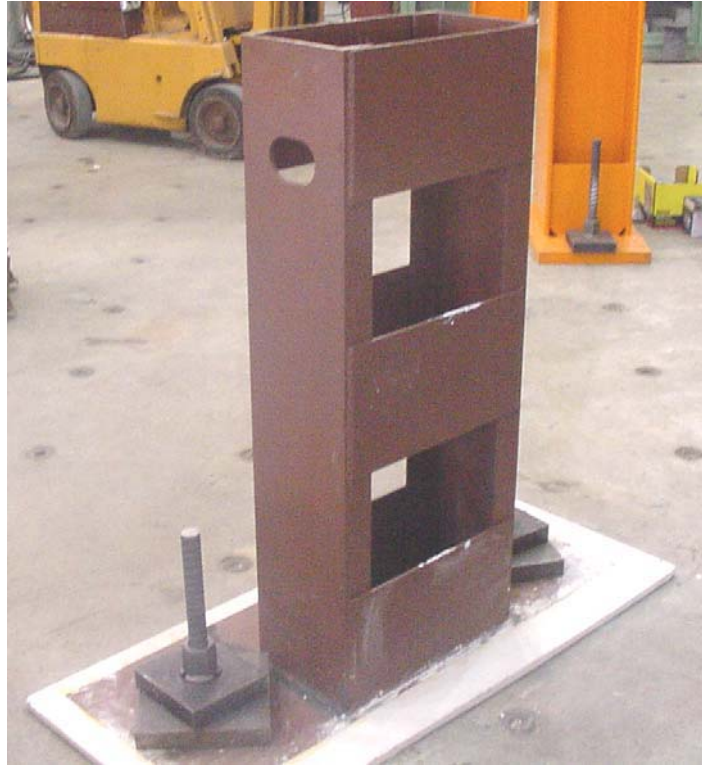
Figure 7.5
Photograph of the roller support column

Two specially designed built-up steel columns provided support reactions to the beam specimens. Each column was fabricated from two C10x20 channel sections, which were welded together using ¼ in. batten plates to form a rectangular section. The built-up columns were welded to each ½ in. thick base plate, which was post-tensioned to the laboratory strong floor with a force of 140 kips. Figure 7.4 shows the details of the column supports. A photograph of the fabricated column is shown in Figure 7.5.

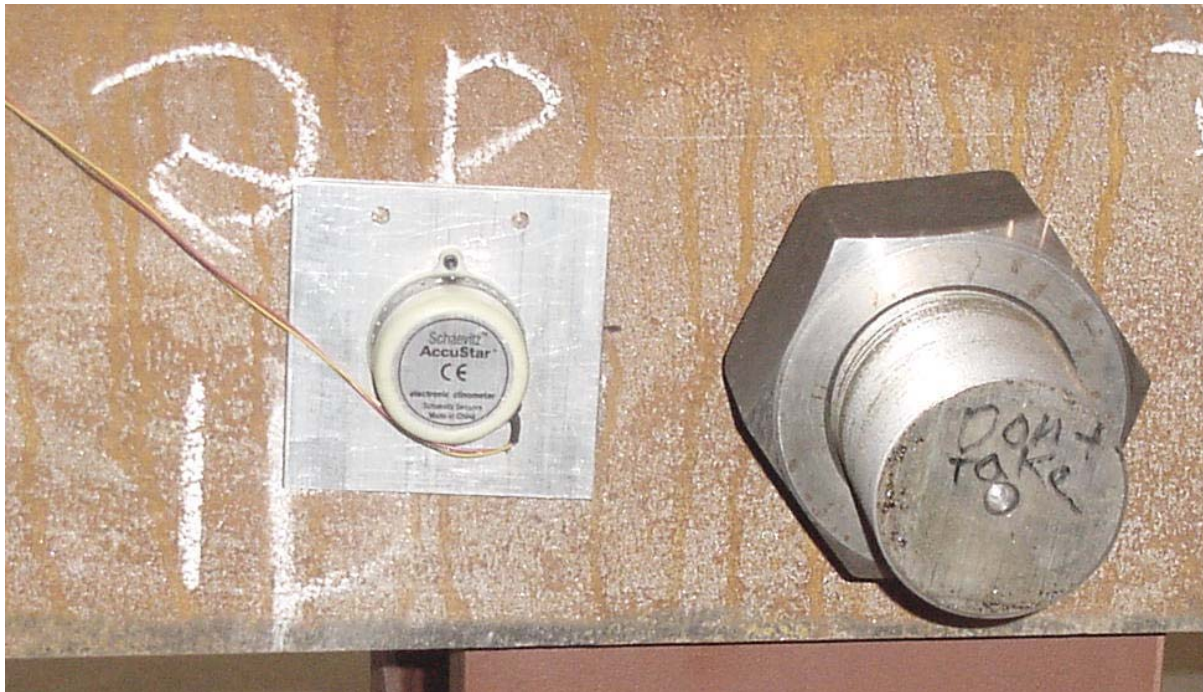
Figure 7.12
Location of rotation meter in respect to roller support

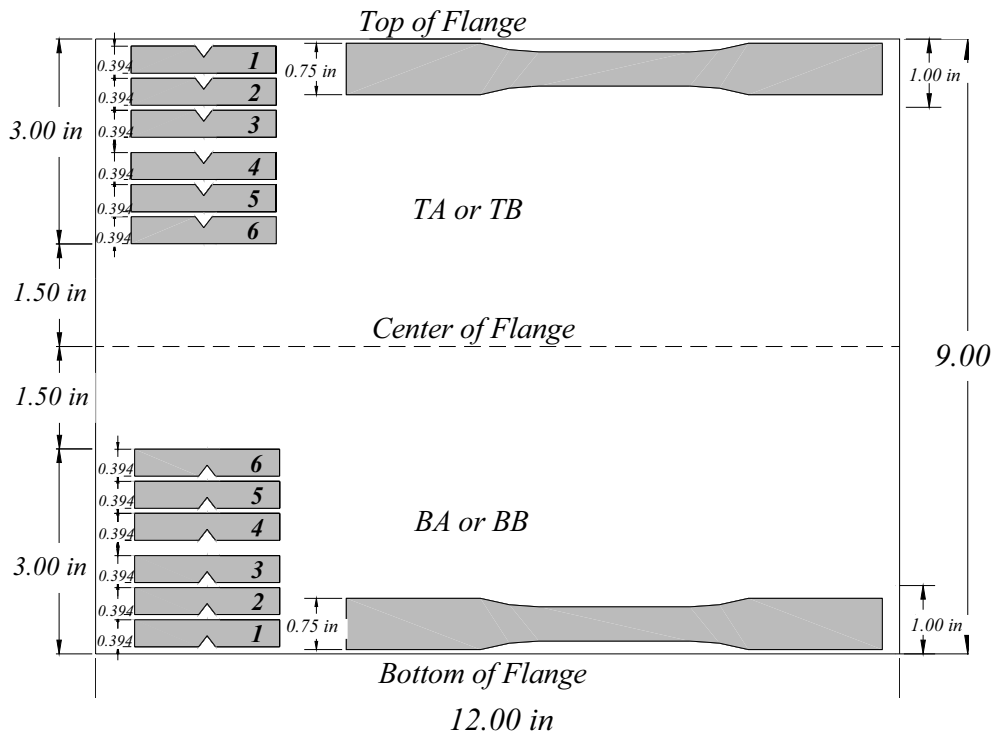
Figure 7.18
Location and nomenclature of undamaged material testing coupons

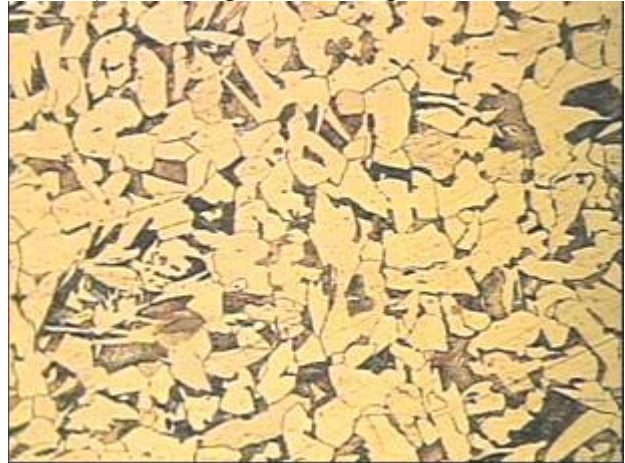
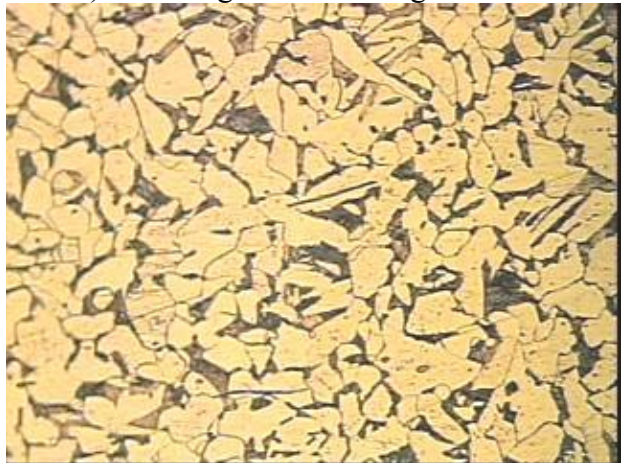
a) Undamaged A7-Flange A

b) Undamaged A7-Flange B

c) Undamaged A36-Flange A

d) Undamaged A36-Flange B

e) Undamaged A588-Flange A

f) Undamaged A588-Flange B

Figure 7.23
Microstructure of undamaged A7, A36, and A588 steel

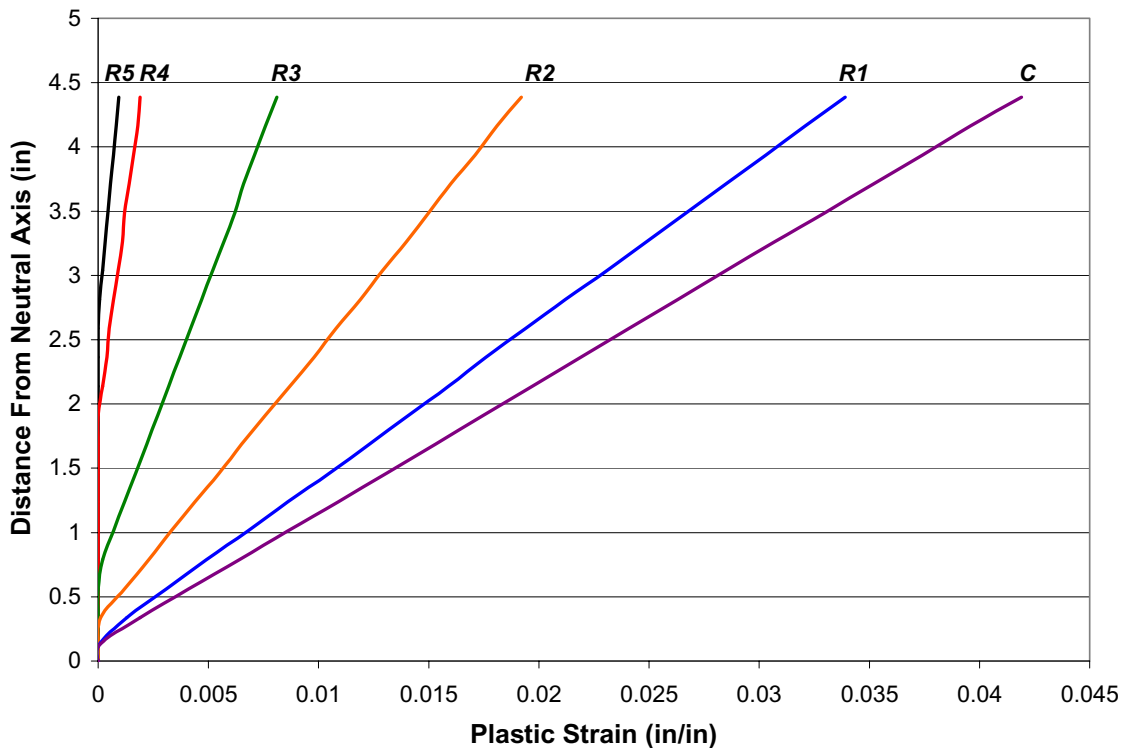
Figure 7.36
Plastic strain distribution along half the depth of A7 beams damaged to $90 \epsilon_y$

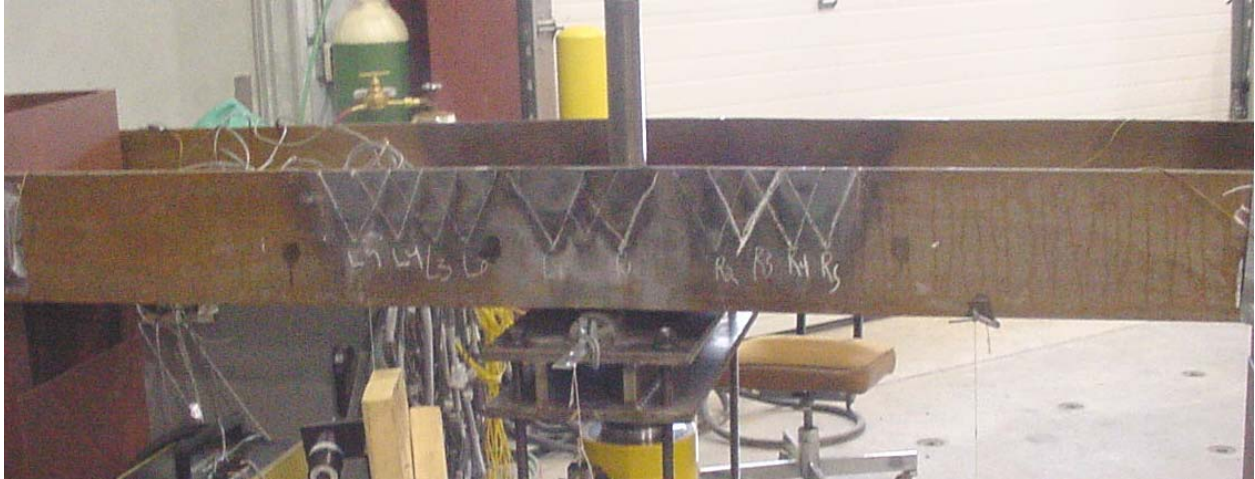
Figure 8.10
Front view of A7-Beam 1 after experimental investigations

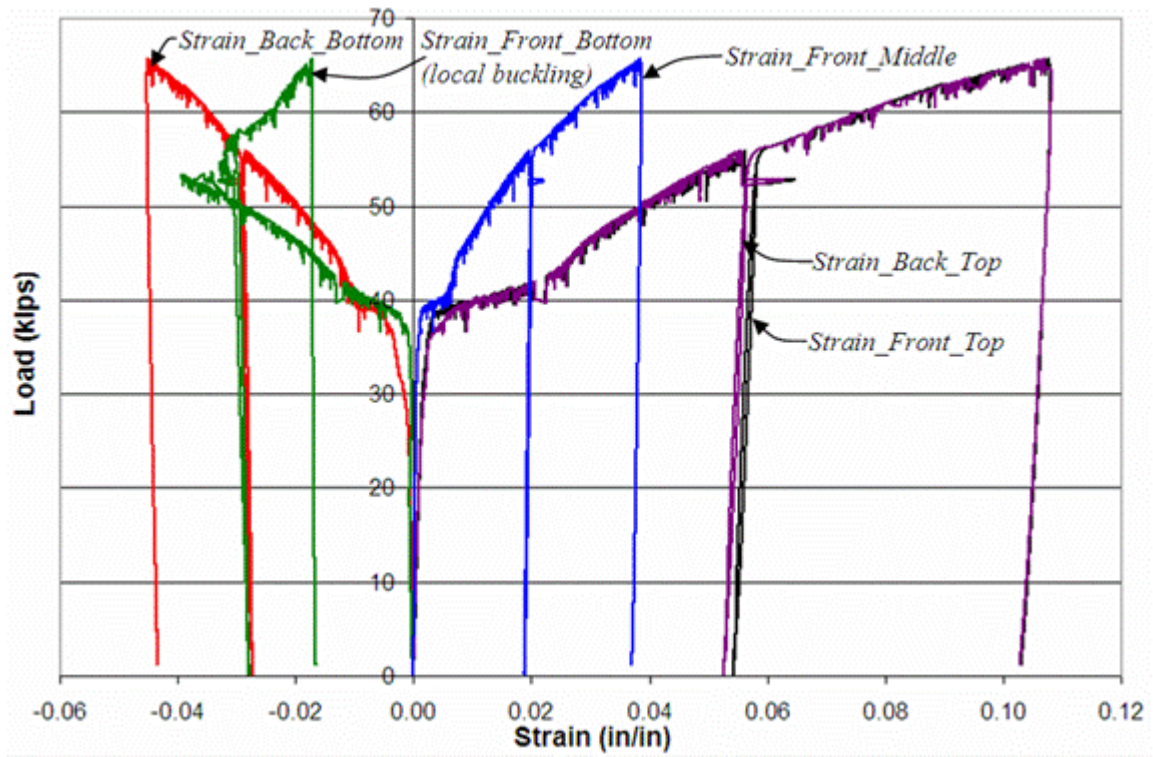
Figure 8.14
Strain gage data during the first damage cycle of A7-Beam 2

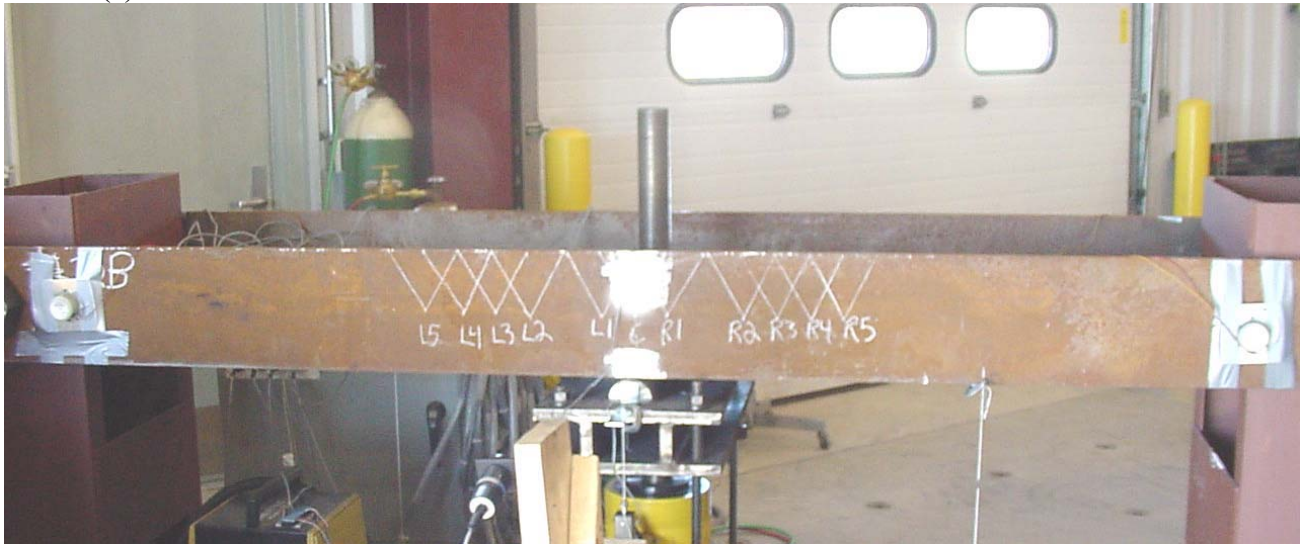
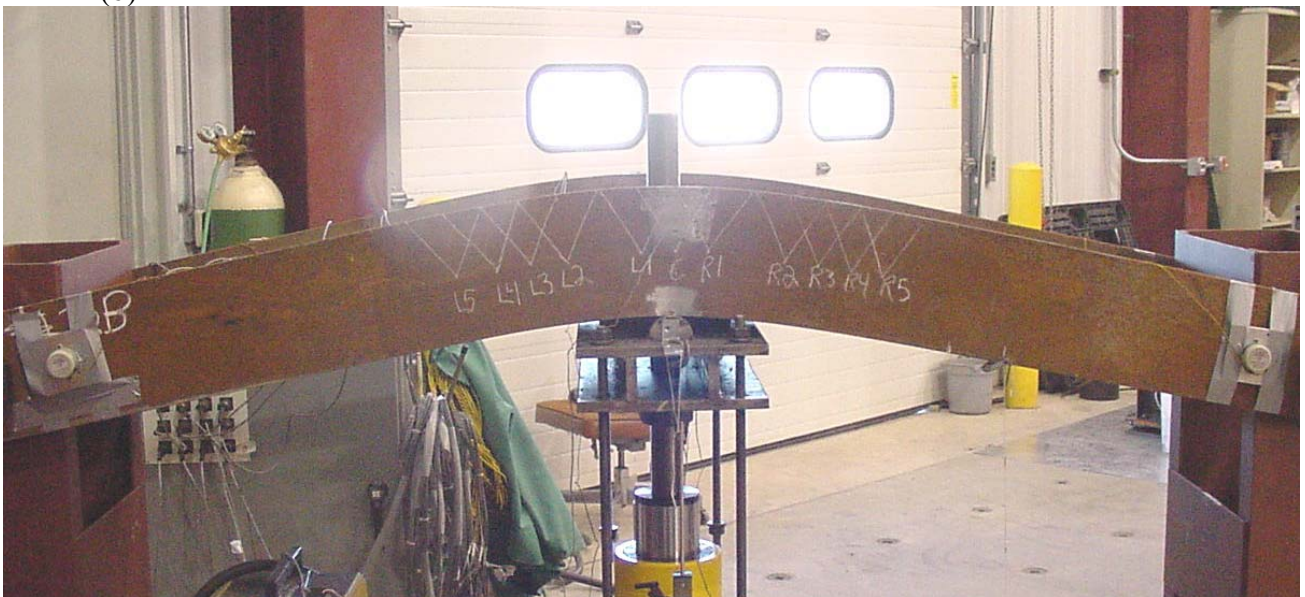
Figure 8.15
Before (a) and after (b) photographs of the first damage cycle of A7-Beam 2

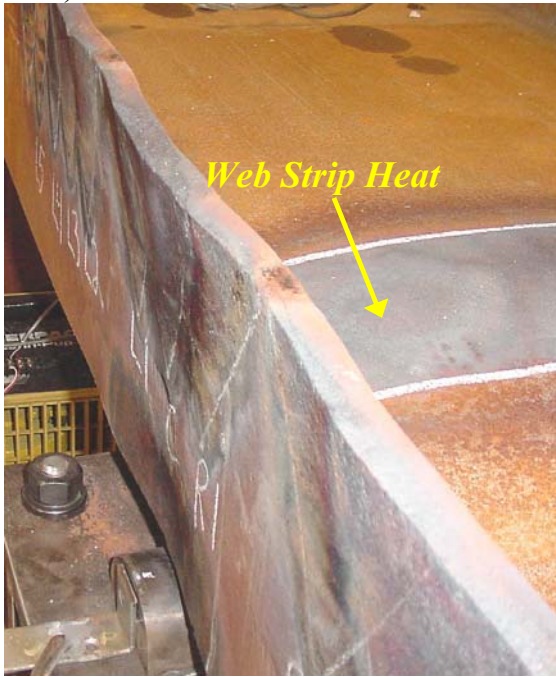
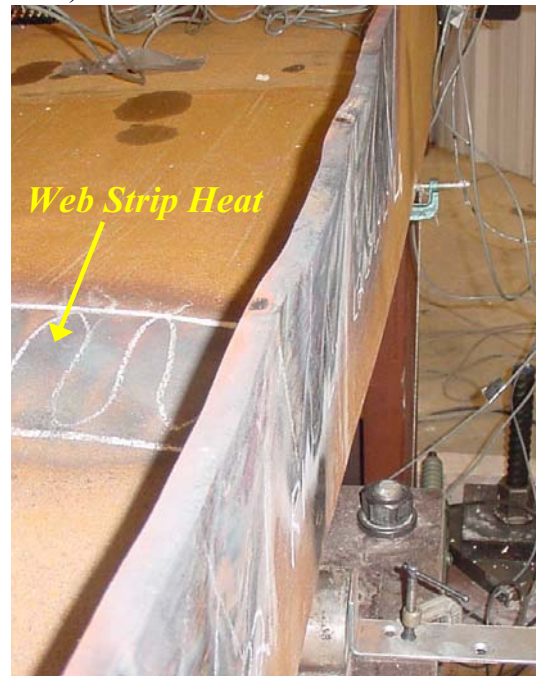
Figure 8.20
Location of strip heats applied to the web of A7-Beam 2

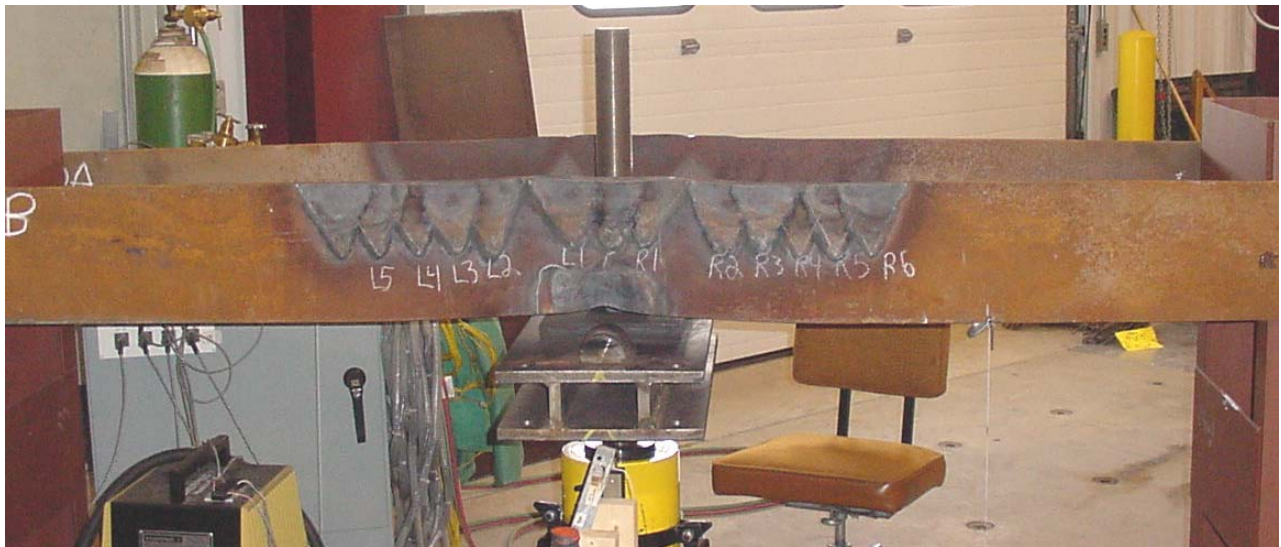
Figure 8.21
Front view of A7-Beam 2 after experimental investigations

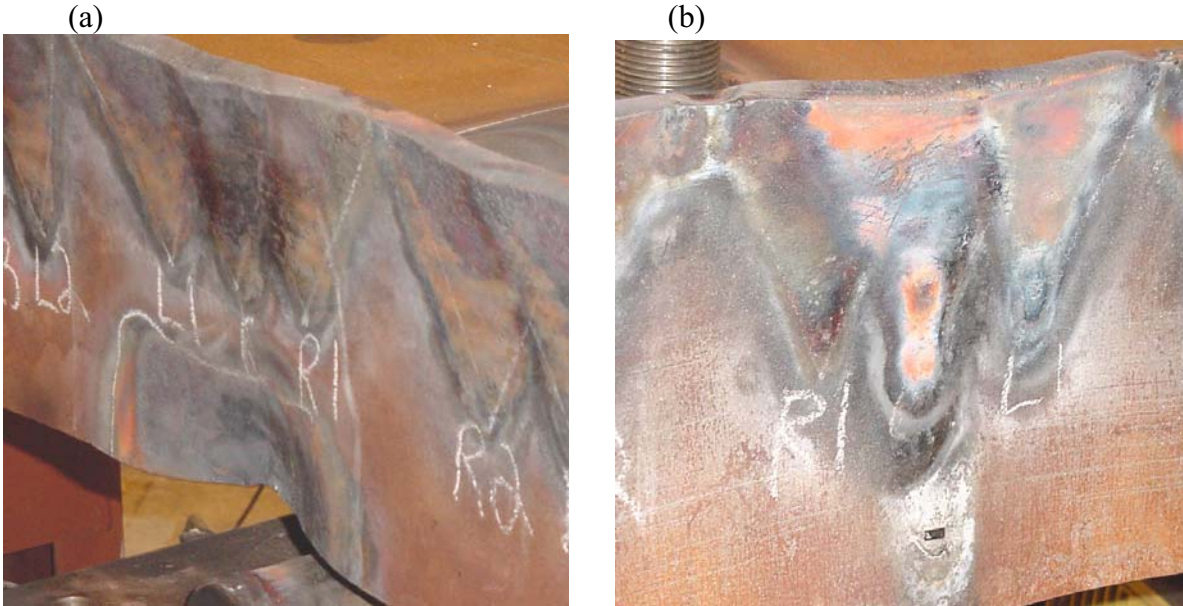
Figure 8.22
Condition of front (a) and back (b) flanges of A7-Beam 2 after repair cycle 3

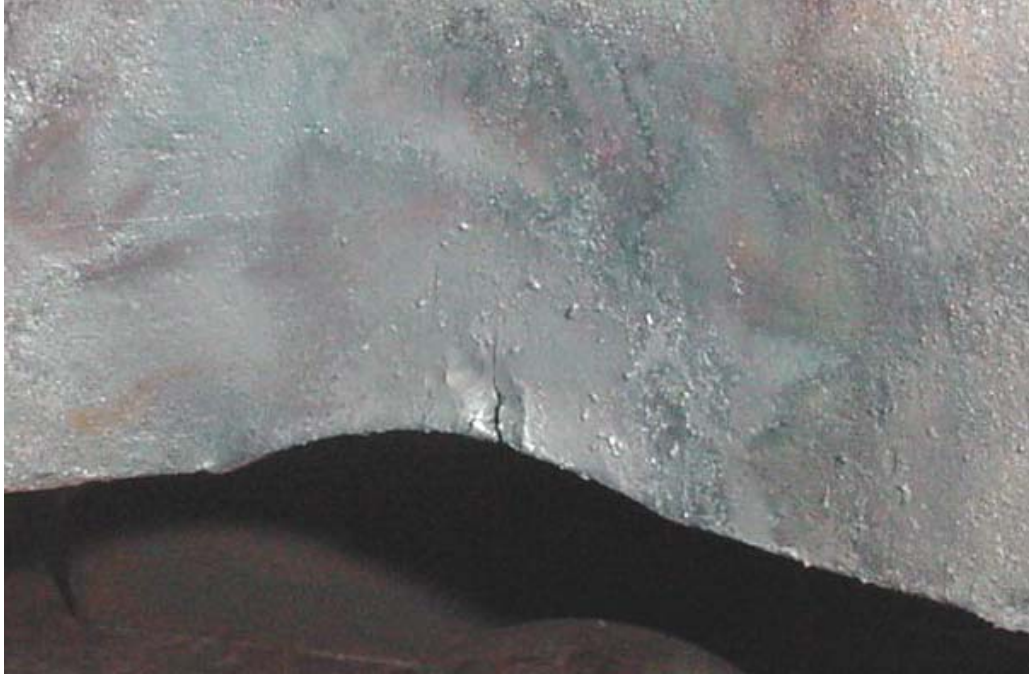
Figure 8.24
Fracture of the material at the buckled location of the front flange of A7-Beam 2

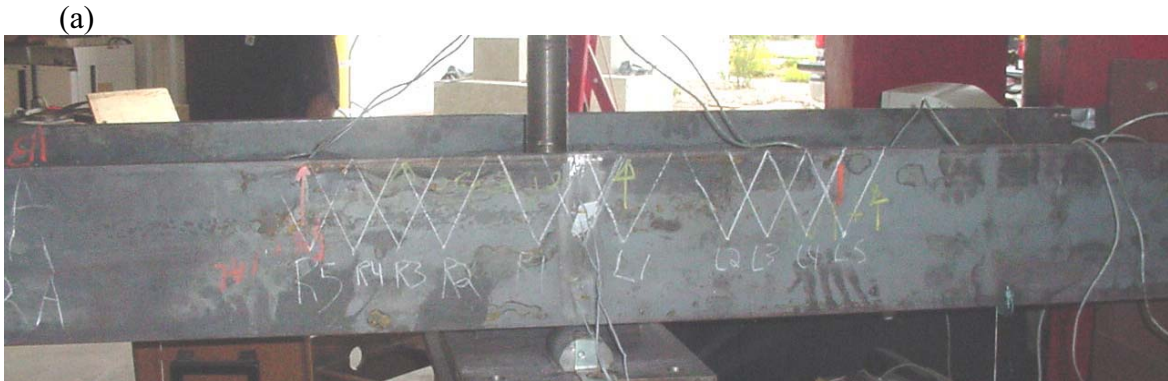
Figure 8.27
Before (a) and after (b) photographs of the first damage cycle of A36-Beam 1

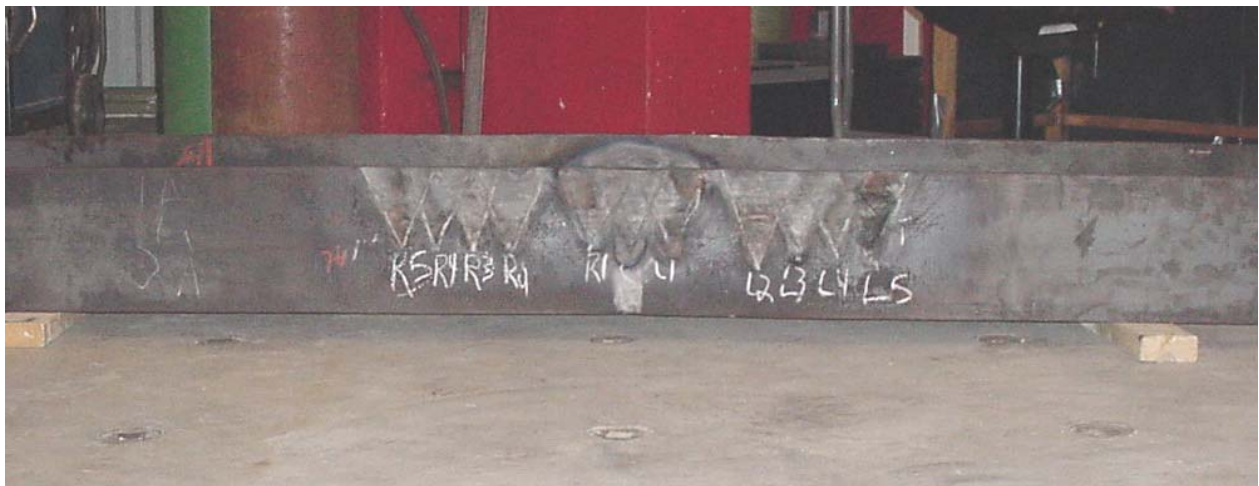
Figure 8.31
Frontal view of A36-Beam 1 after experimental investigations

- Figures 8.31 and 8.32 show the final condition of the beam specimen (A36-Beam 1) after three damage-repair cycles.
- Figure 8.31 shows the full beam span from the front side.
- Figure 8.32 shows the out-of-plane curvature of the flanges.

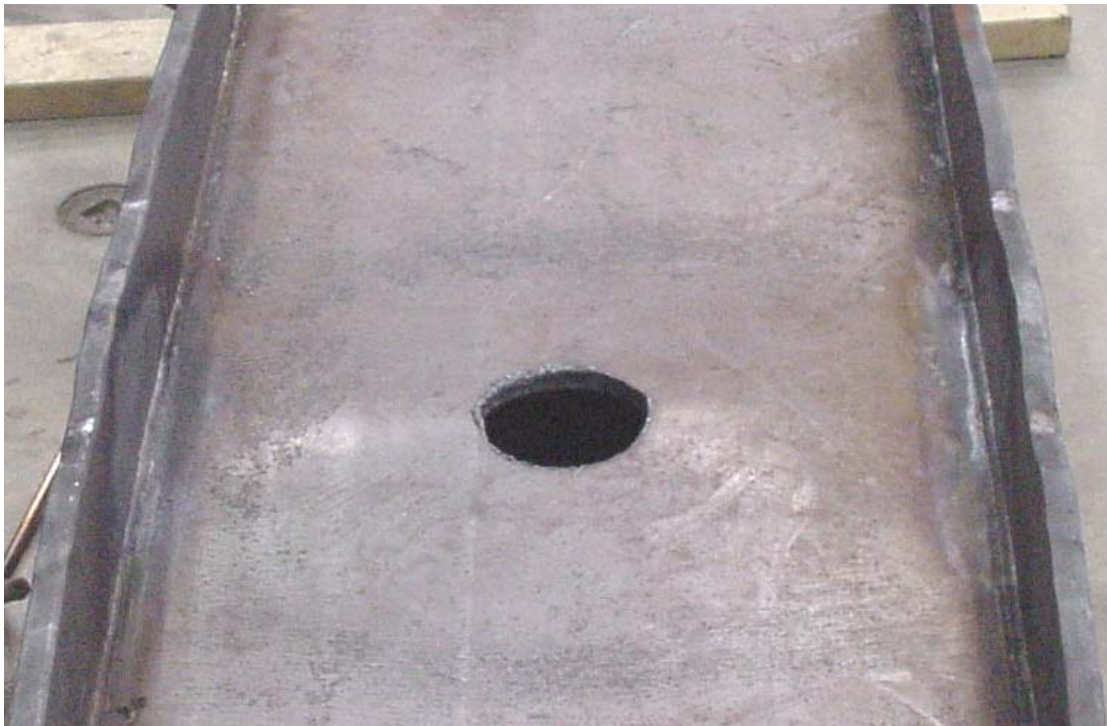
Figure 8.32
Lateral displacement of A36-Beam 1 after experimental investigations

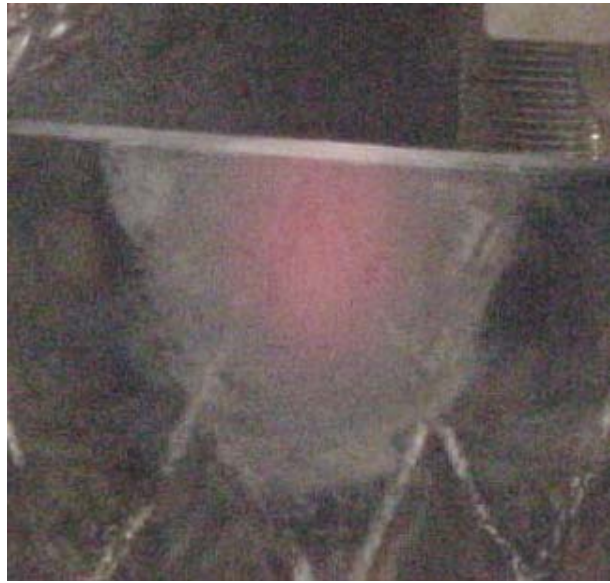
a) 1400 °F (A36-Beam 2)

b) 1200 °F (A36-Beam 1)

Figure 8.36
Color of A36 steel at maximum heating temperatures

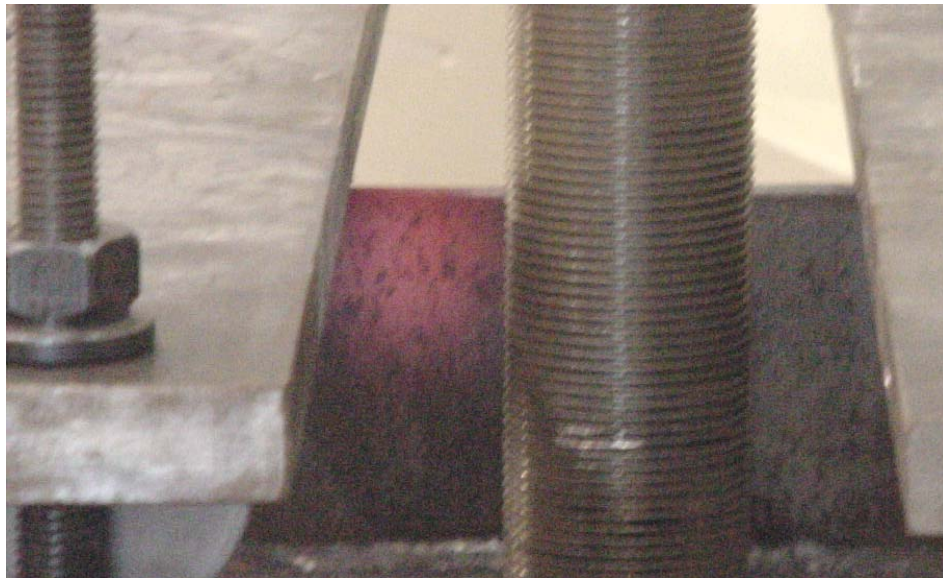
Figure 8.37
Opposite side of Vee heated to a maximum temperature of 1400 °F

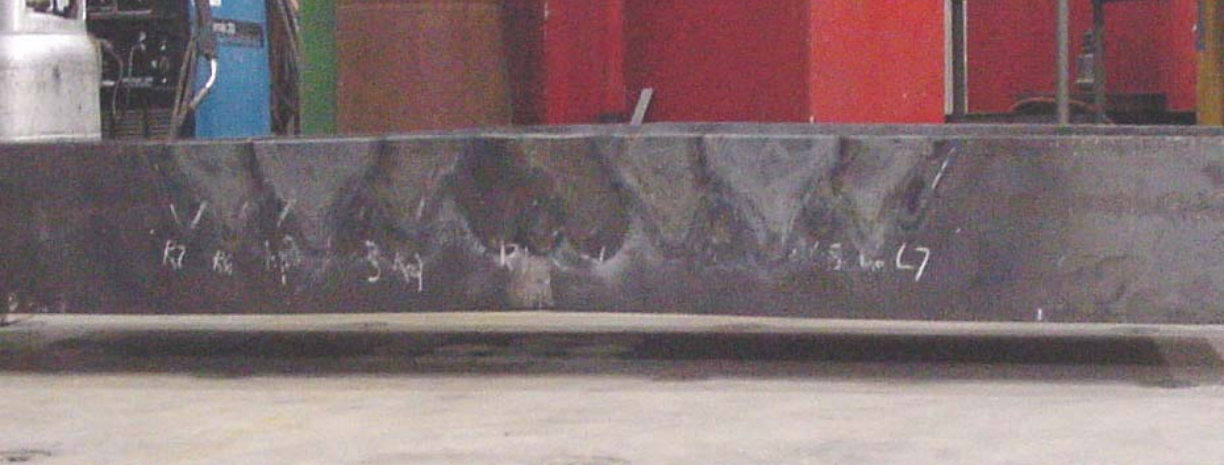
Figure 8.40
Front view of A36-Beam 2 after experimental investigations

- Figures 8.40 and 8.41 show the final condition of the beam specimen (A36-Beam2) after three damage-repair cycles.
- Figure 8.40 shows the full beam span from the front side.
- Figure 8.41 shows the out-of-plane curvature of the flanges.
