**EFFECTS OF MULTIPLE DAMAGE-HEAT
STRAIGHTENING REPAIRS ON THE STRUCTURAL
PROPERTIES OF BRIDGE STEELS**

FINAL REPORT

**Report No. RC-1456
Sponsored by Michigan Department of Transportation**

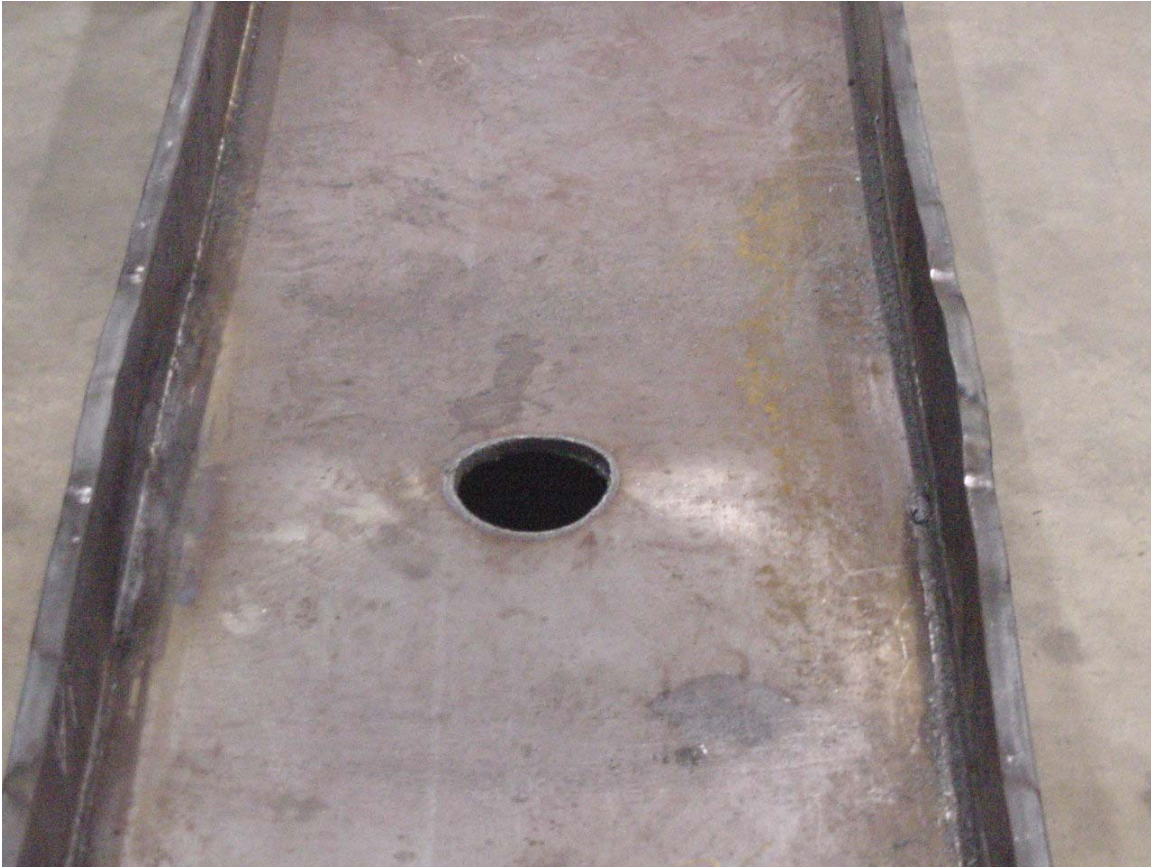
Figure 8.41
Lateral displacement of A36-Beam 2 after experimental investigations

- Figures 8.40 and 8.41 show the final condition of the beam specimen (A36-Beam2) after three damage-repair cycles.
- Figure 8.40 shows the full beam span from the front side.
- Figure 8.41 shows the out-of-plane curvature of the flanges.

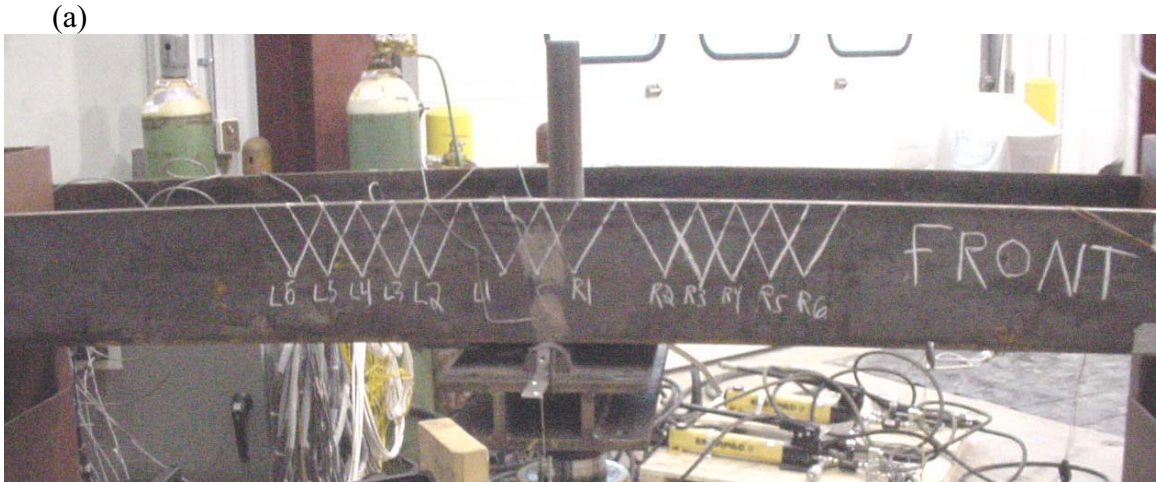
Figure 8.44
Before (a) and after (b) photographs of the first damage cycle of A588-Beam 1

mill scale at smaller damage strains. The conditions of A588-Beam 1 around $4 \varepsilon_y$ and after the first damage cycle are shown in Figures 8.44(a) and (b), respectively.

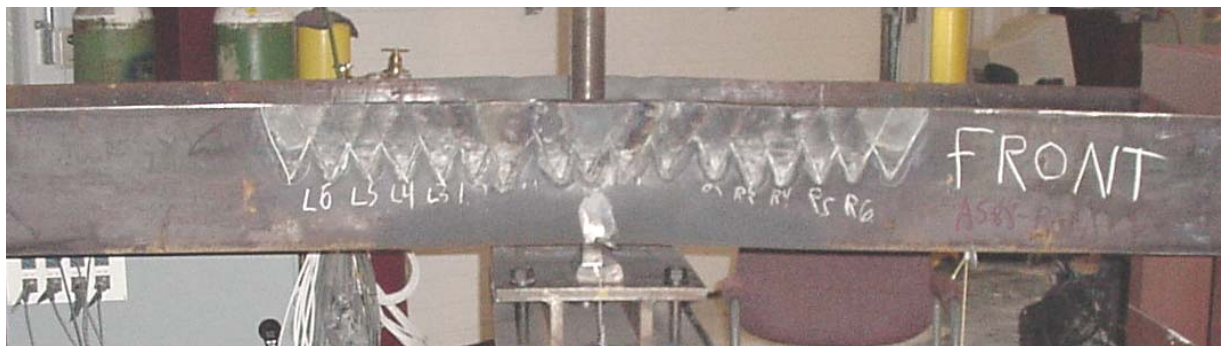
Figure 8.50
Front view of A588-Beam 1 after experimental investigations

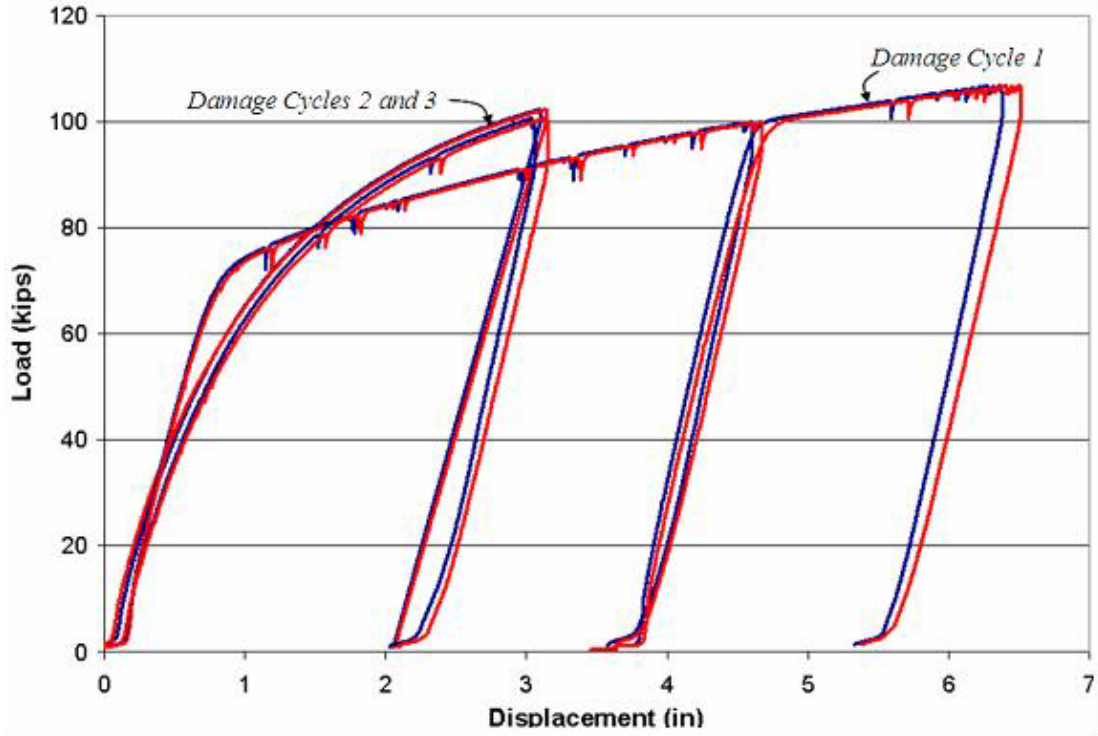
Figure 8.54
Load-displacement behaviors of all three damage cycles of A588-Beam 1

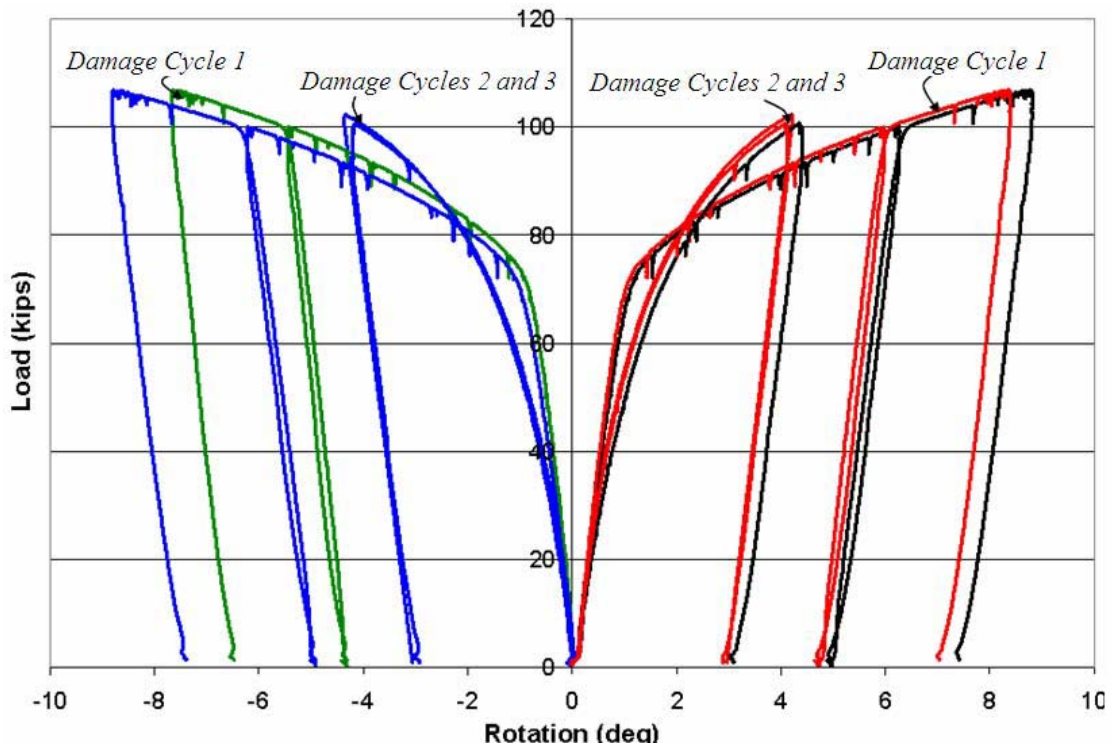
Figure 8.55
Load-rotation behaviors of all three damage cycles of A588-Beam 1

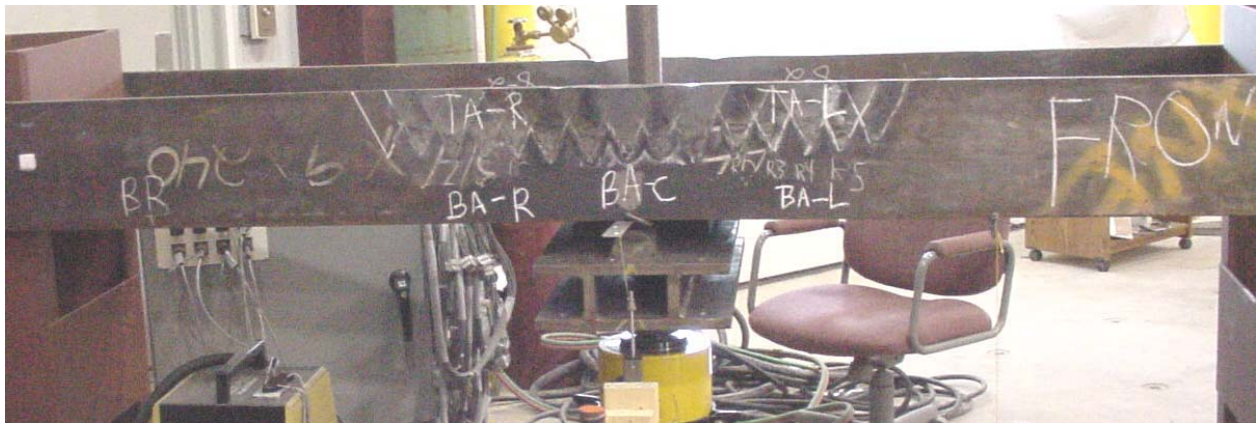
Figure 8.59
Front view of A588-Beam 2 after three damage-repair cycles
