AN INVESTIGATION OF HIDDEN FORM LINING

Research Laboratory  
Testing and Research Division  
Report No. 127  
April 1, 1949

An investigation of Hydron Form Lining.

To compare the surface texture and hardness of concrete cast in contact with Hydron form lining and oiled plywood respectively.

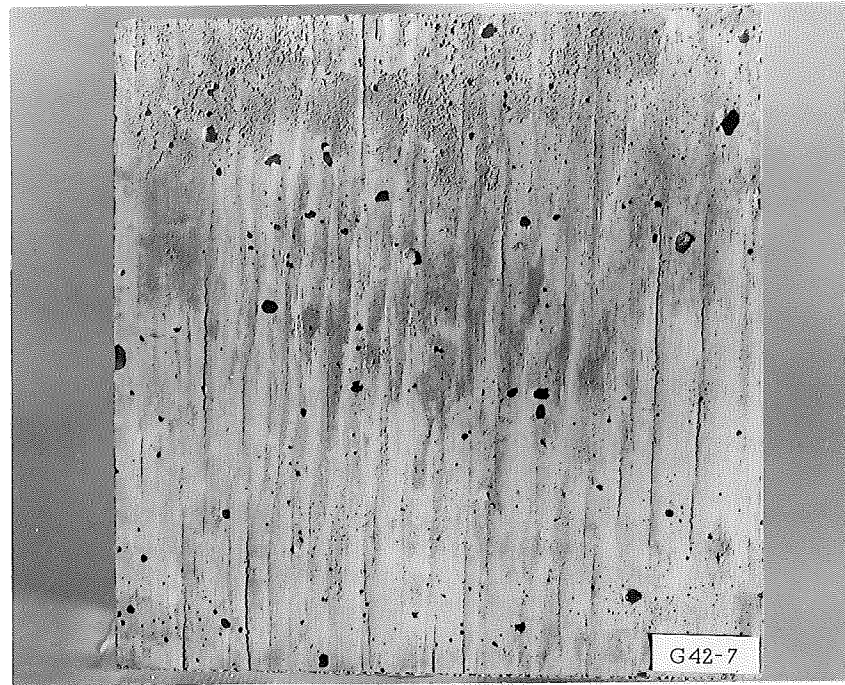
Figure 4. Surface showing effect of warping and cracking of plywood after being used six times.

- (b) The plywood also imparted a smooth surface to the concrete (Figure 3) but began to exhibit signs of deterioration by the 7th block (Figure 4).
- (c) The concrete blocks were vibrated without hand spading or puddling and a considerable number of air pockets developed in all surfaces. This is believed due to the vibrator which was a 2 inch high frequency electric type and the relatively narrow section of concrete. Areas of the least number of air pockets were selected for grinding.
