Investigate Causes and Develop Methods to Minimize Early-Age Cracking on Bridge Decks

(Michigan Department of Transportation)

Project: Investigate Cause and Develop Methods to Minimize Early-age Deck Cracking on Michigan Bridge Decks

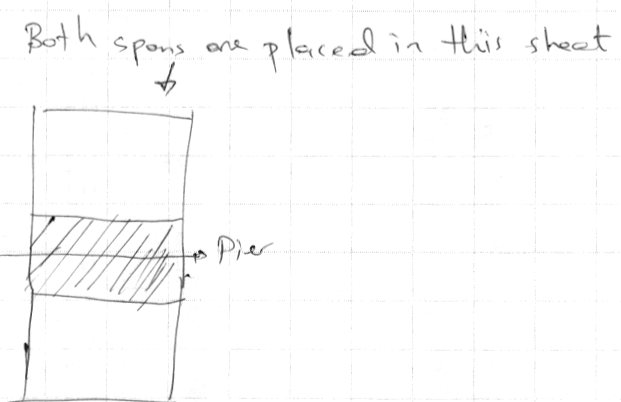
② Pump stopped @ 10:09 started 10:36

③ Stopped @ 10:44 started 10:46

WEST

EAST

Concrete will be covered with the burlap in the morning. Otherwise the texture will be damaged.
