Issue Number 91

October 2000

Restoring Portland Cement Concrete

MDOT Investigates Dowel Bar Retrofit Procedure for Improving and Preserving Load Transfer at Cracks

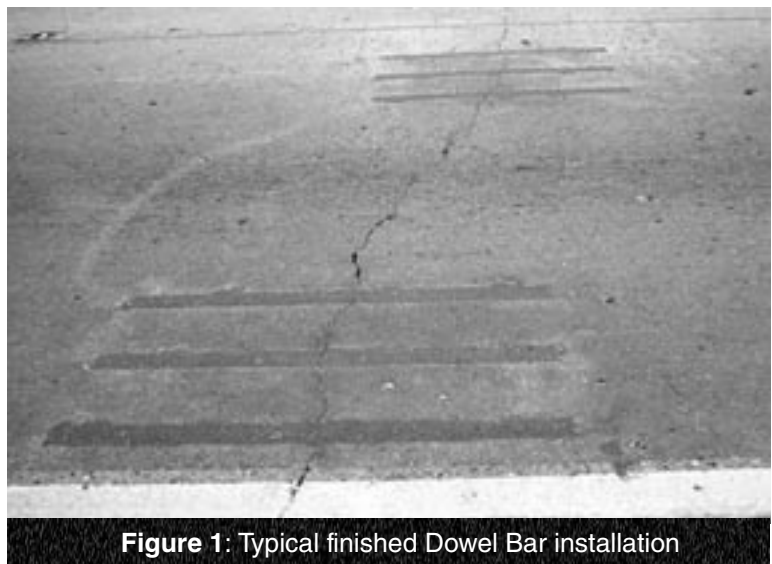
Figure 1: Typical finished Dowel Bar installation

This method of repair has been used throughout the country since the early 1990’s, but it has been most extensively used in Washington in that time frame. Given the success that has been reported from other transportation agencies, MDOT began investigating the feasibility of adopting this method of pavement repair. Unlike the other methods of repair that simply mask the problem, dowel bars restore the load transfer abilities by effectively joining the two adjacent sides of the crack together. See Figure 1 for an example of relative placement and appearance of dowel bar retrofit in a roadway.

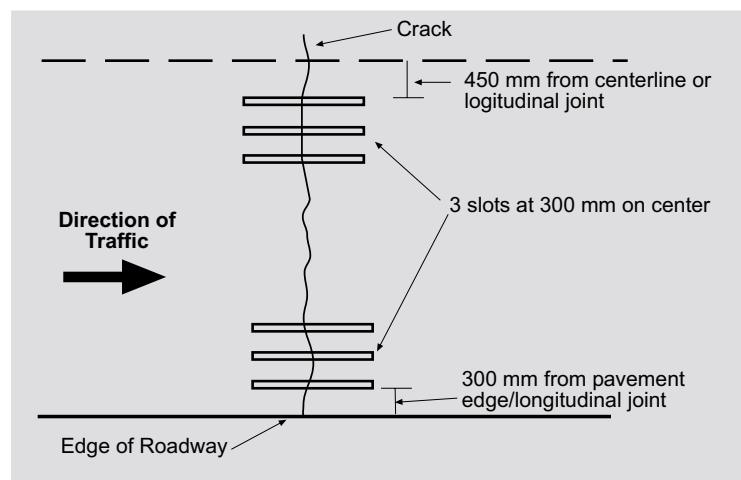
Figure 2: Location of Dowel Bars in relation to the roadway

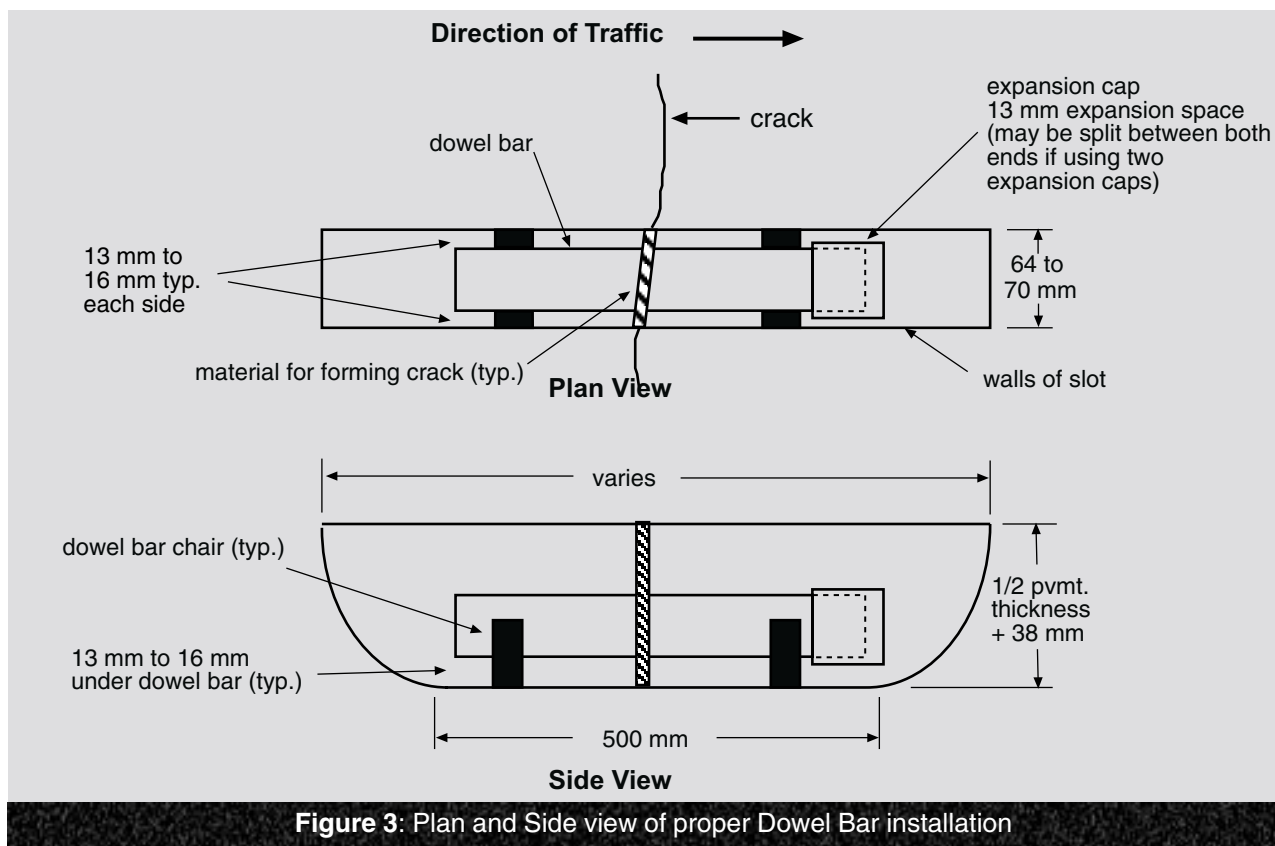
Figure 3: Plan and Side view of proper Dowel Bar installation

1. Slot Cutting - The slots shall be cut using a drum-type carbide machine or a diamond-bladed saw machine. The machine shall be capable of cutting a minimum of three slots simultaneously that are centered over the crack. Three slots will be made in each wheel path across each crack designated by the Engineer as shown in Figure 2. They shall be cut parallel to each other and with the longitudinal joints to the dimensions shown in Figure 3. Slots shall also be centered over the crack or as directed by the Engineer. If the crack wanders, the slots shall be cut to have at least 150 mm of the dowel bar on each side of the crack.

5. Dowel Bar Placement - After final cleaning, the crack shall be sealed with a bond breaker tape or joint sealant to prevent the patching material from entering the crack. The chairs shall be made and situated for the dowel bars to be aligned in the center of the slot, horizontal, and lay 13 mm to 16 mm off the bottom of the slot. When aligned correctly, dowels shall be true to the pavement surface and parallel to the pavement centerline. When using one expansion cap, it shall be fitted on the trailing end of the dowel bar as shown in Figure 3. Total expansion capability, whether using one cap or two, shall be 13 mm. Please refer to Figure 4 for an example of dowel bars with one expansion cap, placed on chairs and ready for installation into the slots.

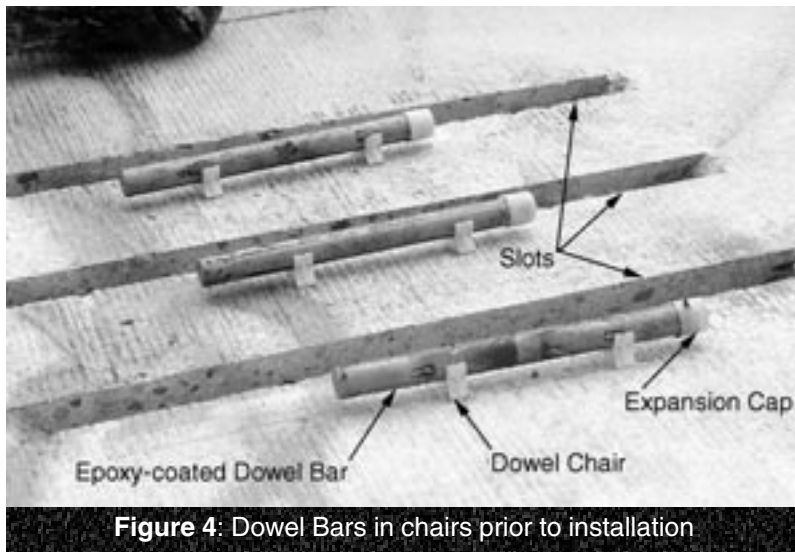
Figure 4: Dowel Bars in chairs prior to installation
