BULKHEAD JOINTS FOR CONCRETE BASE SHOULDERS

Progress Report on a "Category 2" Experimental Construction Project

**Research Laboratory Section
Testing and Research Division
Research Project 70 F-117
Research Report No. R-857
(Work Plan No. 11)**

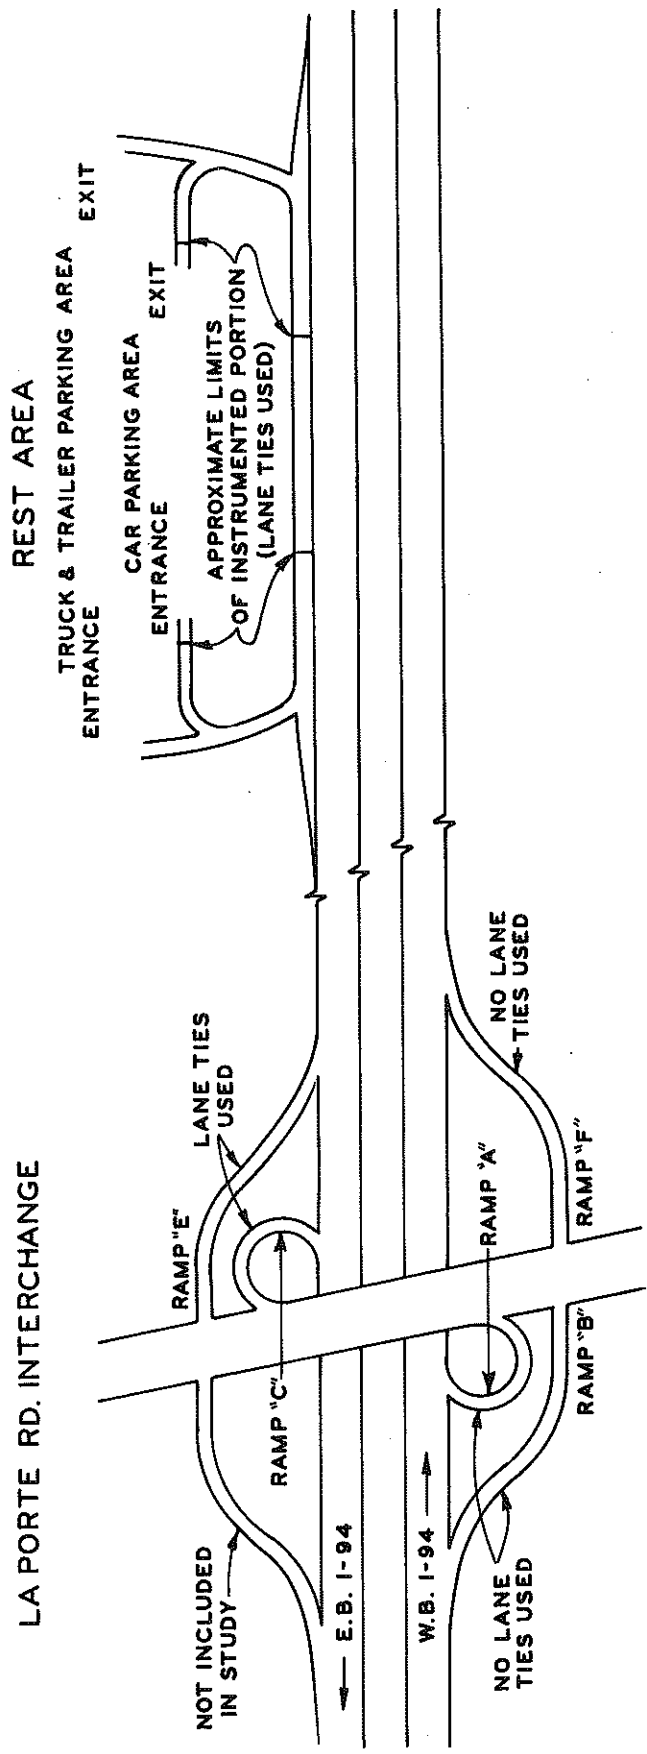
Figure 1. LaPorte Rd interchange and rest area showing location of instrumented ramps.

Hookbolt lane ties were installed in the concrete base course widening for the rest area and ramps C and E of the LaPorte Rd interchange on State Project BI 11014-010 (Fed. No. I 94 - 1 (26) 0) I 94 near the Indiana State Line. The lane ties were placed by authorization on the original contract. Ramps A, B and F of the same interchange, which were added under State Project BI 11014-012, have no lane ties, and are being used as control sections. Figure 1 shows the location and lay-out of the experimental and control ramps.

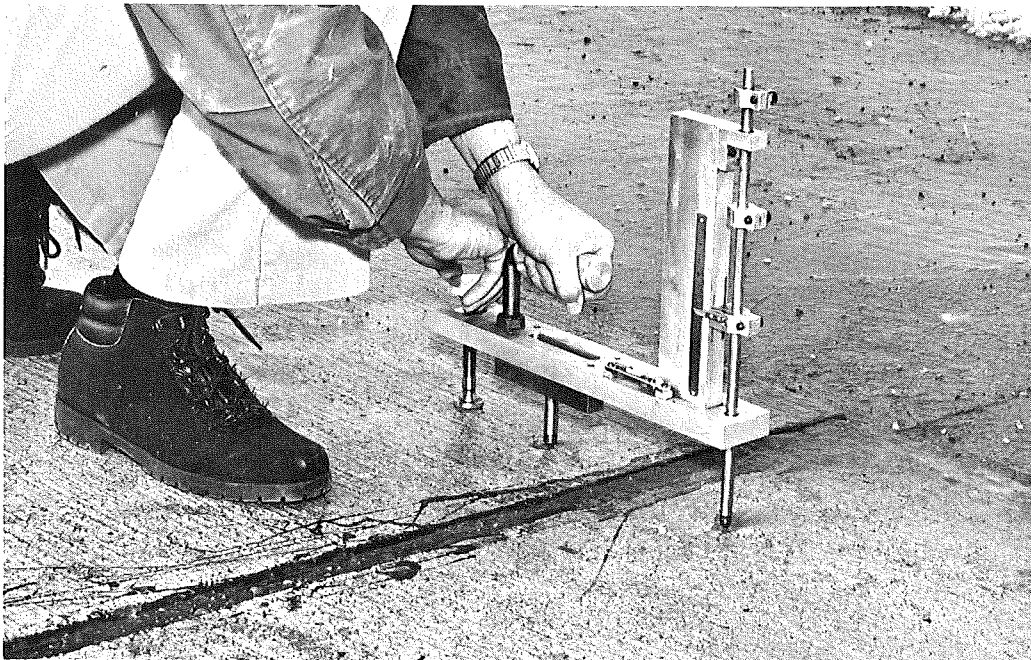
Figure 2. Special fixture for measuring faulting of joint.

Measurements for joint opening and faulting are made across the longitudinal bulkhead joint. Joint opening measurements are made with a vernier caliper, and fault measurements with the special fixture shown in Figure 2. The two forward legs of the instrument are set in the rivets, the rear leg is adjustable and is used to level the device. A reading is then taken from the scale on the right side of the fixture. Changes in reading from one time to another indicate a relative vertical displacement of positions of the roadway and shoulder.
