**THE STRUCTURAL CHARACTERISTICS OF  
A PLASTIC FIBERGLASS OVERHEAD SIGN SUPPORT STRUCTURE**

Research Laboratory  
Office of Testing and Research  
Report No. 293  
Research Project 54 G-73

Michigan State Highway Department  
John C. Mackie, Commissioner  
Lansing, June 15, 1958

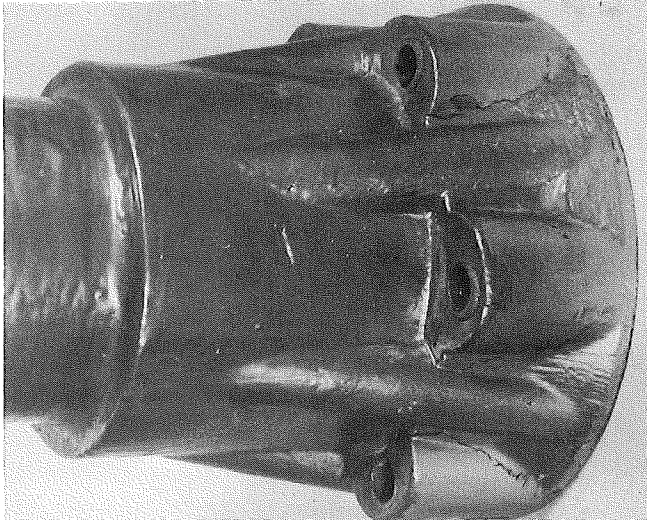
Figure 5. Typical failures of each of the two types of plastic fiberglass chord connections after ultimate tensile load tests, the chord-to-chord connection above and the diagonal-to-chord connection at right.

The results of the tensile tests on both the chord-to-chord and diagonal-to-chord connections are shown in Table 1. Photographs of a typical failure of each of the two types of connection are shown in Figure 5.
