Improved Shallow Depth Patches for Concrete Structures

Final Report to the Michigan Department of Transportation

February 2008

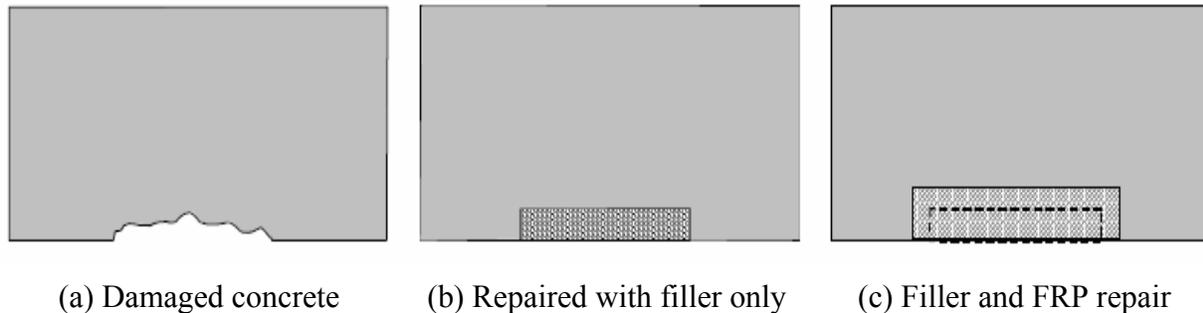
Figure 1-1: Concept of improved dual filler-and-FRP shallow depth patches

MDOT. On the other hand, the use of fiber-reinforced polymer (FRP) fabrics applied in a “band-aid” fashion over traditional patching materials that are currently used, has a very strong potential to provide highly durable patches (see Figure 1-1).

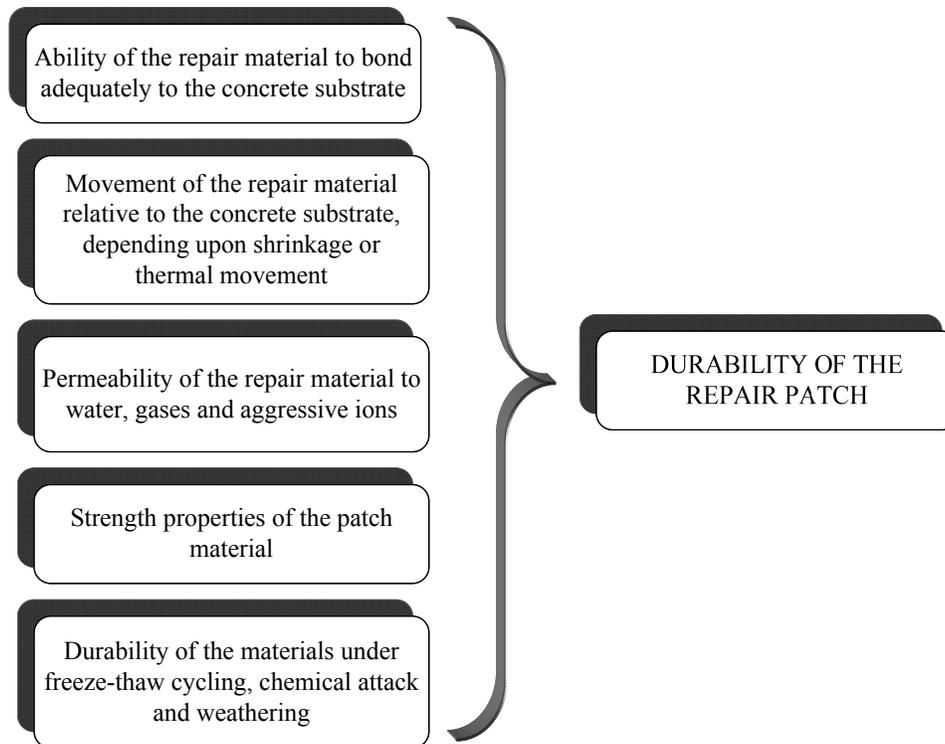
Figure 2-1: Material factors contributing to the long-term performance of the patch (Rizzo and Sobleman, 1989a)

The material properties that most influence the selection of patch repair materials include shrinkage strain, bond strength, modulus of elasticity, and tensile and shear strength (REMR Technical Note, 1994). The long-term performance of the patch materials is the key consideration while comparing different alternatives. There are numerous material factors that affecting the long-term performance of the patch, as illustrated in Figure 2-1.

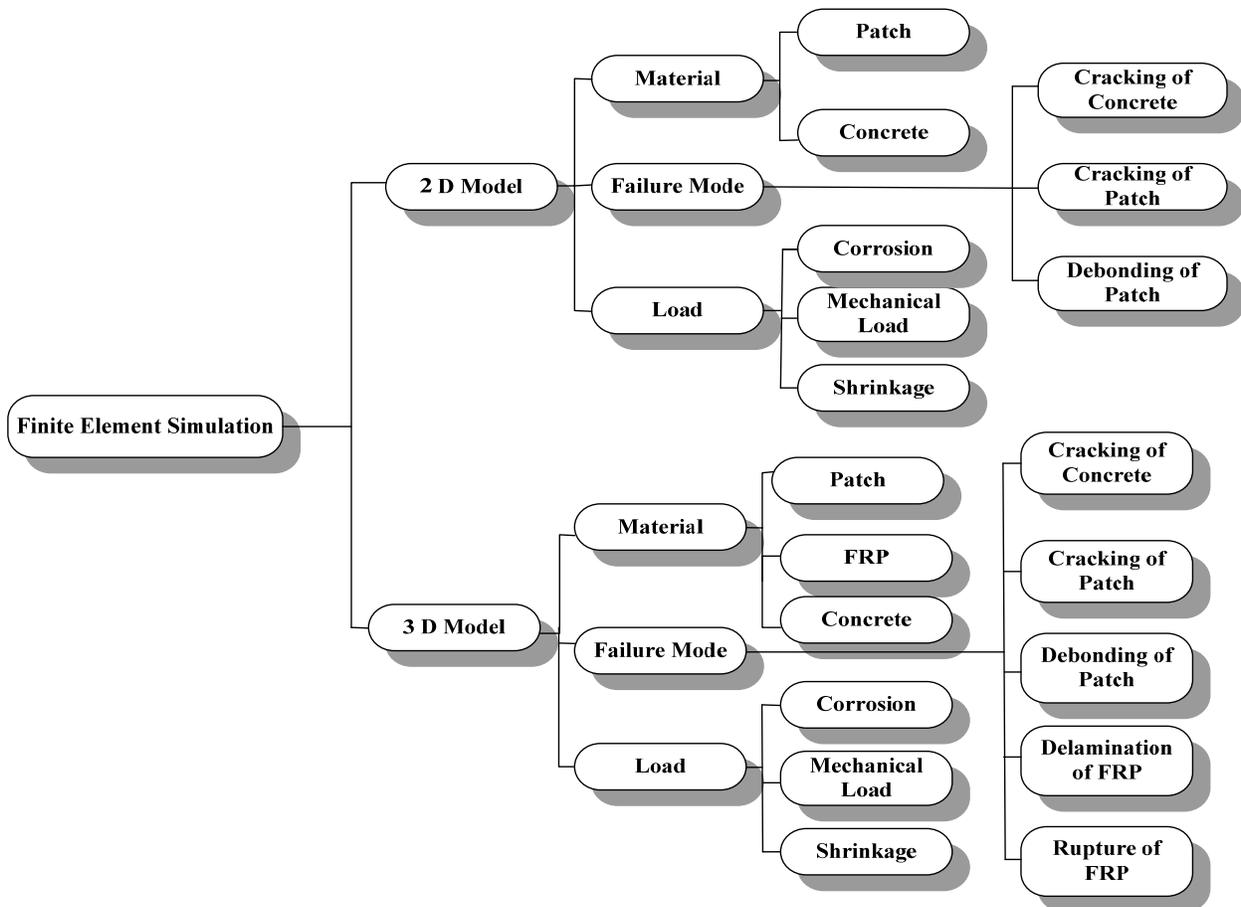
Figure 3-1: Finite element evaluation matrix

This chapter presents the development of finite element models to evaluate and predict the effect of restrained shrinkage, corrosion, and mechanical load on the repair materials and the concrete substrate. The ABAQUS general purpose finite element package was used for all the analysis. The main goal of the numerical studies was to choose a layer of FRP that can sustain all the above loading and prevent further damage on the patch material. Figure 3-1 illustrates the various types of analyses performed using 2-D and 3-D finite element models.

2-D models were used to study the effect of different loading on the repair material and concrete substrate when the FRP overlay was not used. 3-D models were used to select optimally configured layers of FRP on damaged patches. The major limitation of experimental investigation is that they cannot provide detailed information regarding the type of damage in the patch material. The experimental results can indicate the amount of damage in the patch, but often micro cracking cannot be detected and more importantly the cause of each type of damage in the patch material such as cracking or debonding cannot be inferred. In light of these limitations numerical models and results can provide a better understanding of the behavior of the patch material and FRP overlay under different loading conditions.

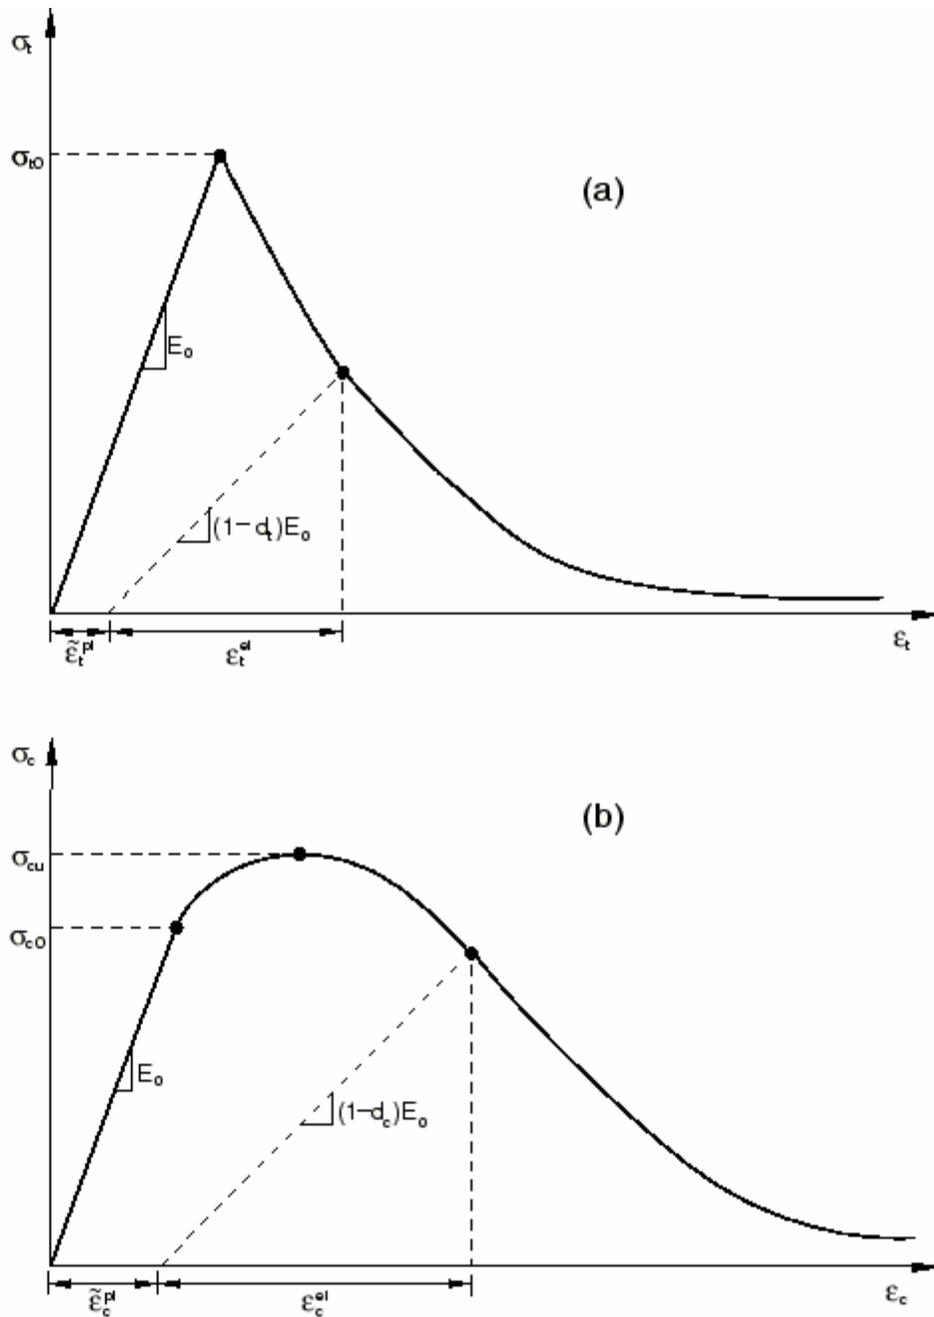
Figure 3-2: Typical concrete uni-axial stress-strain curve in (a) tension and (b) compression (ABAQUS User Manual)

The damage plasticity model is very versatile and capable of predicting the behavior of concretes structure subjected to monotonic, cyclic and/or dynamic loading. It assumes the main failure mechanism of tensile cracking and compressive crushing in compression, and uses the multi-axial plasticity model with a non-associated flow rule and isotropic strain hardening. In tension the model uses a multi-axial damage elasticity model. Concrete in tension is considered as a linear-elastic material until the uni-axial tensile stress, f_t , at which concrete crack is attained and softening behavior is assumed thereafter. A linear softening model is used to represent the post-failure behavior in tension.

The softening rate depends on the post-failure behavior in tension. In the analysis for mechanical loading the number of failed elements was large, because of the high tensile stress; ABAQUS does not have any provision to model the possible high crack widths and the analysis

terminated and prematurely. To resolve this problem, a large tension stiffening value was used to continue the analysis up to the failure. It should also be noted that after initial tension cracking in the concrete the tensile strength of the concrete can't be ignored. Therefore the concrete was modeled as an elastic-plastic material with different properties in tension and compression. The behavior of the model in uni-axial tension and compression is shown in Figure 3-2. Figure 3-3 shows the combined uni-axial stress-strain curve.

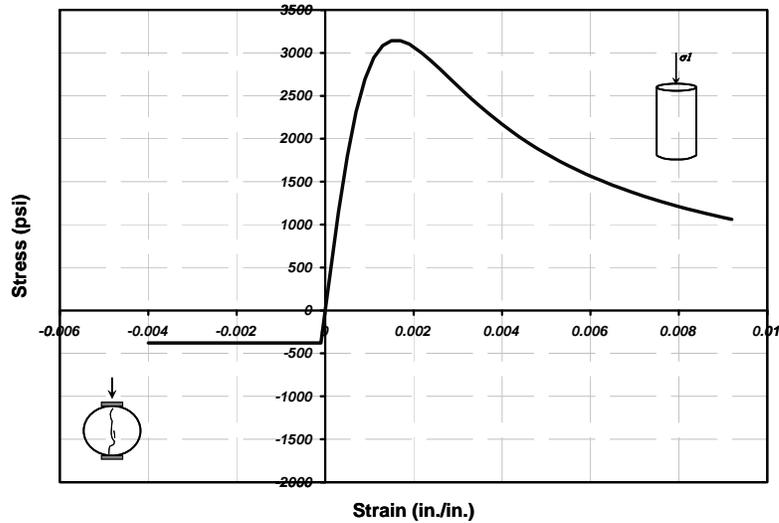
Figure 3-3: Stress-strain curve used for concrete

The uni-axial compression stress-strain curve was defined using the Todeschini empirical stress-strain model. A typical uni-axial compressive and tensile stress-strain curve for 3500 psi concrete is shown in Figure 3-3. As explained earlier the concrete is assumed to have elastic-plastic behavior under the tensile loading.

The calculation for the dilation angle involves complex mathematical derivations, and assumptions using the yield surface of the concrete damage plasticity model. The dilation angle for unconfined concrete in this study was assumed to be 30 degree (30°). The bi-axial stress ratio and the tensile to compressive meridian ratio were assumed to be equal to 1.16 and 0.667, respectively.

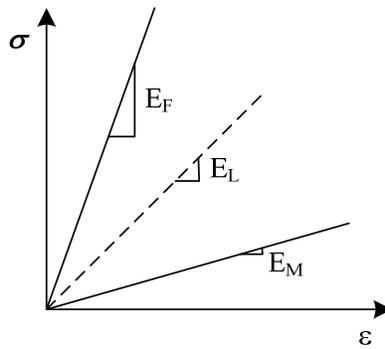
Figure 3-4: FRP stiffness calculation

$$E_L = E_F V_F + E_M V_M \quad (3-4)$$

where E_M and E_F are the matrix and fiber elastic modulus, respectively, and V_M and V_F are the volume fractions of the matrix and fiber, respectively. This equation is commonly called the “Rule of Mixtures” or upper bound theory.

This equation is accurate for composites under tensile loading, but can have a slight error for compressive loading since the fibers act like long columns that are restrained from buckling by the shear stiffness of the matrix.

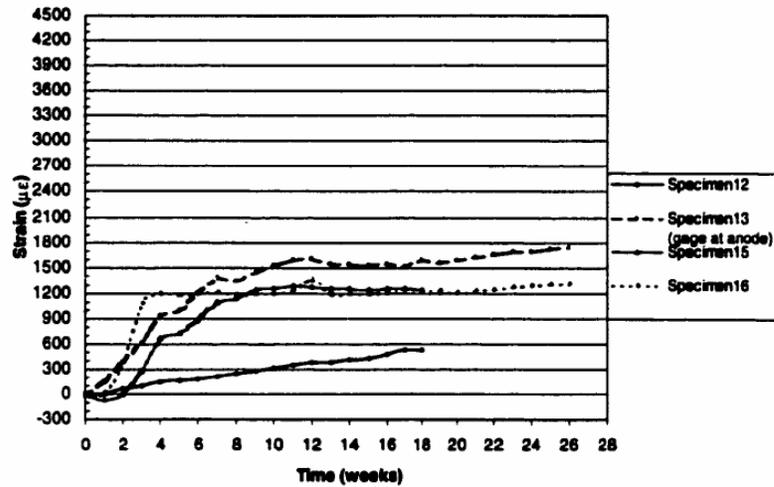
Figure 3-5: Hoop strain in carbon-wrapped specimens (Baiyasi, 2000)

When the reinforcement bars corrode, the corroded steel swells to about 4 to 6 times of its initial volume. However, some of the corrosion product is likely to fill pore voids within the concrete. The expansion induced by corrosion can only be obtained by calibrating with experimental data. In a previous MDOT project (Baiyasi, 2000) strains in FRP wraps were measured for wrapped concrete cylinders subjected to accelerated corrosion. Figure 3-5 shows how the measured strain varied with time.

Fig. 3.46 Hoop strains in bonded, carbon-wrapped specimens

The expansion strain was simulated in ABAQUS using a fictitious coefficient of thermal expansion and a fixed temperature change. The expansion strain was varied until the computed FRP strain was about 1600 $\mu\epsilon$ (maximum strain in Figure 3-5). The corresponding expansion strain applied to the cross section of the # 4 bar was 17500 $\mu\epsilon$.

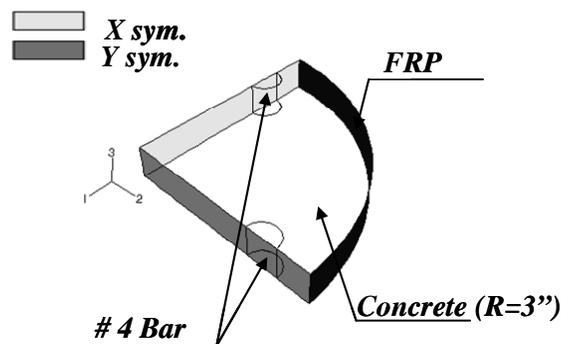
Figure 3-6: Boundary condition and geometry of corrosion specimen

A FE model of the carbon FRP wrapped concrete cylinders was developed, expansion strain was introduced into one steel bar (anode in the original experiment), and the hoop strain in the carbon FRP was computed.

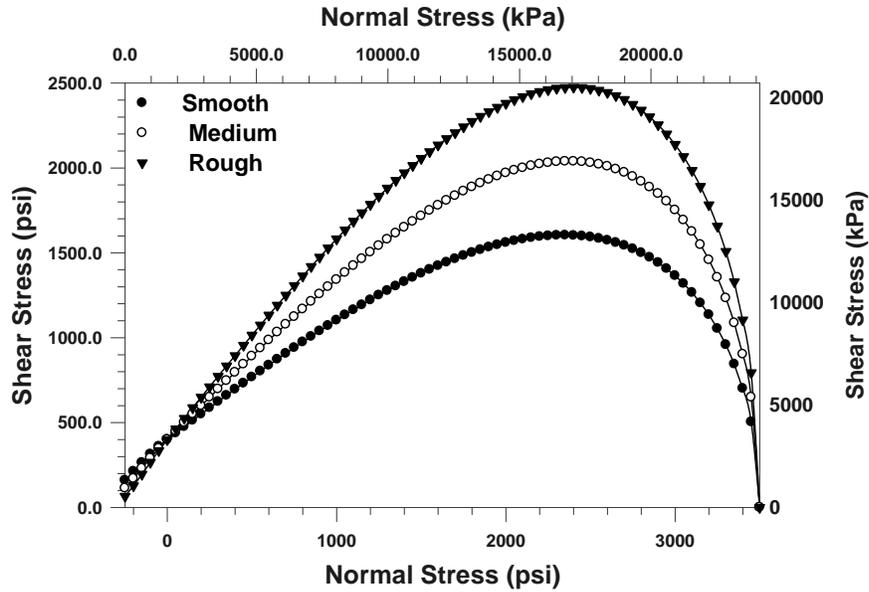
Figure 3-8: Bond failure envelope

Figure 3-8 shows the bond strength envelope for Material 2 based on information in the manufacturer's data sheet for three different surface preparations. The parameter c for Material 2 according to the material data sheet is 400 psi (obtained from direct Shear test-MDOT). Since the tensile and compression strength of Material 2, 600 psi and 5000 psi respectively, exceed the tensile and compression strength of the concrete substrate, 378 psi and 3500 psi respectively, σ_n in equation 3-6 is assumed to be 378 psi or 3500 psi, and failure is assumed to occur in the concrete rather than the patch material. The curves in Figure 3-8 represent the combination of τ_{ij} and σ_{ii} that yield $DI=1$, where τ_n is computed using equation 3-8.

$$DI = \sqrt{(\sigma_{ii} / \sigma_n)^2 + (\tau_{ij} / (C + \mu \times \sigma_{ii}))^2} \quad (3-10)$$

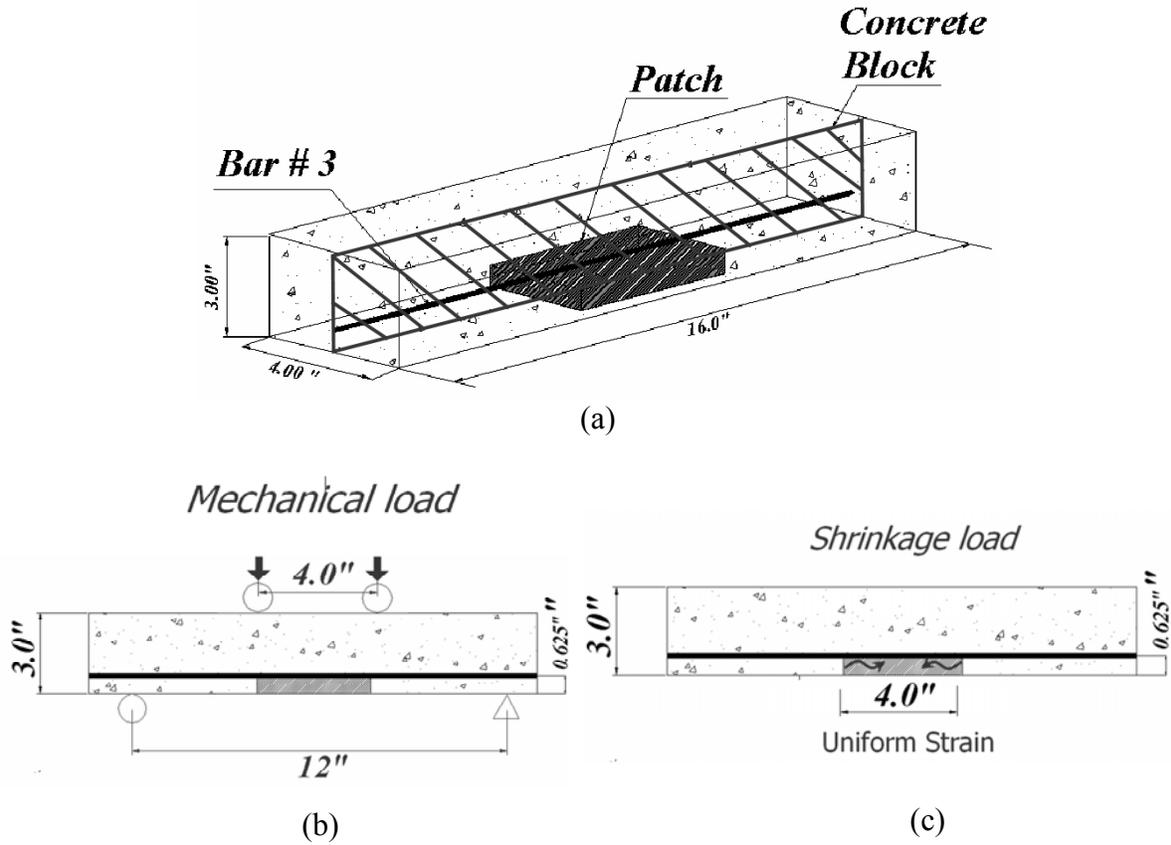
Figure 3-9: Shrinkage and mechanical load: (a) experimental unit, (b) mechanical load model, and (c) shrinkage load model

The model consisted of a simply supported beam with a #3 bar as flexural reinforcement for the shrinkage and mechanical load analysis. For a corrosion case, a concrete block with three #4 bars, two bars as anodes (corroding bars) half in patch and half in concrete, and one as a cathode (non-corroding bar) in concrete were used. Both models had a cavity at the bottom to model the patch. The mid-section of the beam was modeled in 2-D.

The geometry, boundary condition and repair patch are shown in Figure 3-9 and Figure 3-10 for mechanical, shrinkage and corrosion loads.

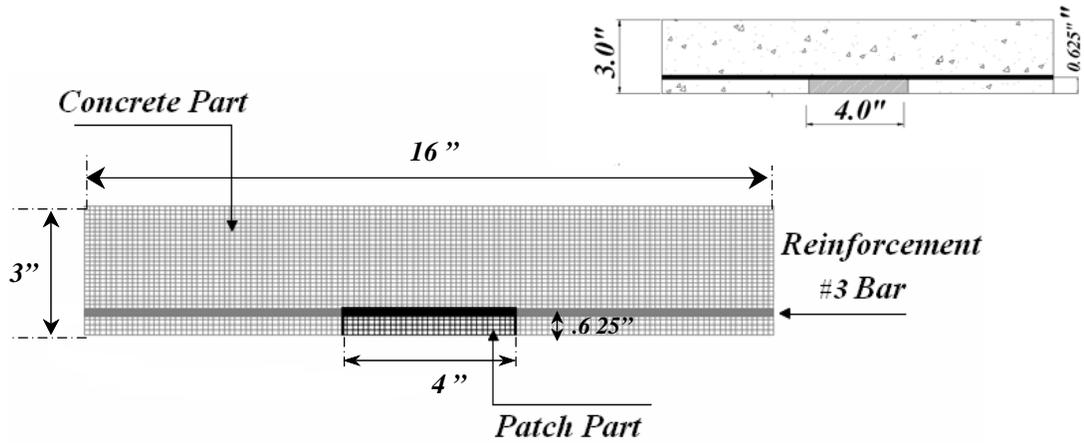
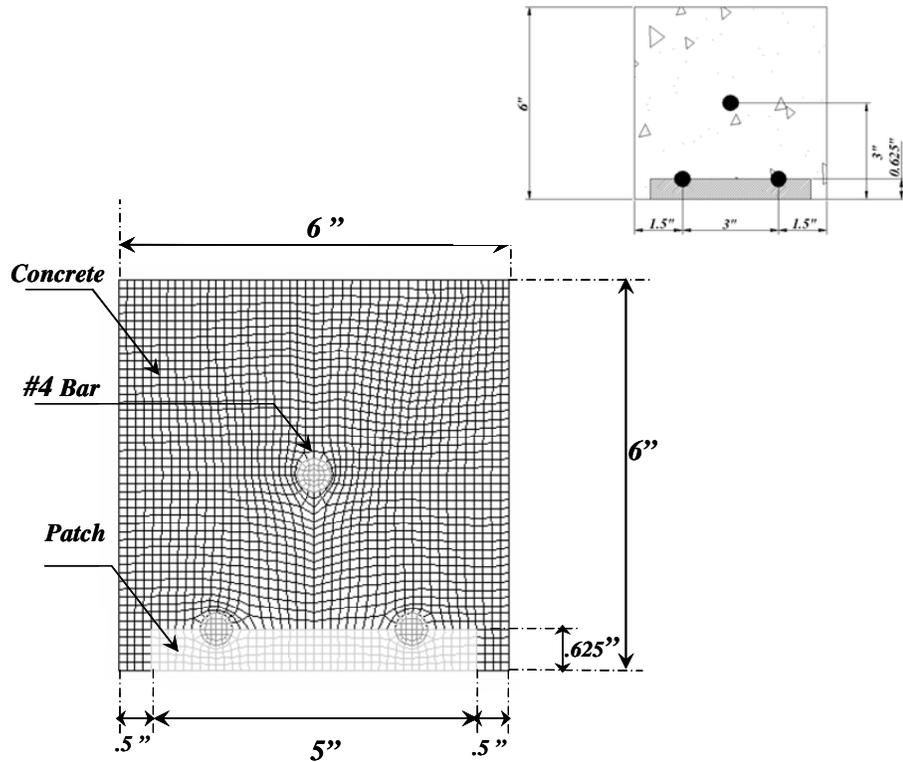
Figure 3-11: 2-D finite element model discretizations: (a) shrinkage and mechanical model, and (b) corrosion model

Figure 3-11 (a) and (b) shows typical 2-D FE mesh discretizations of the beam. The models consist of: a) a concrete part modeled with 4-node plane stress quadrilateral reduced integration elements (CPS4R), b) a repair patch with 4-node plane stress quadrilateral reduced integration elements (CPS4R), and c) a steel reinforcement part modeled with 2-node truss elements (B21) for the mechanical and shrinkage models and a 4-node plane stress quadrilateral reduced

integration element (CPS4R) for the corrosion model. CPS4R elements are versatile and can be used in simple linear analysis or complex nonlinear analysis involving contact plasticity.

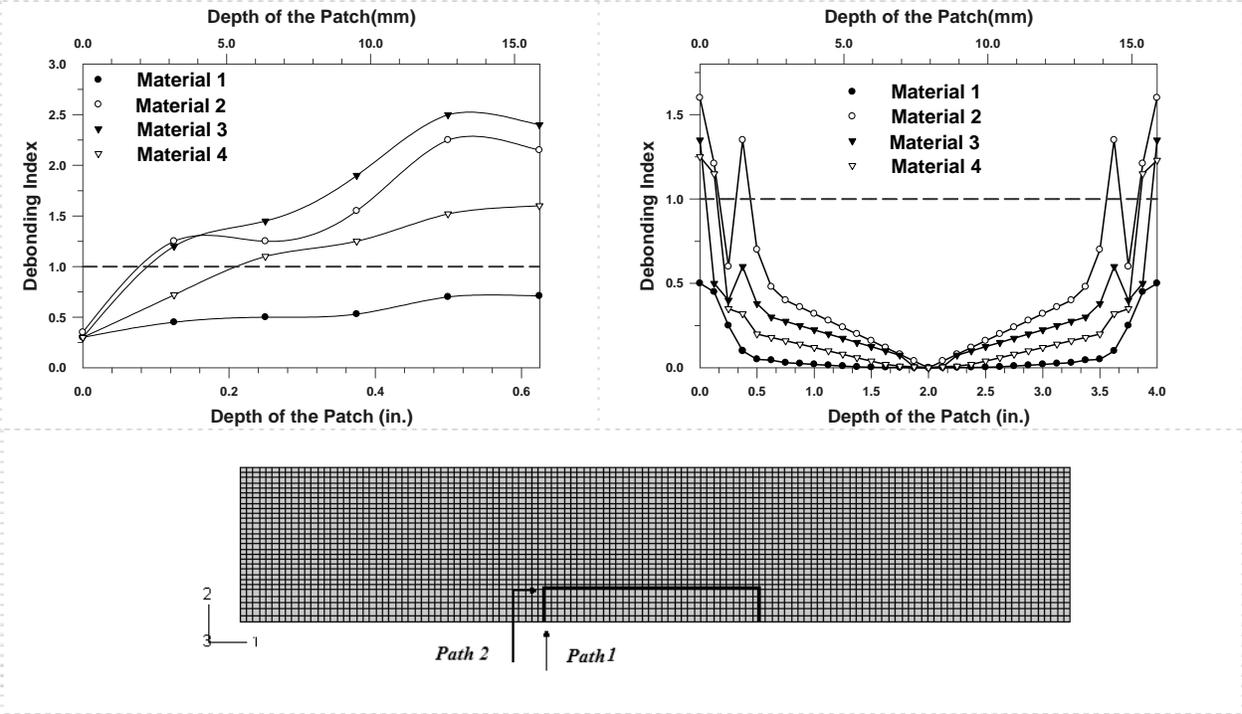
Figure 3-12: Debonding index along bond surfaces due to shrinkage

The stresses inside the patch and the status of the bond between the patch and concrete substrate were assessed by using debonding and tension crack failure indices. When the failure indices exceed unity, failure will occur. Figure 3-12 and

Figure 3-13 shows the FE results due to shrinkage along the patch. The debonding index (DI) is shown along the side and top bond surface, and tension crack index (TCI) is shown along the most critical vertical path located mid length of the patch. By comparing these figures it can be seen that tension-cracking failure occurs before debonding for Materials 2, 3, and 4. No debonding or tension crack failure is observed for Material 1.

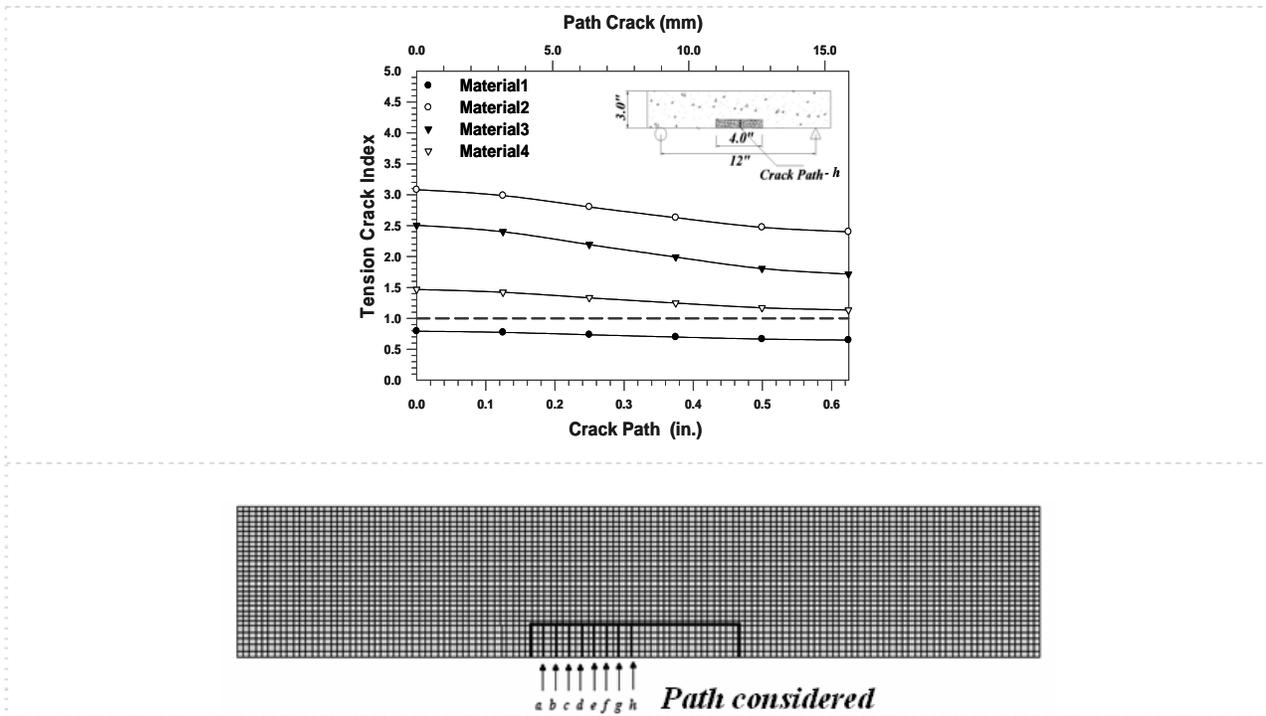
Figure 3-13: TCI along the most critical path (h)

The behavior of the patch bond status and the likelihood of other crack opening after initial cracking were studied by using the model with a pre-opened crack at the most likely location (path h). The conditions along the bond surfaces and inside the patch were evaluated by computing the debonding and tension crack indices.

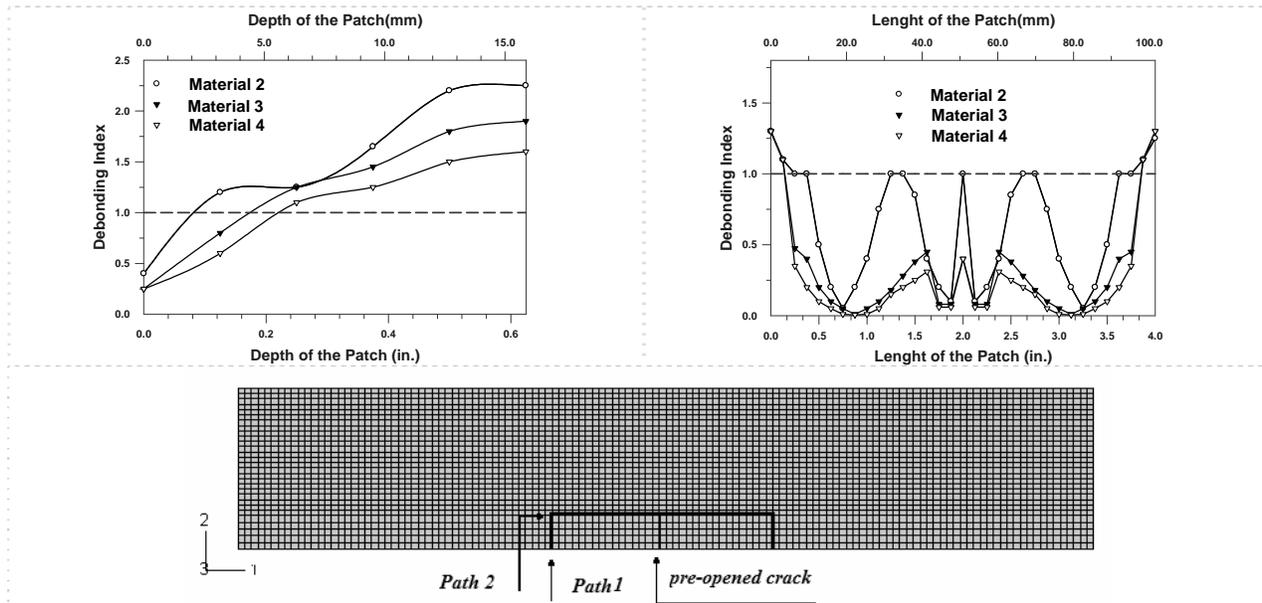
Figure 3-14: Debonding Index on the bond surfaces due to shrinkage after first crack

Since Material 1 did not show any tension cracking or debonding in the first analysis, only materials 2, 3 and 4 were considered in the second analysis. The DI, and TCI along paths 1, 2, and a through g are shown in Figure 3-14 and Figure 3-15, respectively.

Figure 3-14 and Figure 3-15 show that except for Material 2, which has a higher shrinkage strain compared to the other repair materials, the potential for multiple tension cracks on the top face of the patch is larger than the potential for debonding. Therefore, tensile cracks are likely to open randomly and prevent debonding on the bonded surfaces. However, the analyses indicate that not all of the cracks will reach the outside surface of the repair material. For Material 2, the risk of delamination along the top surface is higher than cracking at the side of the patch. The results of the 2-D FEM model under shrinkage loading compares well with the results of the laboratory investigation performed at Michigan Technological University (Ahlborn, 2002) for the two chosen MDOT repair materials (R350 CI and HB2) under shrinkage. Since there is no material data sheet available for the third MDOT material (Sika top 126), this material was not studied.

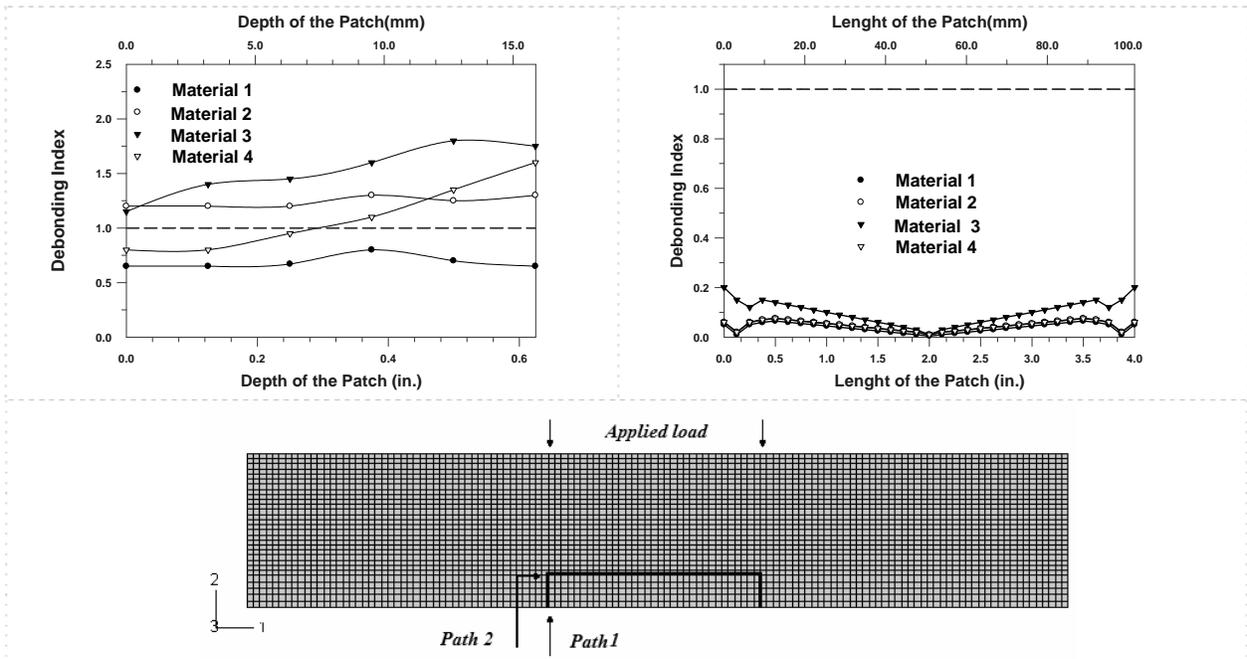
Figure 3-16: Debonding index on bond surfaces due to the mechanical load

Under mechanical loads, the elastic modulus has more influence than the other parameter on the stress distribution, and consequently on debonding or tension cracking.

Figure 3-16 and Figure 3-17 show the debonding and tension crack indices under mechanical load at different locations. Since materials 1 and 2 have the same elastic modulus, they show the same stress distribution under the mechanical load. However because Material 1 has better bond strength according to the manufacturer's data sheet it should behave better and not debond. Except for Material 3, the potential for debonding along the side surfaces (Path 1) is higher than the potential for tension cracking inside the patch. Material 3 shows the worst condition for both failure modes. No tendency for debonding was observed at the top surface of the patch due to mechanical loads. Repair material 1 showed the best behavior under mechanical load as well as shrinkage effects because of its high bond strength and low elastic modulus. Figure 3-18 shows the location having the highest potential for the first crack due to applied mechanical load. This location is most critical because of the geometry of the patch and location of the applied load.

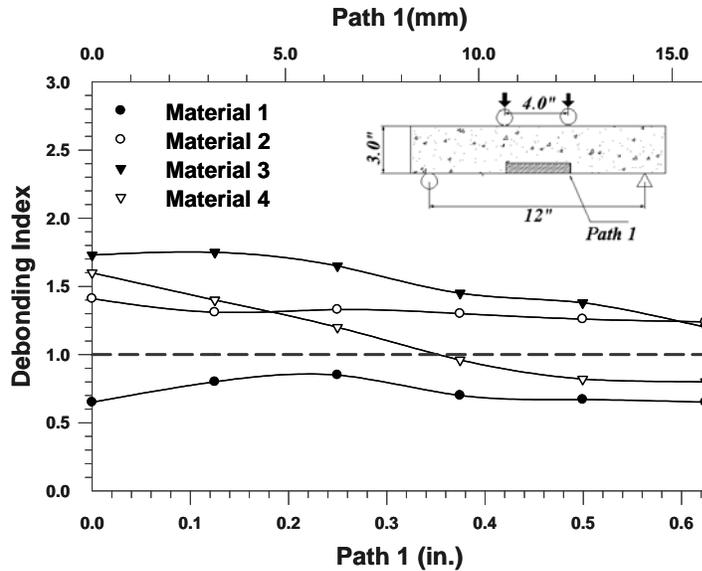
Figure 3-18: DI along location of the first likely crack due to mechanical load

The post-debonding behavior of the patch materials under mechanical load was studied by defining a debonded region between the repair material and the concrete substrate where the debonding index in Figure 3-18 exceeded unity.

Since both chosen patch materials (Material 1 and 2) have the same elastic modulus, they will behave identically under the corrosion loading, and consequently only one of the results is presented here. Figure 3-18 shows the fiber rupture index of the FRP overlay along the critical points (crack path) under the corrosion load. The Figure 3-37 indicates that under corrosion load some of the chosen FRP fabrics are close to failure, but none will actually fail.

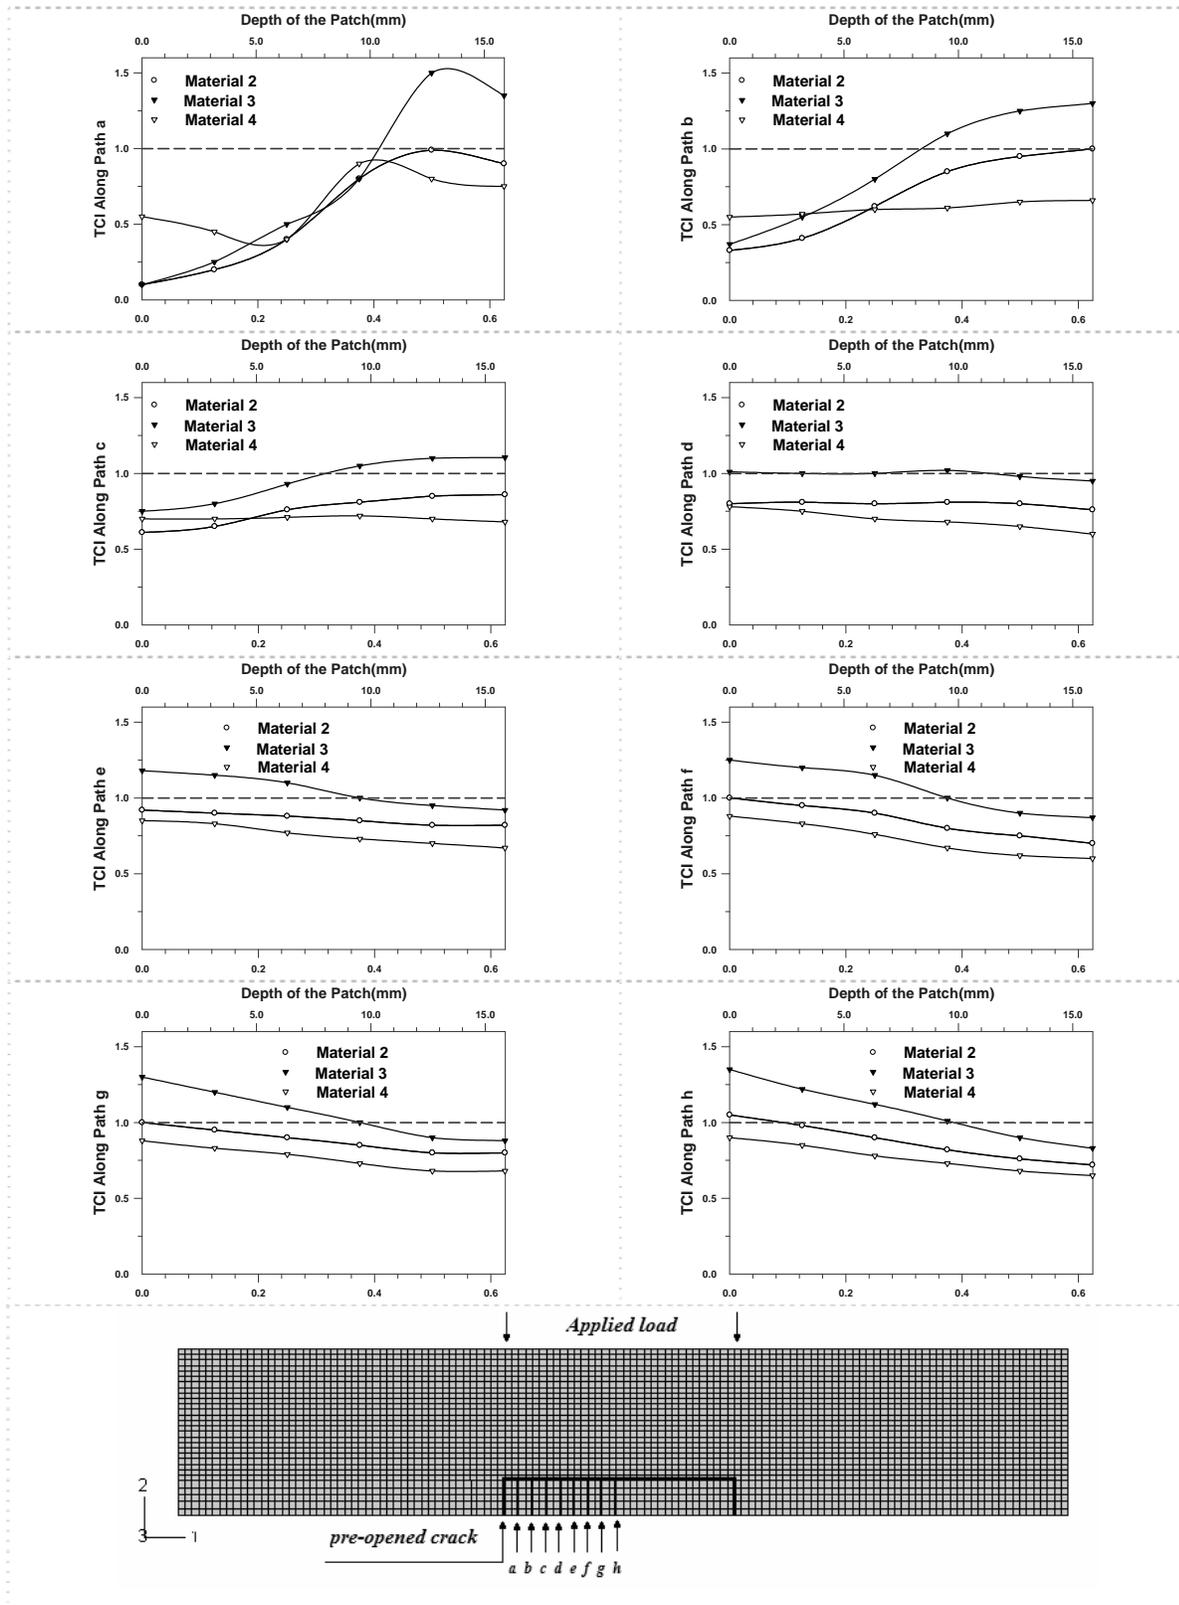
Figure 3-19: Tension crack index along the patch due to the mechanical load after debonding along path 1

Figure 3-19 and Figure 3-20 shows that after initial debonding no major damage occurs for Materials 2 and 4. However, because of its high elastic modulus, Material 3 had the potential of further tension cracking in the patch.

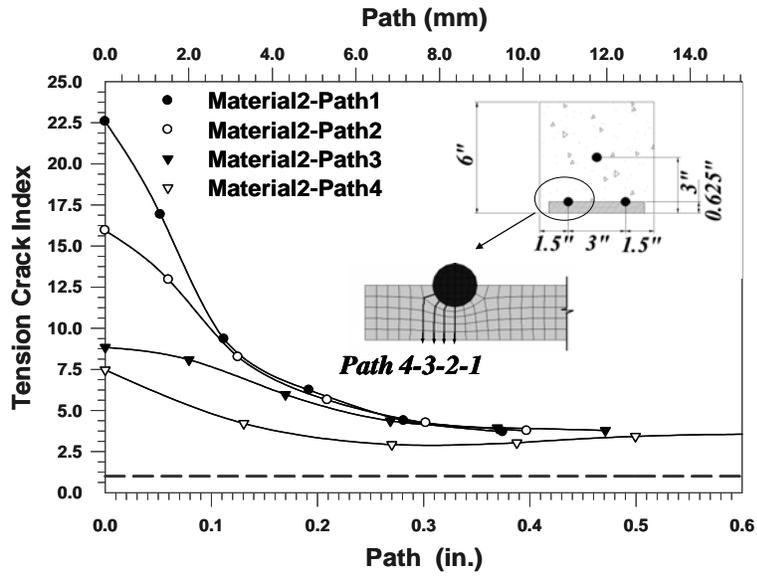
Figure 3-21: Tension crack index due to corrosion along the various paths

As mentioned earlier, when reinforcement bars corrode the corroded steel swells up to about 4 to 6 times of its initial volume. However, some of the corrosion products are likely to fill pore voids within the concrete. The expansion due to corrosion was therefore estimated by calibration with available experimental data for FRP wrapped concrete cylinders subjected to accelerated corrosion (Baiyasi, 2000) as explained before. Based on this calibration, an expansion strain of $17,500 \mu\epsilon$ was applied to the cross section of the #4 bar. Figure 3-21 shows the tension crack index along different paths for patch material 2. Both patch materials behave the same way because their elastic modulus is the same. The Figure 3-21 indicates that since the

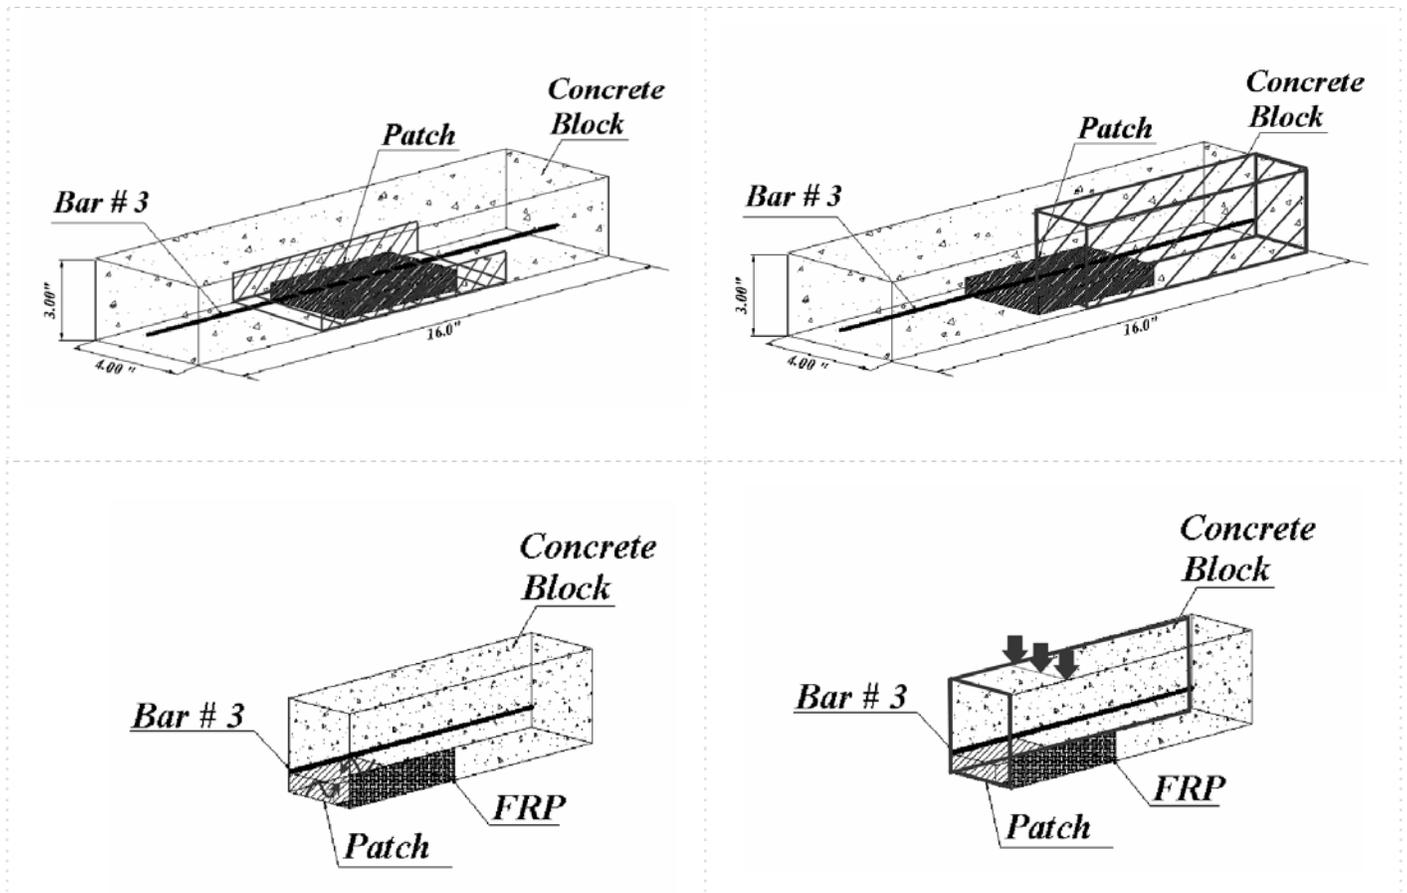
Figure 3-22: 3-D shrinkage and mechanical model

Figure 3-23. To reduce computational effort, only a quarter of the beam was modeled for

all cases. The model geometries are shown in Figure 3-22 and **Figure 3-23**.

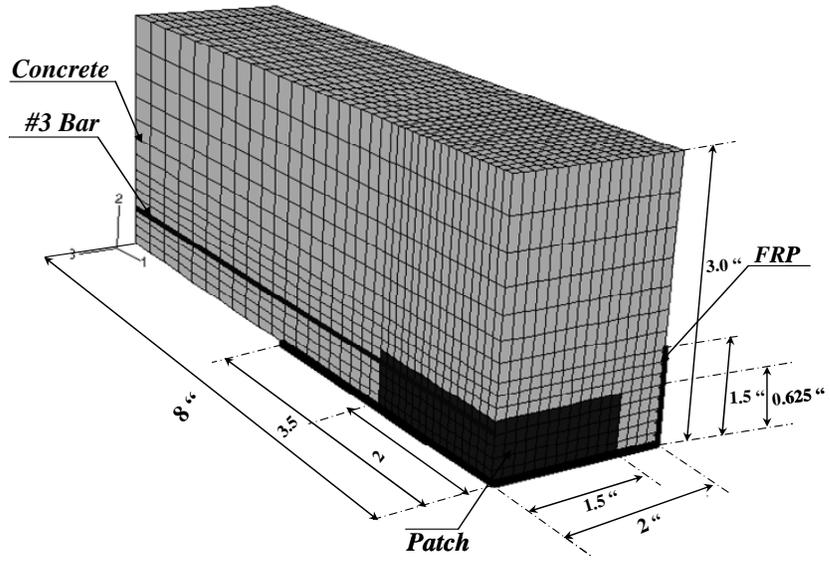
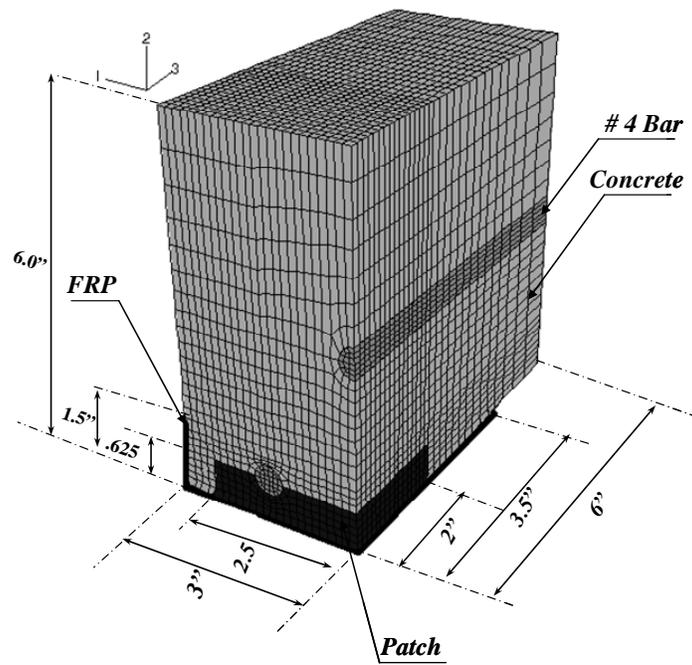
Figure 3-24: 3-D finite element model discretization: (a) shrinkage and mechanical model, and (b) corrosion model

The typical 3-D FE mesh discretization of the quarter of the beam is shown in Figure 3-24 (a) for the mechanical and shrinkage loads and Figure 3-24 (b) for the corrosion load. The model includes: a) a concrete and repair patch part modeled with 8-node reduced integration brick elements (C3D8R), b) a steel reinforcement part modeled with 2-node truss elements (B21) in the mechanical and shrinkage models, with 8-node reduced integration brick element (C3D8R) for corrosion model, and c) an FRP overlay part modeled with 4-node, quadrilateral reduced integration shell element (S4R). These brick elements (C3D8R) are versatile and can be used in models for simple linear analysis or for complex nonlinear analysis involving contact plasticity.

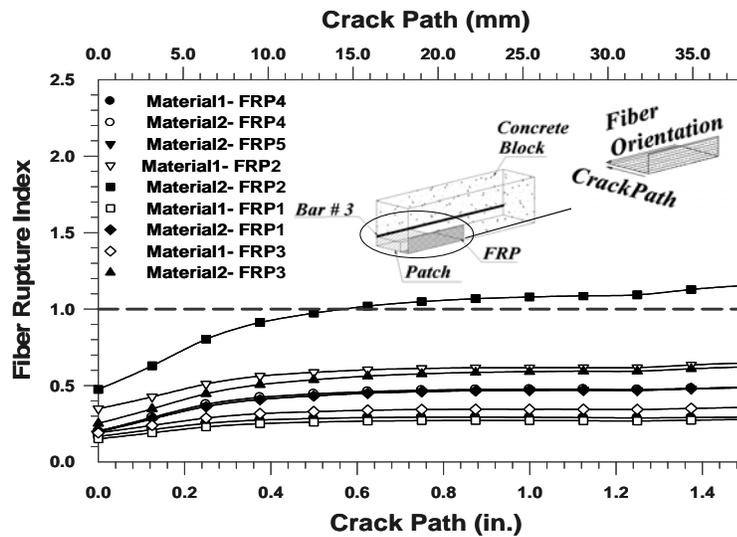
Figure 3-26: Fiber rupture index – Case 10 (TCP, UL)

Figure 3-26 and Figure 3-27 show the fiber/matrix rupture indices along the transverse and longitudinal crack paths for the critical cases (Case 10, and Case 4) in both directions,

respectively. Figure 3-26 shows that FRP 2 with patch Material 2 is likely to rupture under the applied load (Case 10). All other FRPs do not fail with either patching materials. Figure 3-27 indicates that FRP 1, and FRP 4 (unidirectional) with patch Material 2 showed the worst behavior under the applied load (Case 4), but was still well below failure
