Improved Shallow Depth Patches for Concrete Structures

Final Report to the Michigan Department of Transportation

February 2008

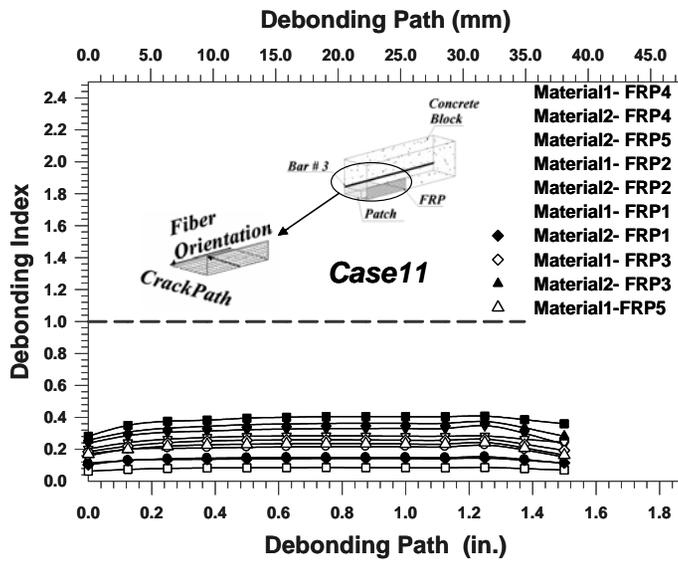
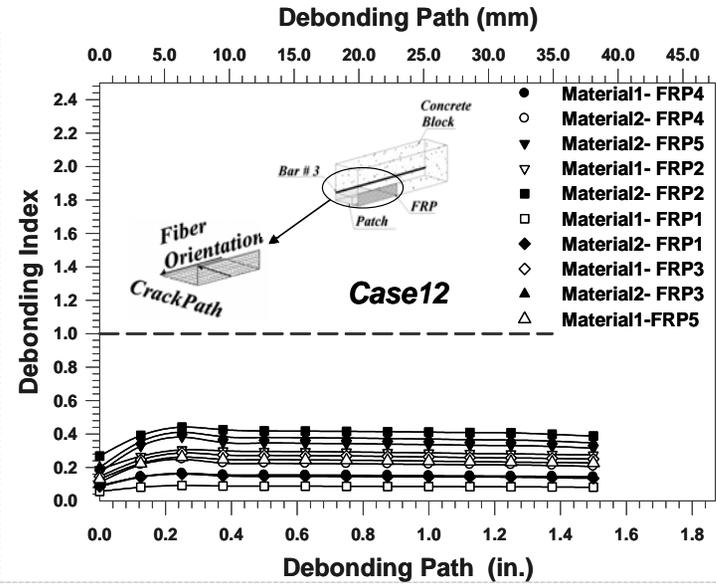
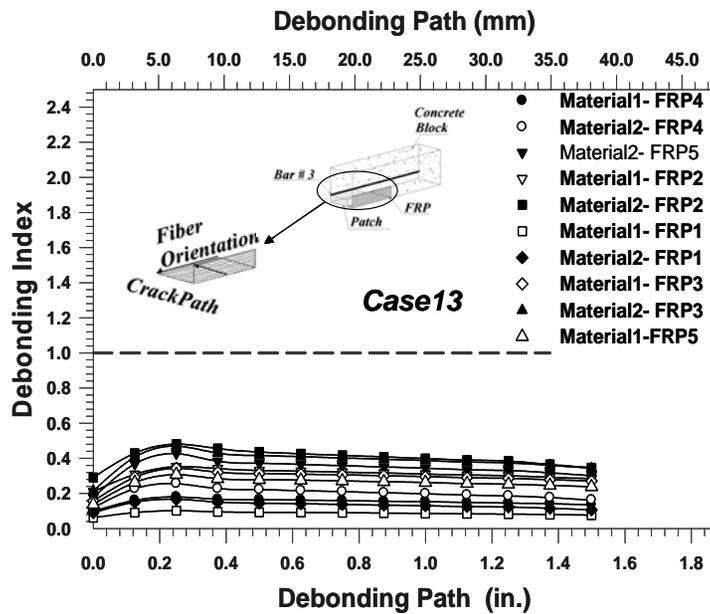
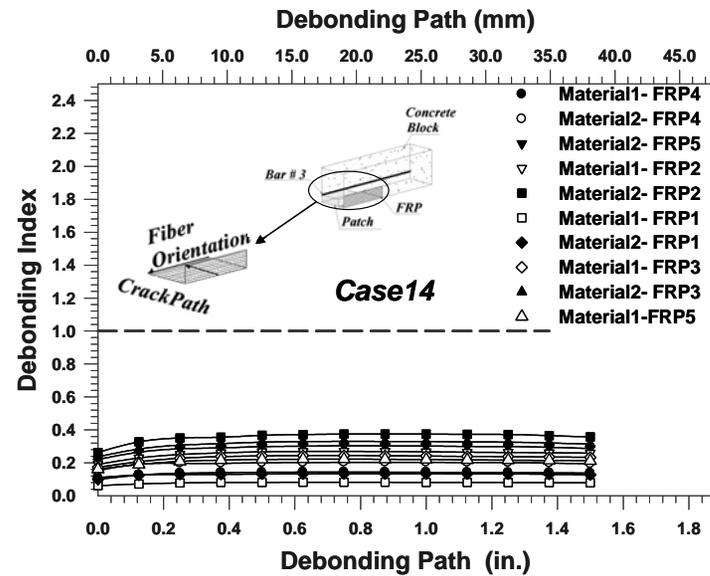
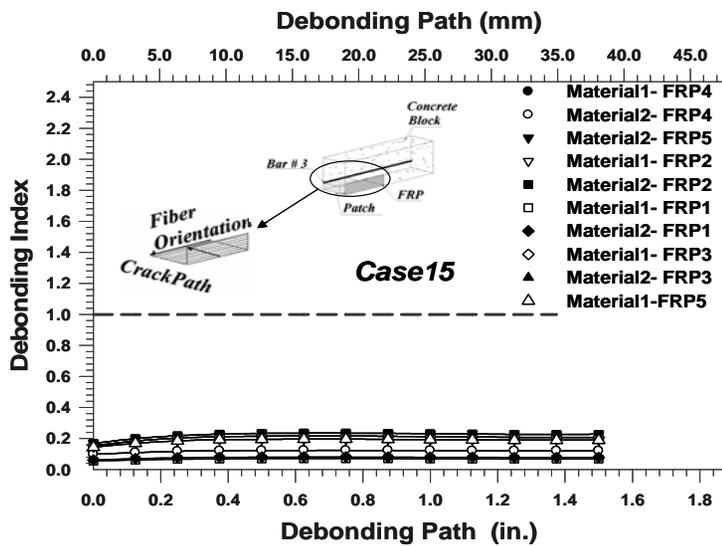
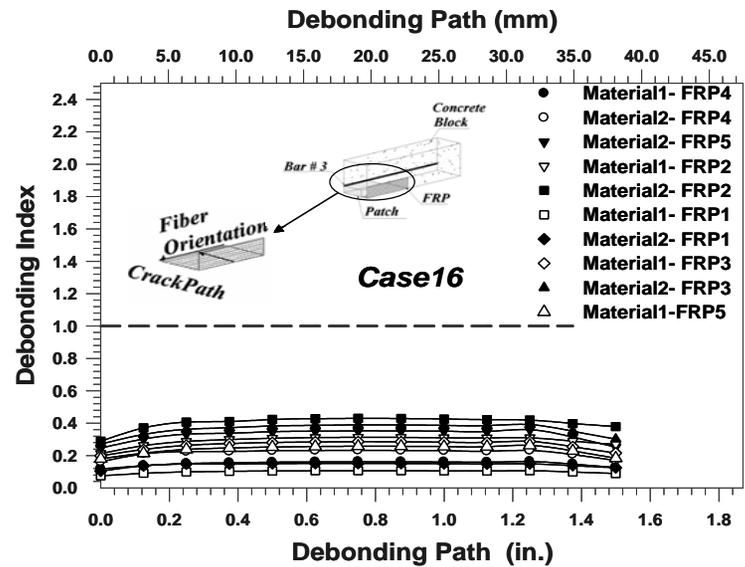
Figure 3-28: M/FRI for different loading conditions along path 1

Path 1 is a debonding path located at the side interfaces between the patch and concrete

All of the FRP fabrics perform satisfactorily with either patching material. Figure 3-28 to Figure 3-31 show the FE results for most of the cases shown in Figure 3-25.

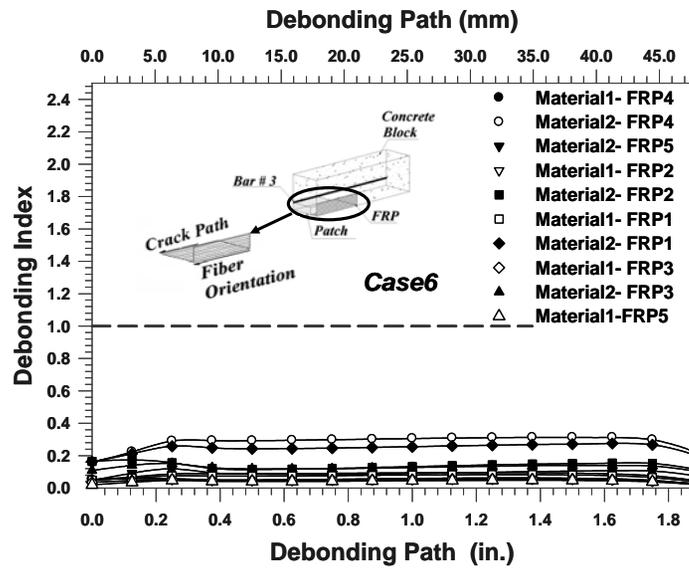
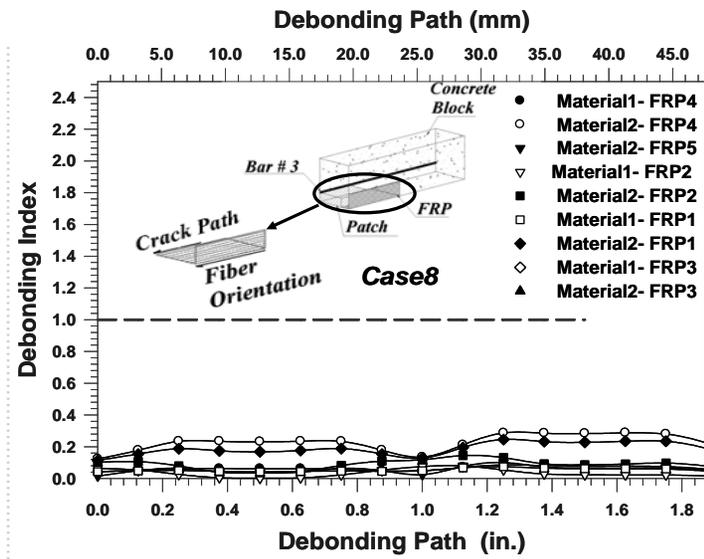
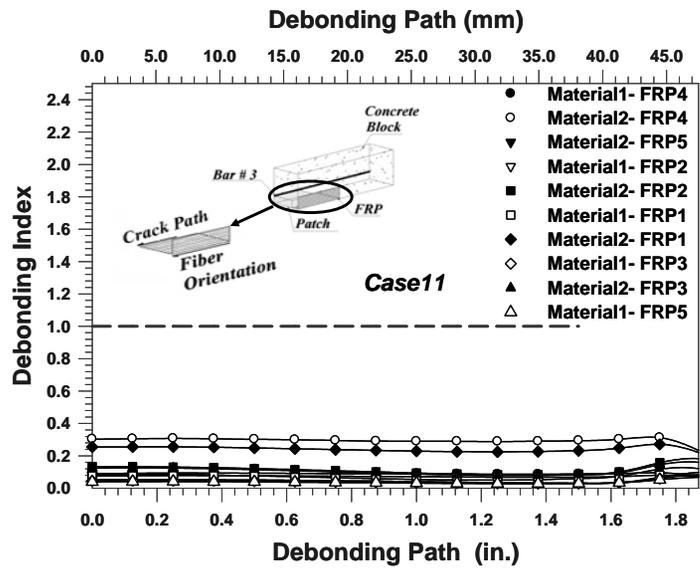
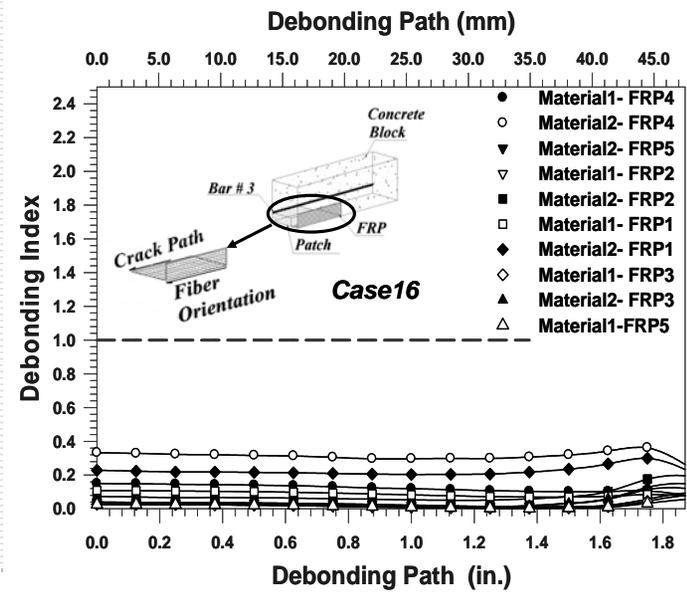
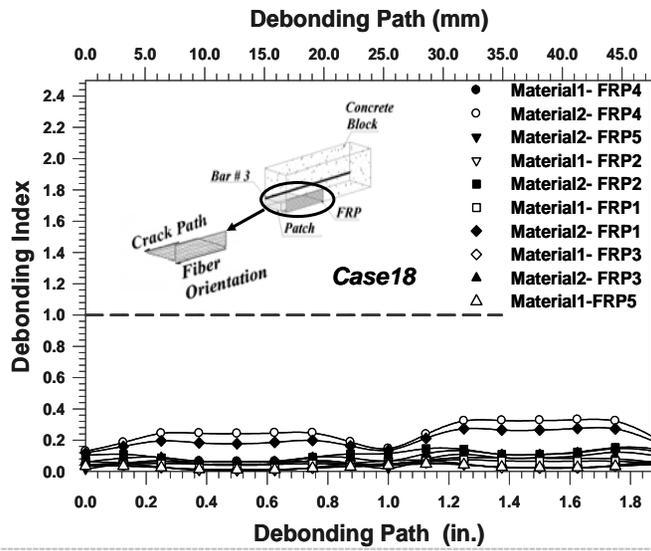
Figure 3-29: M/FRI for different cases along path 2

Path 2 is a longitudinal tension crack path located at the middle of the patch

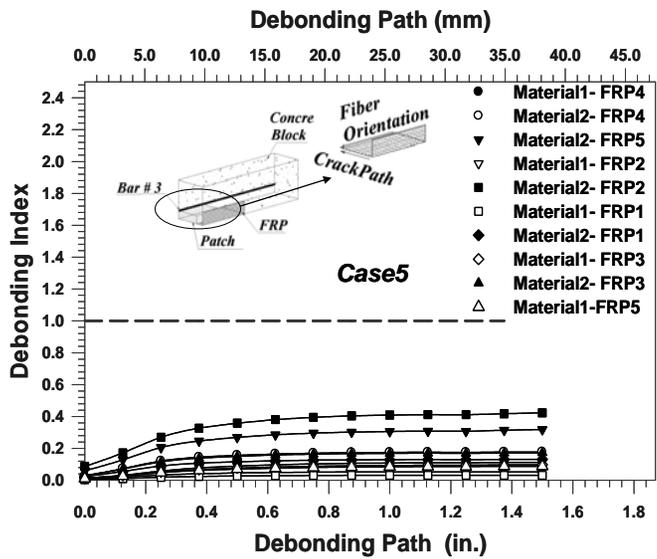
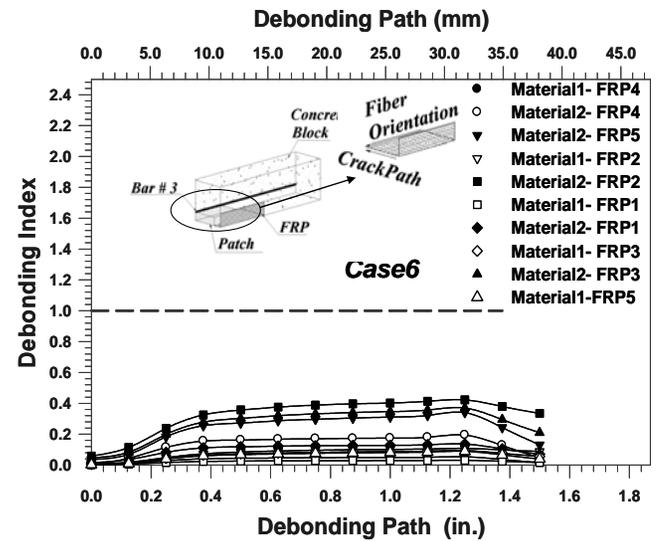
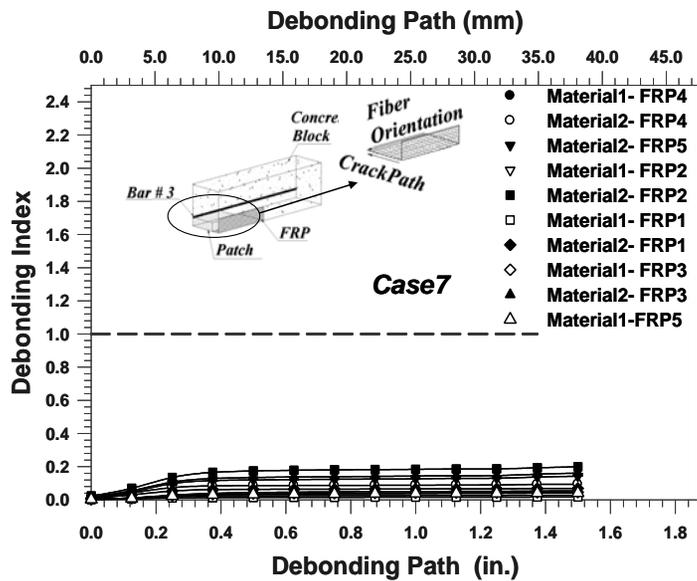
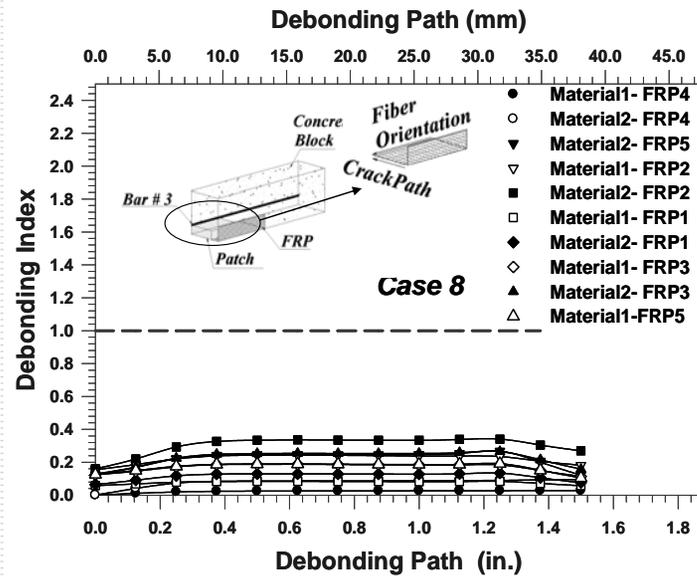
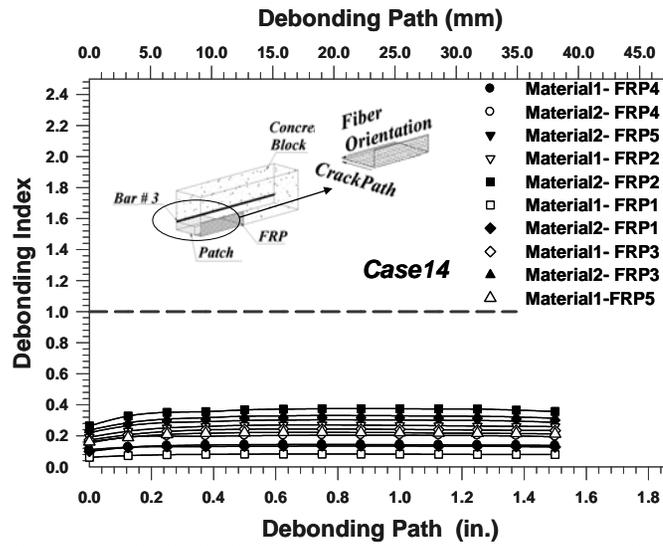
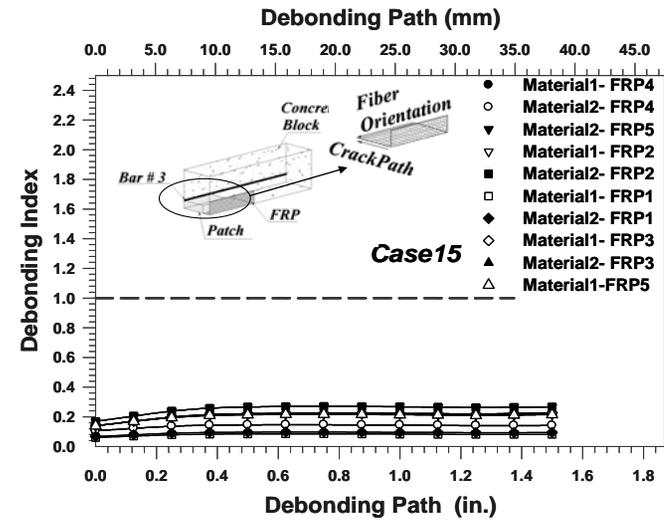
Figure 3-30: M/FRI for different loading conditions along path 4

Path 4 is a transverse tension crack path located at the middle of the patch

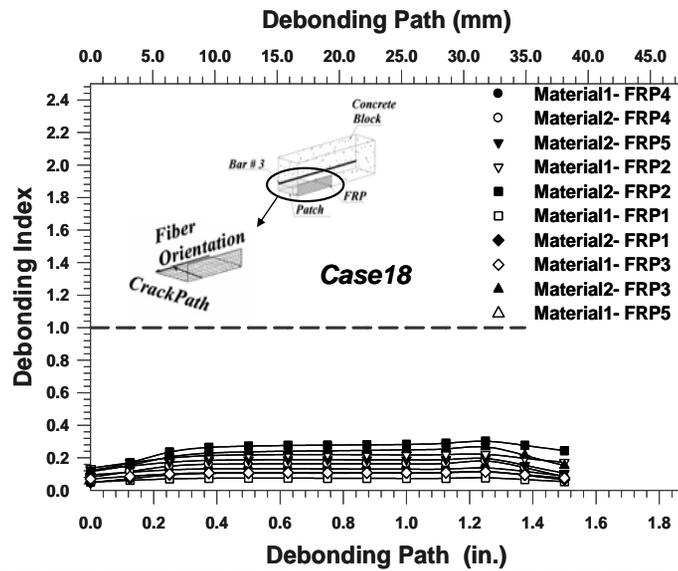
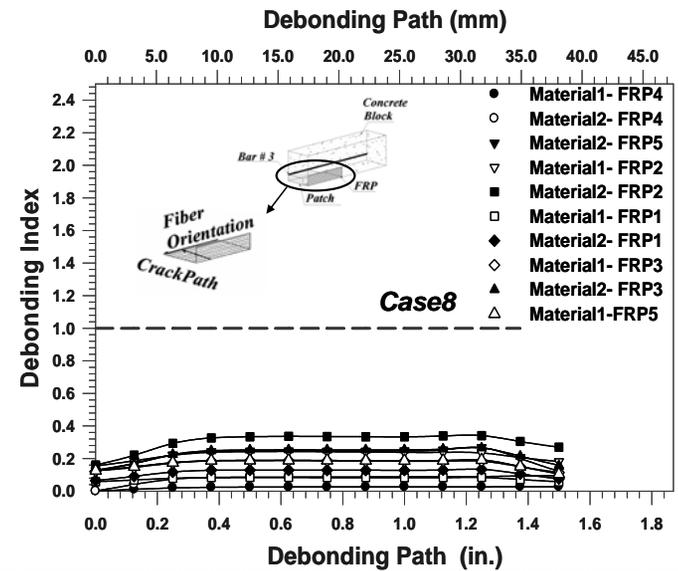
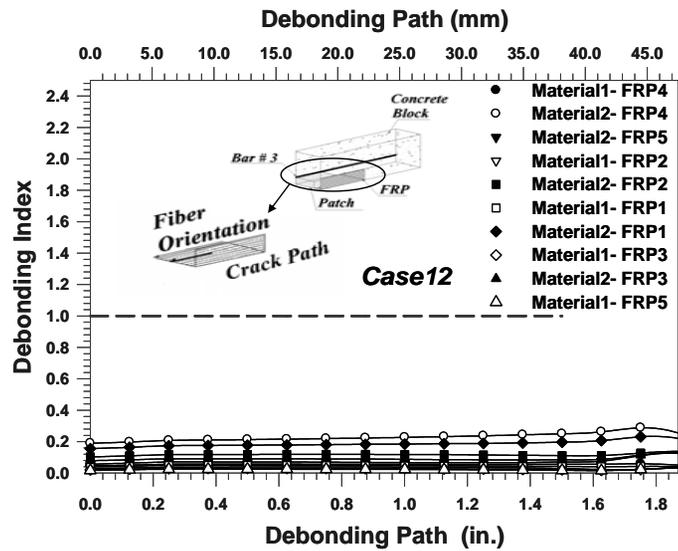
Figure 3-31: M/FRI for different loading conditions along path 3 and 5

Path 5 is a transverse tension crack path and Path 3 is longitudinal a debonding path

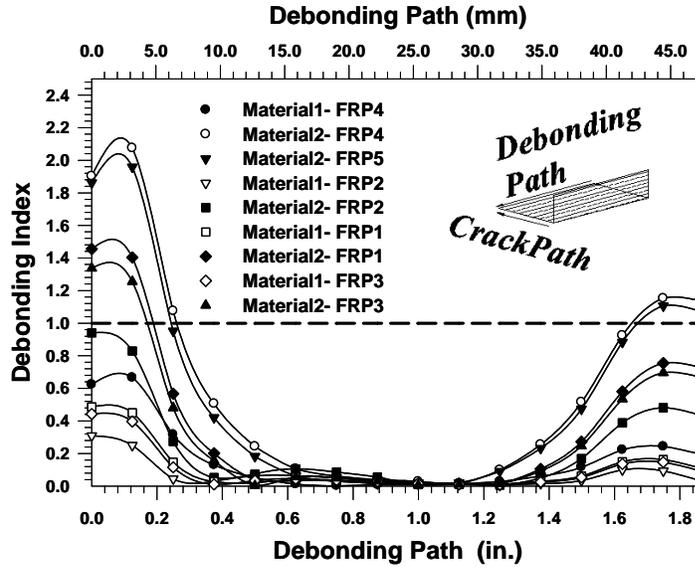
Figure 3-32: Debonding index for Case 10 (TCP, UL)

Figure 3-32 and Figure 3-33 show the calculated debonding index for debonding transverse to the crack paths for the critical cases in both direction (Cases 10 and 4), respectively. Figure 3-32 indicates that there is some debonding between the patch and the FRP near the ends of the patch when patch material 2 is used. Figure 3-33 shows that there is no significant debonding between the patch and FRP for the LCP with either patching material.

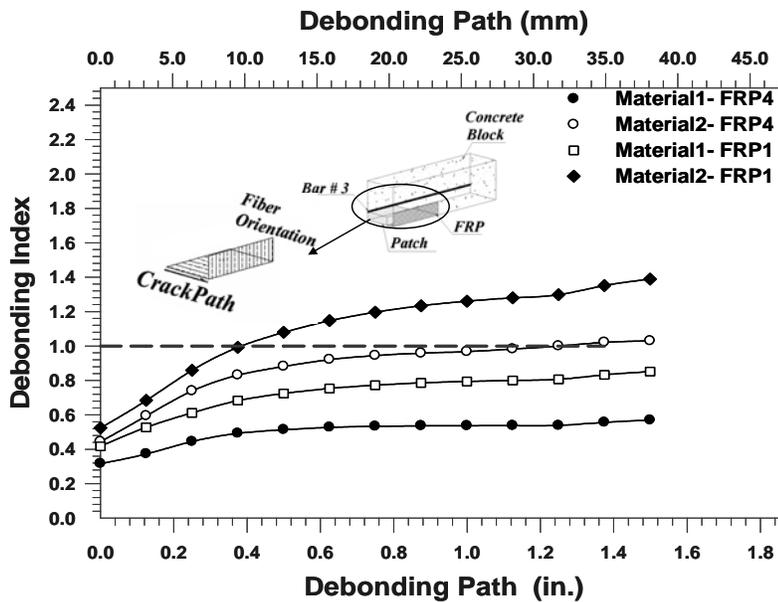
Figure 3-34: Fiber rupture index -Case 10 (TCP, UT)

In a follow-up analysis, the critical case obtained from the initial analysis (Case 10, Figure 3-25) was evaluated again with the opposite orientation of the fibers for the unidirectional FRP 1 and FRP 4. The loads carried by the fibers in the initial analysis were now carried by the matrix and vice versa. As Figure 3-34 indicates, both FRP 1 and FRP 4 failed due to the applied load in Case 10 when used with patch material 2, but do not show any damage when used with patch material 1.

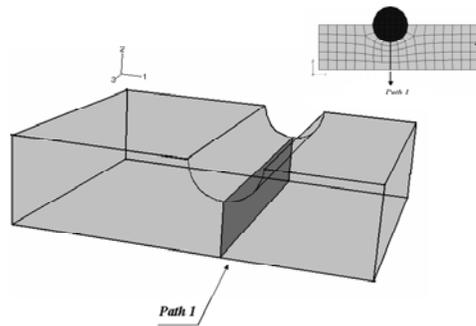
Figure 3-36: Location of the pre-opened crack in the corrosion model

Only two different loading conditions were studied in this section (1) corrosion load, and (2) the combination of corrosion and shrinkage loads. Based on the results from 2-D analyses, a vertical pre-opened crack was introduced in the 3-D model radiating downward from the bar along Path 1, (see Figure 3-36 and Figure 3-21). The model was studied under corrosion load (with FRP fibers oriented in the transverse direction for uni-directional FRP).

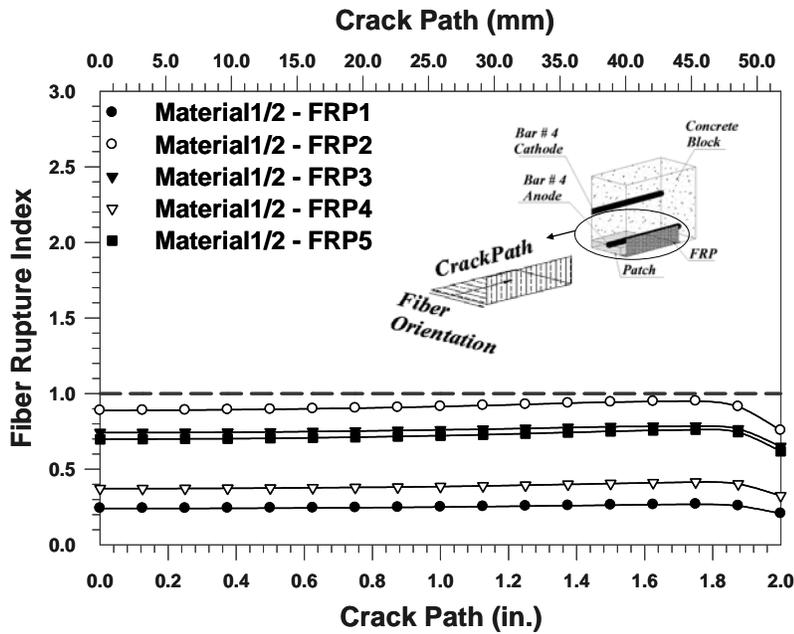
Figure 3-37: Fiber rupture index due to applied corrosion load (LCP, UT)

Since both chosen patch materials (Material 1 and 2) have the same elastic modulus, they will behave identically under the corrosion loading, and consequently only one of the results is presented here. Figure 3-18 shows the fiber rupture index of the FRP overlay along the critical points (crack path) under the corrosion load. The Figure 3-37 indicates that under corrosion load some of the chosen FRP fabrics are close to failure, but none will actually fail.

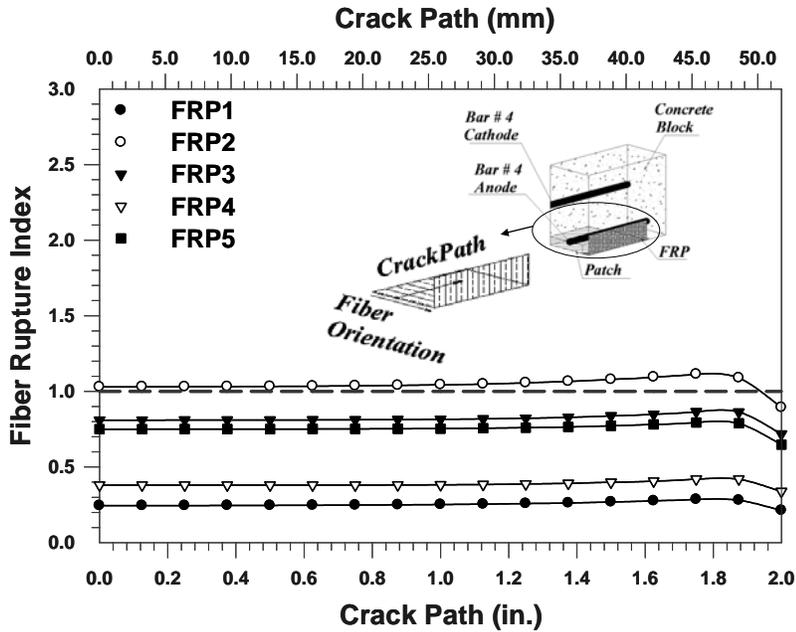
Figure 3-38: Fiber rupture index due to combined loads (LCP, UT)

It should be noted that the combined load case was studied only for Material 2 (highest shrinkage), for comparing the behavior of the FRP overlay under the extreme loading situation. Figure 3-38 shows the fiber rupture index along the crack path and indicates that FRP 2 (chopped glass) showed the worst behavior under the combined load and is expected to fail. The other FRPs do not fail under the combined load.

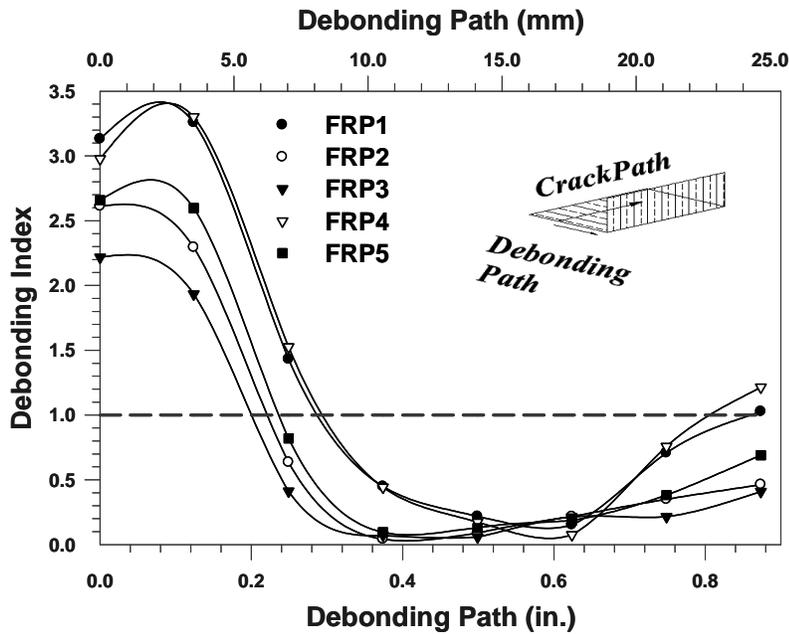
Figure 3-39: Debonding index due to combined load (LCP, UT)

Figure 3-39 shows the DI-values calculated to evaluate the state of the bond between the FRP overlay and the patching material. It was assumed that bond failure initiates in the patching material. The calculated DI-values transverse to the crack path indicate that there will be debonding near the crack location over a 0.2-0.3 in. length for all FRP overlays (left side of Figure 3-39), and debonding near the patch/concrete

interface at the ends of the patch over a 0.1-0.2 in. length for FRP 1 and FRP 4 (right side of Figure 3-39).

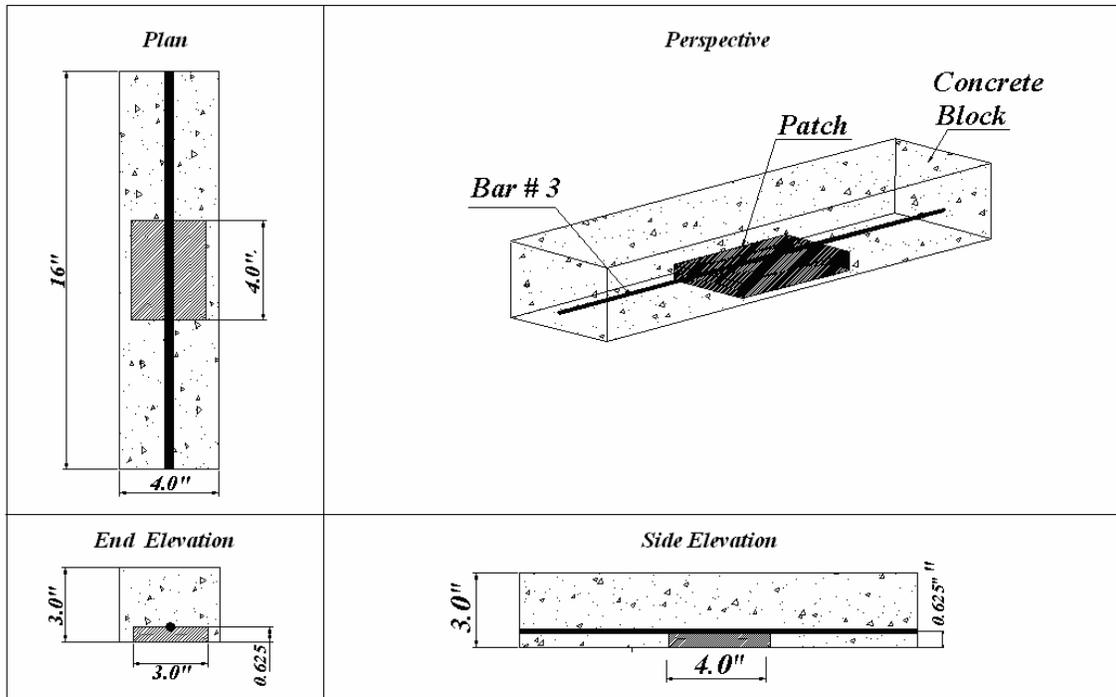
Figure 4-1: Geometry of first set of freeze-thaw and wet-dry test specimens

To evaluate the advantages of the selected repair system, the durability studies were conducted on test units that simulate “undamaged” and “damaged” conditions. The “undamaged” specimens were cast with the full cross section over the entire length. The “damaged” specimens were cast with a rectangular cavity (4" × 3" × 0.625") at mid-span as shown in Figure 4-1 and

The set of specimens had the dimensions shown in Figure 4-1 and Figure 4-3. These specimens had a smaller cavity that was patched, and the patch bonded to concrete substrate on all but the bottom surface.

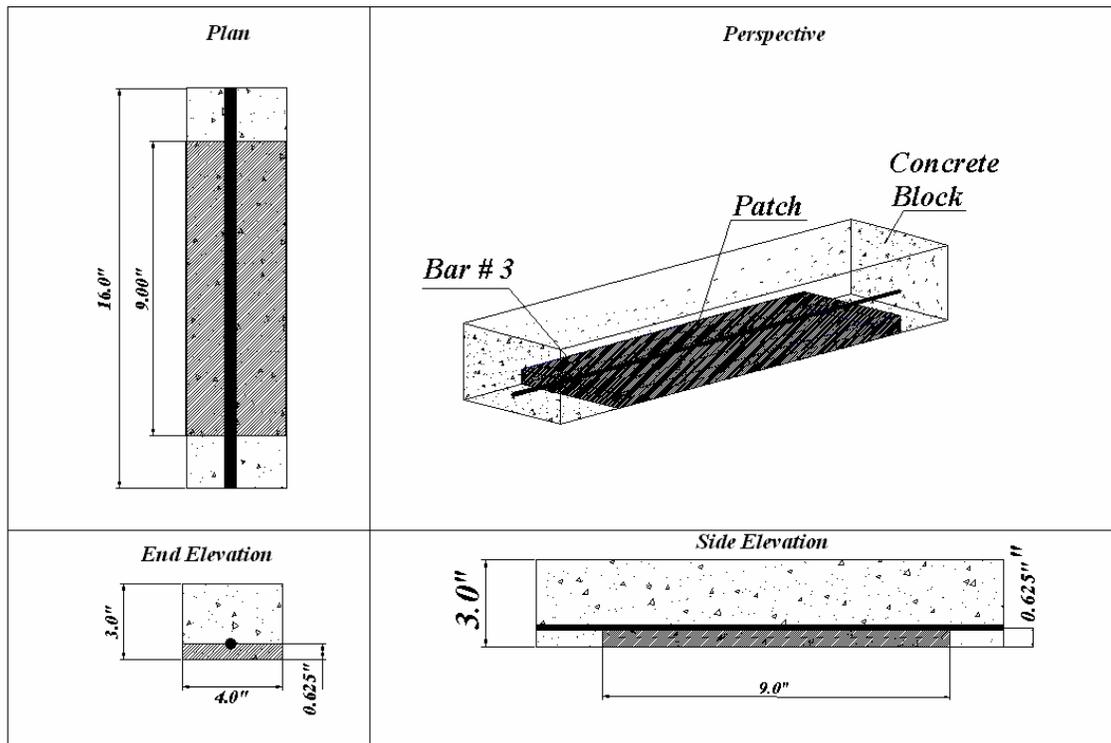
Figure 4-2: Geometry of second set of freeze-thaw test specimens

A second test set of “exposed” and “non-exposed” specimens were therefore fabricated. In this set the cavity size was increased to $9" \times 4" \times 0.625"$ at mid-span as shown in Figure 4-2 . “Exposed” specimens were repaired with the two methods mentioned above and subjected to only to the more aggressive freeze-thaw exposure and “non-exposed” specimens were repaired with the filler material only. “Undamaged” and “exposed” specimens are henceforth referred to as Group 3 specimens or control specimens and specimens repaired with the filler material only and with the filler and FRP system are henceforth referred to as Group 2 and Group 3 specimens, respectively. A summary of the test matrix for each of the subtasks outlined above is given in Table 1. Detailed descriptions of the methods to be followed in each of the tests are given in the respective sections that follow. The number of specimens exposed to each environment is shown in Table 4-2. Figure 4-4 illustrates the evaluation matrix of the experimental program.

To reduce the bonding of the patch to the concrete along vertical surfaces, and to provide more area along which the patch can crack, it was proposed to increase the size of the cavity at the bottom of the test specimens to 4" × 9" × 0.625" as shown in Figure 4-2. The patch now extended across the entire width of the specimens. To prepare the new specimens from the old ones that had a 3" × 4" × 0.625" cavity, the size of the cavity in the old specimen was increased by removing the concrete for the bottom surface using a concrete saw, chisel and hammer. The specimens the saw depth was adjusted so the steel bars were not damaged to the extend possible.

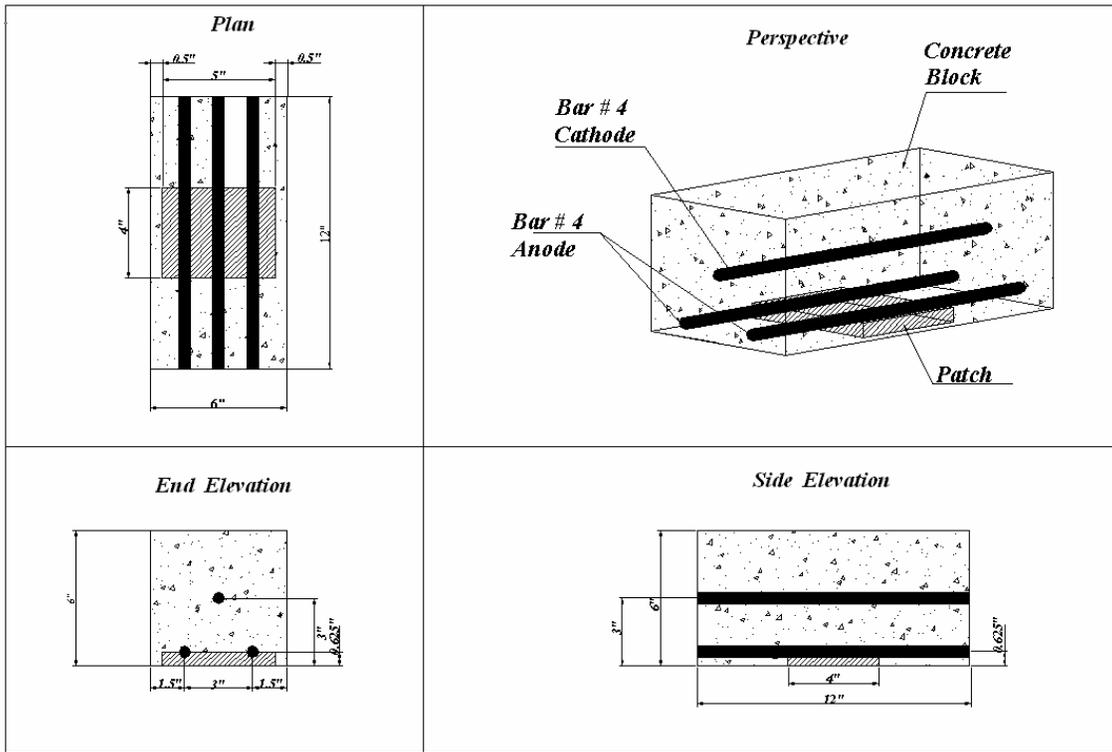
Figure 4-3: Geometry of the corrosion test specimens

Figure 4-3 for freeze-thaw, wet-dry and corrosion tests, respectively. The “damaged” specimens were repaired using two methods: (1) with the filler material only, and (2) with the filler and FRP overlay. Specimens repaired only with the filler material were originally expected to deteriorate significantly when subjected to cyclic fatigue loading following environmental exposure. However as described later, this did not occur.

For the corrosion study, concrete specimens with dimensions of 6" × 6" × 12" with a 4" × 5" × 0.625" cavity on the bottom side, patch Material 1, and three #4 reinforcing bars were used. The anode bars (see Figure 4-3) were corroded in an accelerated fashion using an external power supply. The specimens were soaked in salt water for 1 hour during every 12 hour period. The applied voltage and strain in the concrete cover and sides were monitored.

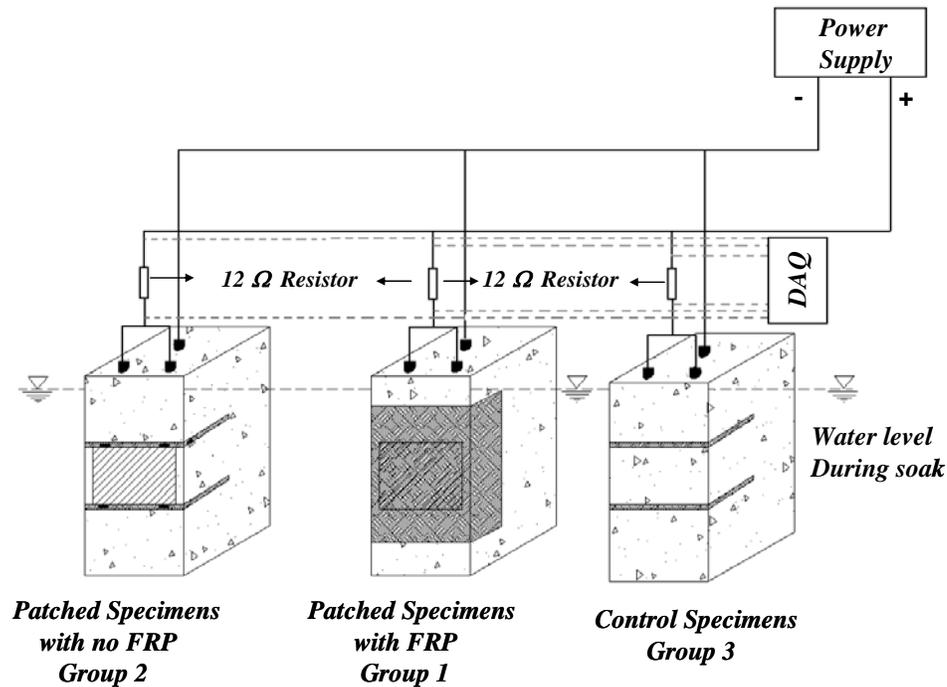
Figure 4-5: Accelerated corrosion test setup

For the corrosion study, concrete specimens (6" × 6" × 12") with three reinforcing bars, two near the bottom face (anode or corroding bars) and one near the top face (cathode), were used. The bottom bars were placed such that half of each bar cross section is exposed to the patching material as described in the FE modeling, and the cathode was placed at the middle of the specimens. A constant voltage of 12 V was supplied from the single bar (cathode) to the other two reinforcing bars (anodes) using an external power source. A 3.5 percent sodium chloride solution (by weight) was used to wet the concrete specimens for one hour in each 12-hour period. The moisture in the concrete specimens and the applied current induced corrosion in the anodic reinforcing bars in an accelerated fashion. Figure 4-5 shows the experimental setup for the corrosion test. The specimens were subjected to accelerated corrosion for three weeks. The applied current was monitored at of two-minute intervals with a voltage data-logging unit

(Omega Engineering Inc., AD128-10T2), since this can be used to estimate the total corrosion in the reinforcing bar.

As shown in Figure 4-5 the specimens were connected in parallel and hence the applied voltage was equal for all specimens.

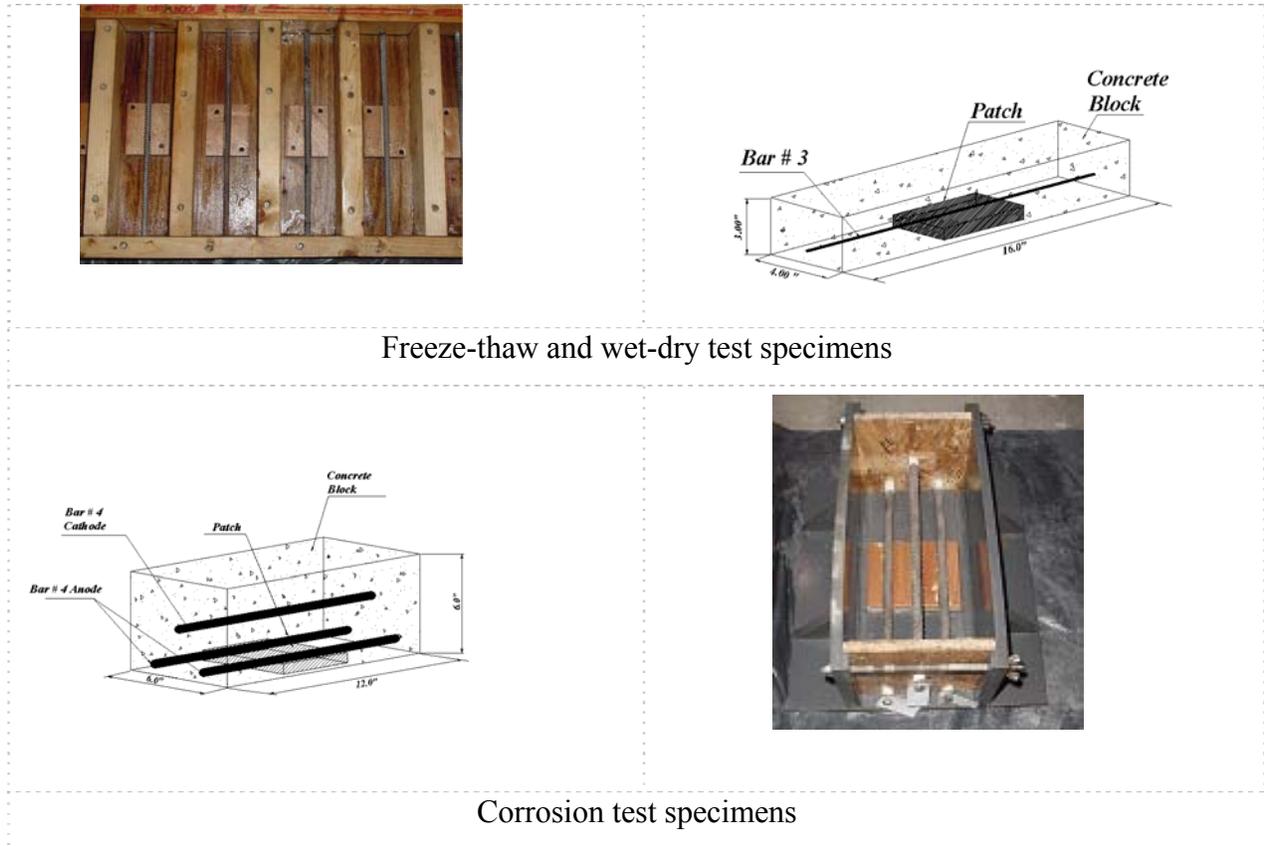
Figure 4-6: Schematics of specimens and photographs of mold

Figure 4-6 shows the molds the location of the patch part and the steel bar inside the molds for the test specimens before casting. A total of 60 specimens were cast for the freeze-thaw and wet dry tests (10 extra) and 12 specimens were cast for the corrosion test (3 extra).

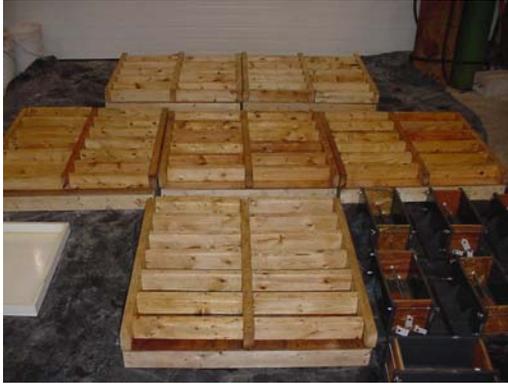
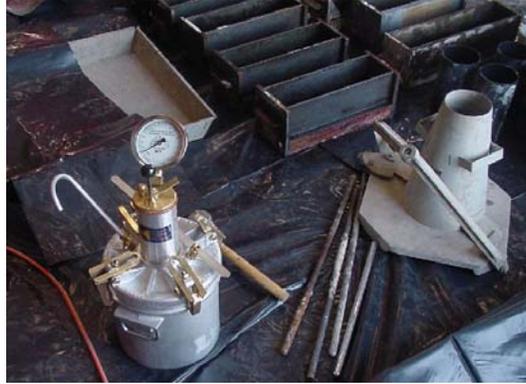
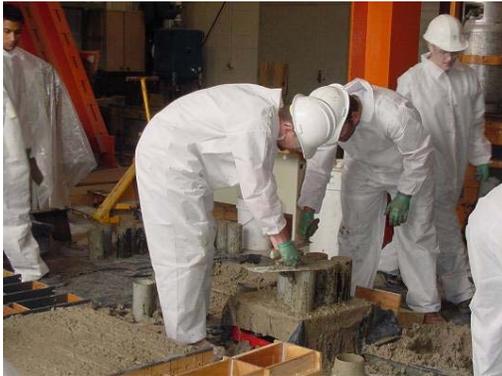
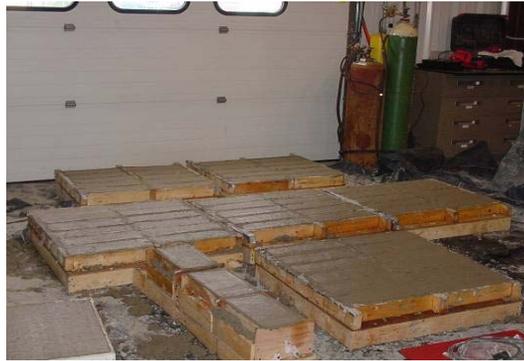
Figure 4-7 : Photographs of molds and casting

Figure 4-7 shows the molds before and after casting and the casting procedure. The specimens were cast on June 3, 2005. The ready-mix concrete used was supplied by Consumer Concrete and the mixture proportion was according to the M-DOT Grade S2 concrete with a water reducer. This concrete mix is usually used for bridges. The fresh properties of the concrete were determined at casting. The fresh properties of the concrete mix as well as some mechanical properties of the cured concrete are given in Table 4-3.

a) Wooden molds before casting

b) Measuring the fresh properties of concrete

c) Casting

d) Specimens after casting

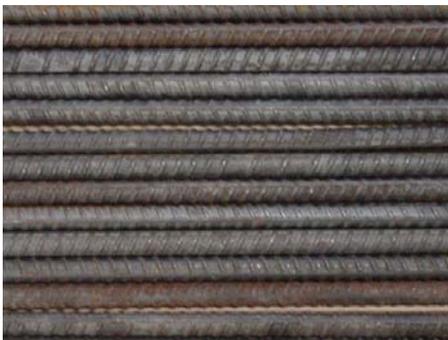
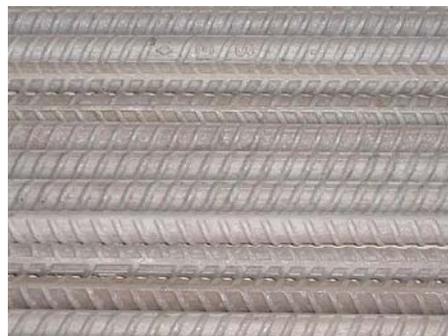
Figure 4-8 : Steel bars after degreasing and cleaning

The reinforcement bar for the corrosion test needed to be cleaned to remove all the rust and all other particle the surface of the bars before casting. The bars were weighed after cleaning so that mass loss could be measured after the corrosion test. The ASTM G1-90 (preparing cleaning, and evaluating corrosion test specimens) procedure was used. Following the ASTM procedure the steel bars first were degreased by soaking in saturated lime solution (CaCO_3) and then was pickled in a acid solution (HCl 5%), as recommended . After weighing of each bar they named with unique name and tagged. Figure 4-8 shows the corrosion steel bar before and after cleaning.

(a) After degreasing

(b) After cleaning with acid

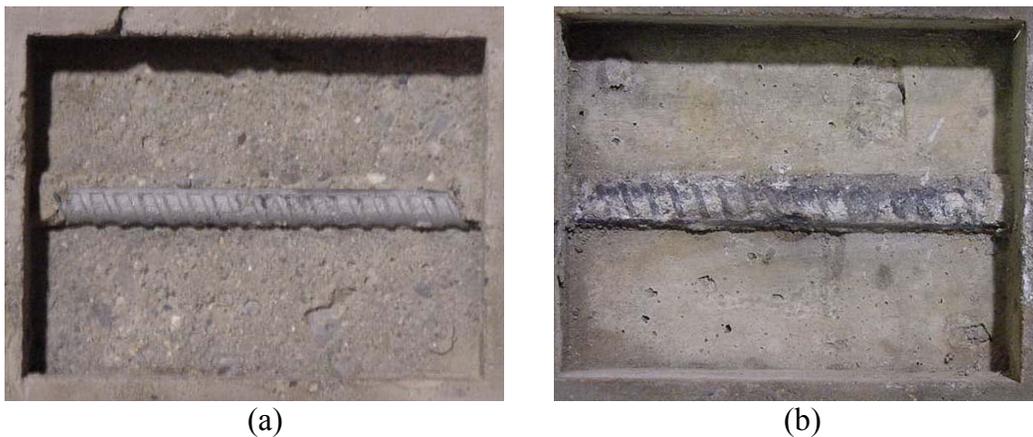
Figure 4-9 : Specimens (a) before and (b) after sand blasting

The specimens to be filled with a patch were sand blast on all of the cavity sides. Sandblasting was performed with the nozzle nearly perpendicular to the surface and was continued for at least 1 minute until no visible change on the surface was observed. After sand blasting the surface was blown with compressed air and then washed.

Figure 4-9 shows the cavity in the specimens before and after sand blasting.

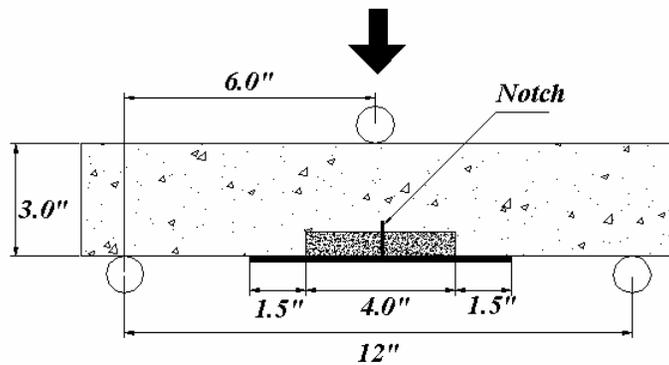
Figure 4-10: Test set up

To investigate the bond strength between the FRP overlay and the patch, the specimens were tested under three-point bending. Figure 4-10 shows the details of the test setup.

All the fabricated specimens had a #3 bar as reinforcement. To best test for bond strength between the FRP and patch, the tension strength provided by the #3 bar was removed by cutting a notch through the beam until the bar was completely cut as shown in Figure 4-10. Thus all the tension force was carried by the FRP overlay. After making a one-inch in deep notch exactly at the middle of the beam, the patch material was applied followed by the FRP overlay with a time interval of one hour, and 24 hour intervals between the application of the patch and FRP. Figure 4-11 shows the preparation procedure for the test specimens.

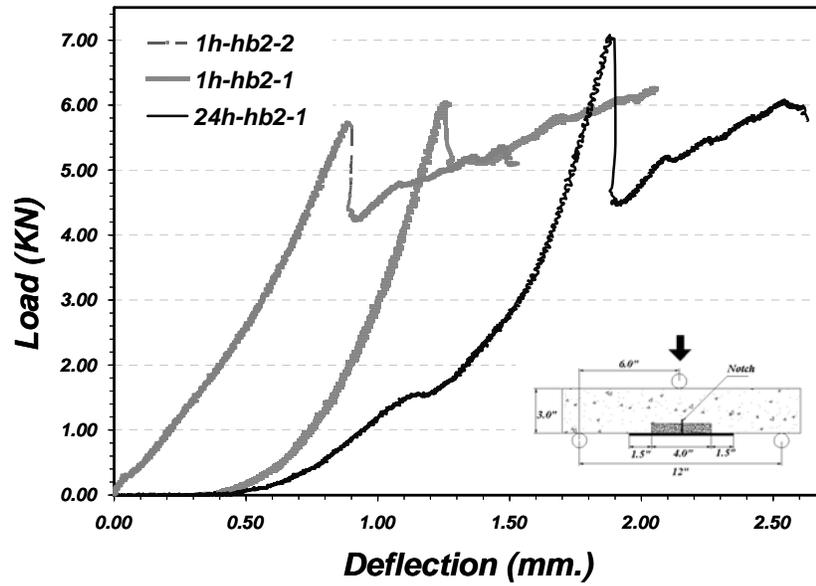
Figure 4-12: Load-deflection curves for Material 1

Figure 4-12 and Figure 4-13 show the force displacement curve for patch materials 1 and 2, respectively.

As Figure 4-12 and Figure 4-13 indicate, there is no significant difference between the overall FRP bond strength for both time intervals. Since the final failure mode in both cases (one hour and 24 hours intervals) occurs due to rupture of the FRP overlay, it is more economical to apply both the patch material and the FRP overlay within an hour of each other. It should be

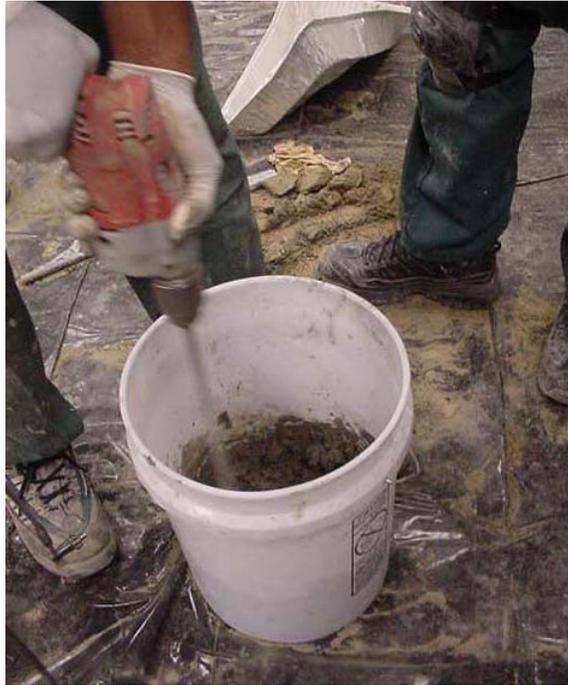
Figure 4-14: Preparing the repair mortar

A slow-speed drill (400–600 rpm) with a Jiffy-type paddle was used to mix the mortars for 3 to 5 minutes. Mixing for more than 5 minutes was not recommended in both material data sheets. The quantities of the liquid component and dry component were pre-measured. For both patching materials, the liquid component was always added prior to the dry component.

of 6" × 6" × 12" were patched with Material 1 for the accelerated corrosion test. All the specimens were patched at the same day. Figure 4-14 shows mixing of the repair mortar with a slow-speed drill.

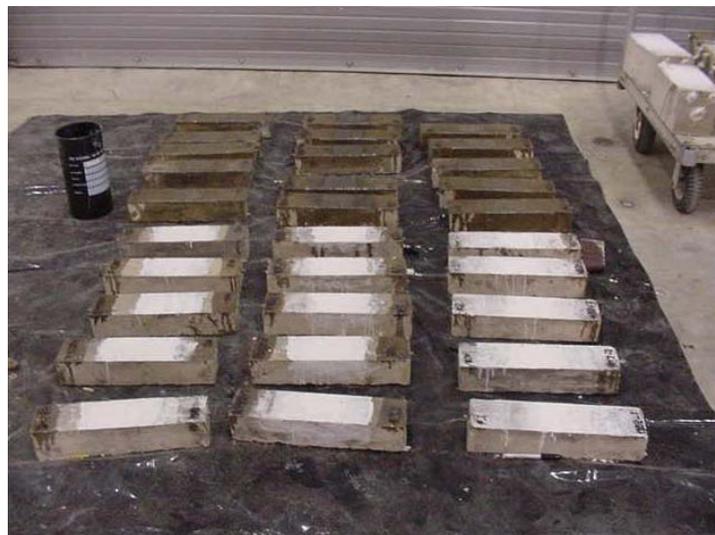
Figure 4-15: Specimens after 10 day of applying the patch and FRP

In this experimental test the dry lay up method was used. First the epoxy was applied to the concrete over the uncured patch with a brush and after that dried, the FRP overlay was placed. The FRP overlay was cut to the appropriate size with heavy duty scissor. A 2 to 2.5 inch extension of the FRP overlay beyond the patch material as it was calculated in Chapter 3 was

used. A smooth steel bar was used as a roller to squeeze out all the air bubble and extra resin. After applying the FRP overlay, one more epoxy layer was applied with the bush over the FRP. After 24 hour of curing the third layer of resin was applied to protect the FRP overlay from environmental conditions as recommended in the material date sheet. These specimens also were cured in an overhead position at room temperature for two days. After two days the specimens were back turned upside down and cured for 10 more days. Figure 4-15 shows the specimens after curing. The specimens were inspected visually after 10 days of curing to detect cracking, spalling, or debonding of the patch mortar.

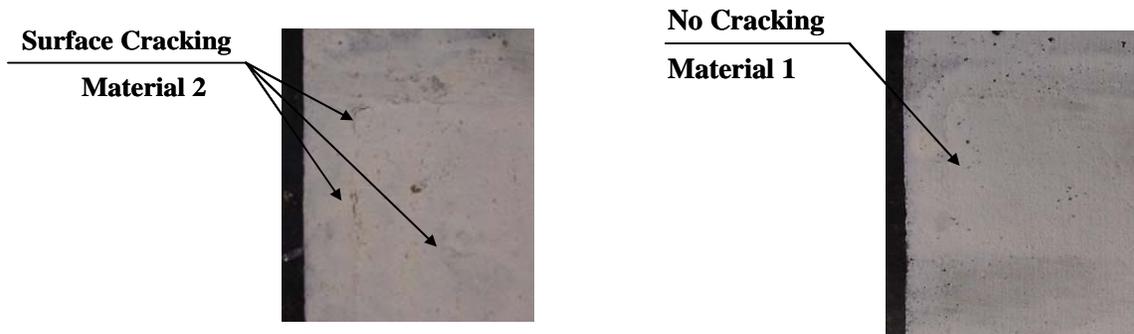
Figure 4-16: Comparison of surface cracking in the two patch material after curing

Initial inspections of the specimen showed some small surface cracking for patch Material 2 in two specimens after curing (Figure 4-16). Patch Material 1, however, displayed no cracks. The cracking in Material 2 could be due to surface tearing and is suspected to be due to over finishing the repair material after it had hardened. The cracking also could be due to the larger drying shrinkage of Material 2 compared to Material 1, as predicted by the FE analysis. None of the specimens displayed any sagging or debonding of the patch material after curing.

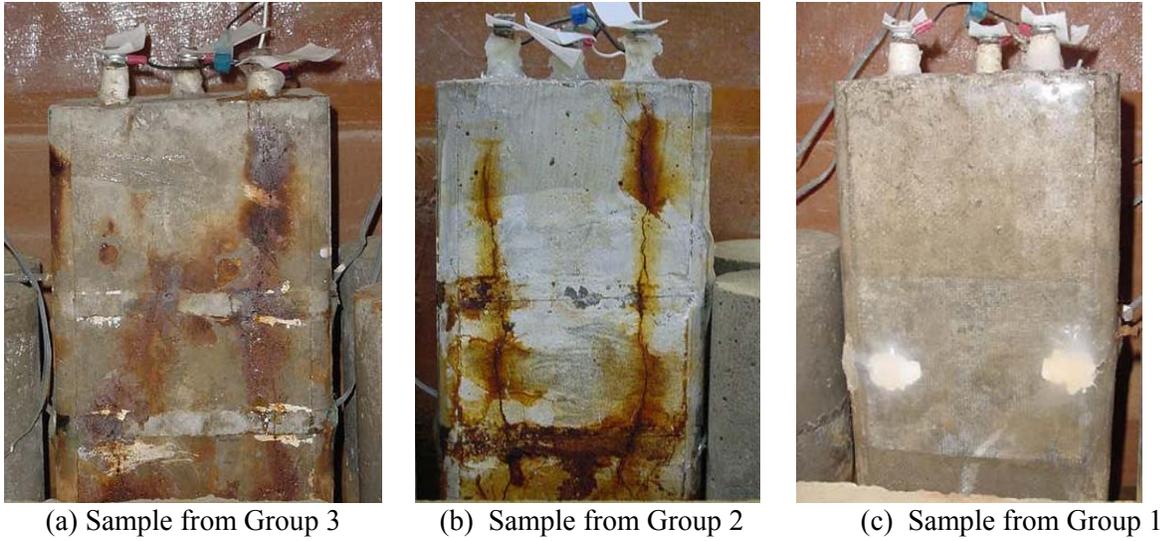
Figure 4-17: Samples from each group after 6 weeks of accelerated corrosion test

As expected and shown in Figure 4-17, all specimens suffered severe cracking, but in Group 1 specimens (with FRP) the crack propagation and damage was much less than in Group 2 and Group 3 specimens (without FRP). The crack pattern due to the corrosion-induced expansion was monitored in more detail for each group of specimens.
