Improved Shallow Depth Patches for Concrete Structures

Final Report to the Michigan Department of Transportation

February 2008

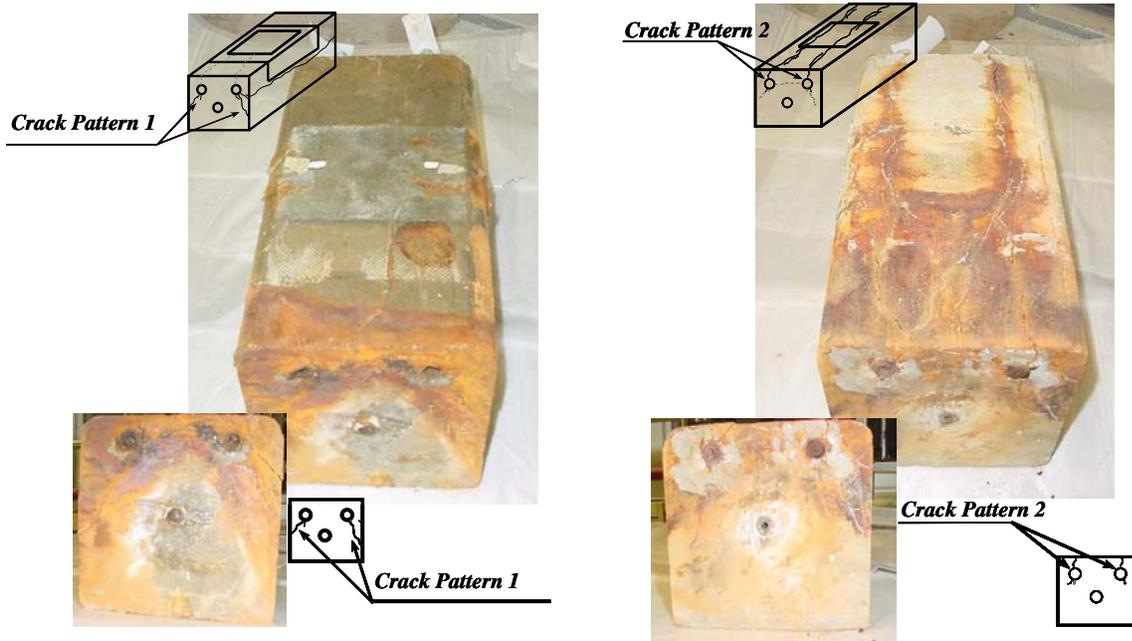
Figure 4-18: Crack pattern due to corrosion

Crack Path: Two different crack patterns were observed. Figure 4-18 shows a schematic and a photograph of the two crack patterns.

Two of the specimens with FRP overlay, H1C5-1 and H1C9-2 (Group 1) had a single dominant crack along the side surface of the specimens parallel to the FRP overlay and reinforcing bar as shown in Figure 4-18(a). This crack path is henceforth referred to as a Pattern 1 crack. Some cracks were observed in the concrete cover but they did not extend to the patch. Also some debonding of the FRP overlay was observed around the crack path as predicted by the FE analysis.

(a) Group 1 crack pattern

(b) Group 2 & 3 crack pattern

Specimens with a patch and no FRP overlay (Group 2), and control specimens with no patch or overlay (Group 3), had a dominant crack at the bottom surface of the specimens parallel to the reinforcing bar. This crack is henceforth referred to as a Pattern 2 crack. In Groups 2 and 3 some specimens also had internal cracks from one corroding bar to the other (anodes), and some internal cracks radiating outward from the reinforcing bar into the concrete.

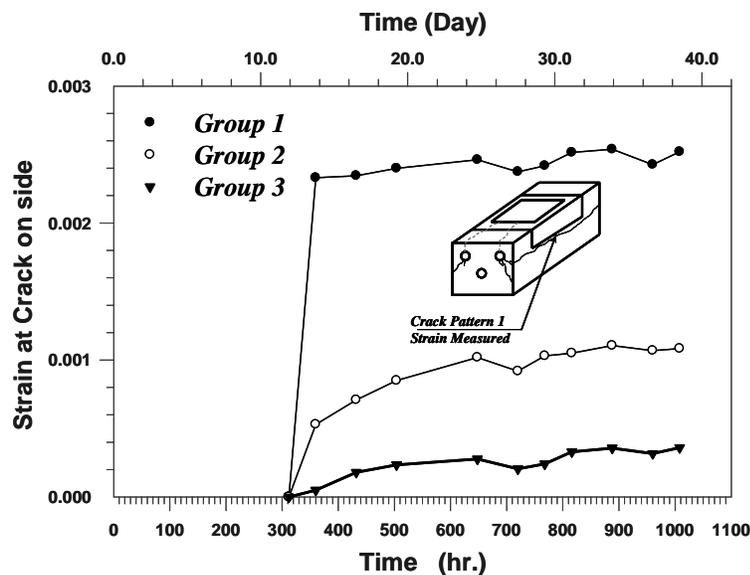
Figure 4-19: Maximum strains in the corrosion test along the crack path for crack pattern 1

Strain gage reading: Figure 4-19 and Figure 4-20 show the maximum strains on the sides and bottom of the specimens as a function of time for typical specimens in all three groups. It should be noted that strain readings were initiated after the first two weeks of corrosion when the rebar started to swell and strains began to develop on the concrete and patch material. Figure 4-19 shows that the strain on the sides is largest for Group 1 specimens (with FRP overlay) which had Pattern 1 cracks (i.e., cracks that propagated to the sides). Figure 4-20 shows that the strain at the bottom is largest for specimens in Groups 2 and 3 (without overlay) which had Pattern 2 cracks (i.e., cracks that propagated to the bottom). The strain levels on the bottom and sides are different and this could be because the strain gages on the bottom were mounted at the crack locations while those on the side were not.

As both Figure 4-19 and Figure 4-20 show, the maximum strain at the sides for the Group 1 specimens are almost 10 times smaller compared to the maximum strain at the bottom of the Group 2 and 3 specimens. This indicates that corrosion can be reduced significantly by using the FRP overlay. The crack widths ranged from 0.2 mm on specimens with FRP overlay (Group 1) to 1.5 mm for specimens without the overlay (Group 2). Thus the FRP overlay also reduces crack widths. The results of the strain gage reading compare well with the FE analysis regarding the prediction of the crack pattern in corrosion specimens as explained in below.

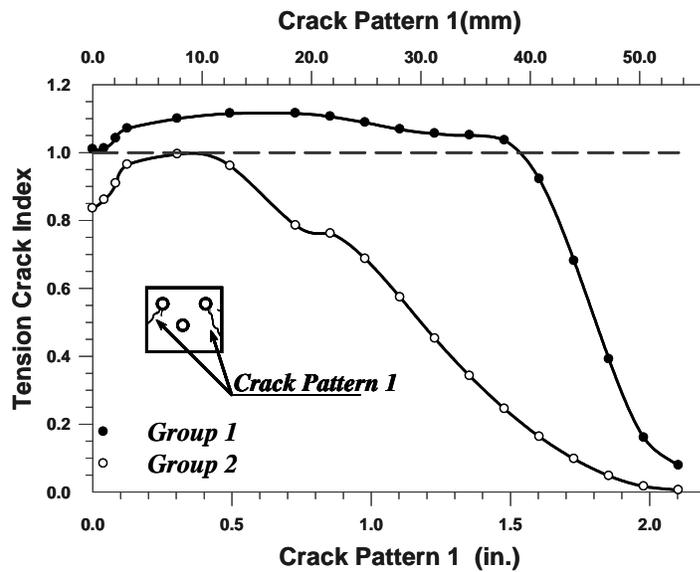
Figure 4-21: TCI along different crack pattern 1

In order to understand the overall effect of the FRP overlay on the stress distribution and crack pattern in the concrete substrate and patch material, the TCI was calculated in the cross section of the model along the two most probable crack paths that were obtained in the experiment. Figure 4-21 and Figure 4-22 show the calculated TCI in the concrete and patch material along the crack paths observed in the experiment and confirm that Pattern 1 cracks will

occur for Group 1 specimens but not for Group 2 specimens, while Pattern 2 cracks will occur for Group 2 specimens but not for Group 1 specimens. The FE analysis indicated that when 14% of the corrosion expansion strain is applied on the Group 2 specimens (without FRP) the first crack opens in the patch material as in Pattern 2, and when the first crack is fully opened the concrete substrate is not yet cracked.

On the other hand, the first crack opens as in Pattern 1 after applying 58% of the expansion strain on the Group 1 specimens (with FRP overlay). The numerical results match the crack patterns observed in the experiment, and cracking is delayed when the FRP overlay is used. The match between experimental and numerical results show that the FE analysis with the rebar corrosion modeled as an initial expansion strain applied uniformly across the entire cross section of the bar gives reasonable results. The FE analysis also is able to explain the mechanical effect of the FRP overlay on the crack pattern and how it delays the onset of cracking.

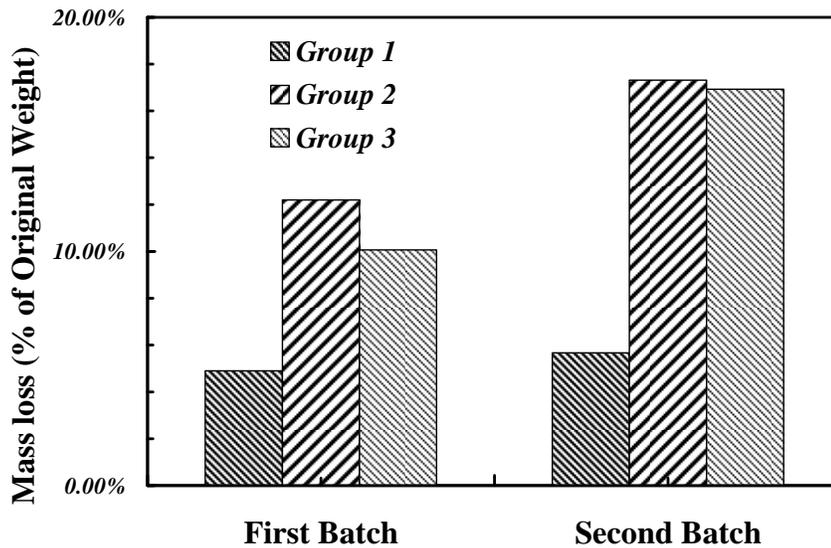
Figure 4-23: Corrosion mass loss for each group

The First batch had 3 specimens and, the second batch had 6 specimens. For the second batch, the applied voltage was 12.83 V, while for the first batch it was 12 V. This is likely to be the cause for the increased mass loss for the second batch compared to the first batch for all groups.

Figure 4-23 indicates that the corrosion level is similar for Groups 2 and 3. However, the mass loss for Group 2 (patched specimens) was slightly more than that for Group 3, since the porosity of the patch material is more than that of concrete and allows oxygen and chloride to diffuse more easily toward the steel bars thereby increasing the corrosion level. Also, as mentioned in the literature review, the anode ring effect and difference in potential between old concrete and fresh patch mortar could increase the corrosion of the reinforcement bars.

Table 4-7 and Figure 4-23 also indicate that the corrosion level was significantly reduced when the FRP overlay was used. This confirms the inference made earlier from strain gage reading for Group 1 and Groups 2 and 3 specimens.

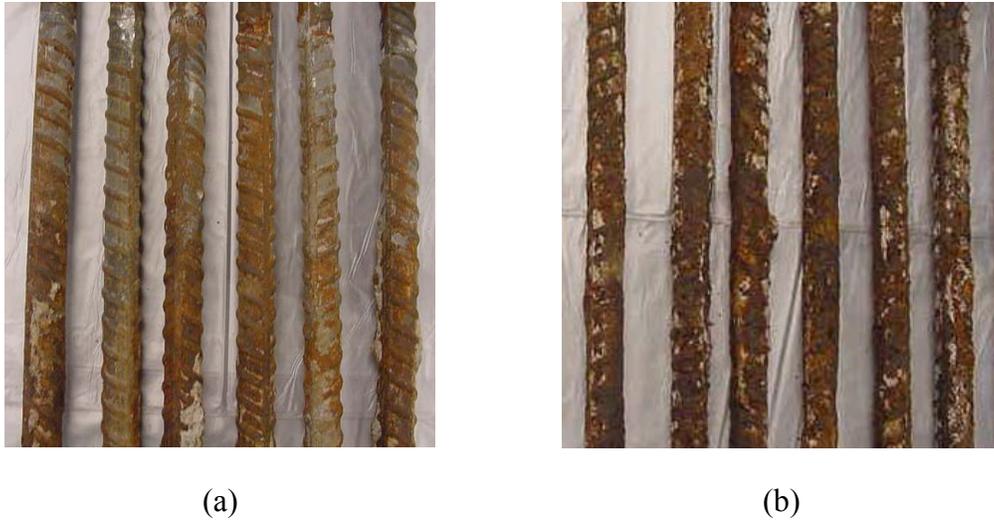
Figure 4-24: Bars after six weeks of accelerated corrosion testing (a) Group 1 (b) Group 2 & 3

The most likely reason for the overlay reducing corrosion is the reduction of diffusion of chloride ions, moisture and air through the concrete and patch due to overlay acting as a barrier. Figure 4-24 shows the corroded bars before cleaning for both Group 1 and Groups 2 & 3. It is clear that the corrosion level in Group 1 specimens (with FRP overlay) was considerably lower compared to the other two groups. Reduction in the corrosion is the main reason for the decrease in the measured strain and the reduction in the crack width for Group 1 specimens.

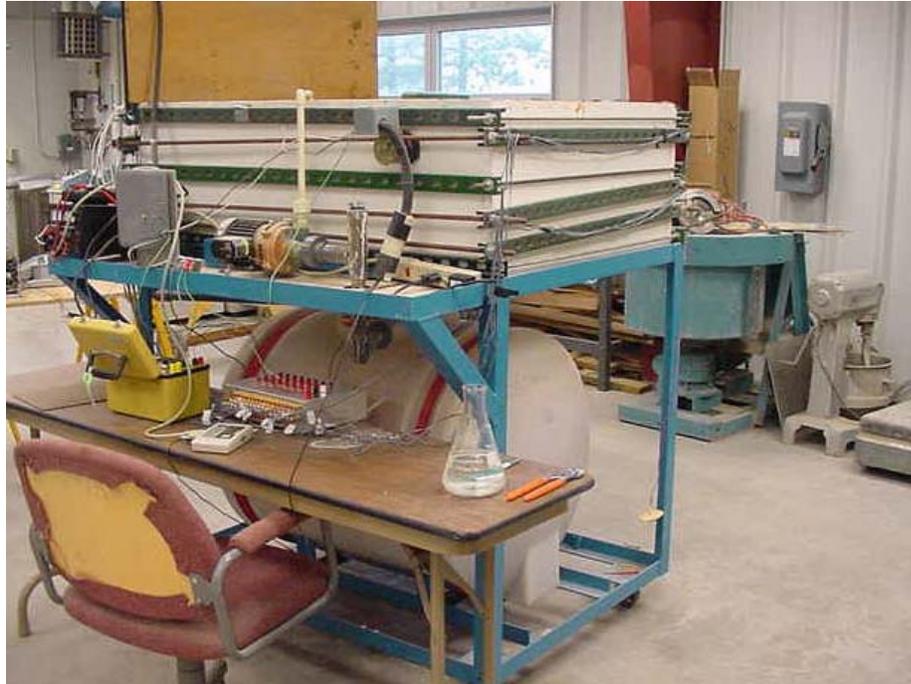
Figure 4-25 : Wet-dry tank

For the wet- dry exposure study, specimens with dimensions 4" × 3" × 16" with one #3 reinforcing bar, half in the patch and half in the concrete, with a cavity size of 3" × 4" × 0.625" were used with only patch Material 1. The specimens were subjected to 300 wet-dry cycles. A 3.5 percent (by weight) sodium chloride solution was used to wet the specimens for one hour in each 12-hour period. Figure 4-25 shows the wet-dry set up. The wet-dry test was started on March 2, 2006, and 300 cycles was completed on July 2, 2006. At the end of each 100 cycles the specimens were inspected to detect any debonding, cracking of the patch material, or damage on the FRP.

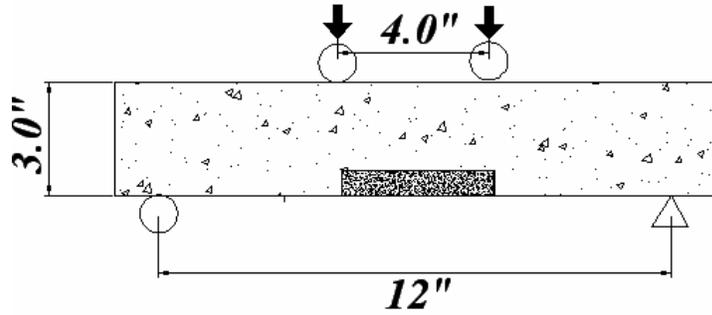
Figure 4-26 : Flexural test set up

After specimens were exposed to the freeze-thaw and wet-dry environments they were to be subjected to a fatigue test under 4-point loading. The maximum fatigue load was initially limited to that which caused a peak strain of $0.2\epsilon_y$ in the steel reinforcement to simulate real field conditions in bridges. A dummy specimen with a strain gage on the reinforcement bar was tested under flexure, and loaded to failure to determine the required load and moment to obtain the target strain and also to determine the load capacity of the specimens. Figure 4-26 shows the test set up for the flexural test, and Figure 4-27 shows the moment-strain results for the dummy specimens. The beam failed in shear at a load of 4.945 kips. The maximum frequency for applying the load was 2 Hz for the MTS machine at the MSU laboratory.

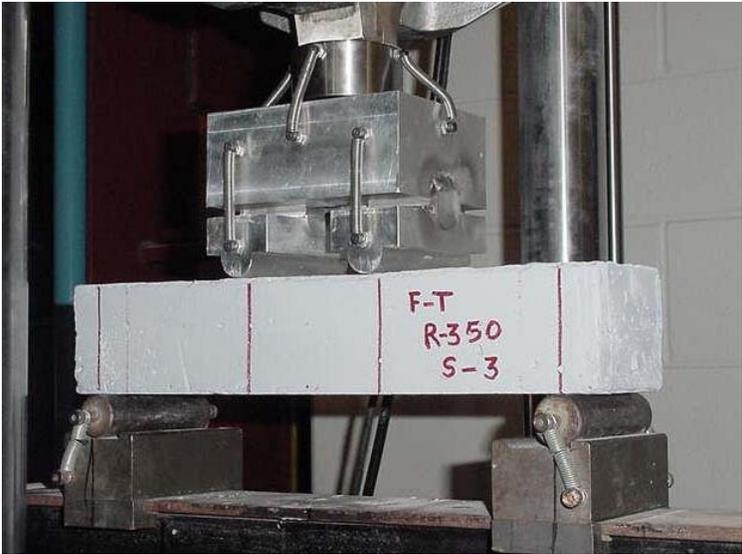
Figure 4-28: Freeze-thaw specimen after almost two million cycles of fatigue testing

Initially an R2F3 specimen (freeze-thaw specimen with patch Material 2 and without FRP overlay) was subjected to the fatigue test for almost two million cycles. A photograph of the specimen after this load application is shown in Figure 4-28. The maximum damage on the specimens was limited to debonding on the sides of the patch directly under the applied loads. In order to induce more damage the maximum bending moment was increased by increasing the applied load to 2.7 kips. This increased the strain level in the steel to $0.4\epsilon_y$. Since the capacity of the specimen was limited by its shear strength the maximum load could not be increased beyond

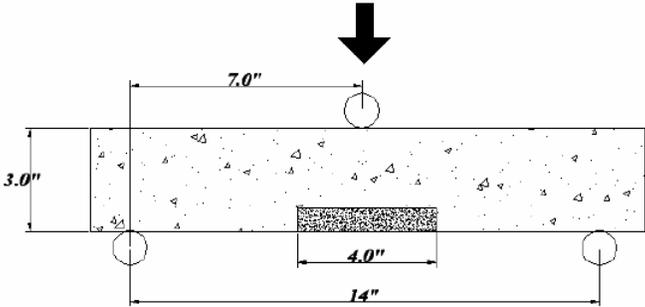
some point. The same specimen was tested again with the new loading, and the test was continued for more than 25,000 cycles. However, no more additional damage was observed on the specimen. To further increase the maximum moment and strain in the steel, the specimen was then tested under three point loading as shown in Figure 4-29. The maximum moment, and consequently the maximum induced strain, was increased by increasing the span from 4 in. to 7 in. The specimen failed by slip of the rebar after less than fifty cycles when the strain in the steel bar was close to the yield stain. Some additional approaches like welding plates at the end of the specimens were also tried but none of were successful. The specimens always failed in an attempt to further increase the strain in the steel before any significant damage occurred to patch.

Specimens in Group 1 and 2 were first subjected to the flexural cycling loading for 1000 cycles, after which they exposed to 300 cycles of freeze-thaw. In the revised test 3-point loading was used as shown in Figure 4-29: New fatigue test set up The span was increased to 14" and the load was also increased to induce a strain of $0.6\epsilon_y$ at the steel bar. Table 4-11 describes the extent of damage in each specimen. The pre-loading was begun on February 14, 2007.

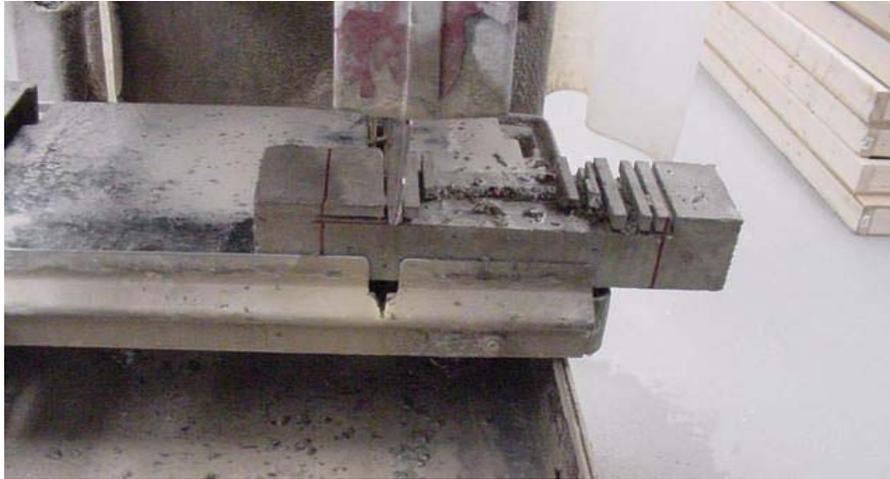
Figure 4-31: Expanding cavity size

To reduce the bonding of the patch to the concrete along vertical surfaces, and to provide more area along which the patch can crack, it was proposed to increase the size of the cavity at the bottom of the test specimens to 4" × 9" × 0.625" as shown in Figure 4-2. The patch now extended across the entire width of the specimens. To prepare the new specimens from the old ones that had a 3" × 4" × 0.625" cavity, the size of the cavity in the old specimen was increased by removing the concrete for the bottom surface using a concrete saw, chisel and hammer. The specimens the saw depth was adjusted so the steel bars were not damaged to the extend possible.

Saw cuts were separated by roughly half an inch from each other and the concrete was removed with a hammer and chisel. Figure 4-31 shows the procedure used to prepare the new specimens. Figure 4-32 shows a typical specimen with the enlarged cavity.

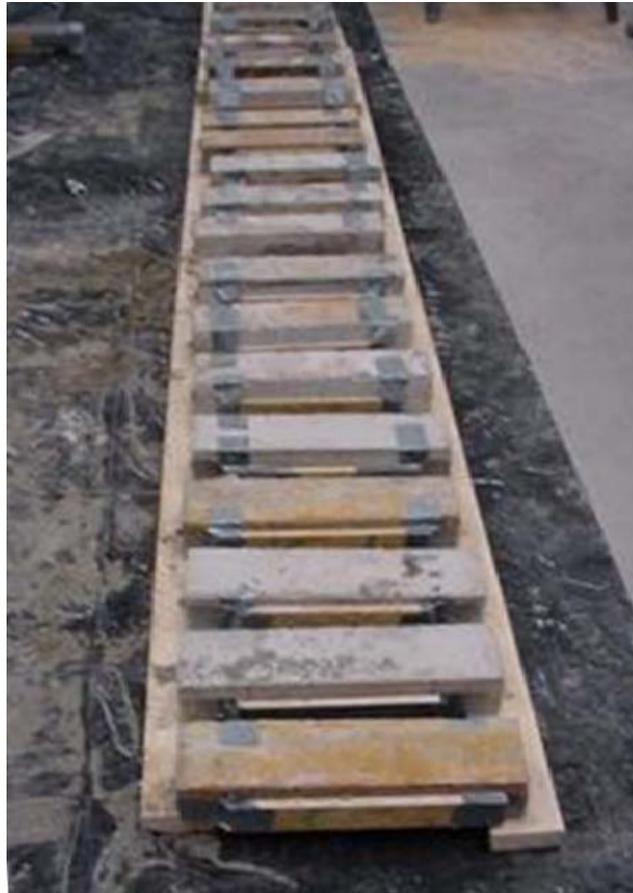
Figure 4-33: curing specimens in overhead position

concrete specimens. Pine boards having one inch thickness were selected for this purpose. The wooden boards were attached to the concrete substrate temporarily with tape. No release agent was applied to the wood forms. Specimens were placed in an overhead position when applying the repair mortar and left in that position for one day, after which they were turned upside down. Figure 4-33 shows the specimens curing in the overhead position.

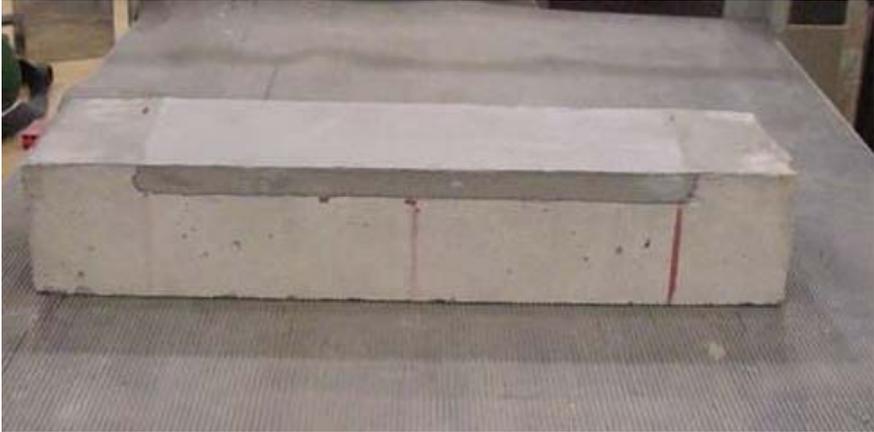
Figure 4-34: New specimen after patching

was applied, and these specimens were cured for 10 days at room temperature. The specimens were inspected to identify any damage on the patch after 10 days of curing. The best specimens were chosen as control specimens (“No exposure”). Figure 4-34 shows a typical specimen after applying the repair mortar.

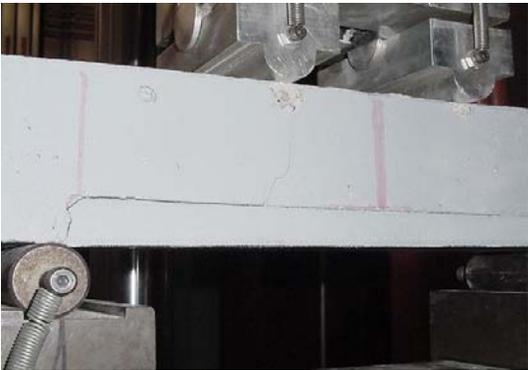
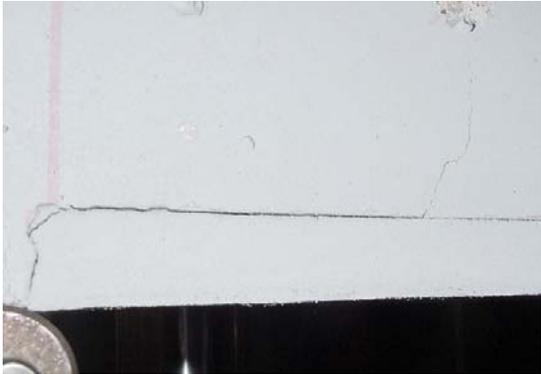
Figure 4-35: Specimen after 1000 cycles of fatigue test

After 10 days of curing a dummy specimen patched with Material 2 was tested under cyclic loading for more than a million cycles. Figure 4-35 shows the condition of the specimen and patch during the fatigue test. The patch cracked and partially debonded from all the bond surfaces. However, while the cracks seemed to have penetrated through the entire bond surfaces, the patch did not actually break apart and could not even be pulled apart by hand.

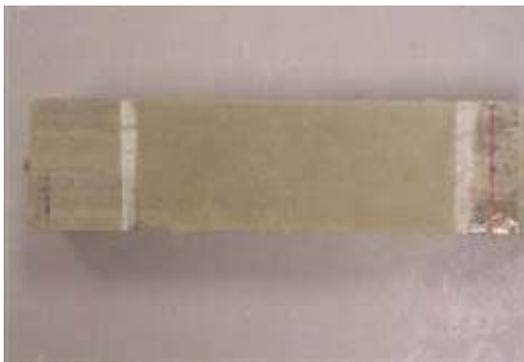
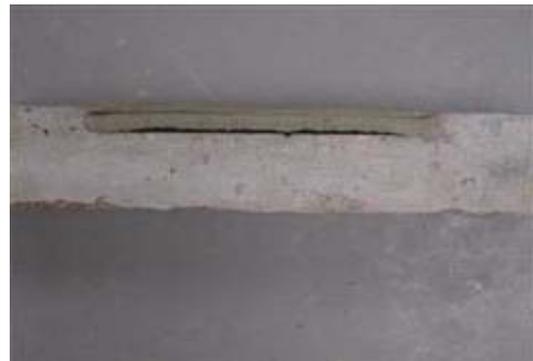
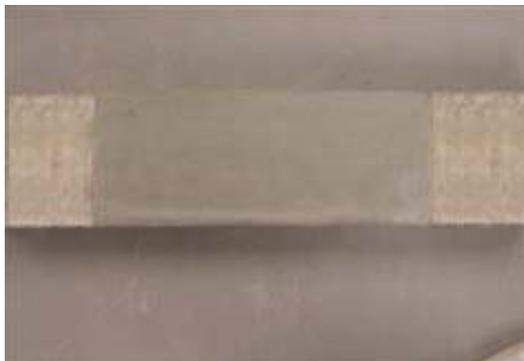
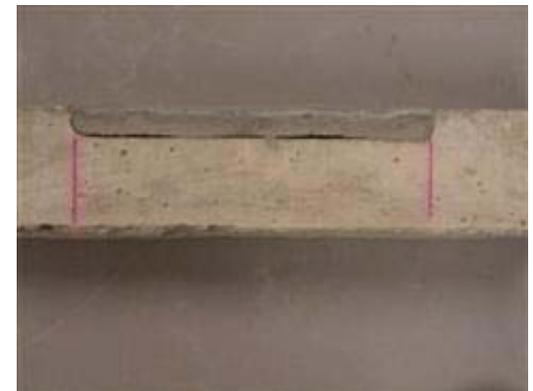
Figure 4-36: Sample specimens after 1 day of curing Pre-Loading

(a) Bottom view of H2F4 specimen

(b) Side Elevation H2F4 specimen

(c) Bottom view of R1F5 specimen

(d) Bottom view of R1F5 specimen

Figure 4-36 shows some of the specimens after 1 day of curing.

H1F3	Slight debonding at the top surface and slight sagging of the patch on one side caused a gap of about 2 mm between the concrete substrate and patch. No debonding was observed at the side surface.
H1F4	No debonding or cracking.
H1F5	No debonding or cracking.
H2F	No debonding or cracking.
H2F2	No debonding or cracking.
H2F3	No debonding or cracking.
H2F4	Significant debonding at the top surface and significant sagging of the patch on one side caused a gap of about 5mm between the concrete substrate and patch. No debonding observed at the side surfaces. (See Figure 4-36: Sample specimens after 1 day of curing (a) and (b)).
H2F5	No debonding or cracking.
R3N1	Slight debonding (visible gap) at the top surface, and debonding at sides.
R3N2	No debonding or cracking.
R3N3	No debonding or cracking.
R3N4	No debonding or cracking.
R3N5	No debonding or cracking.
R1F1	Slight debonding (visible gap) at the top surface and debonding at sides.

R1F2	No debonding or cracking.
R1F3	No debonding on the top surface and debonding on both sides.
R1F4	No debonding or cracking
R1F5	Slight debonding at the top surface and slight sagging of the patch on one side caused a gap of about 1 mm between the concrete substrate and patch. No debonding was observed at the side surface. (See Figure 4-36: Sample specimens after 1 day of curing (c) and (d)).
R2F1	Slight debonding (visible gap) at the top surface, and debonding at sides.
R2F2	No debonding or cracking
R2F3	No debonding or cracking
R2F4	Slight debonding at the top surface and slight sagging of the patch on one side caused a gap of about 2 mm between the concrete substrate and patch. No debonding was observed at the side surface.
R2F5	No debonding on the top surface, and debonding on both sides

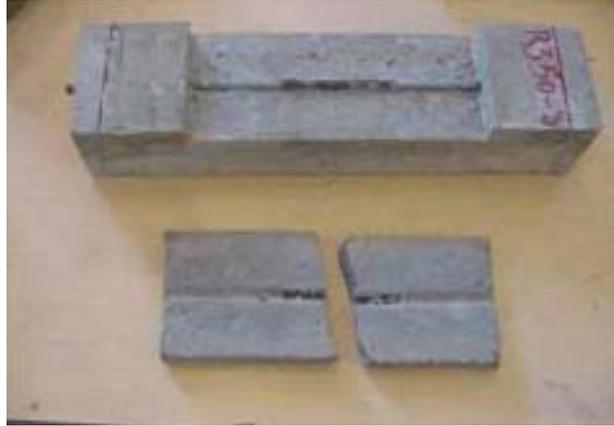
Figure 4-37: Specimen R2F4 after about 400 cycles

All specimens were subjected to cyclic flexural loading for 500,000 cycles from April 2007 and it was continued up to August 2007. The specimens did not show any noticeable further damage than what they had after pre-loading. Only in one specimen (R2F4) did the patch fall off after about 4000 cycles of loading. Figure 4-37 shows specimen R2F4 and debonded patch. The patch broke in to two pieces after falling from the concrete during the test.

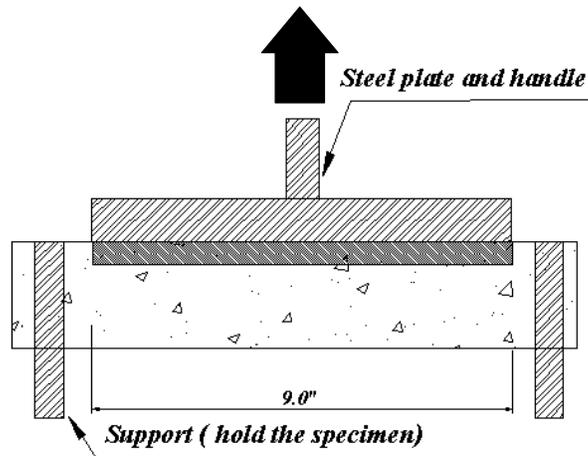
Figure 4-38: Schematic of pull-out test set-up

A 1.5 inch thick steel was glued to the patch surface using the Huntsman TDR 1100-11 two-component epoxy adhesive. The steel plate had the handle at the middle as shown in Figure 4-38. The concrete specimen was secured with two steel grips to the support of the MTS machine, and a tensile force was applied to the handle to pull out the patch. Figure 4-38 and Figure 4-39 show details of the pull-out test set-up.

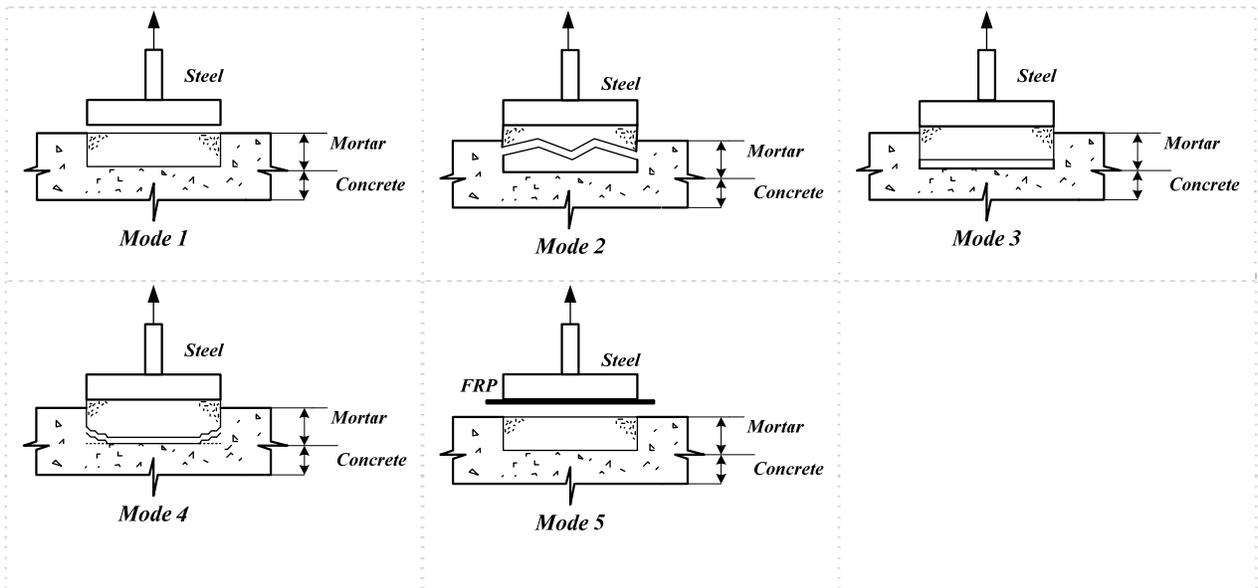
Figure 4-40: Failure modes in pull-out test

Each failure mode is illustrated in Figure 4-40. Only one of the specimens failed due to shear failure of the concrete substrate. This specimen had a shear crack from the pre-loading and since the bond between the patch and the concrete was the specimen failed in shear.

Mode 5: Separation of the FRP overlay from the patch material. When this occurred, the FRP removed and the steel plate was glued directly to the patch and pull-out test was repeated again (Group 1 specimens only).

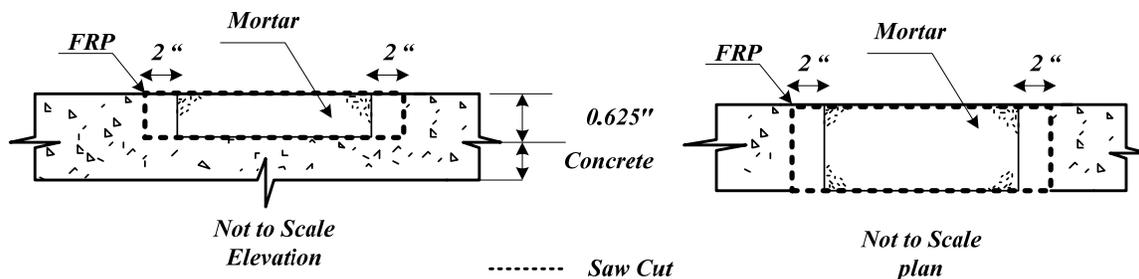
Figure 4-42: Dimension of FRP overlay for pull-out test

The length of extension of the FRP overlay over the concrete substrate was not always the same in all specimens due to variation in fabrication but the differences in extension were at most 0.25 in. Since this extension of the FRP overlay is directly related to the bond strength in Group 1 specimens, the FRP overlay was cut exactly at an extension of 2 in. in the top and 0.625 in. on the sides using saw. This was done so that the results could be compared with each other. Figure 4-42 shows the extension of the FRP overlay over the concrete substrate after cutting.

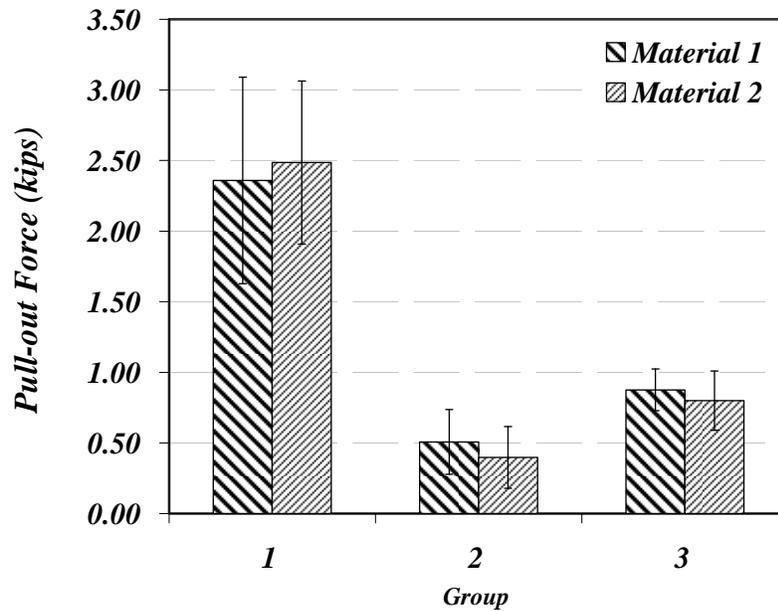
Figure 4-43: Comparison of mean bond strength

The mean bond strength and 95% confidence interval for each mean strength are shown in Figure 4-43. It is apparent that the mean bond strength for Group 1 is significantly higher than that for Groups 2 and 3.

<i>Group 1</i>		<i>Group 2</i>		<i>Group 3</i>	
<i>Specimen</i>	<i>Force (kips)</i>	<i>Specimen</i>	<i>Force (kips)</i>	<i>Specimen</i>	<i>Force (kips)</i>
R1F1	2.80	R2F1	0.58	R3N1	0.65
R1F2	3.21	R2F2	0.54	R3N2	0.60
R1F3	2.67	R2F3	0.30	R3N3	0.72
R1F4	2.28	R2F4	0.00*	R3N4	0.82
R1F5	1.47	R2F5	0.57	R3N5	1.20
Mean	2.49	0.40		0.80	
St. Deviation	0.66	0.25		0.24	
95% Confidence	0.58	0.22		0.21

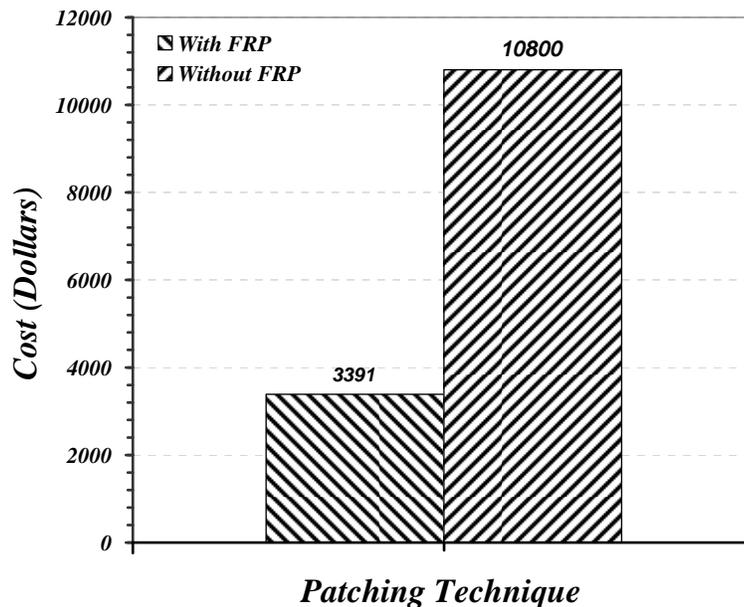
Figure 5-2: Present value of the cost of repair per cubic yard over 15 years

Figure 5-2, Table 5-5 and Table 5-6 show the cost analysis for the bridge maintenance for 15 years using both patching approaches. The interest rate was assumed to be 2.9% for each year based on a 15-year evaluation period (OMB 2007).
