**EXPERIMENTAL CONCRETE AND BITUMINOUS SHOULDER
CONSTRUCTION REPORT
(Experimental Work Plan No. 4)**

**Research Laboratory Section
Testing and Research Division
Research Project 68 F-101
Research Report No. R-844**

**Michigan State Highway Commission
E. V. Erickson, Chairman;
Charles H. Hewitt, Claude J. Tobin, Peter B. Fletcher
Lansing, January 1973**

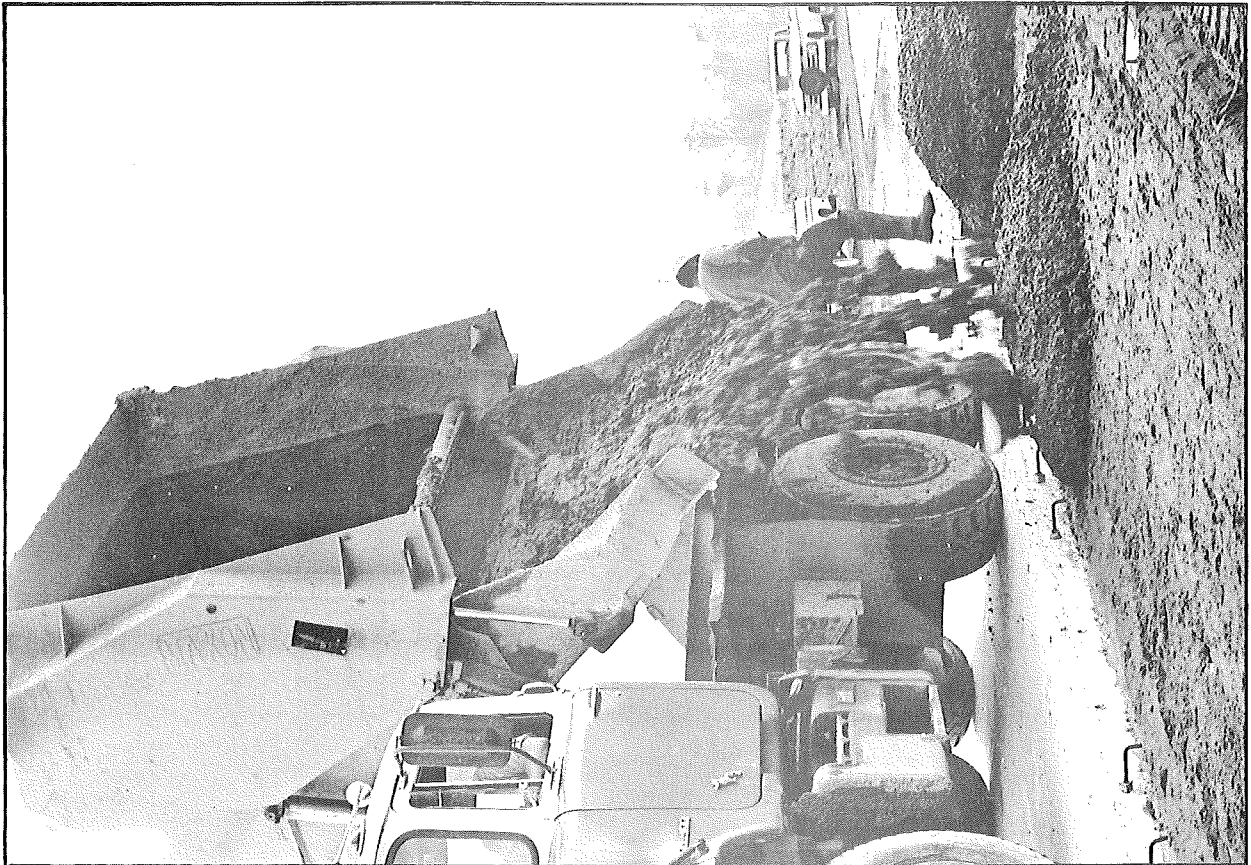
Figure 4. Concrete placed on subbase ahead of paver. Note shape of subbase trim in foreground that allowed use of full 9-in. slip-form on the outside of the paver to place slab that varied from 9-in. at pavement edge to 6-in. near track line. Also note hookbolts in slab edge.

Davco Inc., concrete paving contractor for the project, elected to use a 12-ft CMI slip-form paver to place the shoulders. Since the paver was equipped for 9-in. pavement thickness, and the outside edge of the shoulder was to be only 6-in. thick, the base was trimmed in an unusual fashion to allow retention of the full depth side form. A CMI Autograder was used to trim the subbase and the concrete was placed directly from trucks running on the slab (Fig. 4). The paver was run as shown in Figure 5, to place and consolidate the 9-ft wide shoulder. This operation is not easily accomplished, since steering control is not as positive as it should be. Moreover, coarse aggregate from the mix tends to collect between the oscillating screeds and the existing slab, raising the effective height of the screeds. The job was successfully completed by using additional workmen before and behind the paver to check constantly on the operation, remove excess mix from the vicinity of the edge of slab, and promptly correct any malfunction of the steering mechanism. Special shoulder paving gear was not developed for this project because of the relatively small quantities involved. If future projects, with large quantities of concrete shoulders, are planned, they probably would be done with special equipment, or further adaptation of the slip-form paver, to accomplish the task more easily.

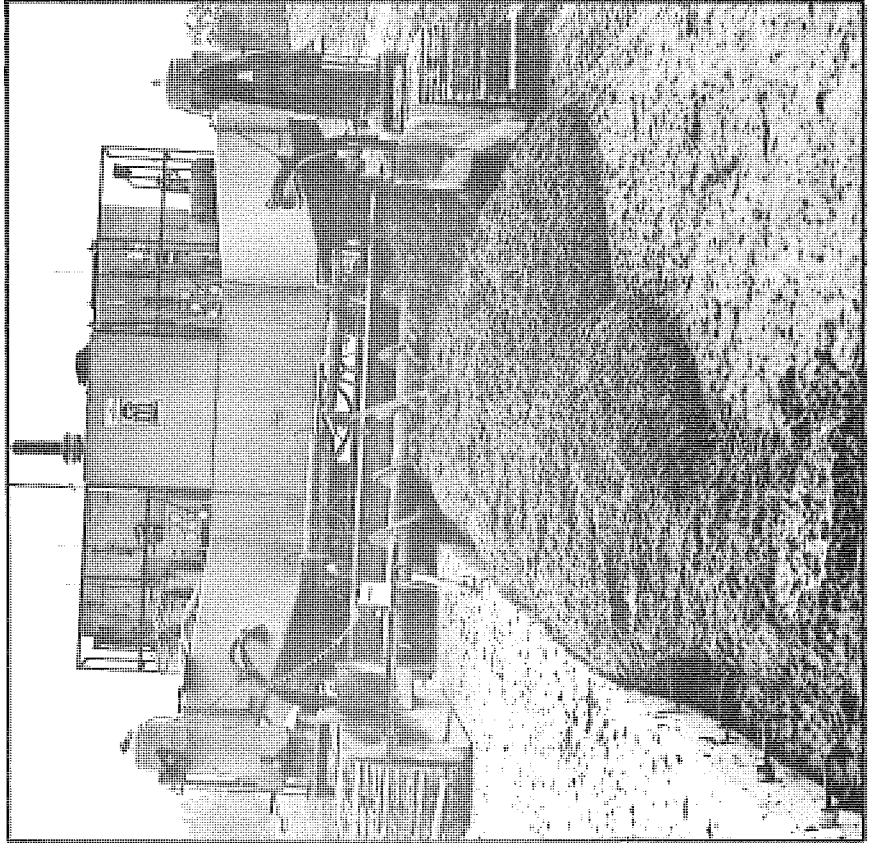
Figure 5. Twelve-ft CMI slip-form paver used to place 9-ft concrete shoulder on I 69 near Charlotte, Michigan.

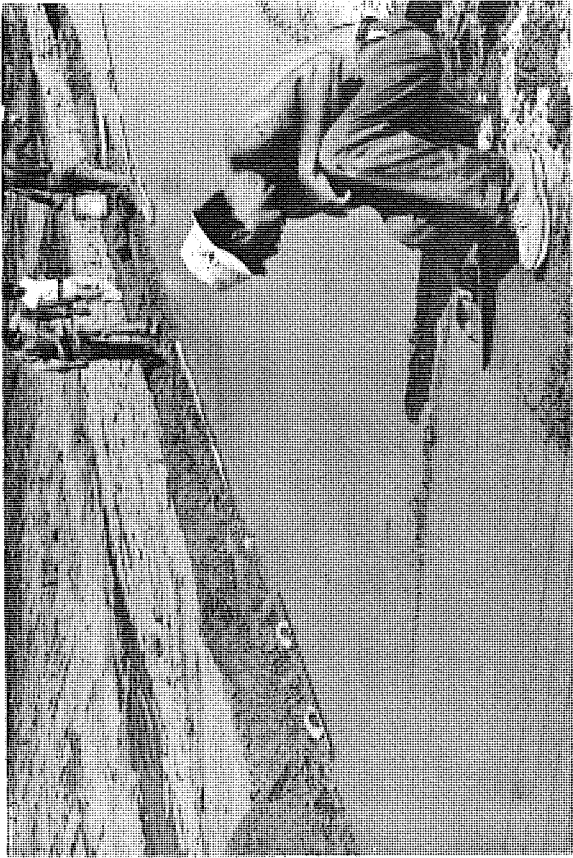
Figure 6. Series of operations used in forming rumble strips. Initial removal of some concrete from the area prevents corrugations from protruding upward where they would be struck by scraper blades.

The surface of the shoulders was hand floated, textured with a burlap drag and cured with white membrane applied by spraying. Rumble strips were formed in the surface by a corrugated metal float, as shown in Figure 6. A board held against the outside edge of the shoulder reduced edge slump during formation of the corrugations.

The rumble strips on the concrete shoulder were terminated about a foot from the longitudinal joint to eliminate jointing and sealing in the corrugated area. Construction workers were able to form the rumble strips without unusual difficulty. These strips cause a loud sound when driven upon and should be a valuable safety device for warning drowsy drivers that they have wandered onto the shoulder. No adverse effects on vehicle control were noted by staff members who drove over the completed sections.
