## In-house Research Improves Concrete Bridge Barriers

**Report Name:** Performance of Michigan's Concrete Barriers  
**Start Date:** April 1997  
**Report Date:** August 2007  
**Research Report Number:** RC-1498  
**Total Cost:** The costs of this research were incidental to the daily activities of the Michigan DOT investigators.  
**Cost Sharing:** None

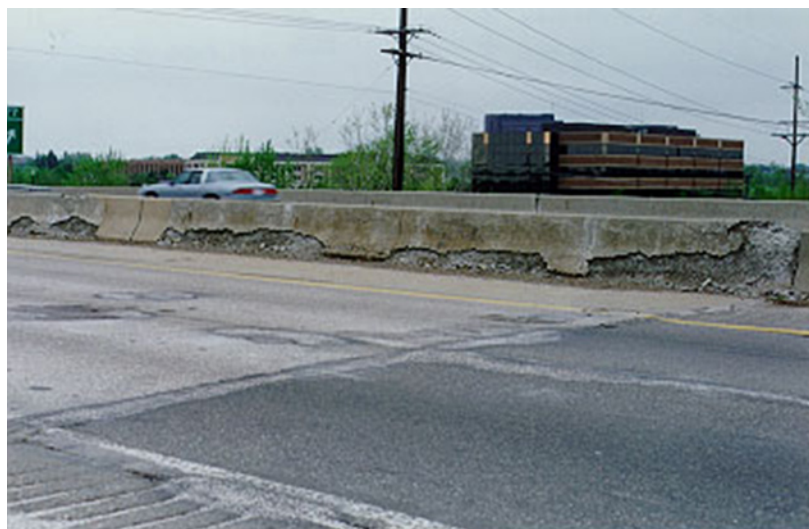
*This barrier shows crumbling common in concrete barriers made with blast-furnace slag coarse aggregates—a discontinued practice in Michigan, thanks in part to this study.*

- The winter freeze-thaw cycles and increased use of chemical deicers proved to be the top external contributors to barrier deterioration. Barrier design, concrete mix design and construction methods need to be optimized to withstand these seasonal factors.
- Early deterioration was commonly seen in concrete walls constructed by slipforming, or continuous casting with a moving form. Compared to casting in-place with a stationary form, slipforming appears to introduce excessive internal stresses in the concrete structure that lead to premature deterioration.
- Concrete mixes containing blast-furnace slag coarse aggregate, a steel industry byproduct, displayed early deterioration and appear to be inappropriate for barrier walls.

These and other observations prompted recommendations to improve the long-term performance of concrete barriers exposed to harsh winters. Michigan DOT has already implemented some of the study's recommended changes, having discontinued traditional slipform construction as well as the use of blast-furnace slag coarse aggregates and other low-durability coarse aggregates
