EVALUATION OF A COLLISION AVOIDANCE AND MITIGATION SYSTEM (CAMS) ON WINTER MAINTENANCE TRUCKS

Research Administration
Reference Number: OR17-103

FINAL REPORT

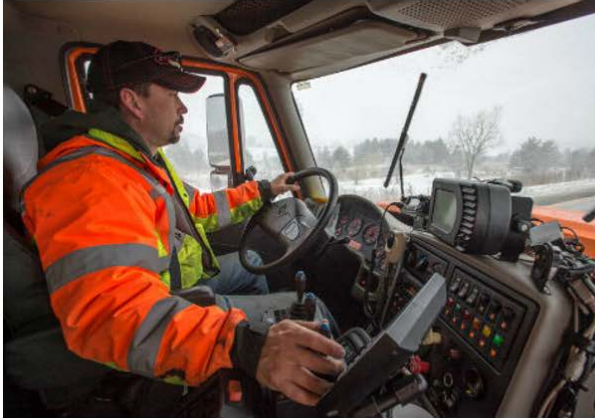
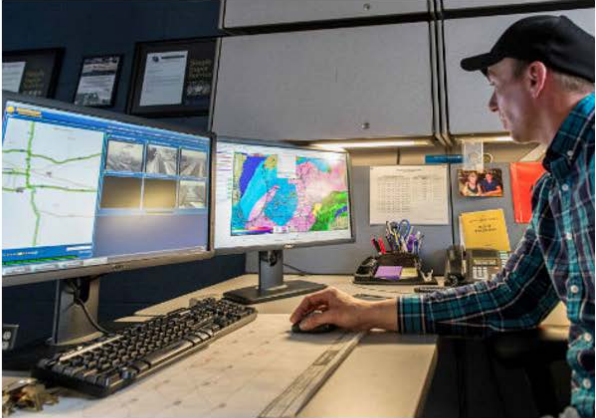
Figure 2-1 MDOT Automatic Vehicle Location (AVL) for Winter Maintenance Vehicles

a) Truck equipped with GPS

b) Control center

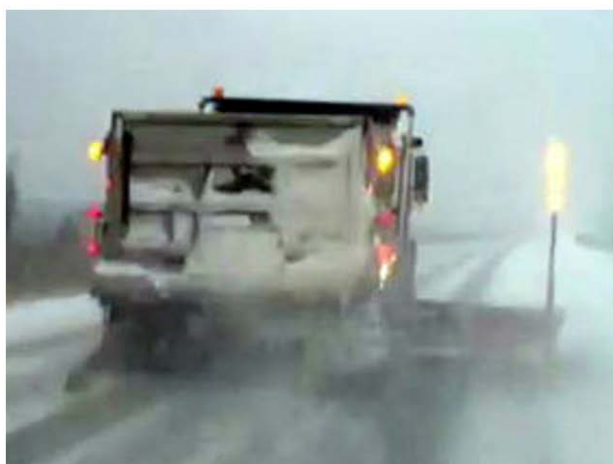
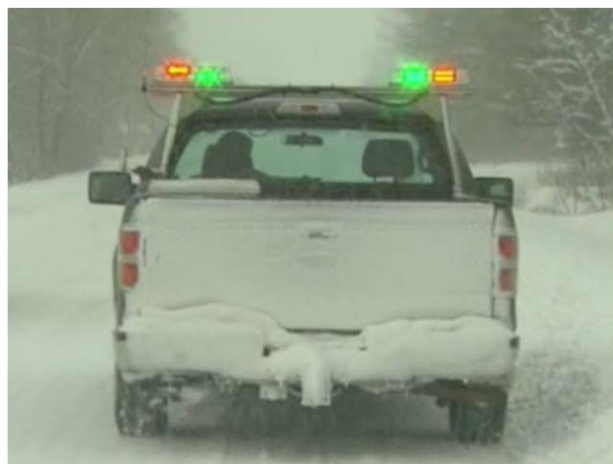
Figure 2-2 Typical Warning Lights for Winter Maintenance Vehicles

a) MDOT vehicle with warning lights

b) Green warning lights

More recently, however, greater emphasis has been placed on ensuring the safety of snowplow drivers and the traveling public during plowing and deicing activities, particularly through the use of enhanced vehicular warning lights. One recent advancement in this area is the use of green warning lights, which increase visibility over traditional amber warning lights due to the sensitivity of the human eye to the green/yellow spectrum. Recently, the Michigan Vehicle Code was modified (Heqimi, Kay, & Gates, 2017) to allow for the use of green warning lights on winter maintenance vehicles, an example of which is shown in Figure 2.2b (Weingarten, 2016). The modest implementation cost of \$100 per vehicle (Cranson & Donohue, 2016) has led to widespread implementation of green warning lights on maintenance vehicles throughout Michigan. It has also become increasingly common to include a warning light mounted on the top corner of the plow blade (Figure 2.2a).

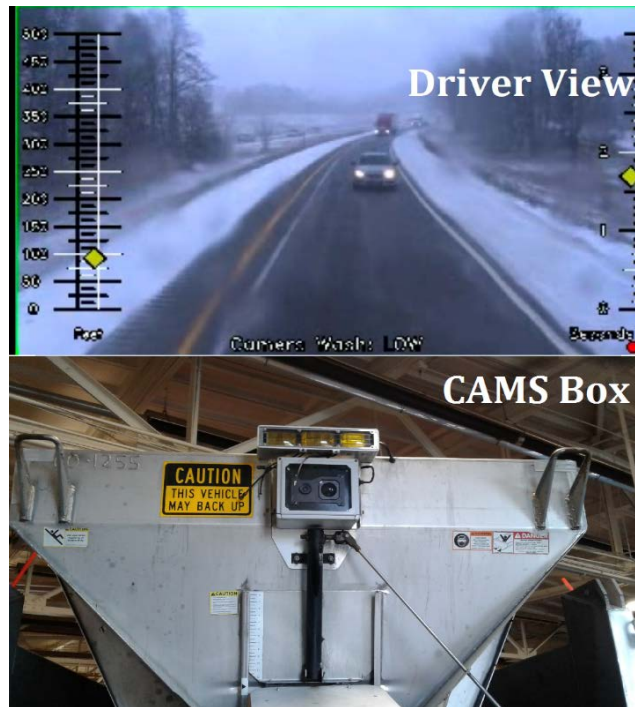
Figure 3-1 Collision Avoidance and Mitigation System

The warning light system is activated according to the following procedure. The ratio of the relative distance to relative speed between the detected vehicle and the WMT provides the relative headway, which is the basis for the warning light activation. When the following vehicle, traveling in the same lane as of WMT, encroaches towards the truck and crosses a pre-specified warning headway threshold, the warning light gets activated. The lighting system can be configured for different patterns in different headway thresholds to alarm the encroaching vehicles. For this study, two different warning alert patterns were established, termed Level 1 and Level 2, and were set to relative headways of 7 and 5 seconds, respectively, after initial controlled testing of the system. Chapter 4 discusses the process of choosing the proper thresholds in more detail. Note that in the current implementation of the CAMS, the warning light is only triggered if the relative headway drops below the threshold. Thus, a vehicle following the WMT with the same speed (i.e., with zero relative speed) would not trigger the warning light, regardless of the following distance, as the distance would remain constant based on the zero relative speed. This is a known drawback to the system as evaluated here, although the system can be reprogrammed to also include a distance-based threshold.

As the radar system performance might be hindered when it is occluded by layers of debris, the system must be kept clear of ice, mud, snow, and salt buildup. To counter this, the radar and camera were encased within a clear plastic housing that included a cleaning system. The cleaning system consists of a defrosting grid on the camera and radar box, and nozzles that spray water and air at certain frequencies to keep the CAMS box clean while the WMT is moving faster than a certain threshold (e.g. 10 miles per hour).

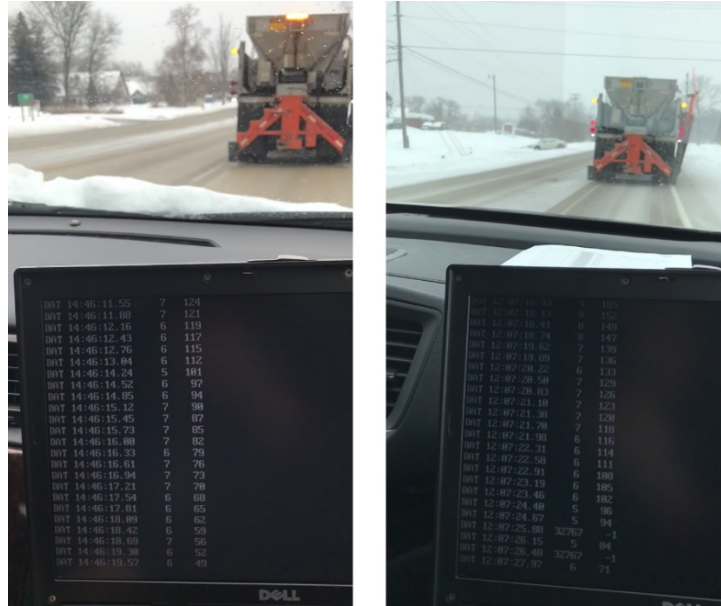
Figure 4-2 Snapshot of the LIDAR data in Test 1

- In each run, as the following car approaches to the truck, the relative distance is recorded via a LIDAR gun at the time that the warning system is activated.
- Note that test runs for each warning threshold were performed in separate attempts. The relative distance is easily recognizable in the logged data as the time at which the following vehicle speed decreases.
- The recorded relative distance via the LIDAR gun should be matched with the calculated distances (Equation 4.1).
- Also, a camera records the video of the data log on the computer screen and the situation in which the flash goes off (Figure 4.2)

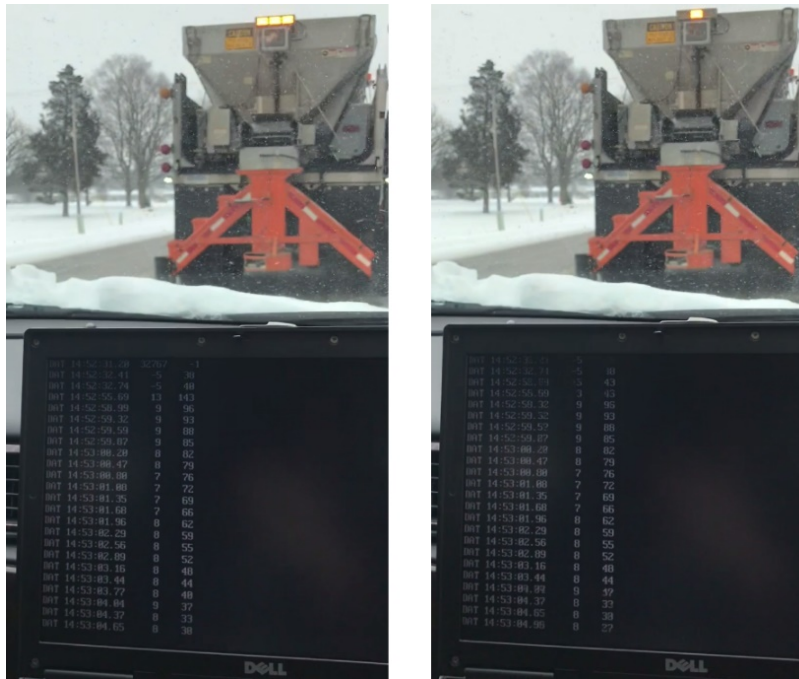
Figure 4-5 Snapshot of the data collection in Test 2

It is observed that for both warning levels the light is turned off up to about 3 seconds after the following car receded.

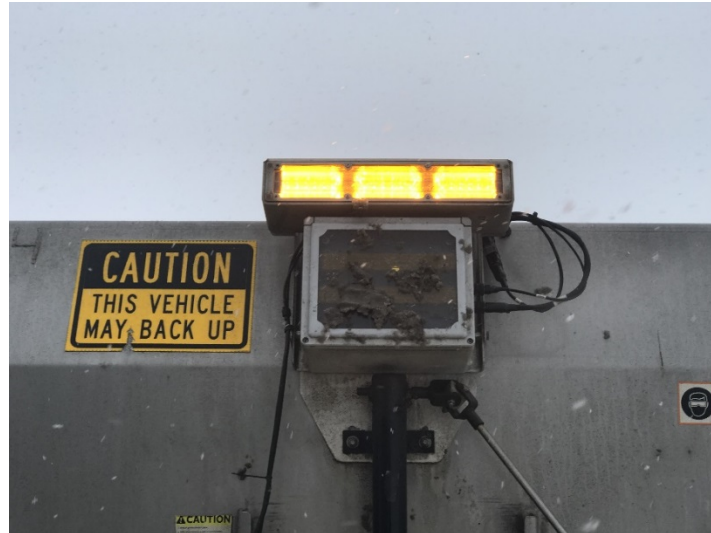
Figure 4-6 CAMS with muddy box in Test 3

The warning light was not activated when the housing for the radar unit was completely covered with mud/grime, such as that shown in Figure 4-6.

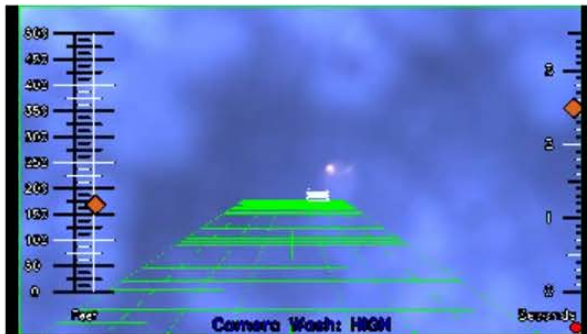
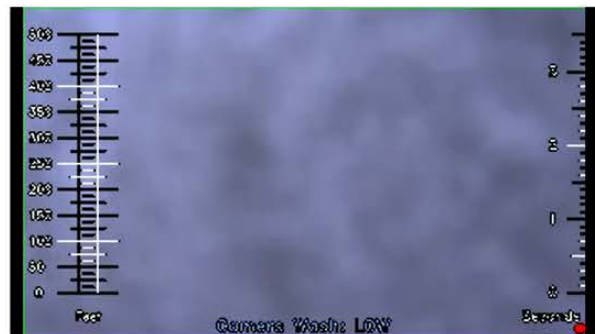
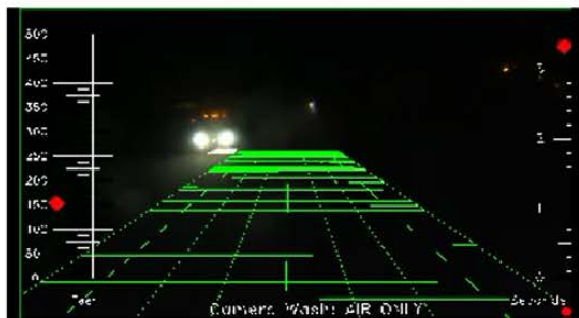
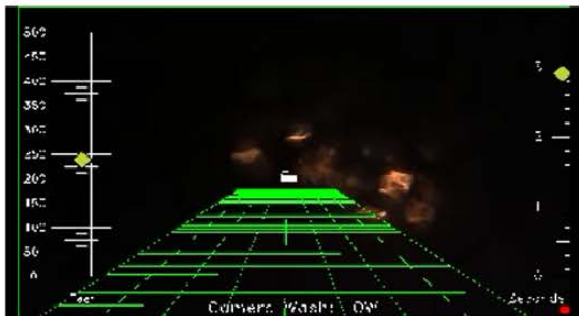
Clear

Slightly Blocked

Moderately Blocked

Totally Blocked

Around 200 hours of recorded videos by CAMS were obtained by the MSU research team to evaluate the performance of the washing system. A review of these videos found that blockage of the CAMS box, which is identifiable by covered camera view, might disrupt the radar system performance. To evaluate the performance of the washing system, four levels of camera view clarity are specified, based on the blockage intensity, which are illustrated in Figure 5.2 for both day and night time operations and described as follows:

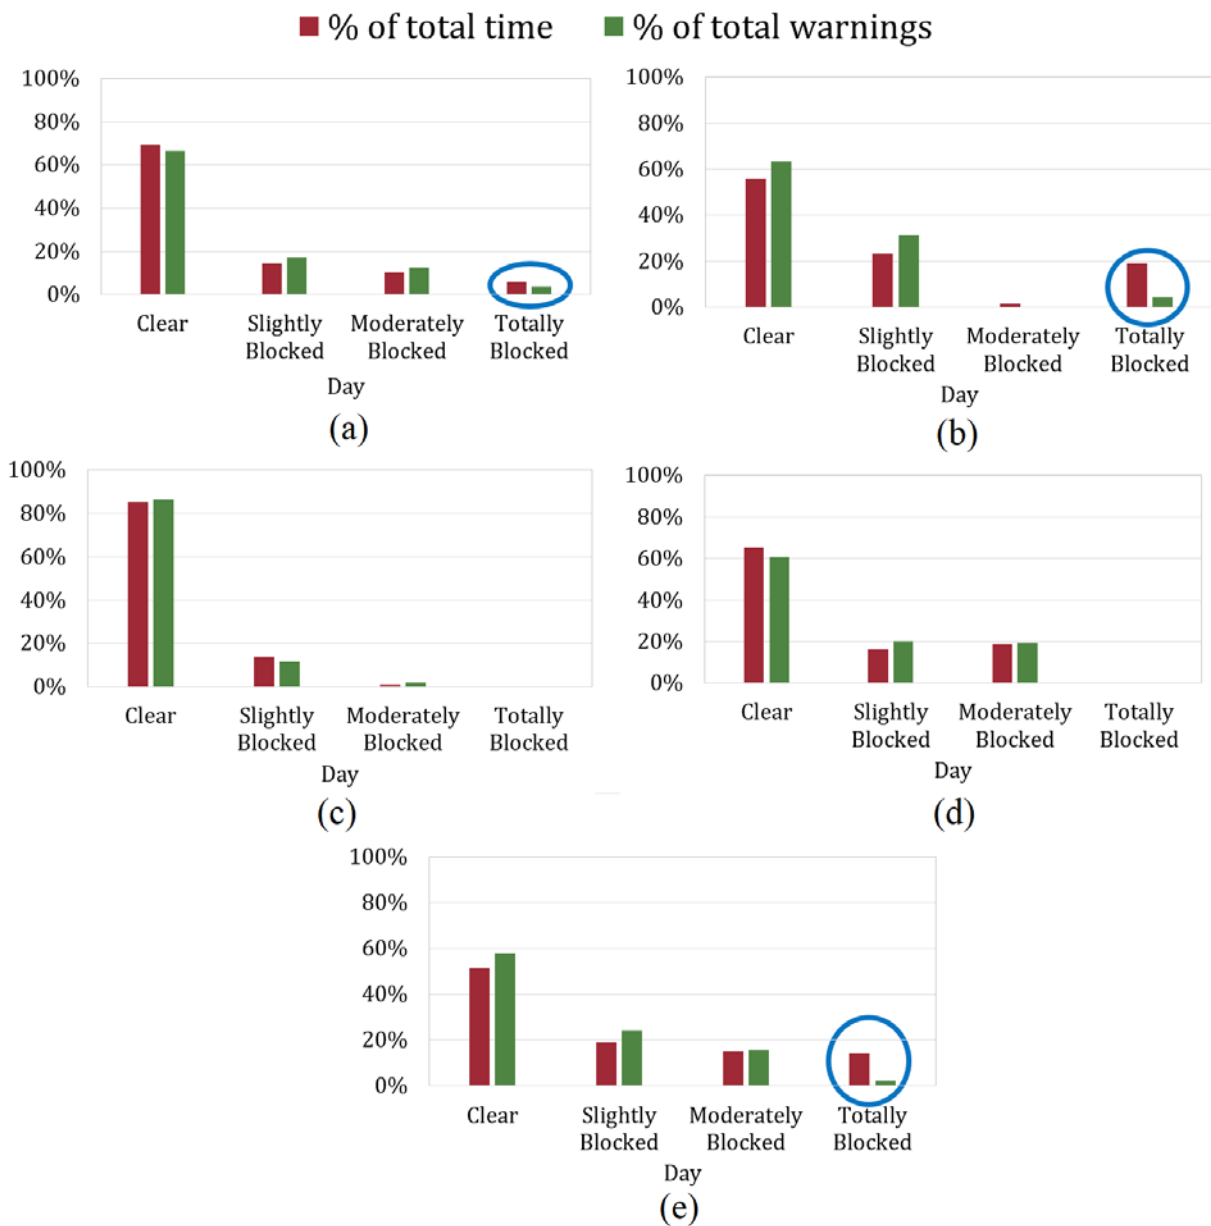
Figure 5-4 Percentage of total time versus the percentage of total warnings for (a) MDOT-4004, (b) MDOT-4005, (c) MDOT-4004, (d) MDOT-4005, and (e) RCOC

To better understand the relationship between the duration of camera blockage and number of recorded warnings, percent duration of each camera blockage level relative to the total time (of recorded videos) versus the percent of triggered warnings during each camera blockage level relative to the total recorded warnings are provided in Figure 5.4. To exclude possible errors due to classifying the night time situations, the durations of each camera view category are presented only for operations during day times in this figure.

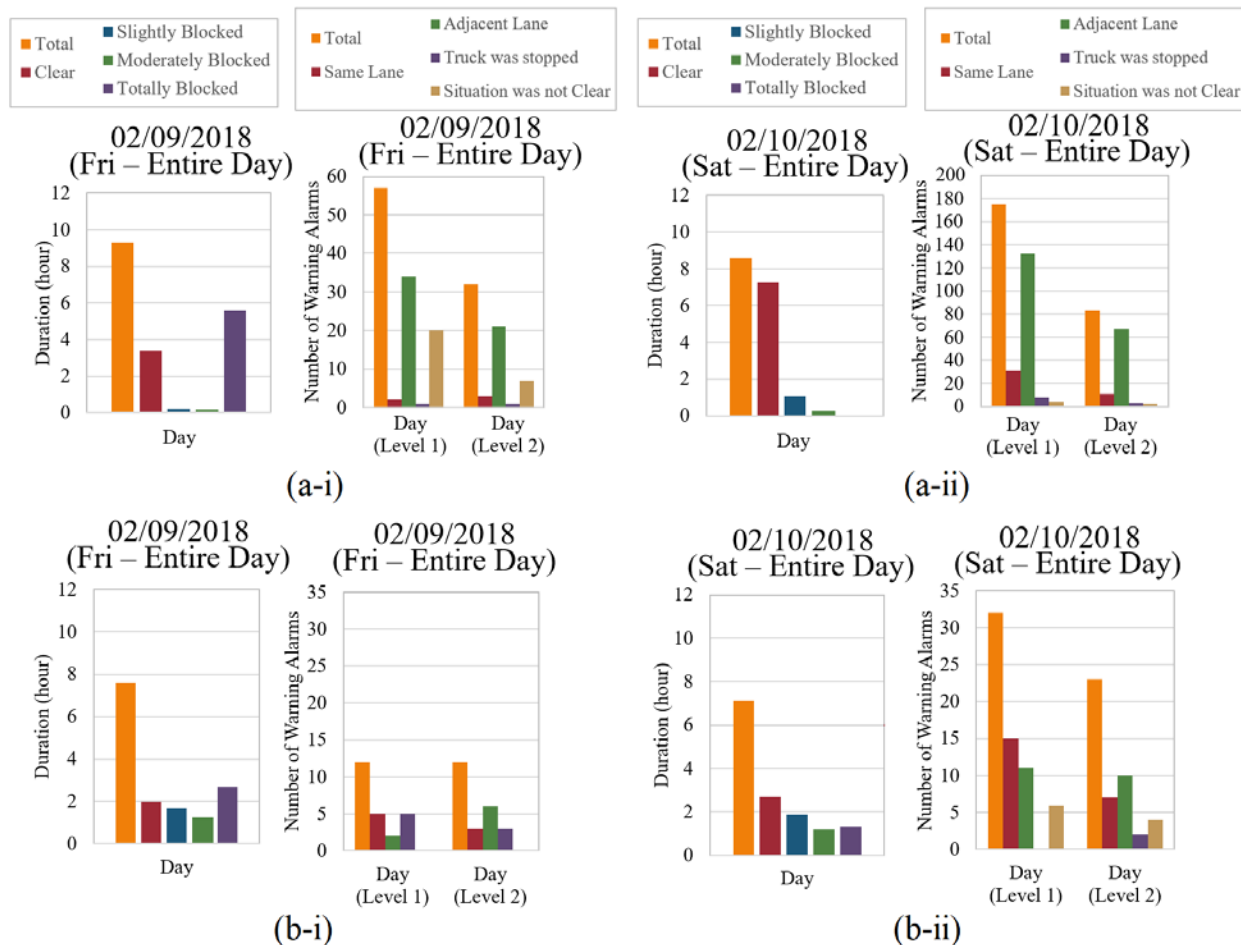
Figure 5-5 Duration of camera views and the number of recorded warnings for (i) Friday (02/09/2018) and (ii) Saturday (02/10/2018) for (a) MDOT-4005, and (b) RCOC

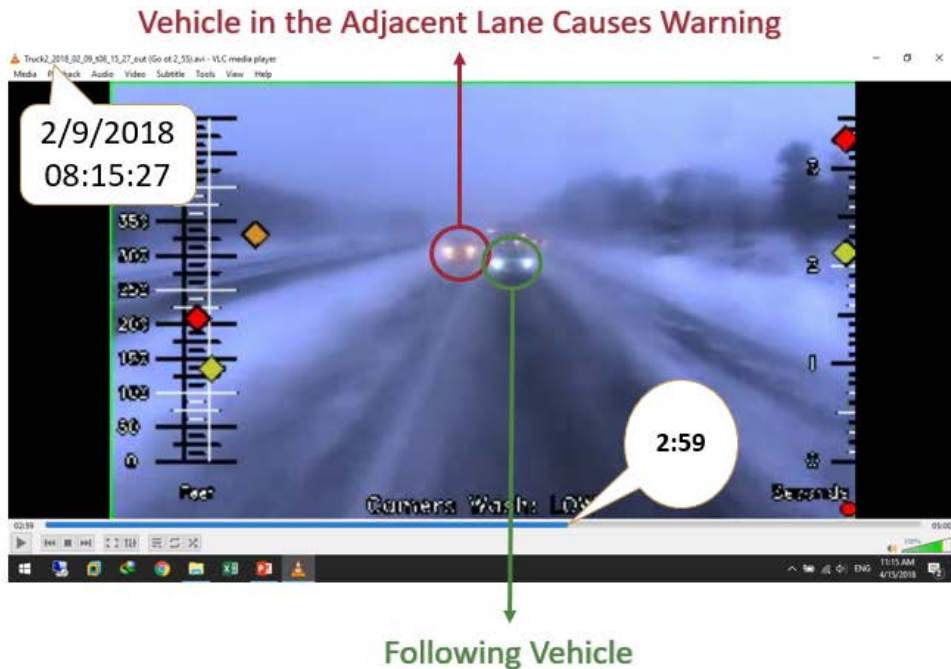
dx: space-gap (meter) vx: relative speed (km/h)
 tx: headway (second) dy: lateral offset (meter)

Figure 5-9 (a) Trajectories of two approaching vehicles to WMT, and (b) The snapshot of the CAMS recorded video at the time that the warning is triggered

that although the vehicles cross the warning threshold in the same lane of WMT, the warning system has not been activated. This suggests required system modifications to prevent these cases.

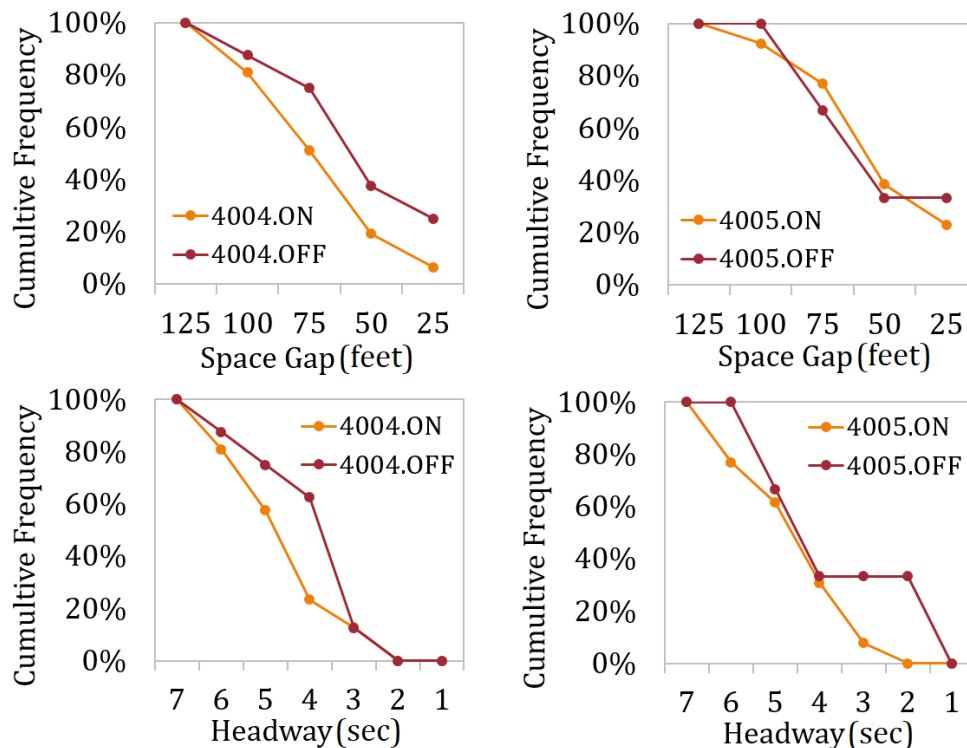
Figure 6-3 Frequency distribution of encroaching vehicles on tangent segments for the two trucks MDOT 4004 and MDOT 4005

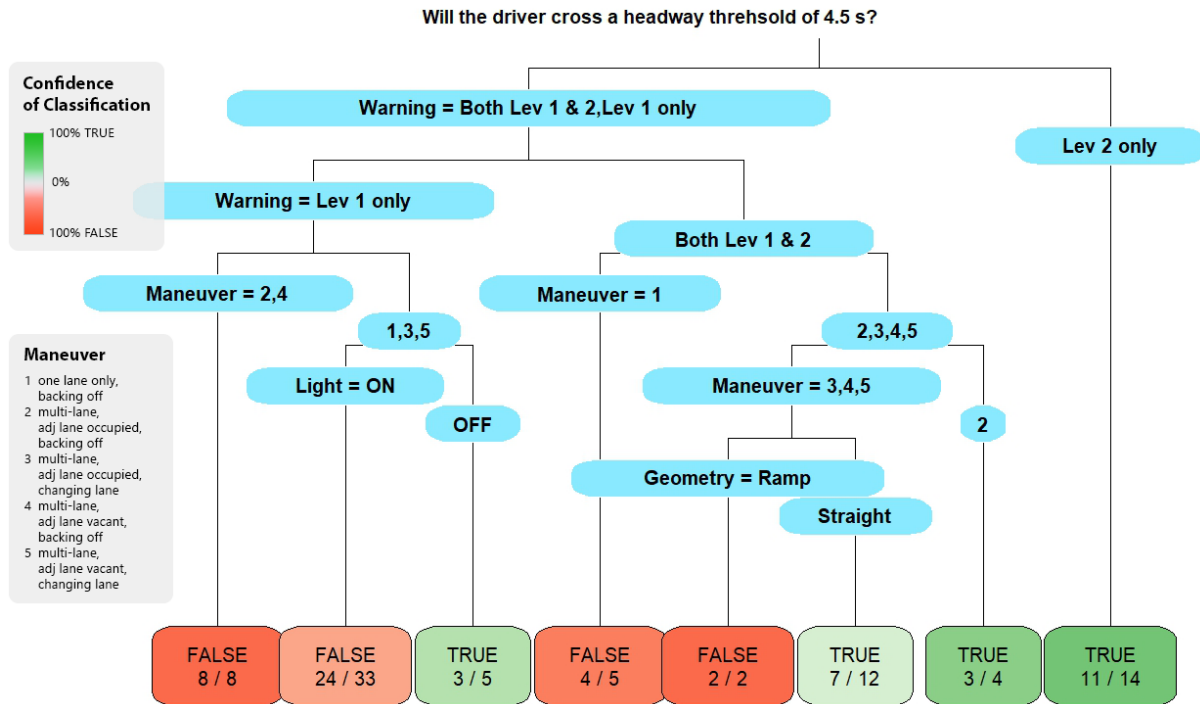
Figure 6-6 Encroachment decision tree for critical headway threshold of 4.5 sec

The target feature for the classification tree model of encroachment rate is posed as a question – “given a situation of the driver following the truck, would he/she encroach into a certain threshold of the relative headway?” This certain threshold, which is a model parameter, is the critical relative headway to ensure safe maintenance operation for WMTs. The tree for the critical headway threshold of 4.5 seconds shows a concise distinction between the ON and OFF cases for a certain combination of maneuvers, warning levels, and segment types (see Figure 6.6).

significant safety benefits by preventing rear-end accidents with WMTs. However, it should be noted that there are just only 7 observations for the OFF case, which may question the statistical significance of the conclusion. One can see that adding just one OFF observation for the curve segments can underestimate this improvement. Thus, a more comprehensive study is needed to observe more data, specifically for the OFF case at different conditions.

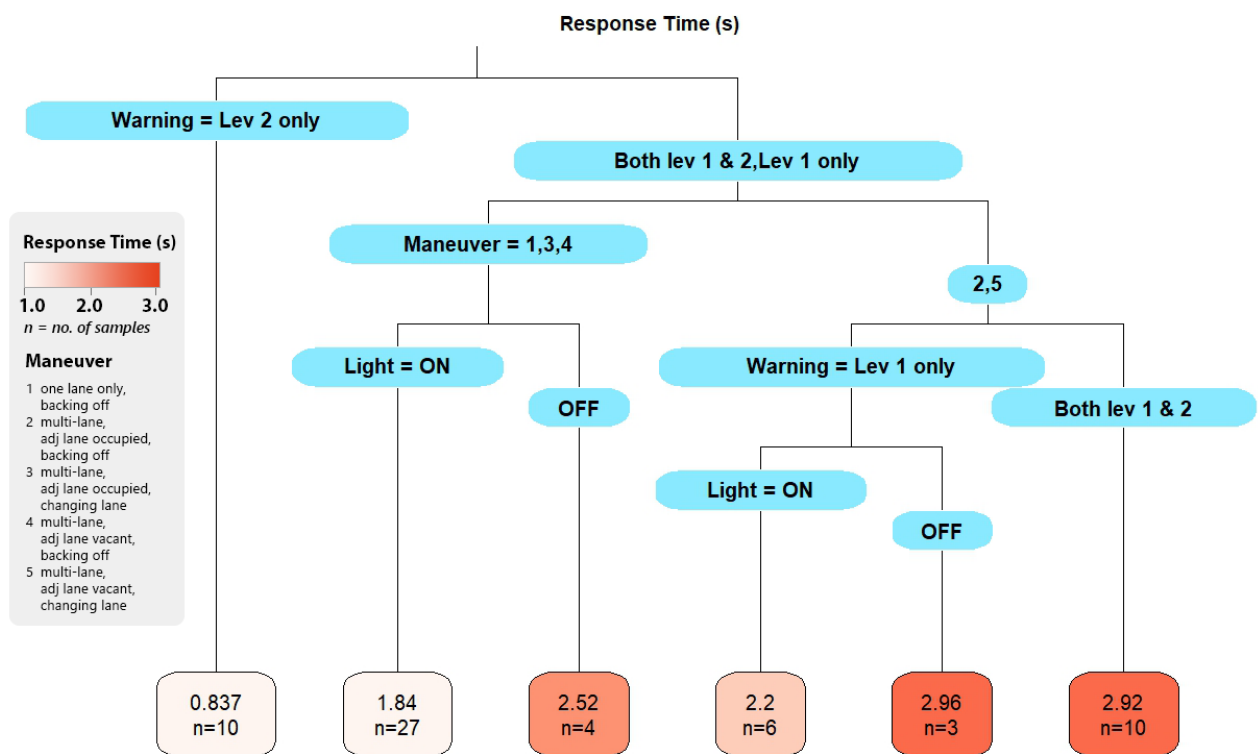
Figure 6-7 Regression tree for response time

Similar to the encroachment analysis a classification-regression tree-based model is presented for the response time in Figure 6.7. In this figure, based on the descriptive features and the associated response time to each of these features, two branches distinguish between the ON and OFF cases. The first branch is associated with “Level 1 only and both Level 1 and Level 2” warnings for Maneuver of “1,3,4”. In this branch, 0.68 seconds reduction, which is about 27% improvement, is observed in the response time, once the warning light is used to alert following vehicles. The second branch associated with “Only Level 1” warning and maneuver “2,5” shows 0.76 seconds reduction, and 25% improvement in the response time, once the warning light is used to alert the drivers. Although these reductions are a significant improvement in terms of safety, it should be noted that the number of observations is limited, specifically for the OFF case. This suggests that there might be some potential for the CAMS to improve safety, but this needs to be confirmed by a more enriched data set including enough number of observations for both ON and OFF cases.

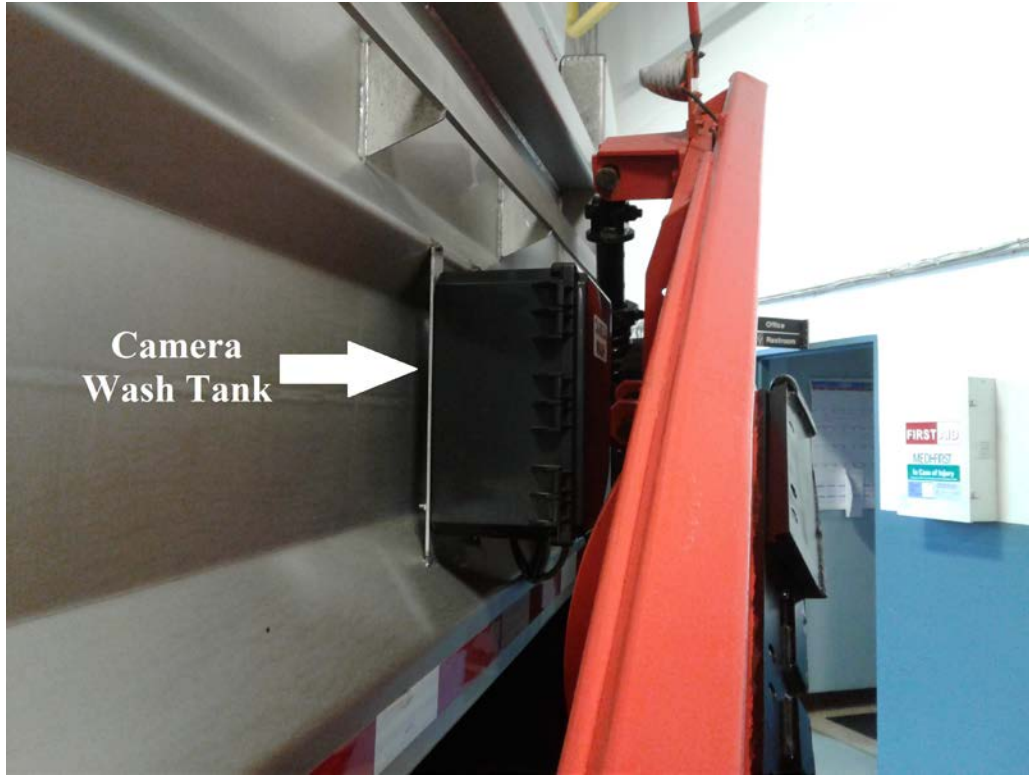
Figure 7-1 Camera Wash Tank

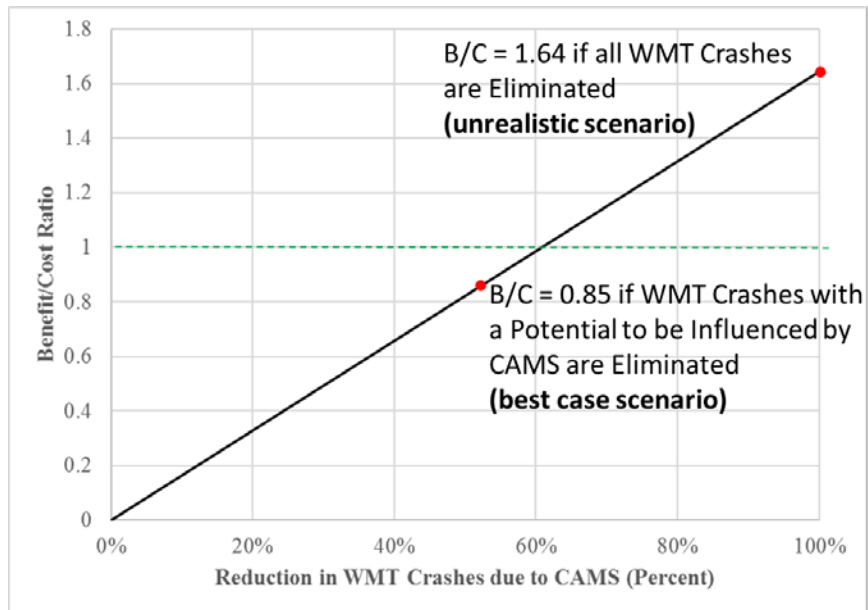
Figure 8-4 Benefit/Cost Ratio for CAMS installation

scale or camera and display elimination, then CAMS must prevent at least 30% of WMT-involved crashes for the benefits to outweigh the costs. As noted previously, the maximum percentage of WMT-involved crashes that may be prevented by CAMS has been estimated at approximately 52%.

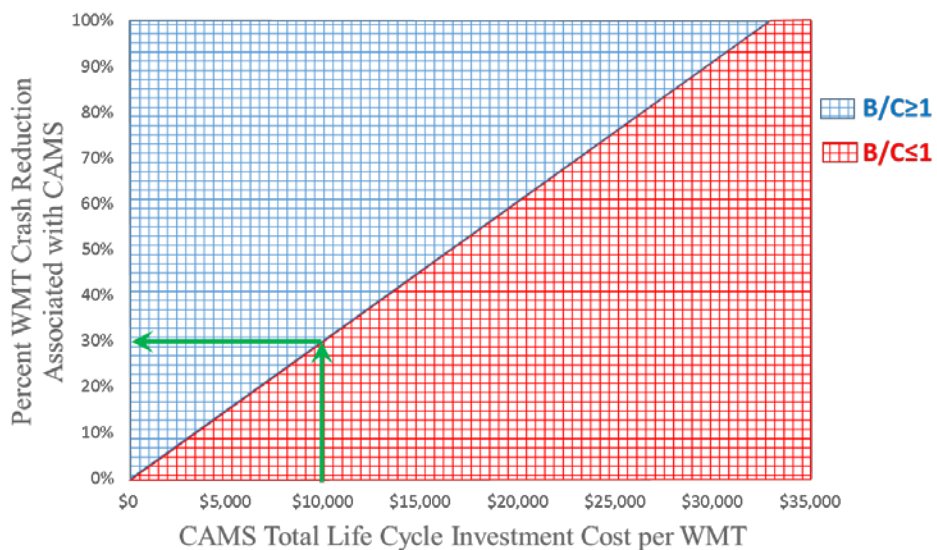
Figure 8-5 Minimum required percent reduction in WMT crashes to ensure profitability of the CAMS for any given life cycle investment cost
