Research Report UMCEE 96-10

LOAD TESTING OF BRIDGES

the Michigan Department of Transportation

Andrzej S. Nowak and Vijay K. Saraf

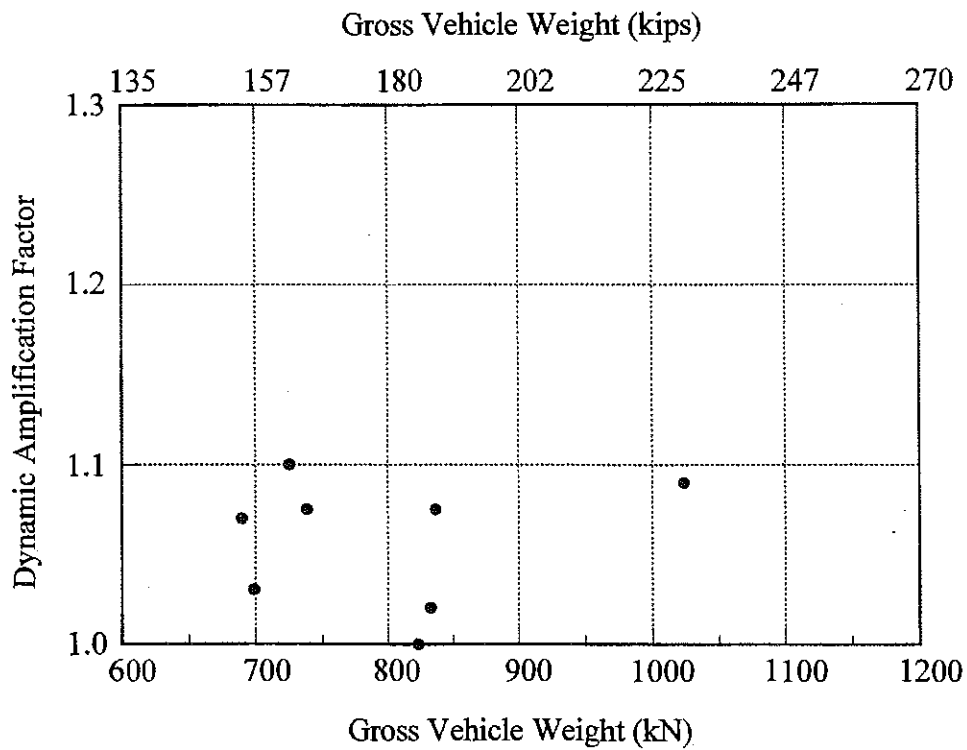
Figure 3-2 : Impact Factors for Heavy Vehicles (Nassif and Nowak, 1995).

As shown in Figure 3-2, the dynamic amplification factors for heavy 11-axle trucks were found to be less than 10 percent. Since allowable loads in Michigan are considerably different than other states, the experimental impact factors would be much more reliable than AASHTO (1992) specified impact factors (see Appendix B of NCHRP Report, 1993). In addition, both the top of the deck and the approach of

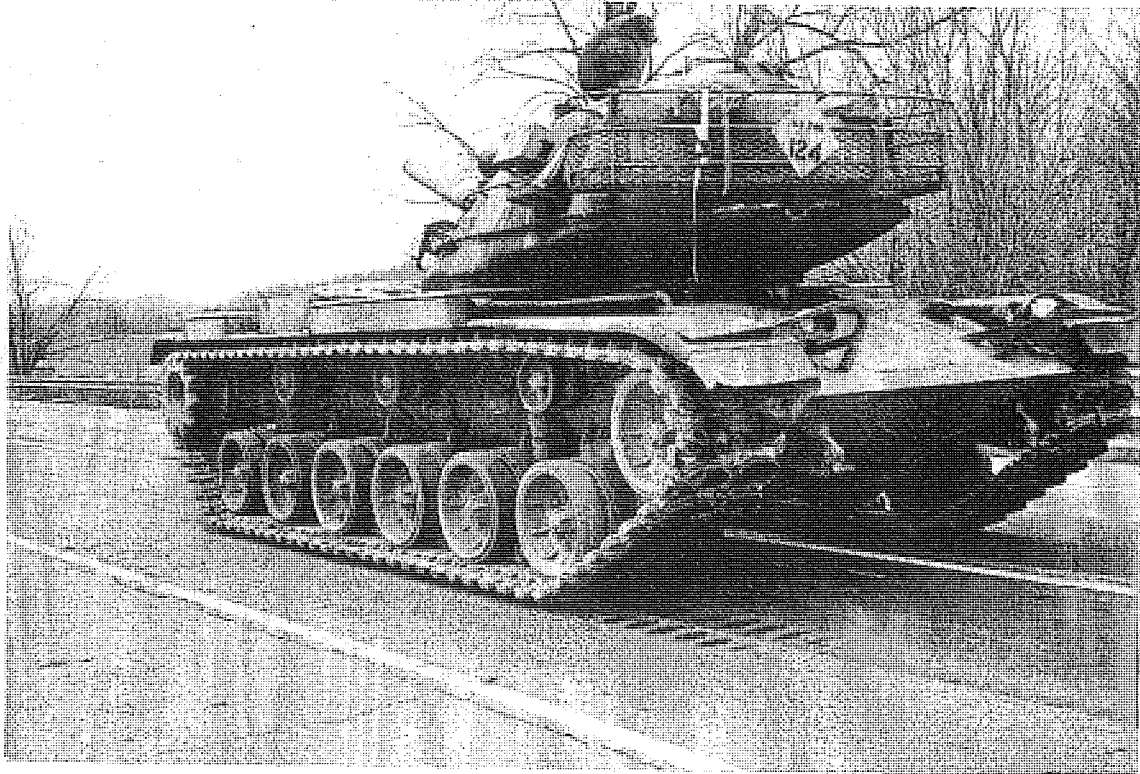
Figure 3-7 : M-60 Tank on Bridge No. 4.

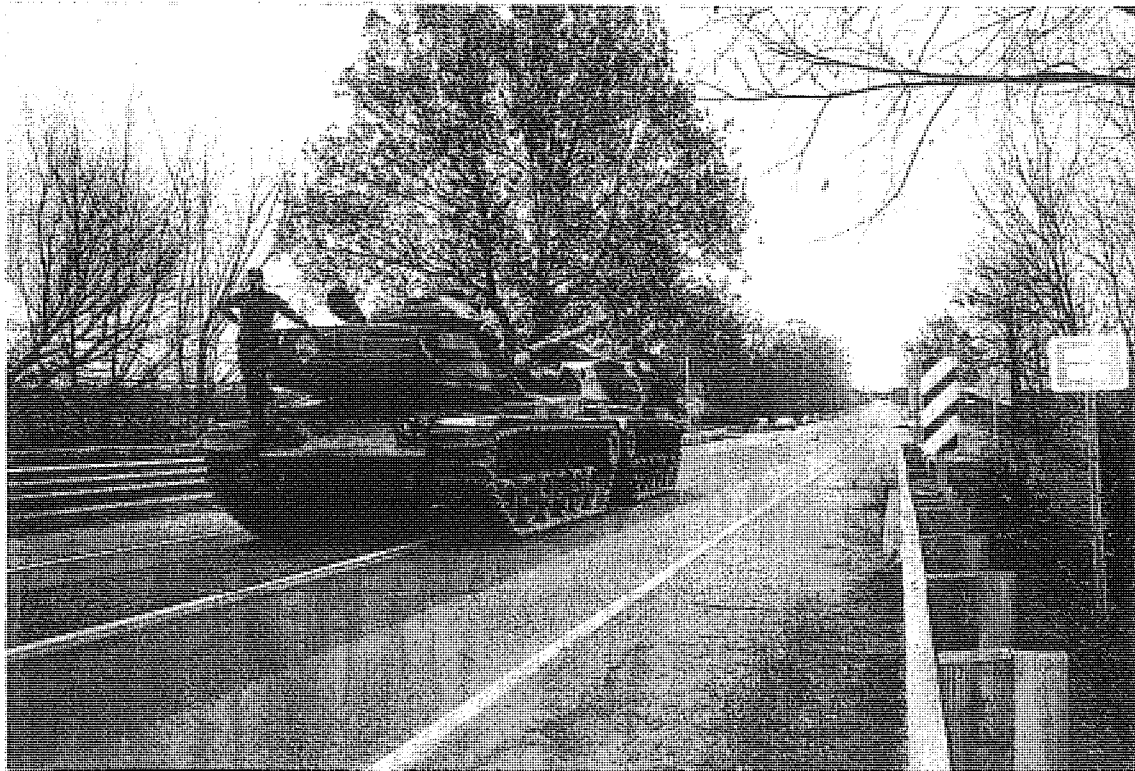
Figure 3-9: Two Tanks on Bridge No. 4.

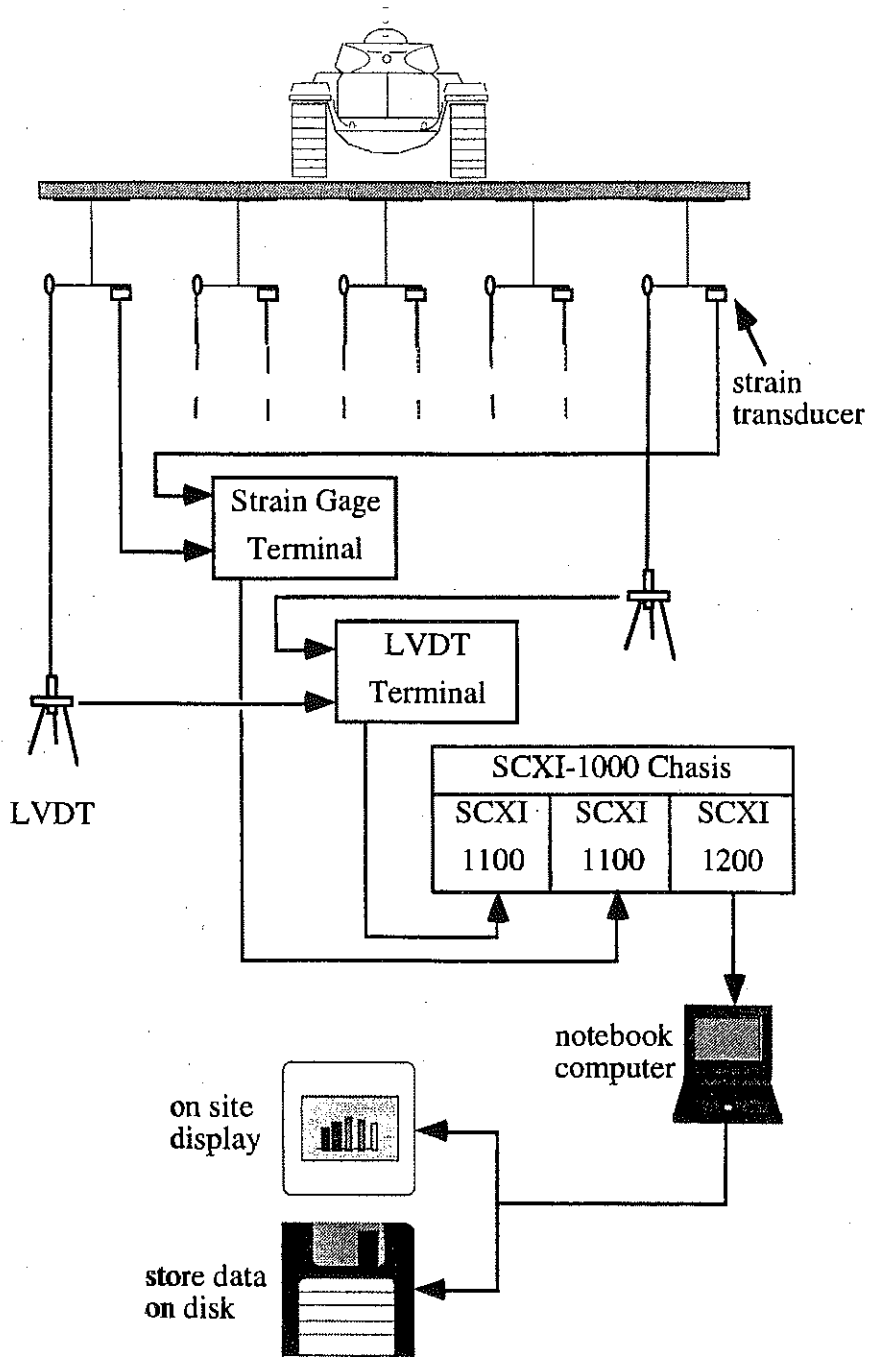
Figure 4-4 : Typical Data Acquisition Setup.

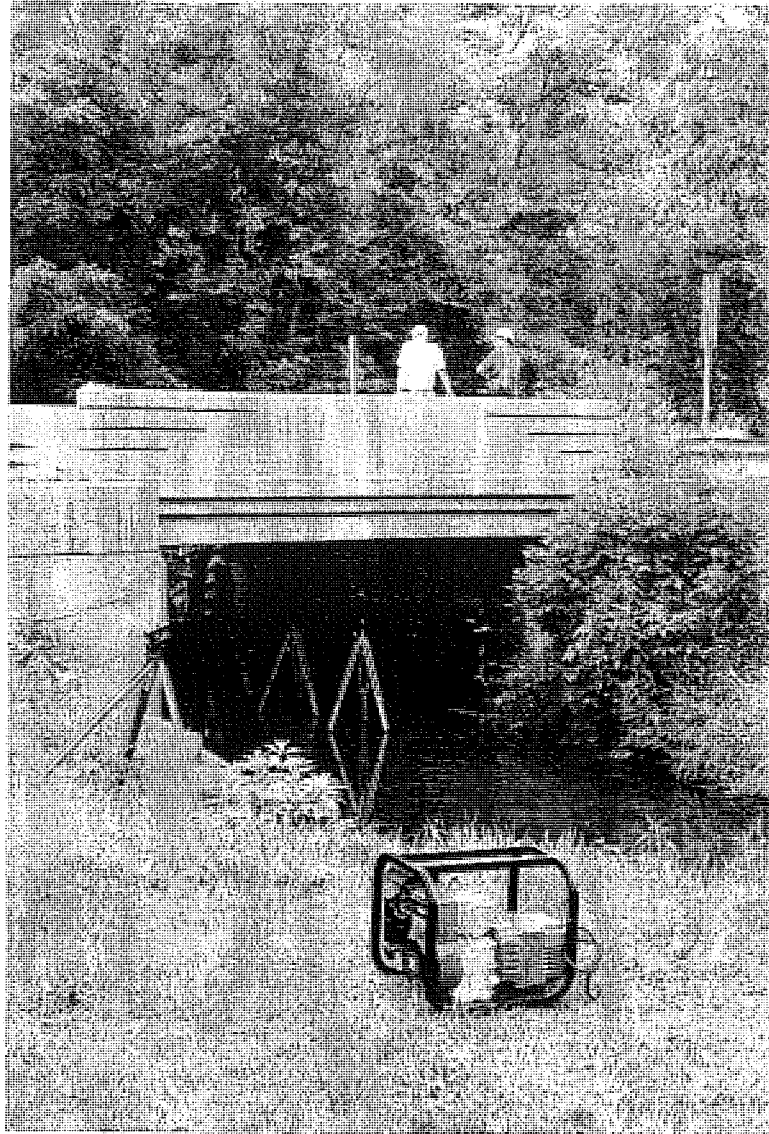
Figure 6-2 : Side Elevation of Bridge No. 1.

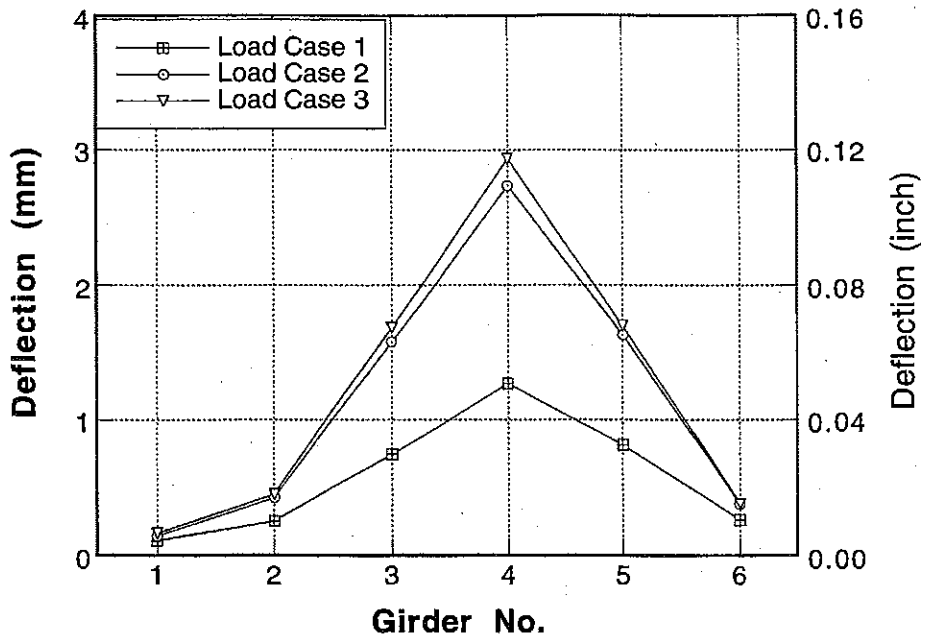
Figure 6-9 : Lateral Load Distribution for Downstream Loading on Bridge No. 1.

For most load cases, the experimental deflections were smaller than the analytically predicted values, which means that the structure is stiffer than the analytical model. The additional unaccounted reduction in deflection at mid-span is caused by partial restraint provided by end supports. The lateral distribution of deflections is also shown in Figure 6-9. Additional graphs and the processed data are listed in Appendix-A. The target proof load was reached without any noticeable non-linearity in bridge response. The new operating rating factor for a two-unit 11-axle truck is 1.21, using Equation 3-6. Therefore, the bridge was found to be safe to carry legal truck traffic.

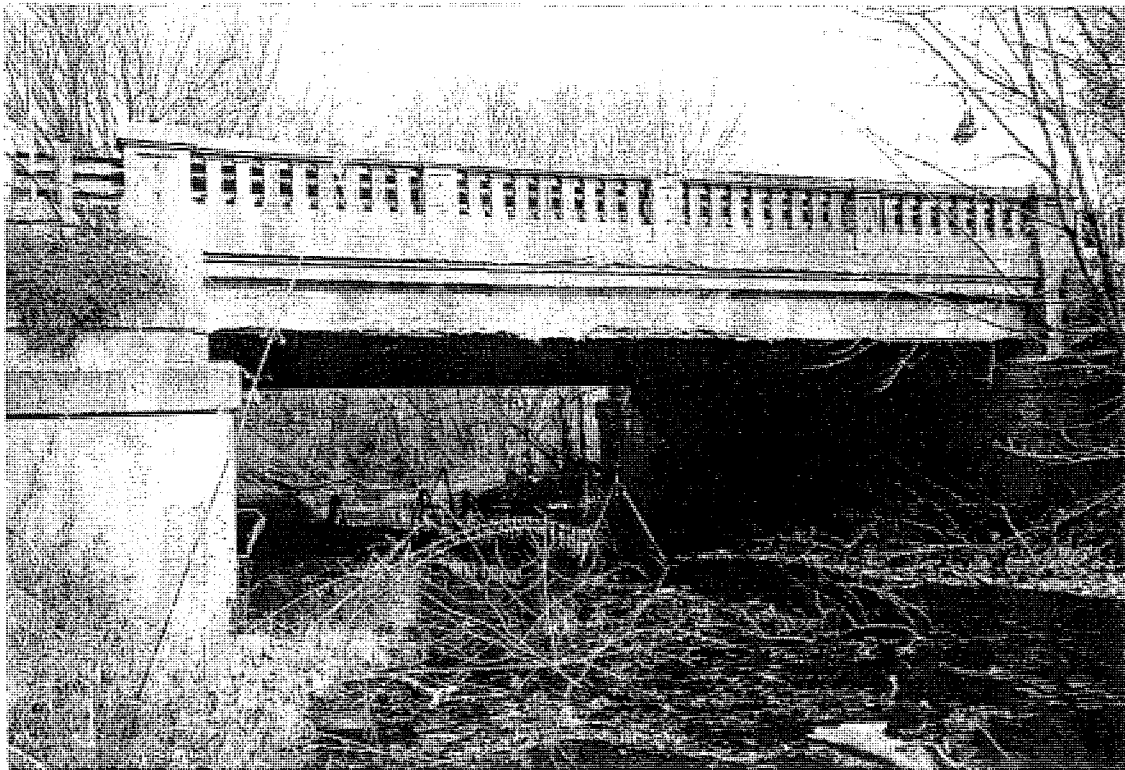
Figure 9-1 : Side Elevation of Bridge No. 4.

This bridge is located in Clinton County, Michigan, close to Ovid. It carries state highway M-21 over Little Maple River. The side elevation of the bridge is shown in Figure 9-1. It was built in 1929 and has ten steel girders with a 165 mm (6.5 in) thick concrete slab. The thicknesses of the concrete wearing surface and the asphalt are 152 mm (6 in) and 76 mm (3 in), respectively. The width of the structure is about 22.2 m (74 ft) and the span length is 11.7 m (38.5 ft). The ADT on this bridge is about 5,100. The cross-section and the girder details are shown in Figure 9-2.
