Final Report

Impact of Non-Freeway Rumble Strips

Phase 1

June 26, 2012

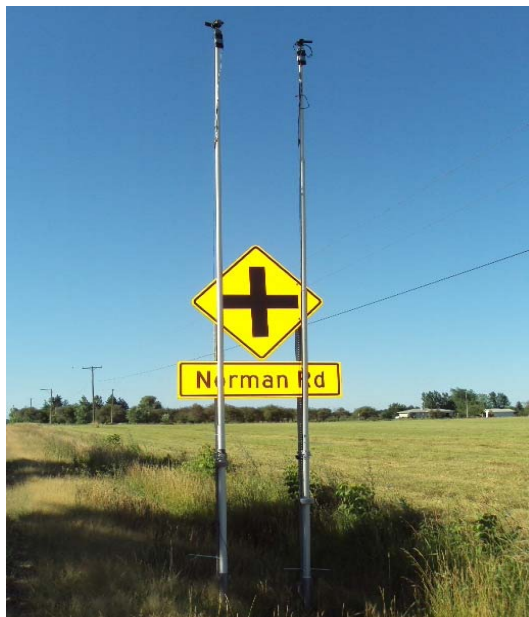
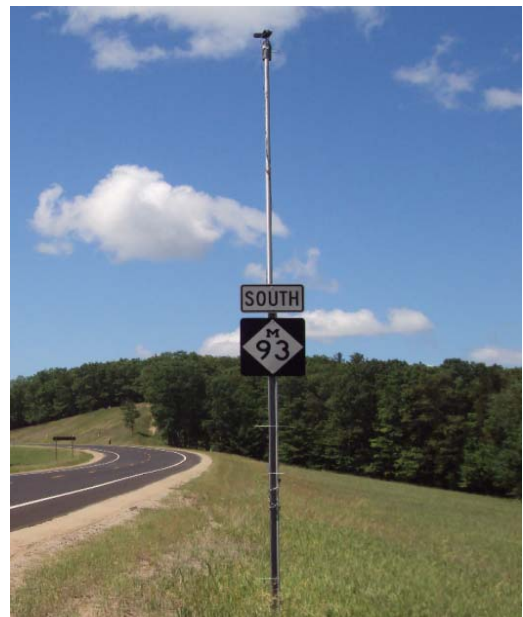
Figure 3. Typical Elevated Video Camera Setup

A single camera setup was utilized at the curve locations and was mounted in a position that maximized the field-of-view of vehicles traveling through the curve and the adjacent tangent segment of the highway. The maximum clear viewing distance along a roadway for a single camera location was approximately 1,000 feet. The passing zone locations utilized two cameras mounted at the same telescopic pole location, but the cameras were aimed in the opposite directions. The two-camera setup doubled the effective viewing distance and greatly increased the likelihood of capturing all passing events. Examples of the video camera setups for both passing zones and curve locations are shown in Figure 3. These camera setups on existing roadside posts created a concealed environment to capture driver behavioral data and retrieve quality data for verification.

a. Passing Zone (two cameras in opposing directions)

b. Curve (single camera aimed towards curve)

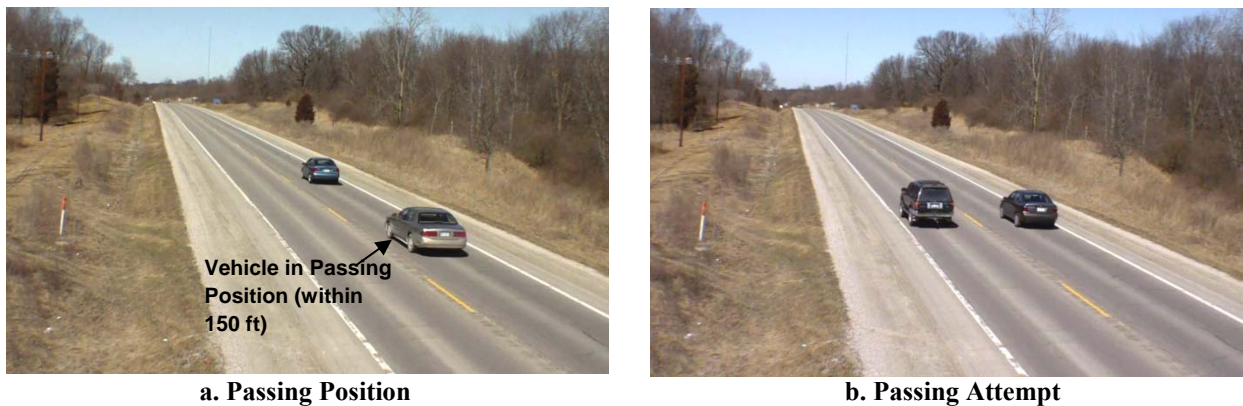
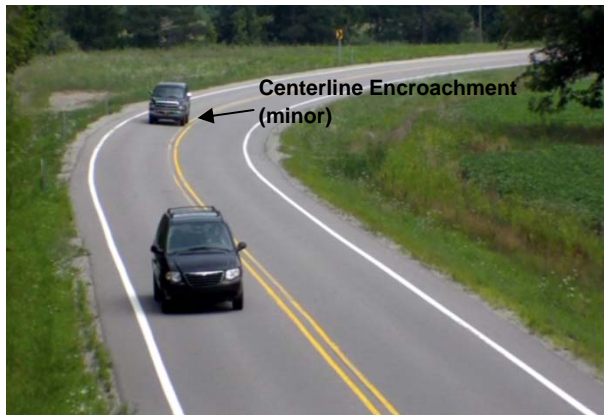
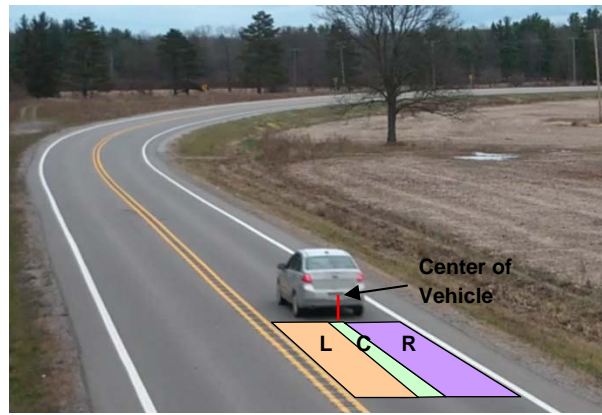
Figure 4. Example Driver Behavior Assessment

Each vehicle was monitored to determine if a centerline or edgeline encroachment occurred at any point along the visible portion of the tangent section or curve section. Encroachments were categorized based on whether the vehicle’s near tire either touched or completely crossed over the centerline or edgeline at the most extreme point. Tangent encroachments and curve encroachments were counted separately for each vehicle traveling through the study section.

c. Centerline Encroachment (Curve)

d. Lateral Lane Placement Assessment (Tangent)

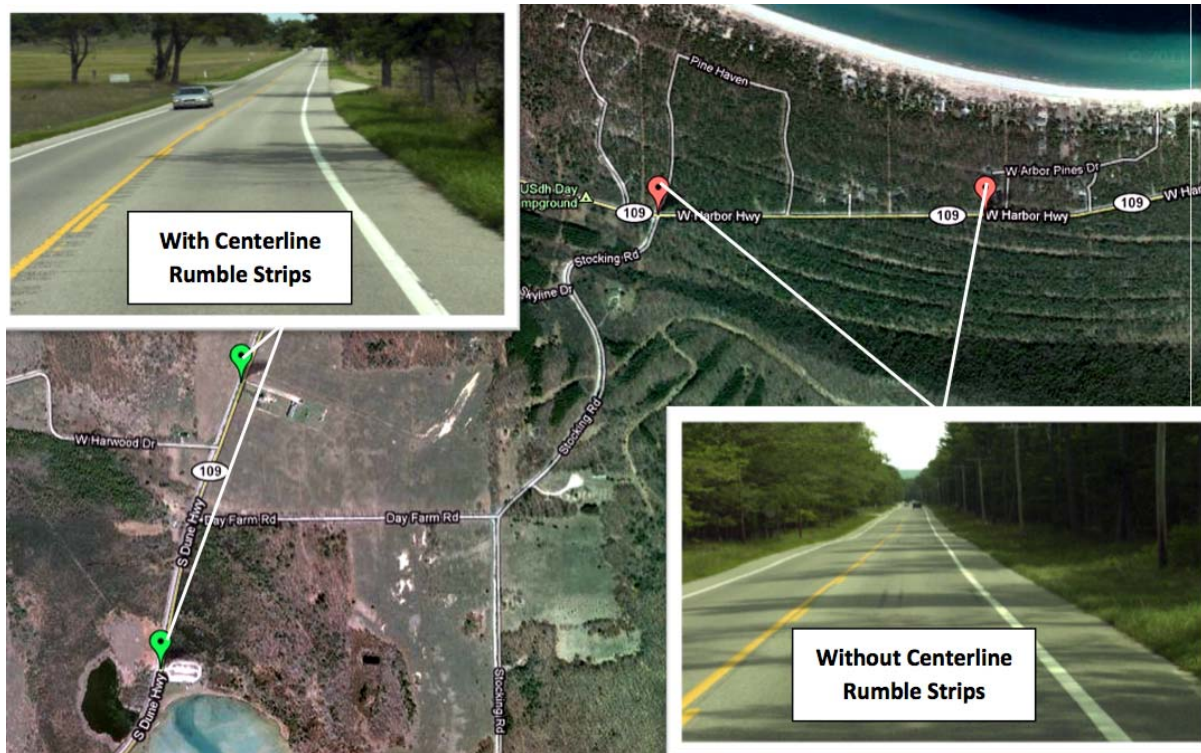
Figure 5. Study Segments

In order to evaluate the driver behavior in the presence of bicyclists, a field study was conducted on Michigan Highway 109 (M-109), shown in Figure 5. It is a two-lane rural section of MDOT trunkline in the northwestern Lower Peninsula and serves as a popular bicyclist route, particularly during the summer.

M-109 is unique in that it includes one stretch where there are consecutive segments that are identical, with the exception of centerline rumble strips. This feature creates an appropriate setting for a controlled comparison of driver behavior when passing bicyclists with respect to the presence of centerline rumble strips. Two 0.5-mile long segments of M-109 were selected for the purposes of this field study. These segments were separated by a distance of approximately 1.1 mile distance and were selected to control for two factors: (1) roadway geometry and (2) individual driver behavioral characteristics. Selecting two locations in close proximity to one another, along the same route, allowed for both of these concerns to be addressed in this study. Each segment consisted of a relatively straight, level alignment, with identical posted speed limits (55 mph), lane widths (11 ft), and shoulder widths (4 ft). Neither of the two segments included shoulder rumble strips. Furthermore, given their close proximity, most of the drivers that were observed, passed over both study segments during the analysis period. Centerline rumble strips were installed on the southernmost of these two segments and their presence was the only substantive difference between the two. The centerline rumble strip dimensions were as follows:

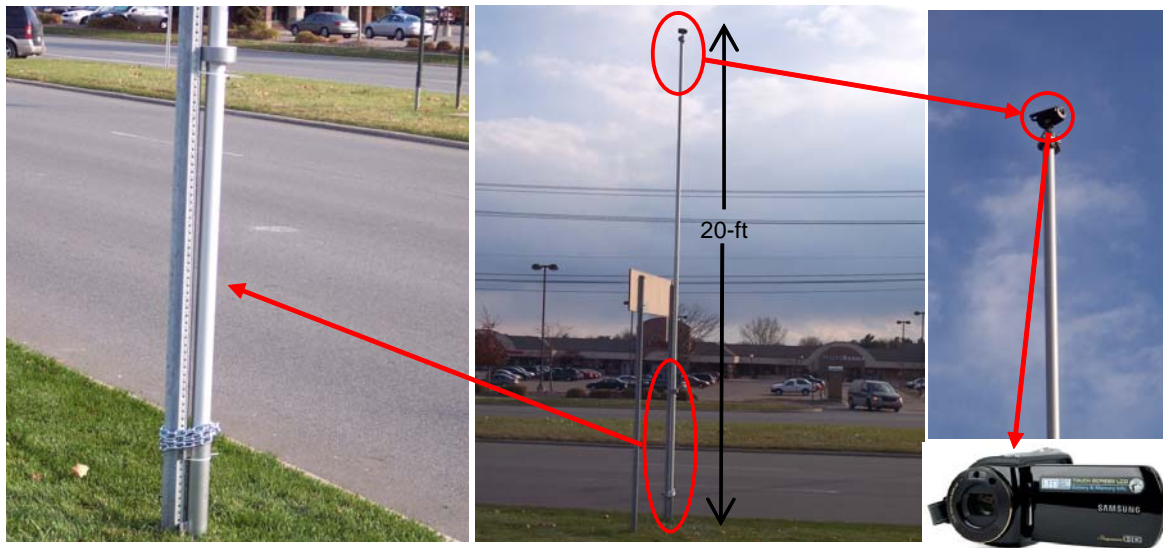
Figure 6. Field Setup for Elevated Video Recording of Road User Behavioral Data

In order to assess the lateral placement of each motor vehicle observed, a series of four pole-mounted, high-definition cameras were setup on each side of the roadway throughout each 0.5-mile study segment. These cameras were mounted on top of 20-ft tall poles that were secured to roadside signposts. An example of this elevated camera installation, which has been used previously in a series of field studies of road user behavior (39,36,44), is shown in Figure 6. This data collection method was completely unobtrusive, involved no interaction with road users, and allowed for data collection without influencing driver or bicyclist behavior.

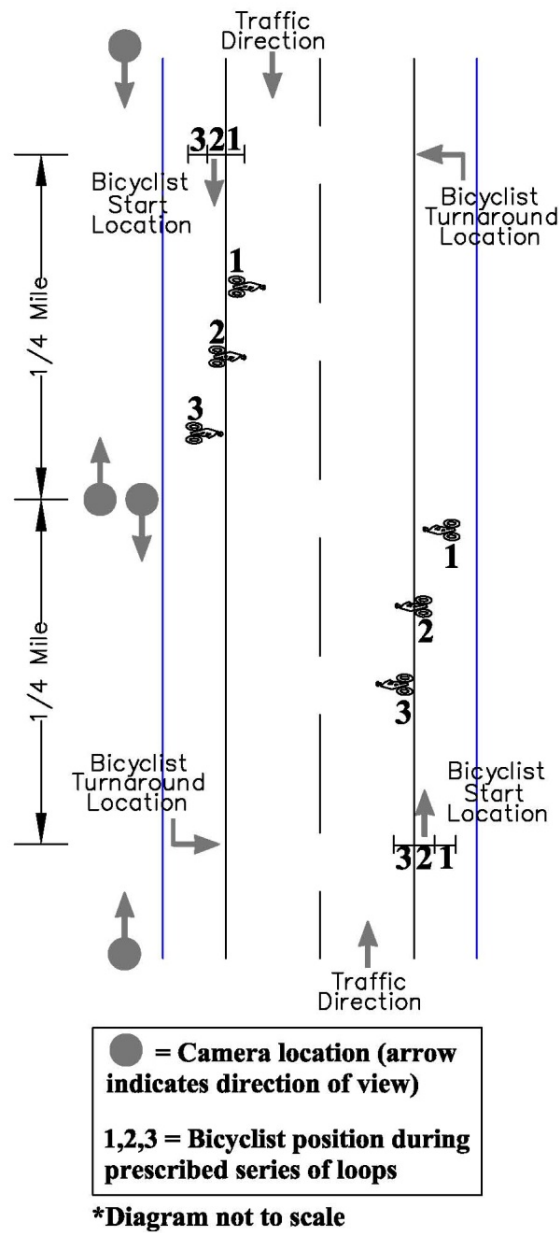
Figure 7. Schematic Diagram of Data Collection Plan

lateral position for approximately one hour before taking a break and continuing in a different lateral position during the subsequent loop. The loops were evenly distributed among three predetermined lateral positions, which included: (1) within the center of the shoulder; (2) on the left edge of the shoulder; and (3) on the right edge of the travel lane. A schematic of the data collection plan is shown in Figure 7.

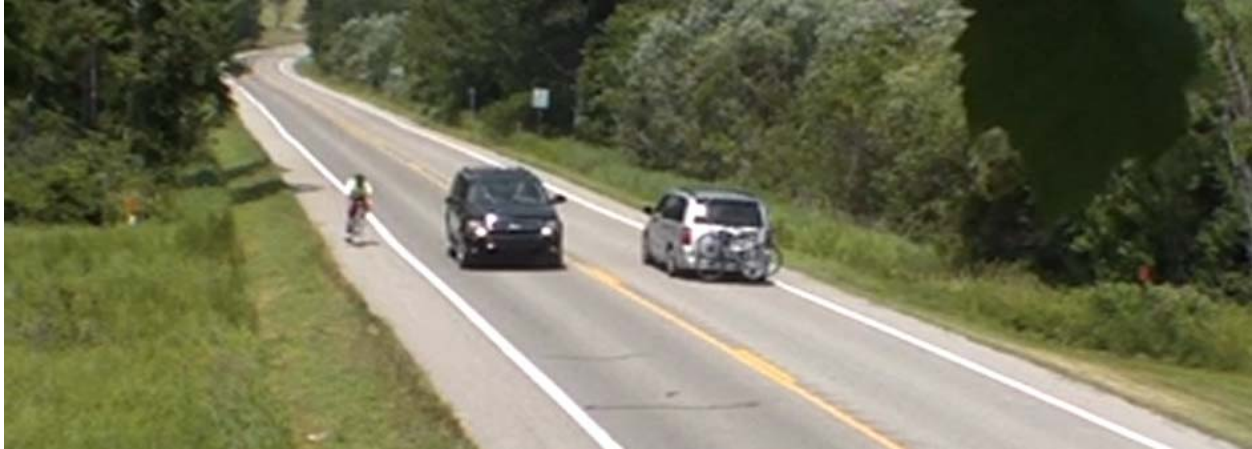
Figure 8. Example Screenshot of Video Review

After completion of the field data collection, the videos were transferred to a computer for review and data extraction. During the video review, data were randomly checked to ensure continued consistency and precision among observers, as well as compliance with the review protocol. Figure 8 shows an example screenshot from a video review.

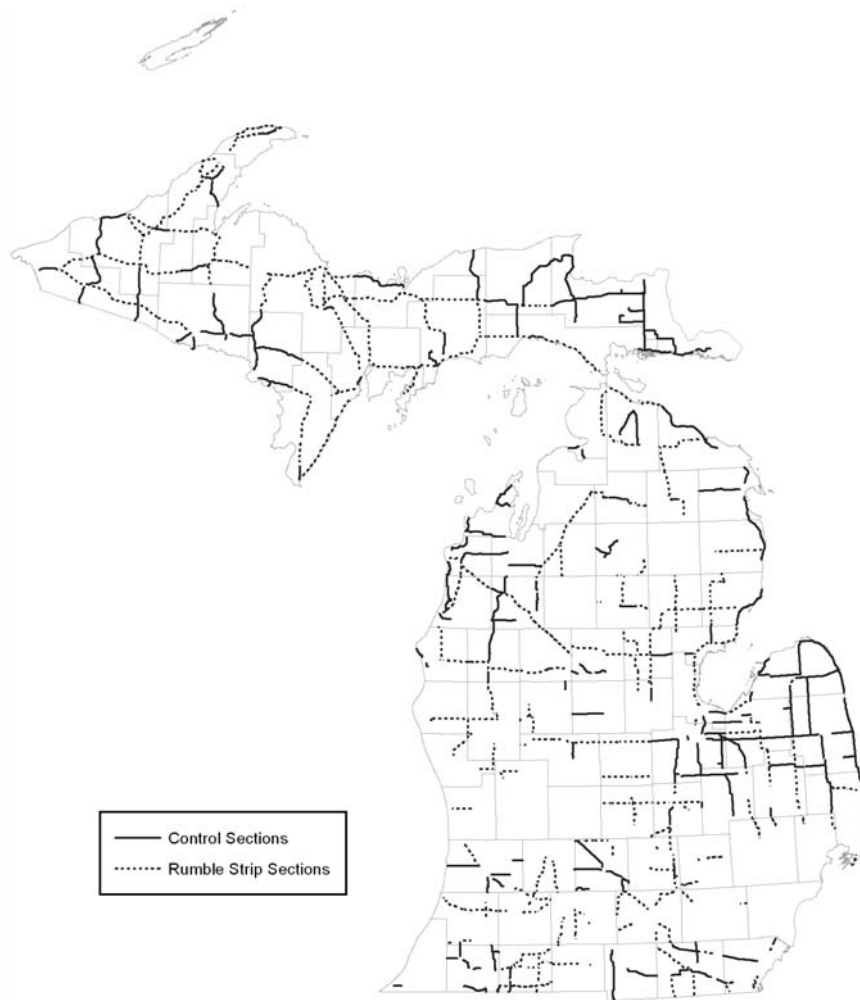
Figure 9. Map of Rumble Strip and Control Sections

Imagery data for the years 2006 to 2010 were obtained for the purposes of this study. In order to determine the impacts of centerline rumble strips on short-term pavement performance, the change in the number of cracks intersecting the centerline over a two-year period (also referred to as crack propagation) was used as the performance measure. In order to allow for a controlled comparison to isolate the effects of rumble strips on crack propagation, a database was created that disaggregated all MDOT, high-speed, rural non-freeways into 0.1-mile segments. This database included information on the roadway geometry, traffic volume, and geographic location, as well as whether centerline rumble strips had been installed at the location. These segments were subsequently combined into larger, longer one mile segments, each of which shared similar geometric, traffic, and geographic characteristics. Figure 9 provides a statewide map that illustrates the locations of rumble strip and control sections that was used in the study of short-term pavement performance study.

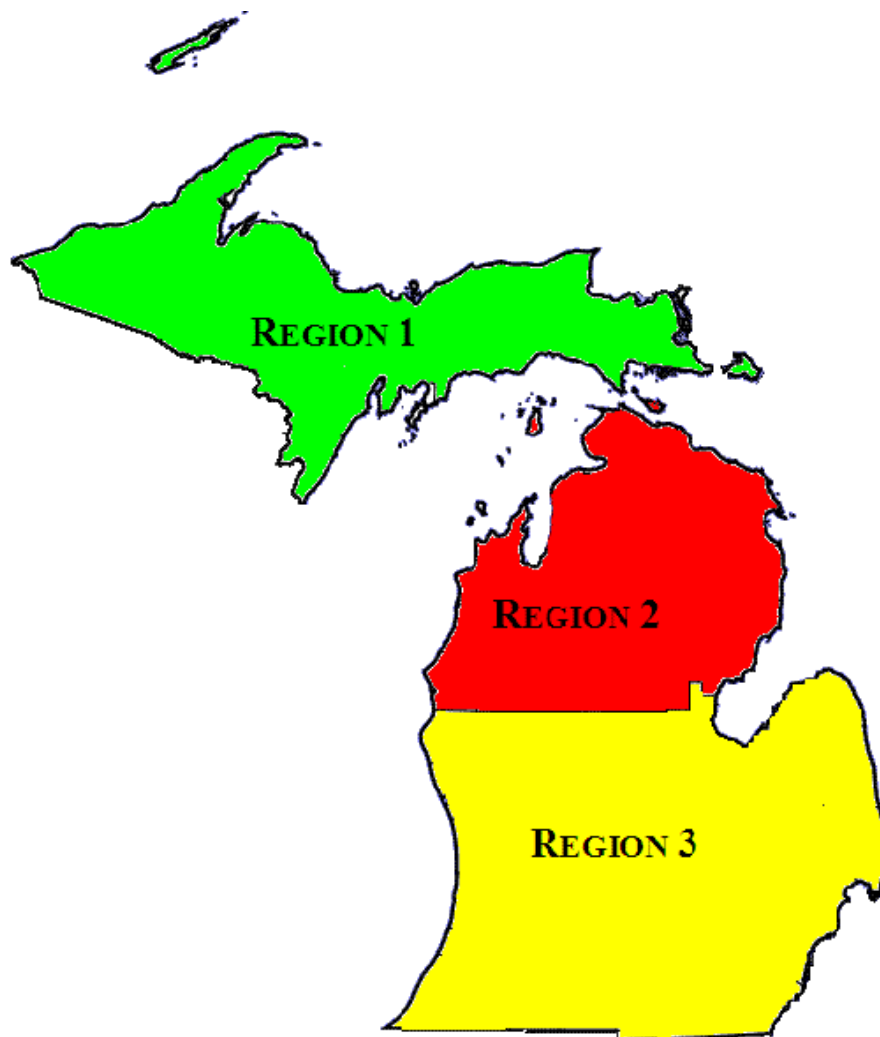
Figure 10. Map of Michigan Geographic Regions

Northern Lower Peninsula (Region 2), and the Southern Lower Peninsula (Region 3) as shown in Figure 10. These regions were selected largely based upon similarities in weather, as differences in Michigan's freeze-thaw cycles are likely to impact pavement performances.

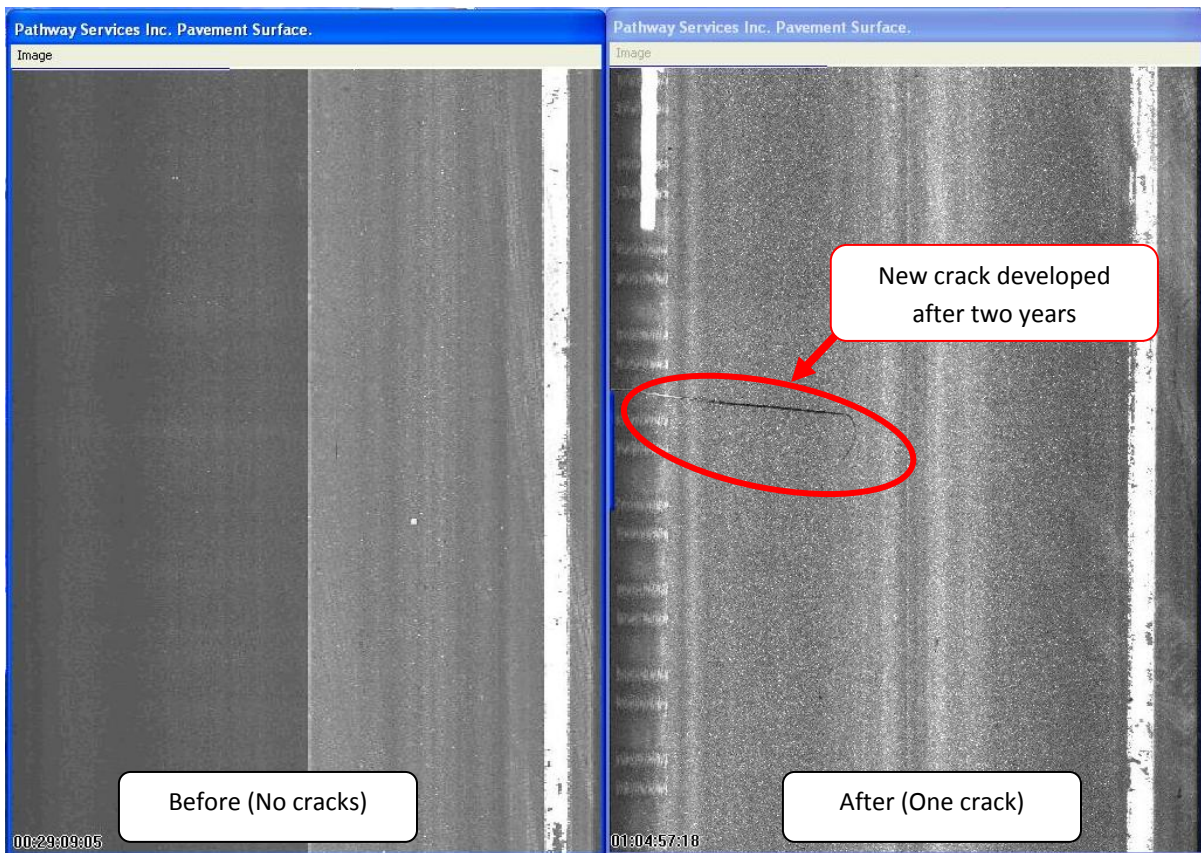
Figure 12. Example Pavement Imagery from Before and After Rumble Strip Installation

For the purposes of this study, only transverse cracks that intersected the centerline were counted, as these are the types of cracks most directly related to the rumble strips. Longitudinal cracks or transverse cracks that did not intersect the centerline were assumed to be due to other factors. Figure 12 shows example imagery from a specific segment before and after rumble strip installation. It can be observed from this image that one new transverse crack had developed.

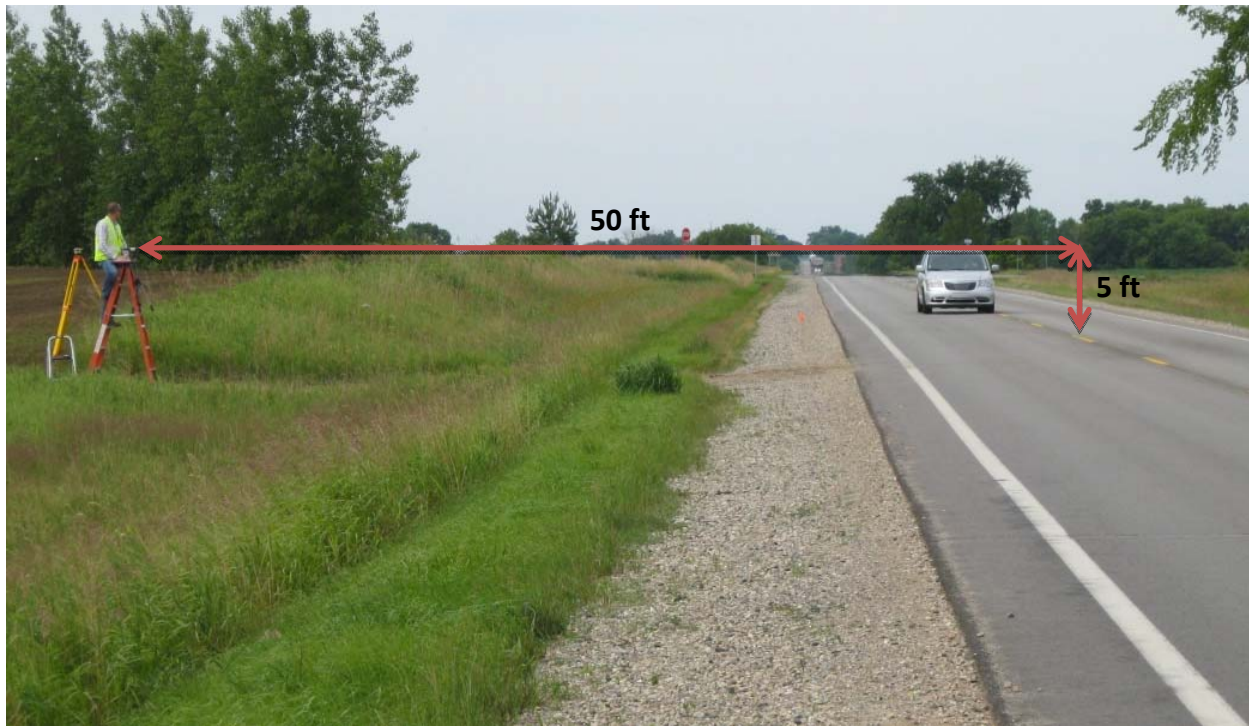
Figure 13. Example Sound Meter Setup and Test Vehicle Pass

A Tenma digital sound meter with a foam windscreen was utilized for the noise measurements. The sound meter was placed at a suitable roadside location that was 50 ft away from the roadway centerline at a height of 5 ft above the pavement surface, as recommended by the FHWA for roadside noise measurement (34). The 50 ft lateral offset is also consistent with MDOT’s procedure for roadside noise measurement on rural roadways. To ensure that the peak noise measurement was recorded during each pass of the test vehicle, the sound meter was programmed to measure at the fastest possible rate of one measurement per 125 milliseconds. A typical sound meter setup and test vehicle pass is shown in Figure 13.

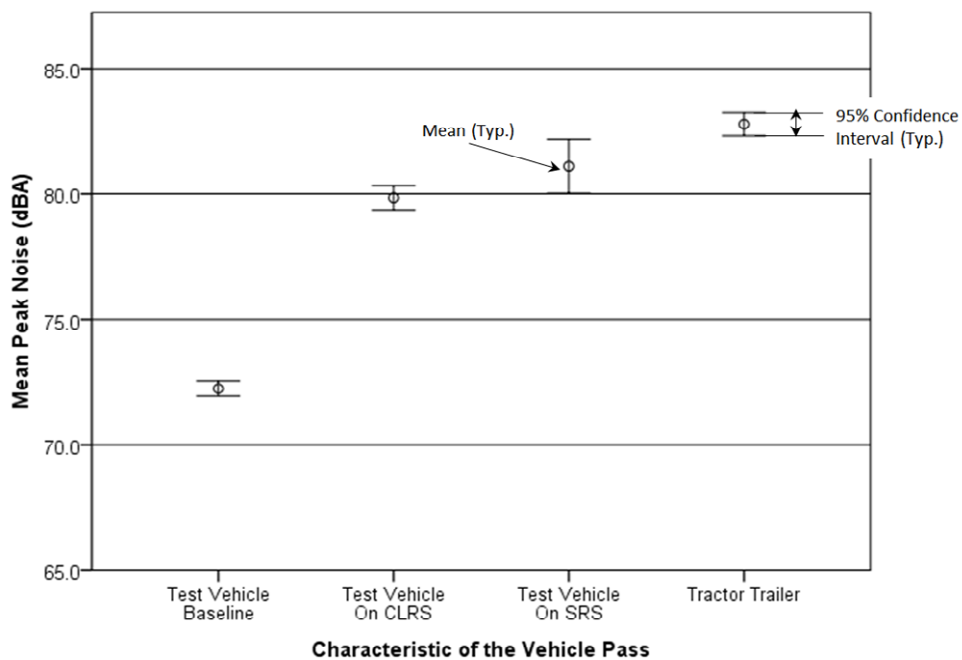
Figure 14. Test Vehicle Noise Data Summary

It can be observed from Table 18 (page 55) that the overall baseline mean peak noise produced by the test vehicle traveling at 55 mph without contacting the rumble strip was 72.61 dBA. Contact with the CLRS during the test vehicle passes produced an increase in overall mean peak noise by 8.11 dBA to 80.72 dBA. Contact with the SRS produced an even greater mean noise level of 82.57 dBA. The sample of random tractor trailers produced mean peak noise levels of 83.08 dBA. The aggregated mean peak noise results are displayed graphically in Figure 14 along with the 95 percent confidence intervals.

The one-way ANOVA found these differences in noise levels with respect to the characteristics of the passing vehicle to be statistically significant at a 95 percent level of confidence. A post-hoc analysis using Tukey HSD showed that the mean noise produced by the test vehicle traveling over the SRS was not significantly different from that of either the CLRS or tractor trailers. While the mean noise produced by the test vehicle in contact with the CLRS was not significantly different from the SRS, it was significantly lower than what was produced by the tractor trailers.

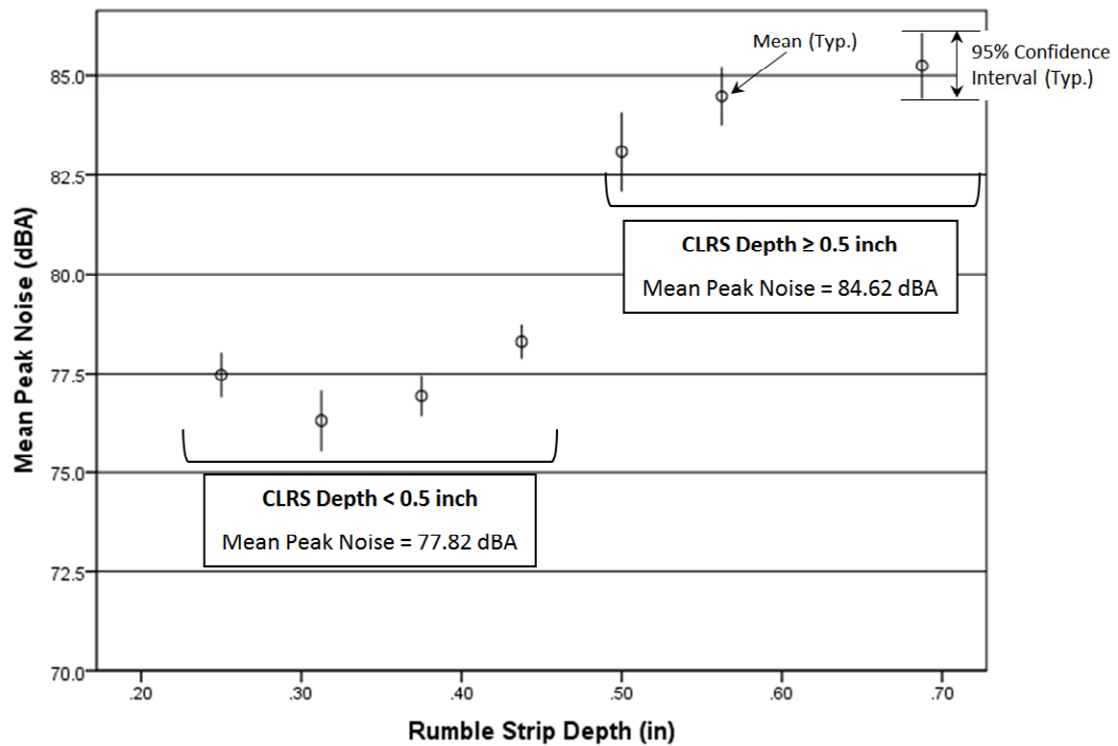
Figure 15. Impacts of CLRS Depth Using Test Vehicle

The depth of the CLRS had the greatest effect on noise produced by the test vehicle when it made contact, as indicated by the relative magnitude of the F-statistic. Figure 15 provides a graphical representation of peak CLRS noise measurement versus depth. As expected, CLRS noise levels were positively correlated with the depth of the corrugations, although this correlation was non-linear, as evidenced by the sharp increase in peak noise at depths of 0.5 inches. For CLRS with depths of less than 0.5 inches, the mean peak noise was 77.82 dBA. For CLRS with depths of 0.5 inches and greater, the mean peak noise increased by 6.8 dBA to 84.62.
